MINISTRY OF WORKS, TRANSPORT AND COMMUNICATION

AIRCRAFT INCIDENT REPORT

REF: INCID/112903/14-101

Aircraft Type, Registration and Serial No :	Cessna 414 ZS-LZD/4140619
No and Type of Engines :	Two Continental TSIO 520J
Year of Manufacture :	1974
Date and Time (UTC) :	29 th November 2003, 0900 hrs
Location :	Rundu Airport Taxiway
Type of Flight :	Private
Persons on Board :	Crew - 2 Passengers - Nil
Injuries :	Crew - Nil Passengers - Nil
Nature of Damage :	Propellers, Nose wheel, Undercarriage
Commander's License :	CPL
Commander's Age :	33 years and 8 months
Commander's Flying Experience :	2.400 hours
First Officer's Flying Experience :	(co-pilot) not applicable not required for this type of aircraft
Information Source :	Incident Report

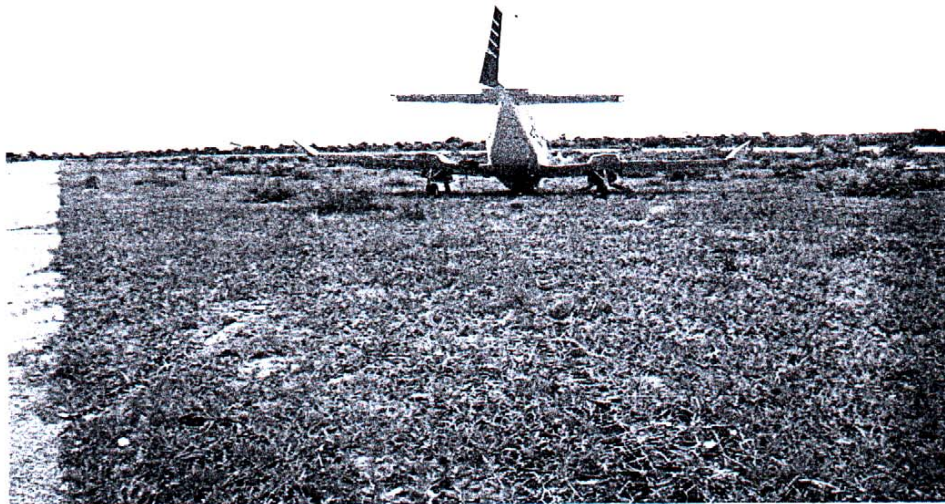
Angola. The taxiway to the holding point for take-off, the pilot lost directional control of the aircraft and it went out of the taxiway into the soft sandy area. When the nose wheel entered the sandy area, the nose landing gear collapsed and both propellers contacted the ground. The propellers were damaged and the aircraft sustained substantial damages.

The directional control loss caused the aircraft to leave the taxiway and entered into a sandy (soft) area which resulted in the collapse of the nose gear and subsequent damage of the cone and propeller blades.

- i. It is recommended that pilots should not taxiing too fast on the taxiway.
- ii. It is recommended that pilots should not fly any aircraft without validation from the aircraft's state of registry.
