# SOUTH AFRICAN CIVIL AVIATION AUTHORITY

## AIRCRAFT INCIDENT REPORT AND EXECUTIVE SUMMARY

<b>Aircraft Registration</b>	<b>ZU-DAX</b>	<b>Date of Incident</b>	29 September 2005	<b>Time of Incident</b>	0741Z
<b>Type of Aircraft</b>	Jabiru SP	<b>Type of Operation</b>	Training		
<b>Pilot-in-command Licence Type</b>		<b>Age</b>	25	<b>Licence Valid</b>	Yes
<b>Pilot-in-command Flying Experience</b>	Total Flying Hours	1 285	<b>Hours on Type</b>	68	
<b>Last point of departure</b>	George Aerodrome (FAGG)				
<b>Next point of intended landing</b>	George Aerodrome (FAGG)				
<b>Location of the incident site with reference to easily defined geographical points (GPS readings if possible)</b>					
On runway 11 at George Aerodrome (FAGG)					
<b>Meteorological Information</b>	Wind: 100 %05 kts; Visibility: Good; Temperature: 20 °C; CAVOK.				
<b>Number of people on board</b>	1 + 1	<b>No. of people injured</b>	0	<b>No. of people killed</b>	0
<b>Synopsis</b>	<p>During a training flight in the George area, the instructor and student pilot informed the Aviation Training Organisation that they were experiencing mechanical problems with the elevator control system. The aircraft was responding only to

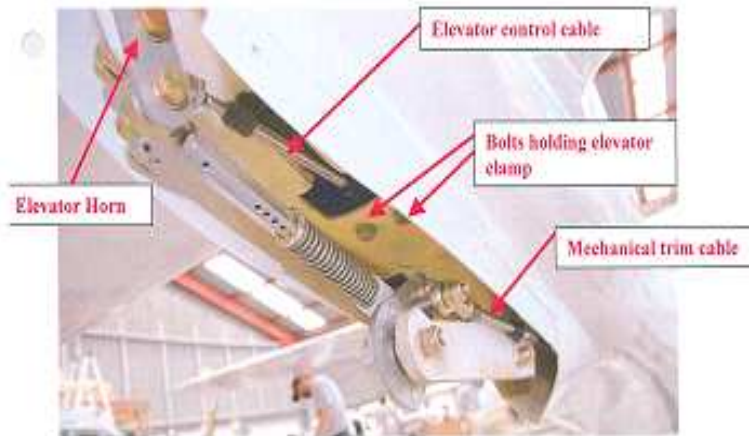
- (2) The rear capture of the push-pull cable was found to have moved from its installation. This was due to the detent on the rear capture not being correctly installed. See photographs below.

**Figure 1.** The elevator control cable installation at the anchor point.

- 3.1.4 During an inspection performed by the manufacturer, it was found that the rear capture elevator push-pull cable had moved or was incorrectly installed.

- 3.2.1 The aircraft landed hard on the runway, causing the nose gear to collapse, which in turn damaged the propeller.
- 3.2.2 It is considered that the elevator control cable moved as a result of the anchor point clamp not being properly installed.

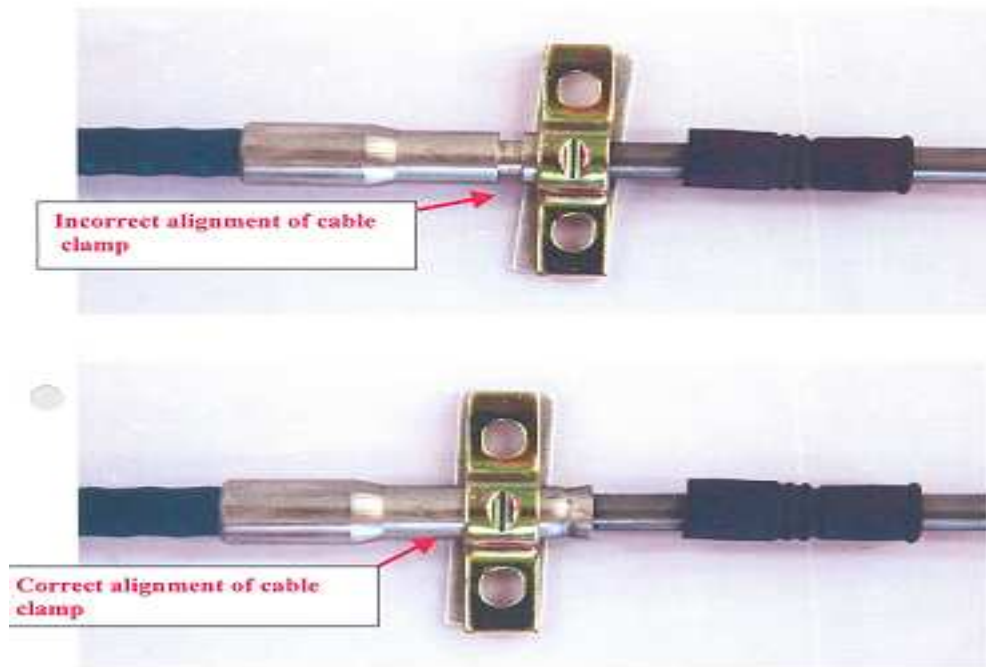
**Figure 2.** The anchor point cable clamp installation

1.16.7 As stated above in [1.16.1(ii)], the manufacturer found that the rear anchor point clamp had moved. As part of the investigation, a physical inspection was done on the anchor point installation. The conclusion was that it is not possible for the anchor point clamp to move, due to the fact that it is held into place by two (AN3-10A) type bolts, tightened by nylock-nuts as required. (See Figure 5 for method of bolt installation)

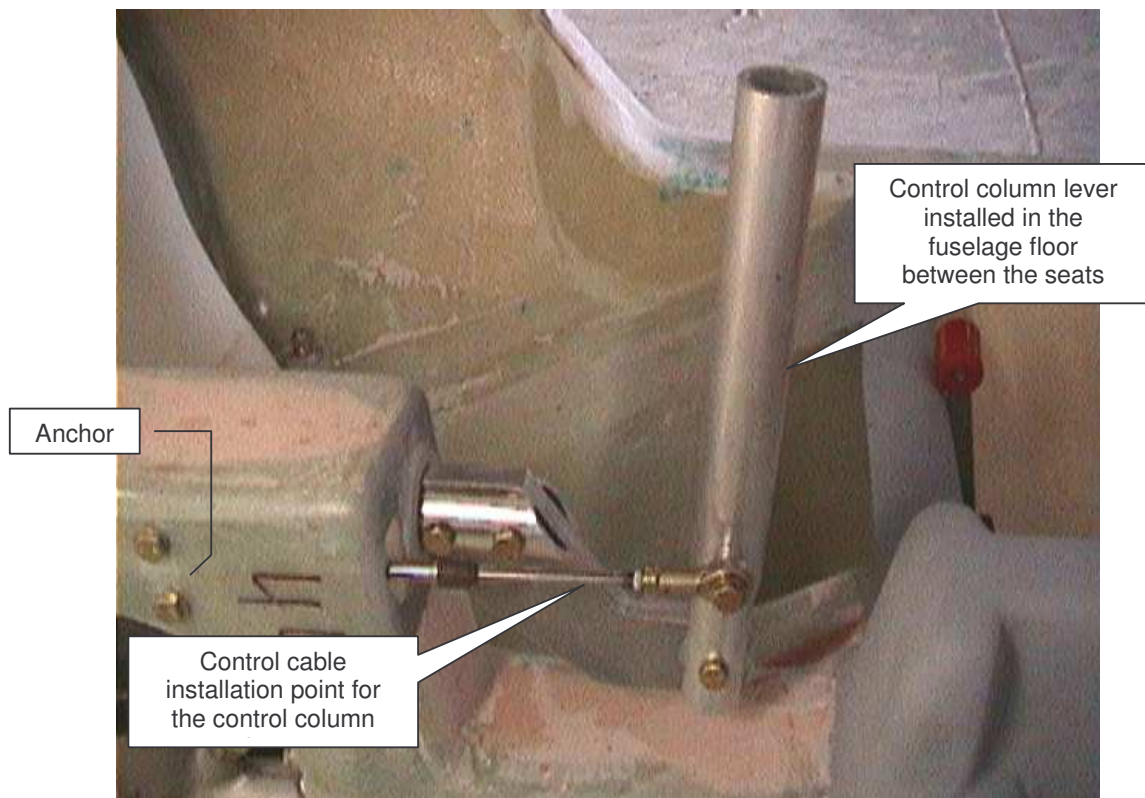
1.16.4 The elevator control system is operated from the control column lever located in the cockpit of the aircraft. Elevator control is activated through the forward and aft (push and pull) movement of the control column lever by the pilot. The control cable is installed and routed from the control column lever, secured by the first anchor point clamp in the cockpit. The control cable (green sheath, 3 655 mm) is installed through the length of the airframe and to the tail section of the aircraft. (See Figure 3 below)

**Figure 3.** Elevator control column and cable installation in the cockpit.

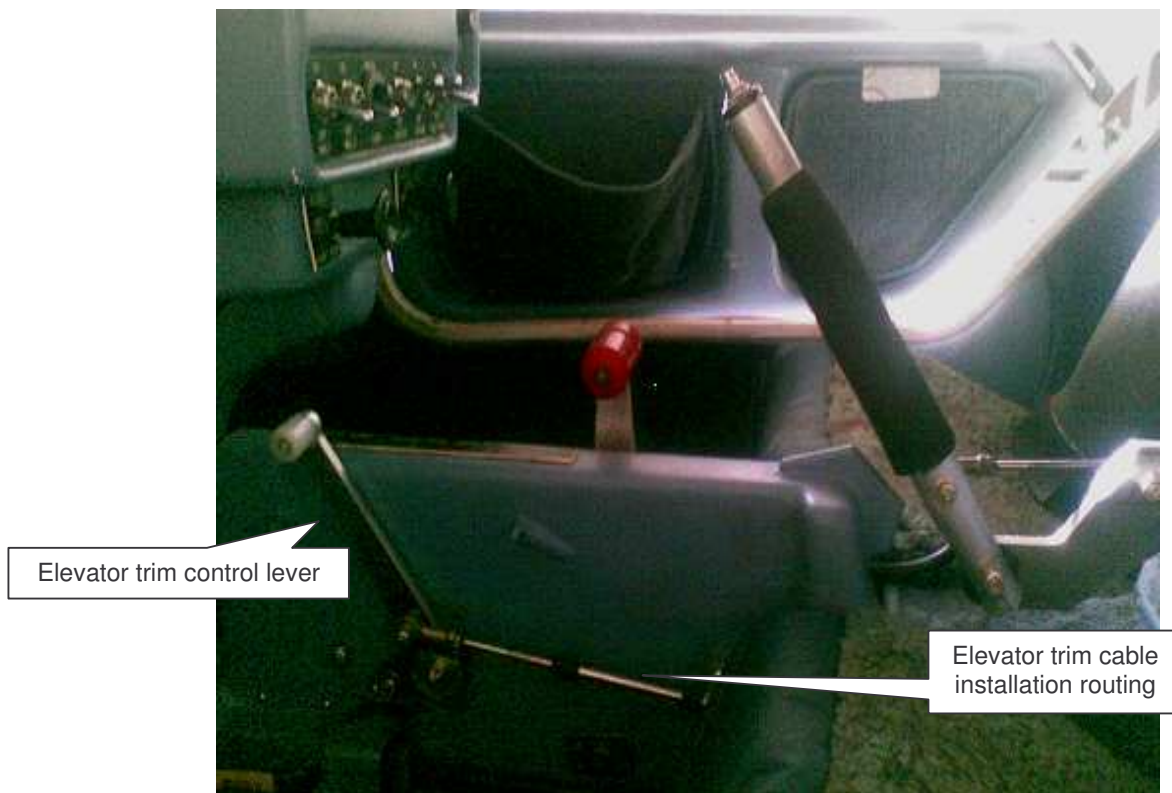
- 1.16.5 The elevator trim control system is operated from a control lever located in the cockpit of the aircraft. The trim system is activated through the forward (nose-down) and aft (nose-up) movement of the trim control lever by the pilot. The trim control lever is secured by an anchor point clamp in the cockpit. The cable is routed through the length of the airframe to the tail section of the aircraft. (See Figure 4 below)

**Figure 4.** Elevator trim control system Installation.

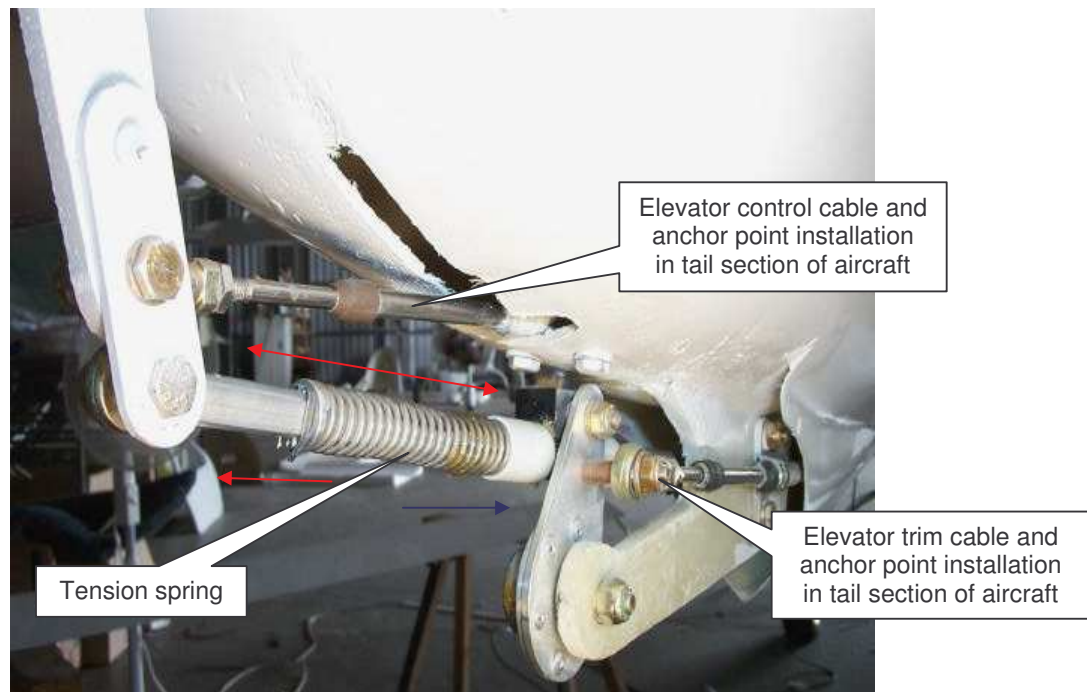
- (ii) If the trim control lever is pushed to the nose-down or nose-up position, the elevator control column moves in the same direction. What can be concluded is that the elevator control lever movement operates independently from the trim system. On the other hand, it was found that mechanically, any input on the trim control lever subsequently has an influence on the elevator control column, due to the fact that the two control systems are mechanically connected. It was found that irrespective of which control system became defective, the pilot would still be able to control the elevator. This was unless a deficiency occurred, such as where the elevator flight control surface unexpectedly became stuck for some reason. (See Figure 5 below)

**Figure 5:** Elevator flight surface and control mechanism in the rear of the aircraft.

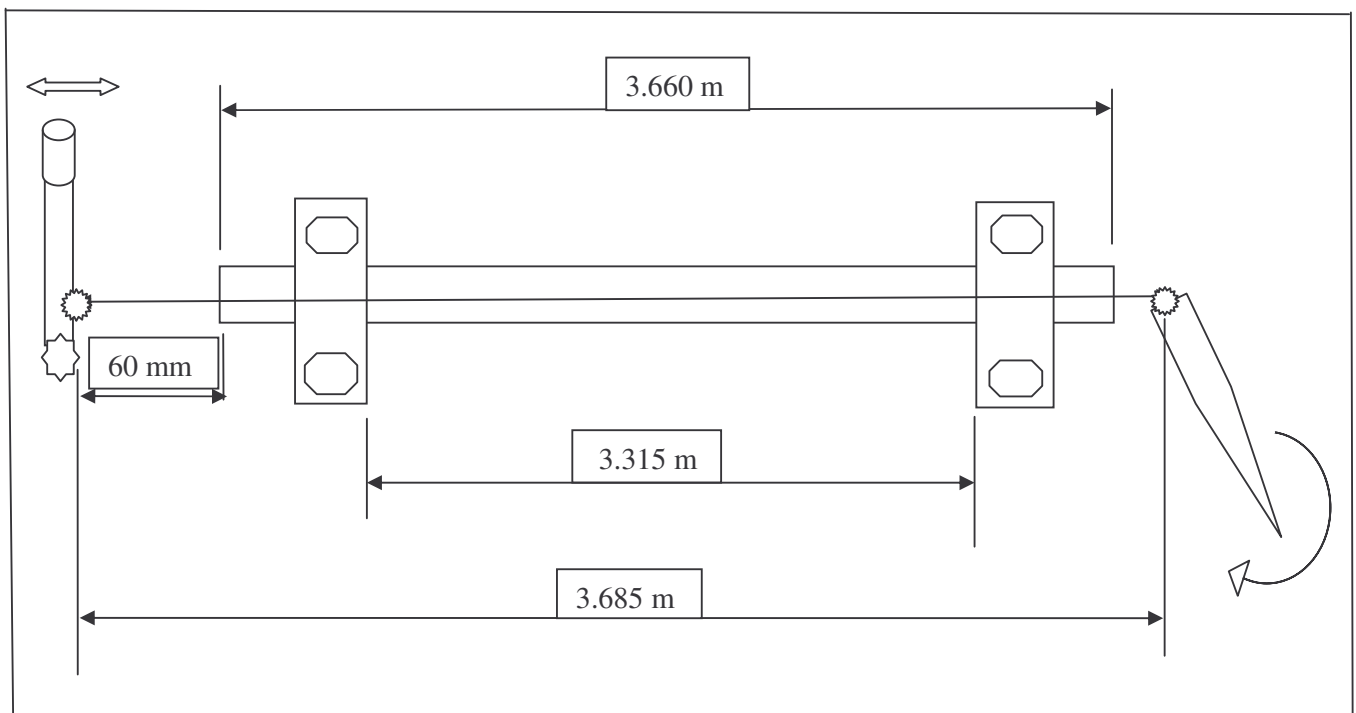
1.16.10 The following technical information of the elevator control system was submitted by the manufacturer: (See Figures 4 & 5 also)

- (i) The overall length of the elevator cable between the control column lever and flight control surface attachments was determined to be approximately 3.685 m. The operation of the elevator system is through the movement of the control lever aft or forward, resulting in a deflection of the flight control surface (up or down). There are only two anchor points, installed approximately 3.315 m apart. The one is installed in the cockpit, close to the elevator control lever and the other in the rear of the aircraft tail section. The cable is then clamped at the anchor points for security of installation. The elevator cable requires that rigging be done during maintenance to allow movement of approximately 60 mm in order to facilitate the correct deflection of the flight control surface.
