EXECUTIVE SUMMARY - AIRCRAFT INCIDENT REPORT

Reference: CA18/3/2/0566	
Aircraft Registration	ZS-BFC	Date of Incident	05 February 2007		Time of Incident 1225Z
Type of Aircraft	Piper PA28-180		Type of Operation Private		
Pilot-in-command Licence Type		Private	Age	19	Licence Valid Yes
Pilot-in-command Flying Experience		Total Flying Hours	94.3		Hours on Type 11.2
Last point of departure		Wonderboom Aerodrome (FAWB)			
Next point of intended landing		Wonderboom Aerodrome (FAWB)			
Location of the incident site with reference to easily defined geographical points (GPS readings if possible)					
On the grass next to runway 29 at Wonderboom Aerodrome					
Meteorological Information		Wind 300° at 10 kts gusting 15 kts, temperature 32°C, visibility CAVOK			
Number of people on board	1 + 1	No. of people injured	0	No. of people killed	0
Synopsis					
<p>The pilot was on a local flight to the general flying area.</p> <p>The pilot stated that after returning from the general flying area, she was too high on her approach for landing on runway 29. She then reduced power in order to descend, but on touchdown, at an indicated airspeed of 85 mph and 20° flap setting, she was unable to control the a

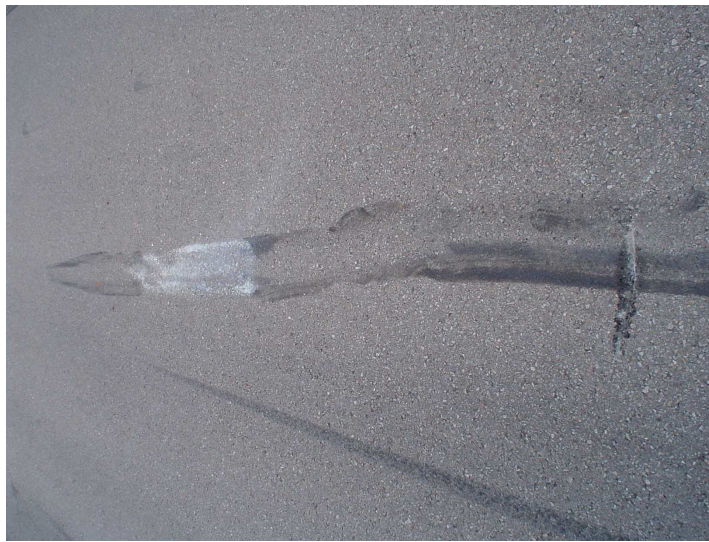
Photo 1: Skid marks on the runway indicate that the pilot must have landed on the nose wheel first
