## AIRCRAFT INCIDENT REPORT AND EXECUTIVE SUMMARY

| | | | | Reference: | | CA18/3/2/0568 | |
| <b>Aircraft Registration</b> | <b>ZS-RBB</b> | <b>Date of Incident</b> | 1 February 2007 | | <b>Time of Incident</b> | 1008Z | |
| <b>Type of Aircraft</b> | MBB BO-105-CBS-4 (Helicopter) | | <b>Type of Operation</b> | | Law Enforcement | | |

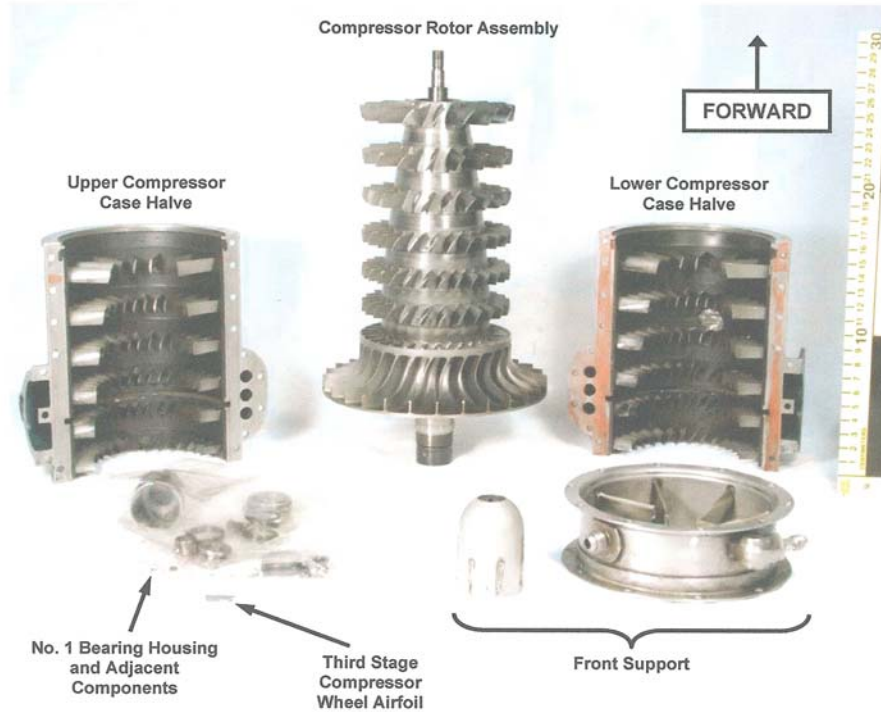
Figure 1 shows the as-received condition of the Compressor Front Support, No. 1 Bearing Housing and adjacent components, Compressor Rotor Assembly, and Upper and Lower Compressor Case Assemblies. Table I lists the components submitted to Rolls-Royce Corporation Materials Laboratory.

Figure 1. As-received conditions of the Front Support, No. 1 Bearing housing and components, Rotor Assembly (with separated third stage wheel airfoil), and the Upper and Lower Case halves. Scale = cm.

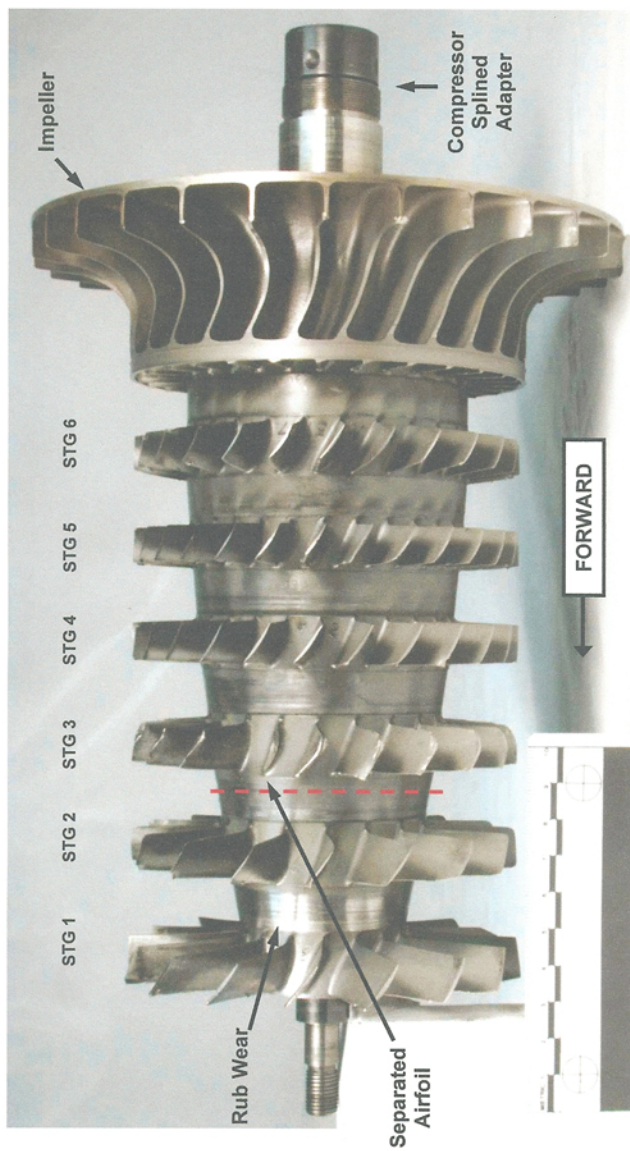
Figure 2 shows the general condition of the rotor assembly. An airfoil was separated from the third stage compressor wheel. The third stage compressor wheel airfoils were labeled sequentially clockwise (forward looking aft) for the purposes of this report and the separated airfoil was identified as position #1. The general condition of the second and third stage compressor wheel is shown in Figure 3 after the rotor was disassembled. Impact damage was observed on the second and third stage airfoil leading edges. The tips of the airfoils were bent opposite the direction of rotation and evidence of coating cracks were observed on many of the airfoils. The coating cracks were considered secondary damage.

Figure 2. As-received condition of the rotor. Scale = cm.

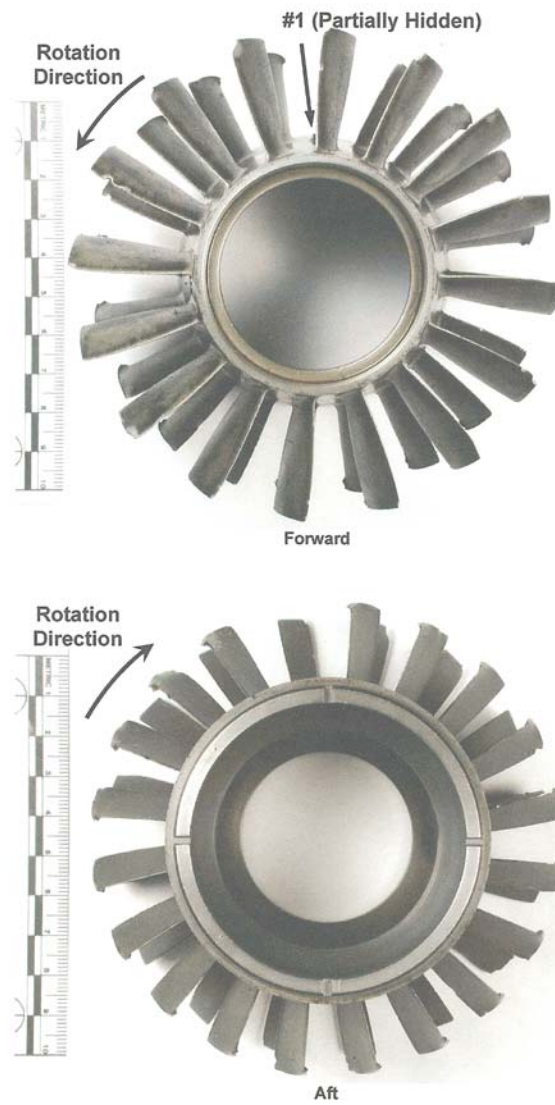
Figure 3. Photographs showing the as-received condition of the second and third stage compressor wheels.  
Scale = cm.

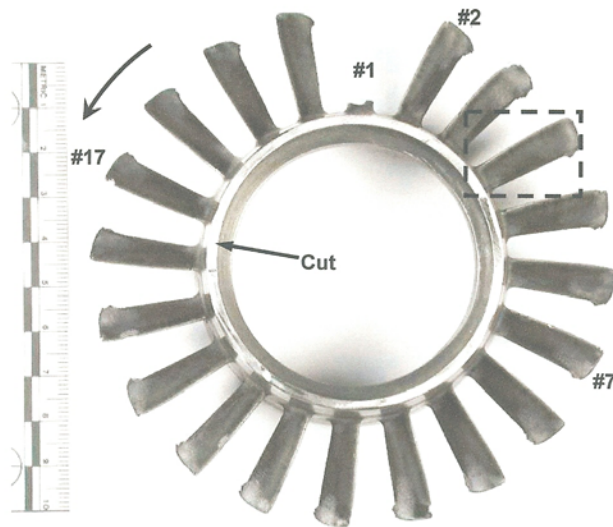
The second stage wheel was cut from the third stage wheel to facilitate visual examination of the third stage wheel forward face, shown in Figure 4. Figure 5 shows a photograph detailing erosion of the coating observed along the leading edge of a representative third stage airfoil. Further inspection identified corrosion pits on the leading edges of multiple third stage airfoils. Severe examples of corrosion pitting included airfoils #7 and #17. Fluorescent penetrant inspection (FPI) of the third stage wheel revealed background fluorescence due to imperfections and cracks present in the coating.

Figure 4. Photograph showing the third stage compressor wheel (forward view, second stage removed). Arrow shows the direction of rotation during engine operation. Cracks in the coating give a whitish appearance to the airfoils. Dashed box shows region of further examination. Scale = cm.

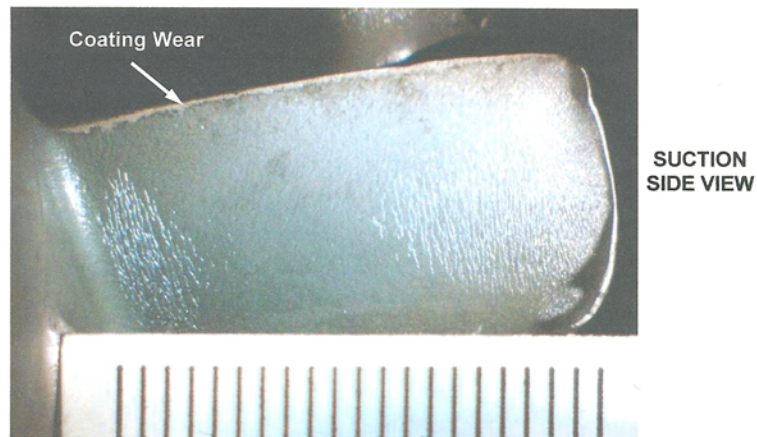
Figure 5. General view showing representative erosion of the coating at the leading edge of airfoil #4 (suction side). Cracks in the coating were considered secondary damage. Scale = mm.

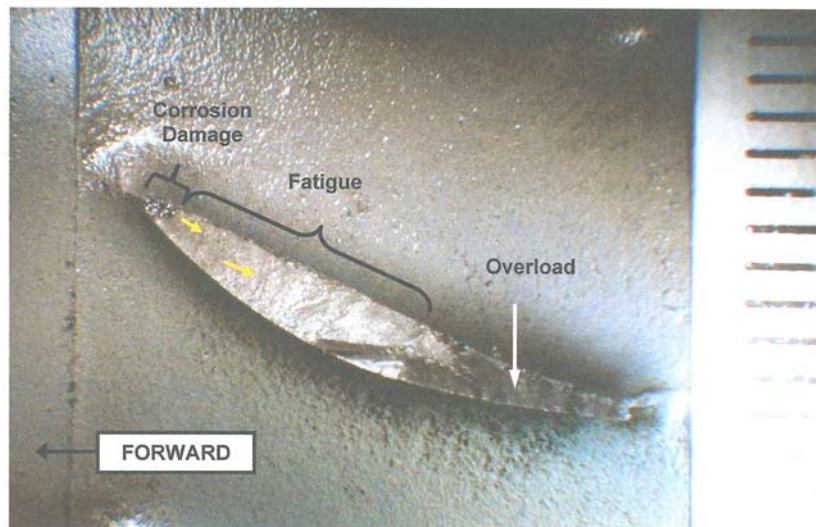
- One (1) Third Stage Compressor Wheel airfoil fractured in fatigue approximately 0.063 inch outboard of the wheel rim. The fracture initiated from an area of intergranular corrosion at the leading edge and propagated 0.31 inch before the airfoil separated in overload.

Figure 6 shows the fracture surface of airfoil #1 had features consistent with fatigue propagation. The crack grew approximately 0.31 inch before the blade ultimately separated in overload. The fracture originated approximately 0.063 inch outboard from the rim and corrosion damage was also generally observed along the leading edge inboard of the fracture surface, near the root, shown in Figure 7. Scanning electron microscope (SEM) images detailing the intergranular features of the corrosion damage are shown in Figure 8.

Figure 6. Photograph showing the fracture surface of the separated third stage airfoil. Yellow arrows show the general direction of fatigue propagation. Scale = mm.

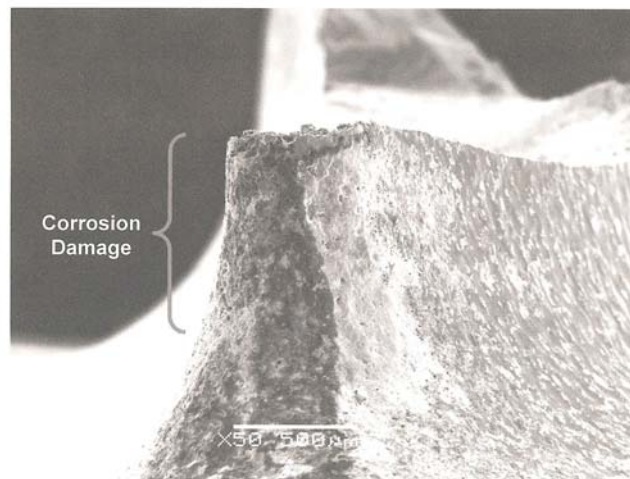
Figure 7. SEM image showing corrosion pitting along the leading edge of the fractured airfoil.

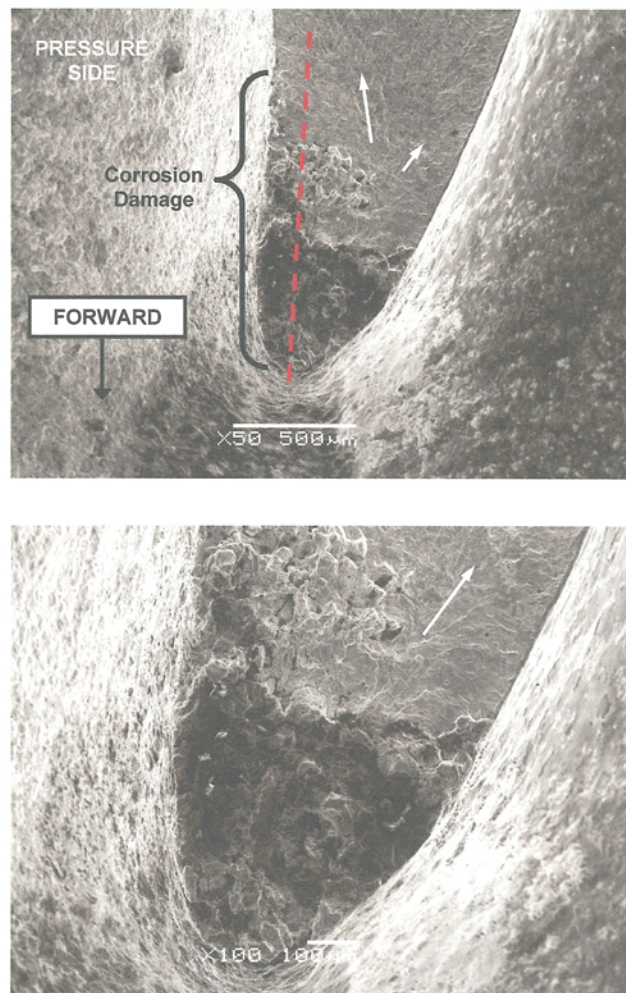
Figure 8. Photographs showing corrosion damage at the leading edge near the fracture origin. White arrows indicate the general direction of fatigue propagation. A dashed line shows the plane of metallographic examination.

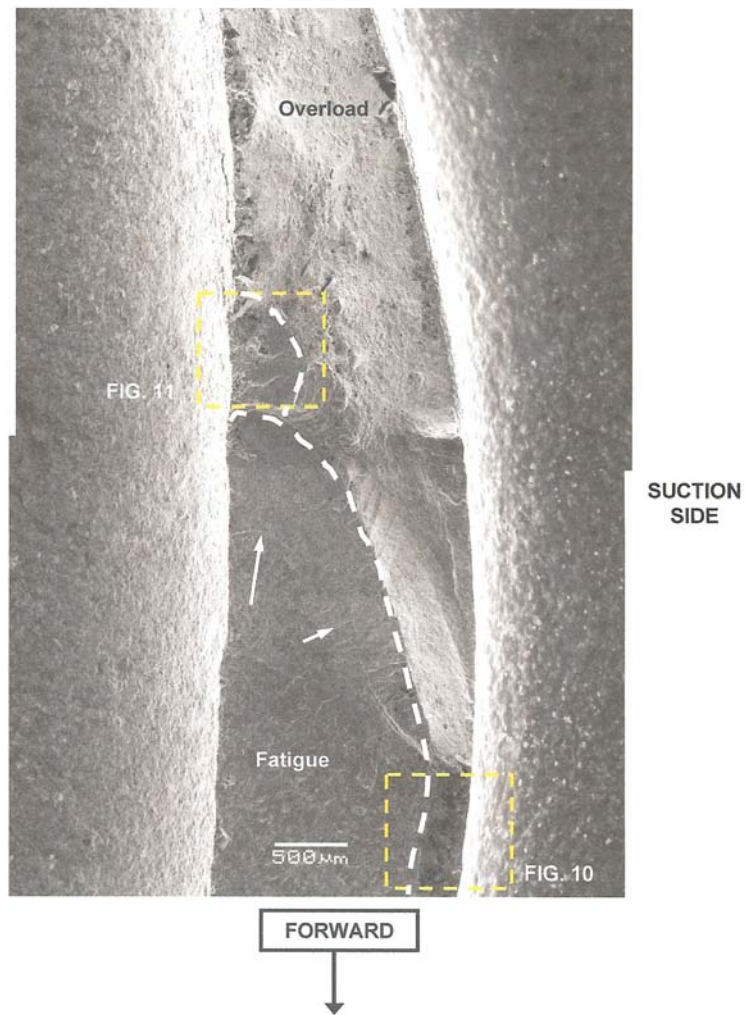
Corrosion damage was also observed at other two other locations along the fracture surface pressure and suction sides. An SEM montage of the transition region shown in Figure 9 identifies the location of the two regions of corrosion damage that are detailed in Figures 10 and 11. Fatigue propagation was observed originating from one region of corrosion damage located on the pressure side of the airfoil shown in Figure 11. Figure 12 shows a detailed SEM image of the transition from fatigue propagation to overload. Damage to the fracture surface precluded detailed analysis of the stria spacing, but the general fracture morphology was consistent with high cycle fatigue (HCF) progression.

Figure 9. SEM montage showing the fracture surface near the airfoil trailing edge. Arrows show the general direction of propagation. Dashed boxes show regions of further examination. Mag ~30x.

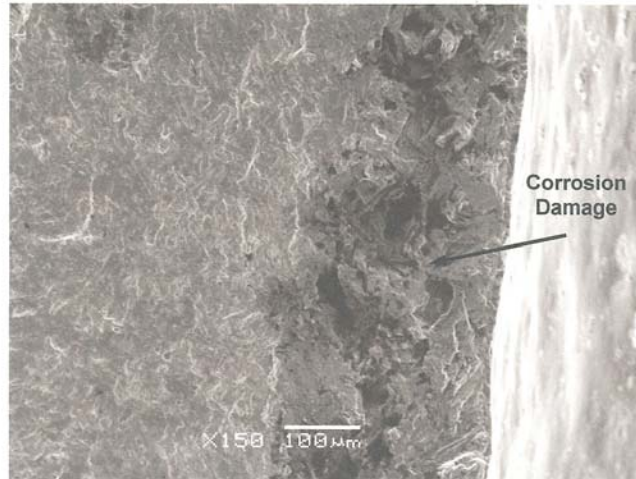
Figure 10. SEM image showing detailed view of corrosion damage observed on the suction side of the airfoil.

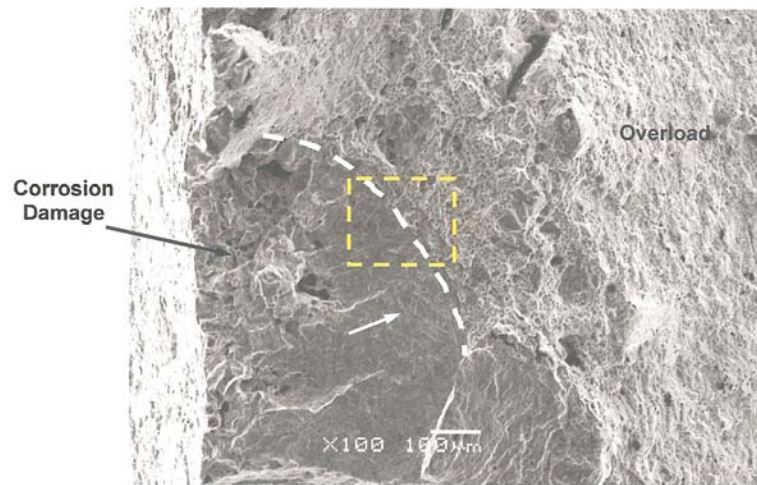
Figure 11. SEM image showing detailed view of fatigue propagation from a region of corrosion damage observed on the pressure side of the airfoil. Dashed box shows region of further examination.

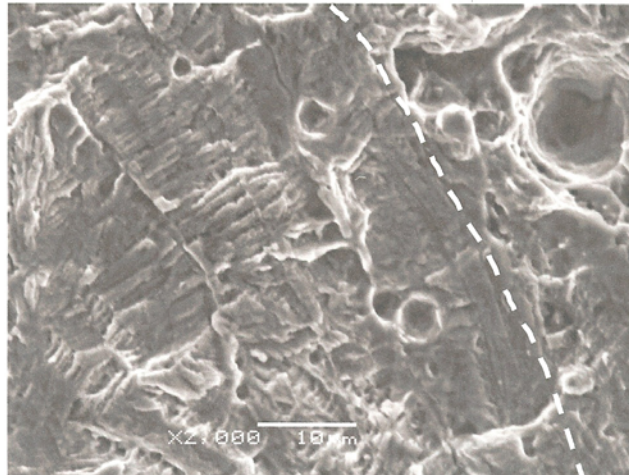
Figure 12. SEM image showing transition region (reference Figure 11) from fatigue (lower left) to overload (upper right).

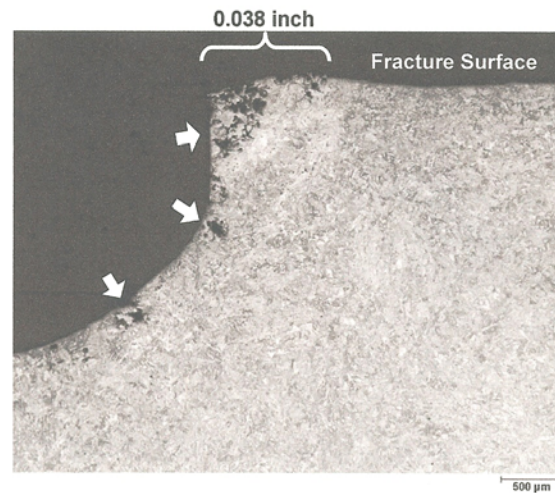
Figure 13 shows a metallographic plane through the corrosion damage at the leading edge of airfoil #1. The observed cracking was consistent with intergranular corrosion and spanned approximately 0.038 inch along the fracture surface and down the leading edge inboard to the root.

Figure 13. Micrograph of airfoil #1 showing cross section through corrosion damage along plane indicated in Figure 8. Bracket and arrows show corrosion damage. Etchant: Stainless Steel #2, 25x.

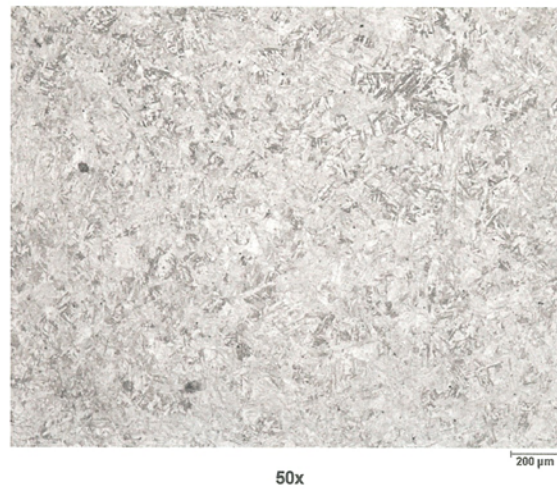
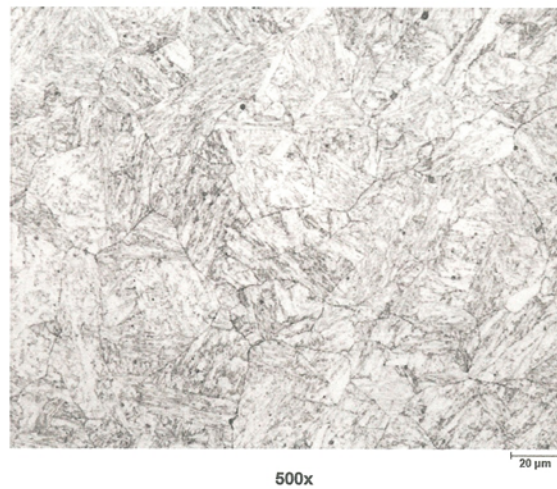
The general microstructure not associated with the corrosion damage is shown Figure 14. The microstructure was typical for solution and precipitation heat-treated AM 5355 (17-4 PH).

Figure 14. Micrograph showing representative microstructure of the wheel (away from region of corrosion damage) was typical for 17-4PH. Etchant: Stainless Steel #2.

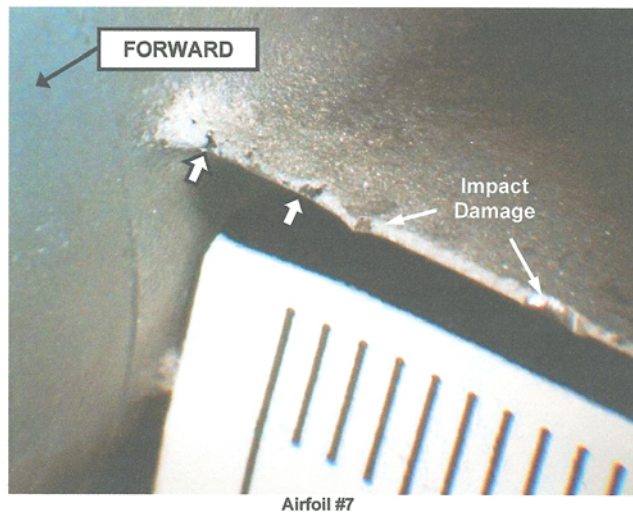
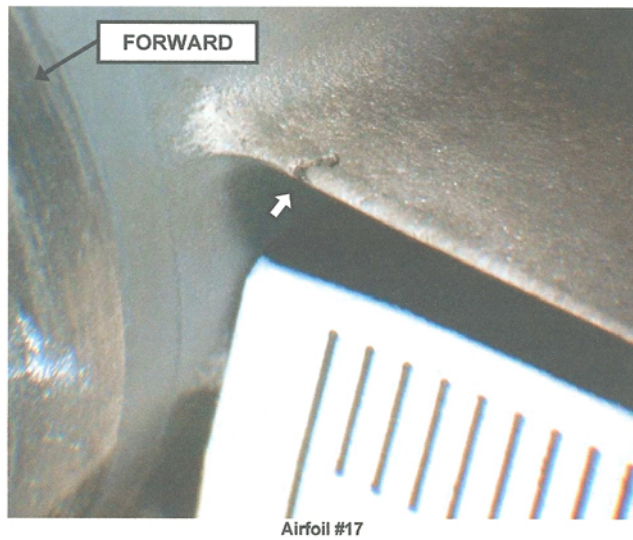
Severe examples of corrosion pitting visually observed on the leading edges of airfoil #7 and #16 are shown in Figure 15. Airfoil #17 was lab-fractured through the corrosion pit located approximately 0.093 inch outboard from the rim (reference lower photograph in Figure 15). Corrosion damage was observed up to 0.075 inch deep but no evidence of fatigue propagation was observed. Figure 16 details the fracture surface which had features consistent with overload resulting from lab-fracture.

Figure 15. Detailed views showing most severe examples of pitting observed on the airfoil leading edges and identified by block arrows. Scale = mm.

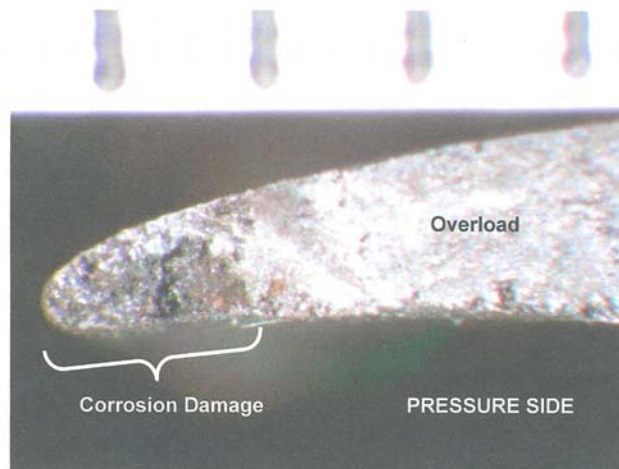
Figure 16. Photograph showing lab-fractured surface of airfoil #17 (view looking inboard). Corrosion damage was observed at the lead edge. Scale = mm.

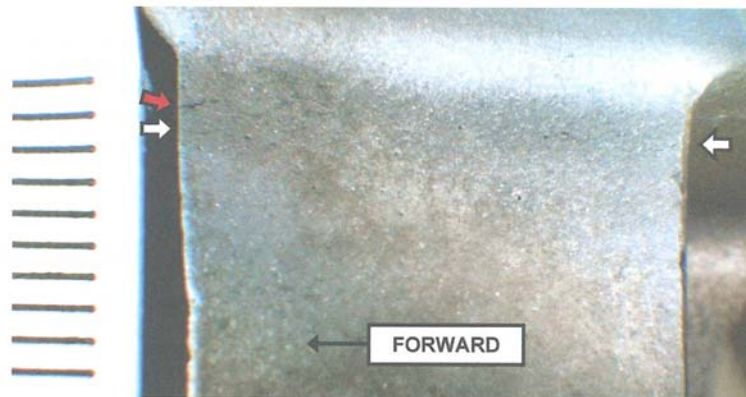
Leading and trailing edge cracking visually observed on airfoil #2 is shown in Figure 17. Airfoil #2 was lab-fractured approximately 0.125 inch outboard from the rim. Fatigue propagation emanating from regions of corrosion damage (dark areas) along the fracture surface was observed, shown in Figure 18. An SEM image, shown in Figure 19, details the intergranular features of the corrosion damage near the leading edge.

Figure 17. Detailed view showing leading and trailing edge cracks observed near the root of airfoil #2 (pressure side). Block arrows identify location of observed cracks and the red block arrow indicates the lab-fractured crack. Scale = mm.

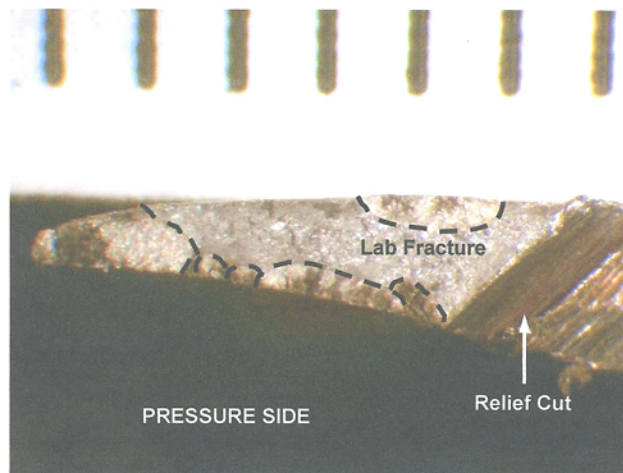
- One (1) additional Third Stage airfoil exhibited cracking near the leading edge root area. The crack was lab-fractured revealing fracture features consistent with fatigue progression from corrosion damage.

Figure 18. Photograph showing the lab-fractured surface of airfoil #2 (view looking outboard). Corrosion damage (dark regions) was observed along the pressure and suction sides and at the leading edge. Dashed lines show multiple regions exhibiting fatigue propagation. Scale = mm.

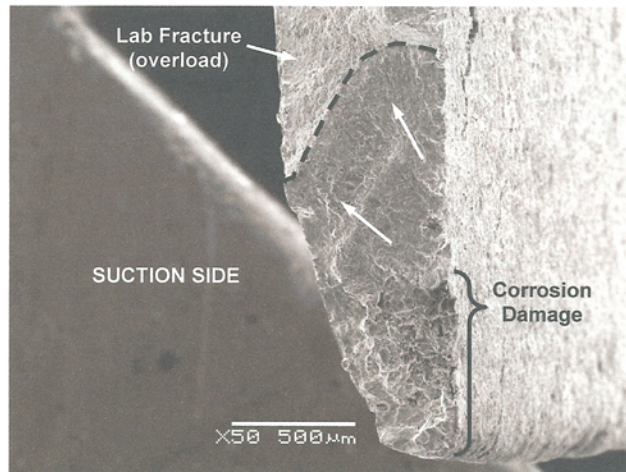
Figure 19. SEM image showing fatigue propagation from a region of corrosion damage at the leading edge of airfoil #2 (view looking outboard). Arrows show the general direction of fatigue propagation.

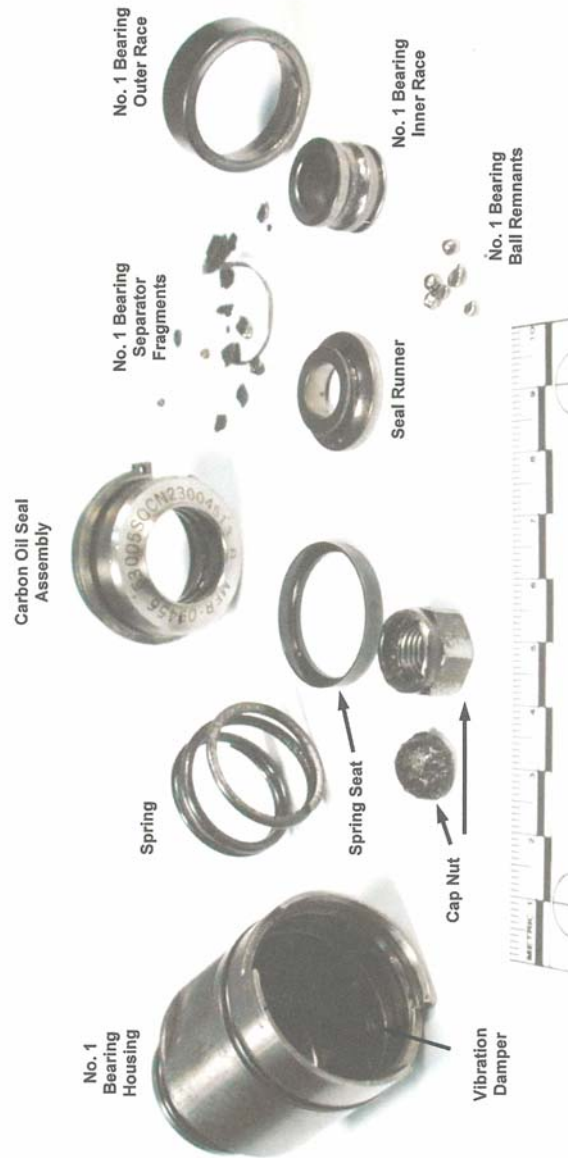
Figure 20. As-received condition of the No. 1 Bearing housing and components. Scale = cm.

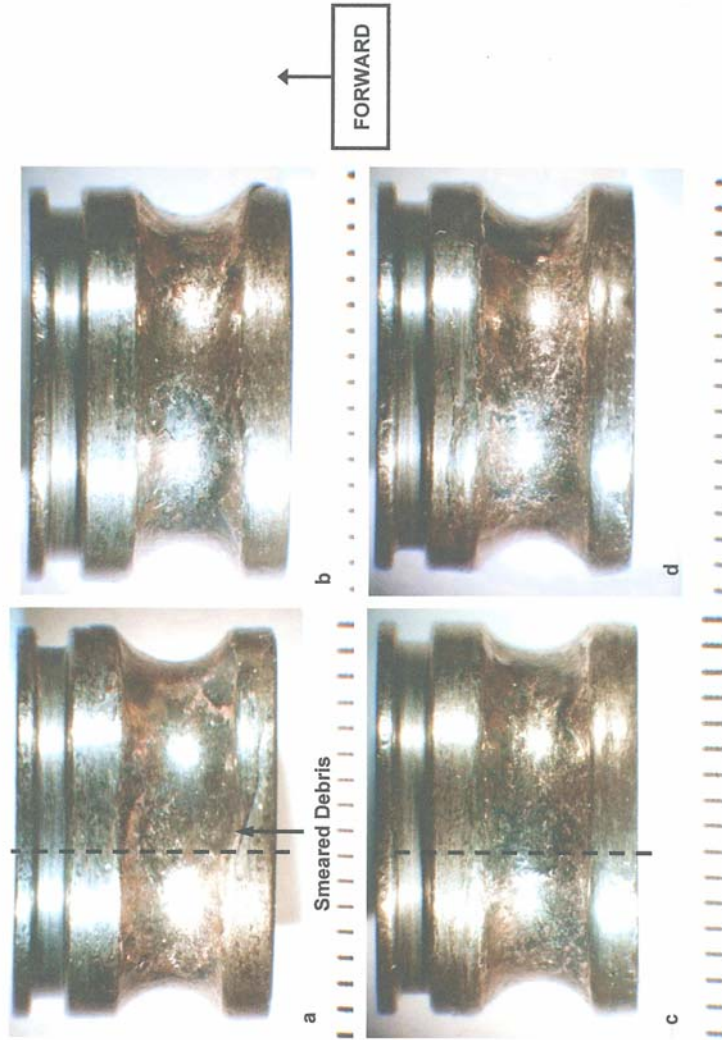
Figure 21. Detailed views showing the inner race of the No. 1 bearing rotated increments of 90 degrees (clockwise, aft looking forward). Debris from the separator was observed smeared onto the race. Dashed lines show approximate plane of metallurgical examination. Scale = mm.

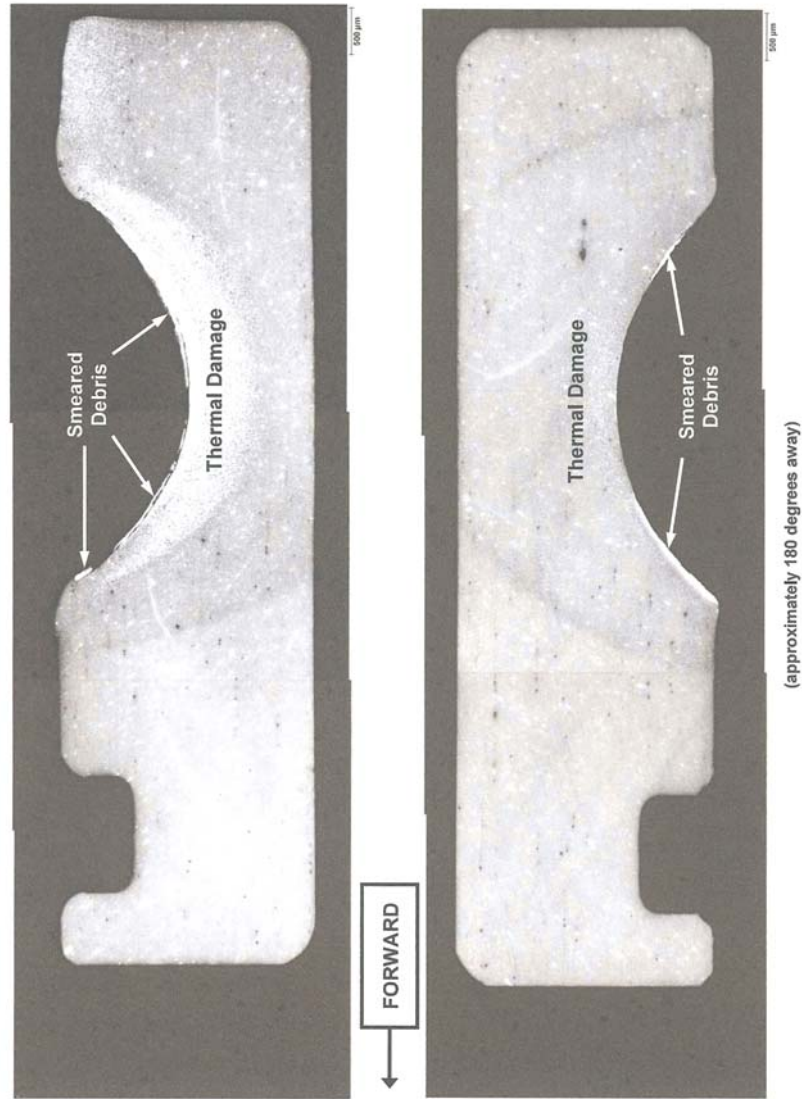
Evaluation of the No. 1 bearing revealed significant damage to the ball bearings and oil separator. A cross-section of the inner raceway of the bearing revealed localized thermal damage consistent with high radial loads.

Figure 22. Photographic montages showing the cross section through the No. 1 bearing inner raceway. Evidence of thermal damage was observed. Etchant: 5% Nital, 18x.

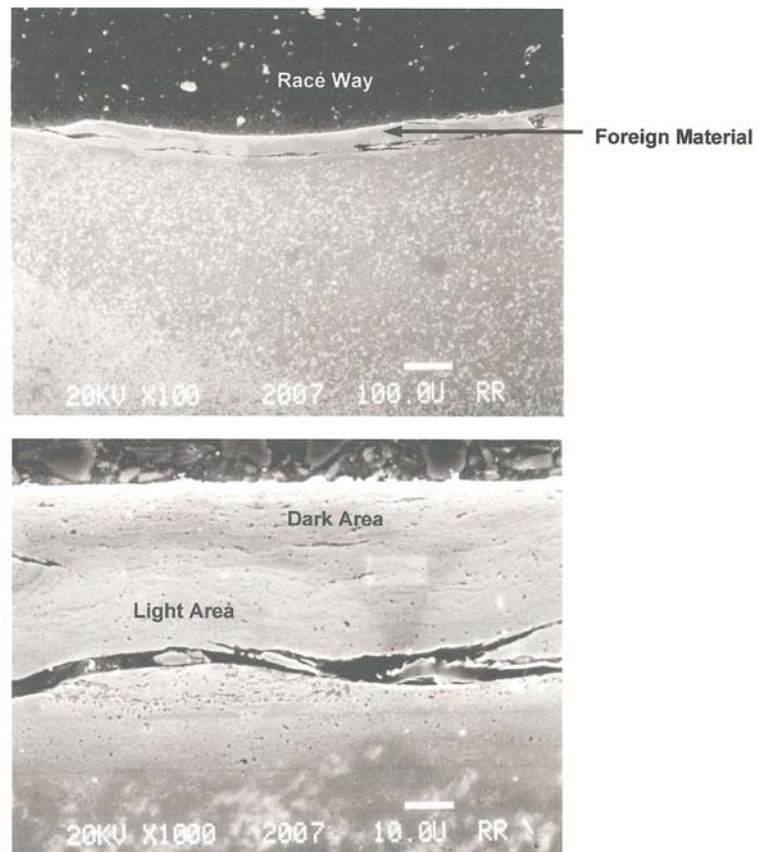
Figure 23. SEM images showing metal debris smeared onto the inner raceway. XEDA results indicating composition for light and dark regions and the inner race and ball bearing material included.

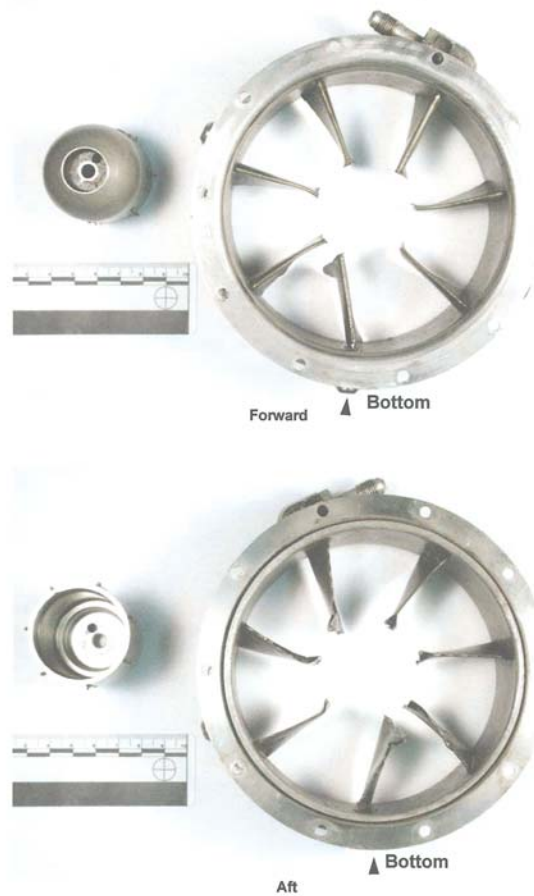
*Figure 24* shows the general condition of the compressor front support. Seven (7) radial struts fractured from the inner hub. The oil supply and oil scavenge tubes supplying lubrication to the No. 1 bearing running through the radial struts were considered to have fractured when the bullet nose (inner hub) of the front support separated. Photographs showing the fractured tubes are shown in *Figure 25*. All seven radial struts also visually exhibited cracking at the attachments to the outer wall on the forward end of the support. Damage to the compressor front support precluded identification of a specific failure mode and detailed fractographic examination of the radial struts was not conducted. The damage was indicative of secondary damage generated during the event sequence. The oil inlet tube, although fractured, had no indications of blockage. No metallurgical or chemical analyses were performed on the compressor front support.

Figure 24. As-received photographs of the front support. Scale = cm.

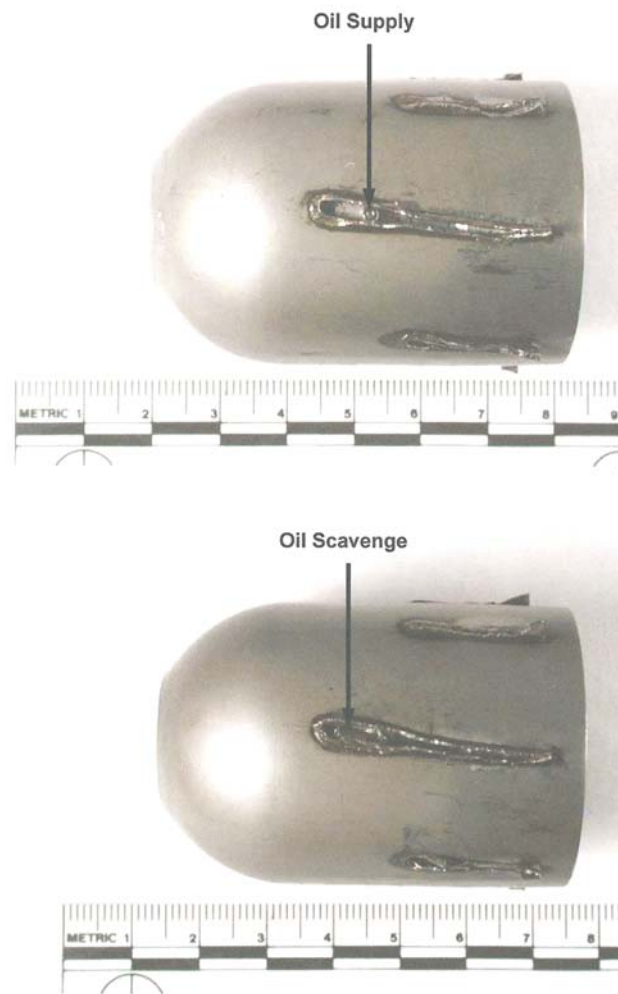
Figure 25. Photograph showing the fractured bullet nose (inner hub) of compressor front support. The oil supply and oil scavenge tubes were fractured. Scale = cm.

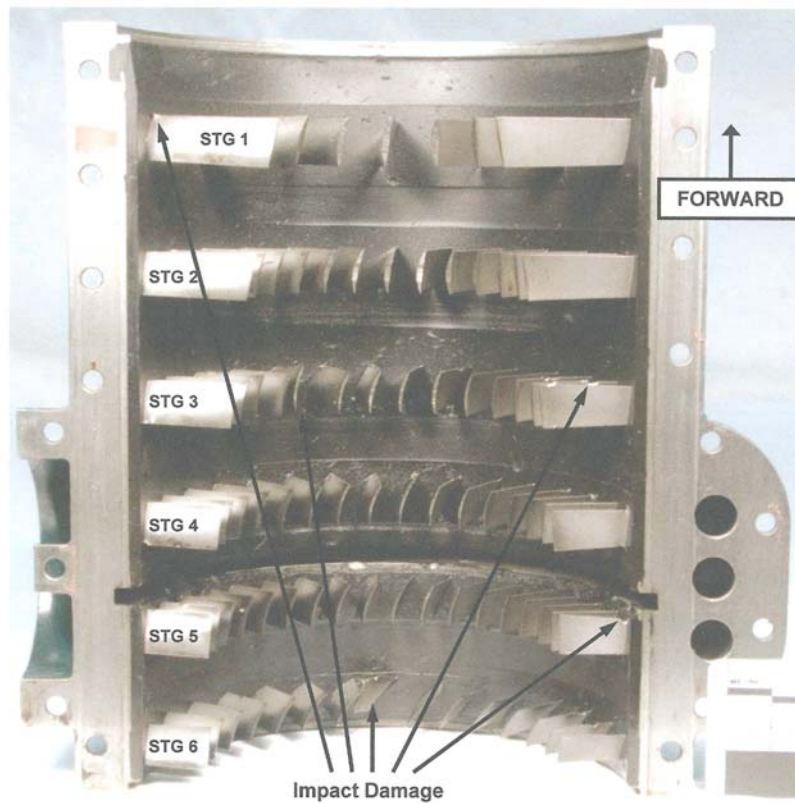
*Figures 26 and 27* show the general condition of the upper and lower compressor case halves. The upper and lower compressor cases exhibited impact damage to the leading edges of multiple vanes. Several vanes also exhibited rub wear on the outboard tips or were observed bent in the direction of rotation of the compressor rotor.

Damage to the upper and lower compressor cases was consistent with secondary damage generated during the event sequence. No metallurgical or chemical analyses were performed on components of the compressor case assembly.

Figure 26. As-received condition of the Upper Compressor Case and Vanes. Scale = cm.

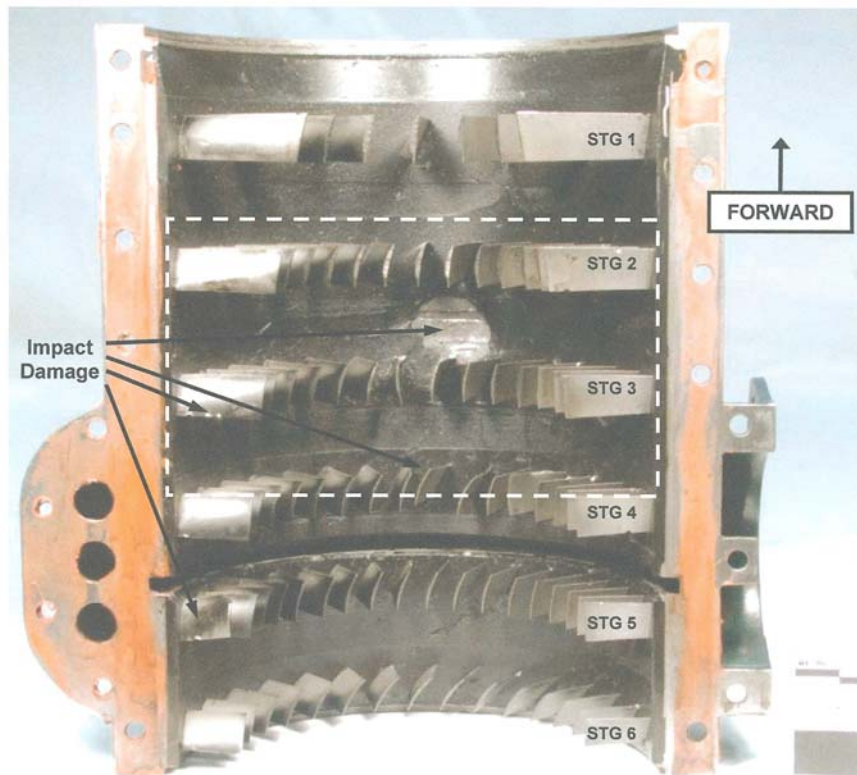
Figure 27. As received condition of the Lower Compressor Case and Vanes. Dash-boxed region is detailed in Figure 28. Scale = cm.

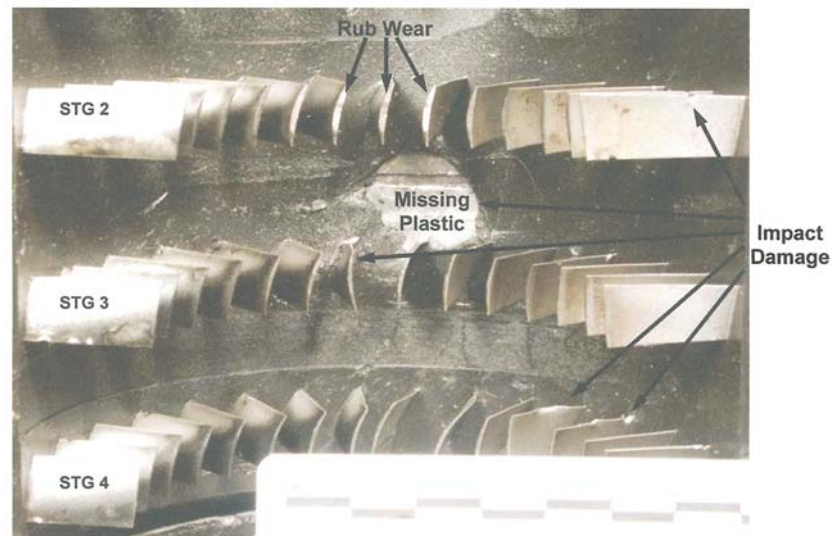
The abrasible plastic coating inside the cases also exhibited impact damage. The sheet metal of the vane assembly was exposed between the second and third stage vane rows (this is also the third stage blade path for the third stage compressor wheel) on the lower case. The location of the missing plastic was consistent with secondary damage resulting from the separation of the third stage airfoil from the compressor wheel. A detailed view of the damage to the abrasible plastic coating is shown in *Figure 28*.

Figure 28. Detailed view of the lower compressor case showing rub wear on the inboard vane tips. Impact damage to the vanes, abradable plastic, and cracking of the abradable plastic was observed. Scale = cm.

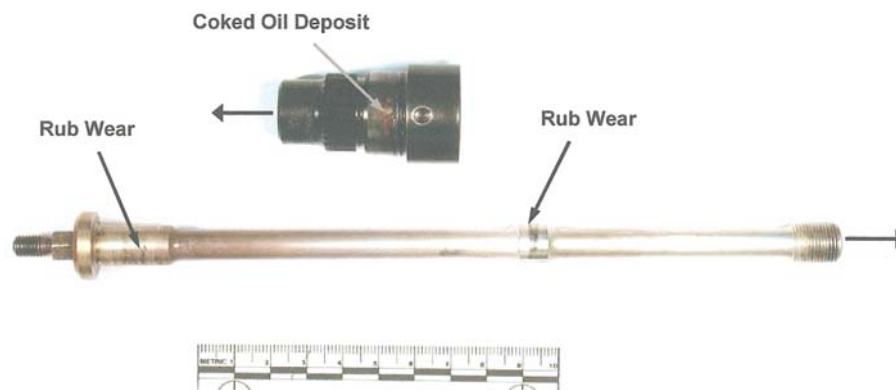
Photographs showing the general conditions of the compressor splined adapter and compressor tiebolt are shown in *Figure 29*. The compressor splined adapter exhibited no visual indications of fretting wear or cracking on the splines. Debris consistent in appearance to coked oil was observed. The compressor tiebolt exhibited rub wear on the mating surfaces to the fourth stage compressor wheel and the impeller. No metallurgical or chemical analyses were performed on the compressor splined adapter or compressor tiebolt.

Figure 29. General condition of the compressor splined adapter and tiebolt. Arrows at center-line indicate forward direction for each component. Scale = cm.
