AIRCRAFT INCIDENT REPORT AND EXECUTIVE SUMMARY

| | | | | Reference: CA18/3/2/0781 | |
| Aircraft Registration | ZS-KHW | Date of Incident | 10 May 2010 | | Time of Incident 1425Z |
| Type of Aircraft | Piper PA28-181 | | Type of Operation | | Private |

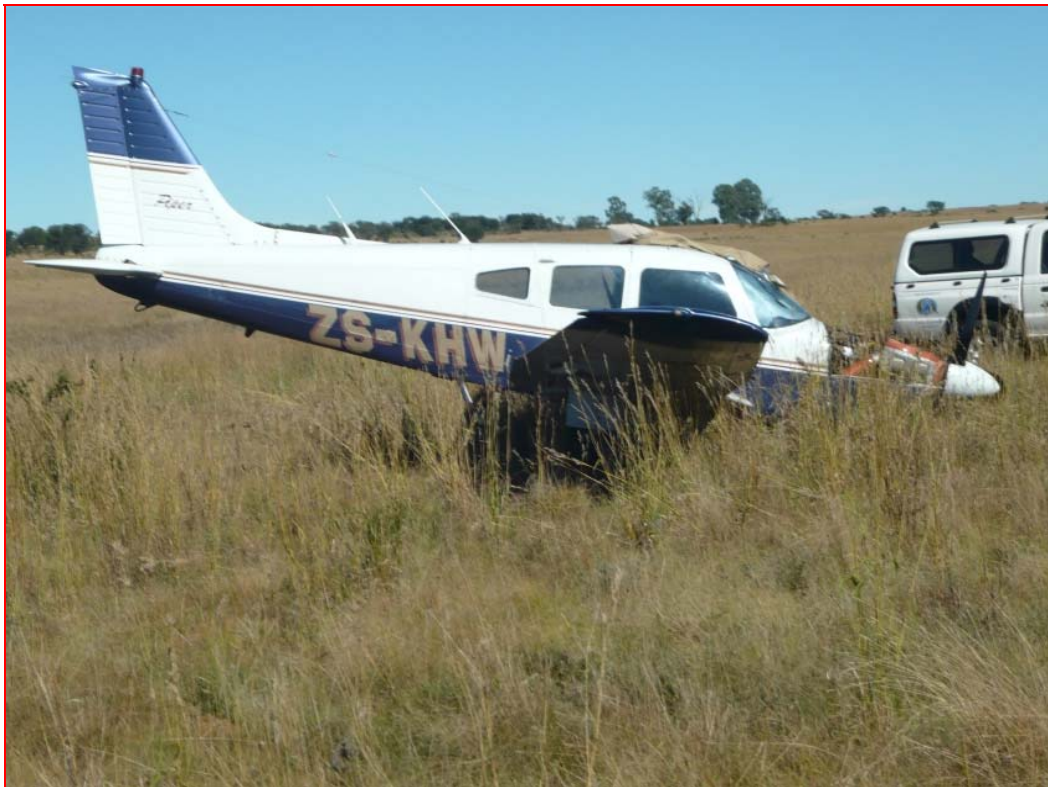
1.3.1 The aircraft sustained damage to the nose gear and propeller during the forced landing.

Figure 1. Damage was limited to the nose gear and propeller.

- 1.12.1 The pilot reported that while he was en route from Potchefstroom to Mafikeng, the engine failed.
- 1.12.2 He immediately transmitted a Mayday call and initiated a forced landing on an open stretch of grass field.
- 1.12.3 During the landing, the nose gear collapsed and the propeller made contact with the terrain.

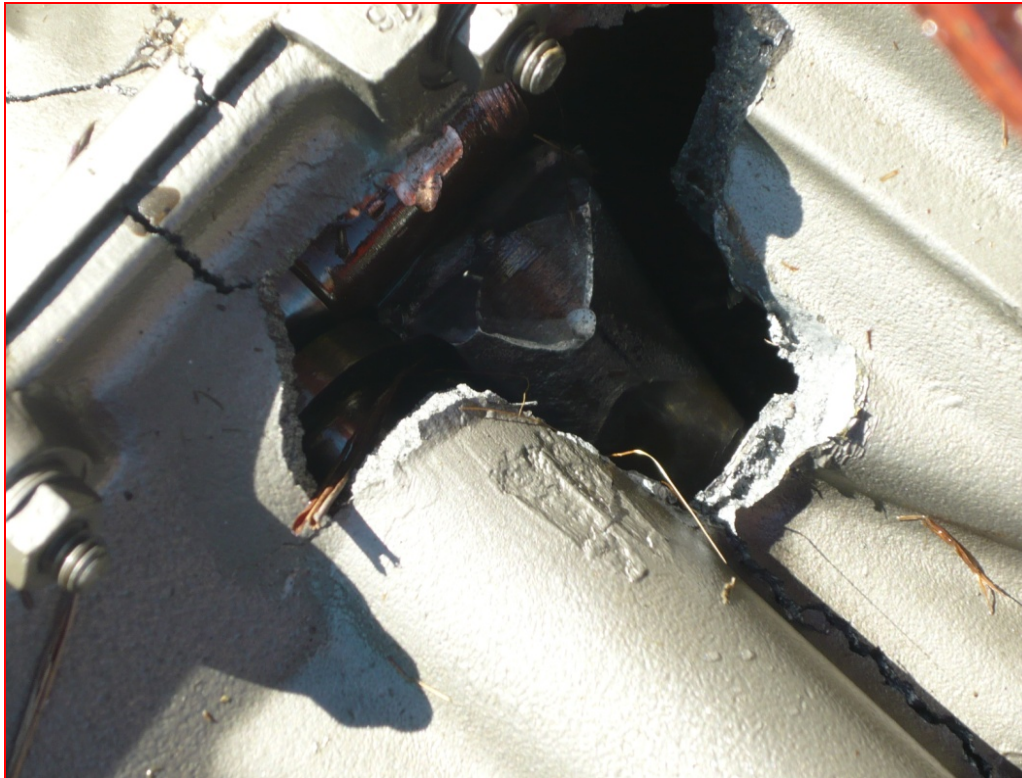
1.16.2 During the investigation, it was found that one of the connecting rod bolts from the number 4 connecting rod had failed.

1.16.2 This resulted in the connecting rod punching a hole in the crankcase as shown below.

1.16.3 The bolt, an approved part for the engine, was damaged to an extent that made it impossible to establish the reason for the failure.

Figure 2. Damage to engine crankcase after failure of conrod attachment bolt.

- 2.6 There was no evidence of fire in flight or after the impact, and the incident was considered survivable.
- 2.7 Investigation revealed that a connecting rod bolt from the number 4 connecting rod broke, causing a catastrophic engine failure. The reason for the failure of the bolt was not established.
