AIRCRAFT INCIDENT REPORT AND EXECUTIVE SUMMARY

Reference: CA18/3/2/0965	
Aircraft Registration	ZS-ZWP	Date of Incident	27 February 2013		Time of Incident 1155Z
Type of Aircraft	Boeing 737-800		Type of Operation		Domestic Schedule
Captain Licence Type	Airline Transport Pilot	Age	43	Licence Valid	Yes
Captain Flying Experience	Total Flying Hours	7 738,0		Hours on Type	450,5
First Officer Licence Type	Airline Transport Pilot	Age	32	Licence Valid	Yes
First Officer Flying Experience	Total Flying Hours	6 700,0		Hours on Type	570,0
Last point of departure	Cape Town International Airport (FACT)				
Next point of intended landing	OR Tambo International Airport (FAOR)				
Location of the incident site with reference to easily defined geographical points (GPS readings if possible)					
On Runway 01 at Cape Town International Airport (FACT)					
Meteorological Information	Surface wind: 330°/22 kt, Temperature: 24 °C, Dew point: 16 °C, Cloud cover: 1-2 octas, Cloud base: 3500 feet AGL

Probable cause					
Aborted take-off as a result of the No. 2 engine failure due to the failure of the HPT blade.					
Contributory factor					
Failure of the HPT blade coating resulting on a corrosion and a subs

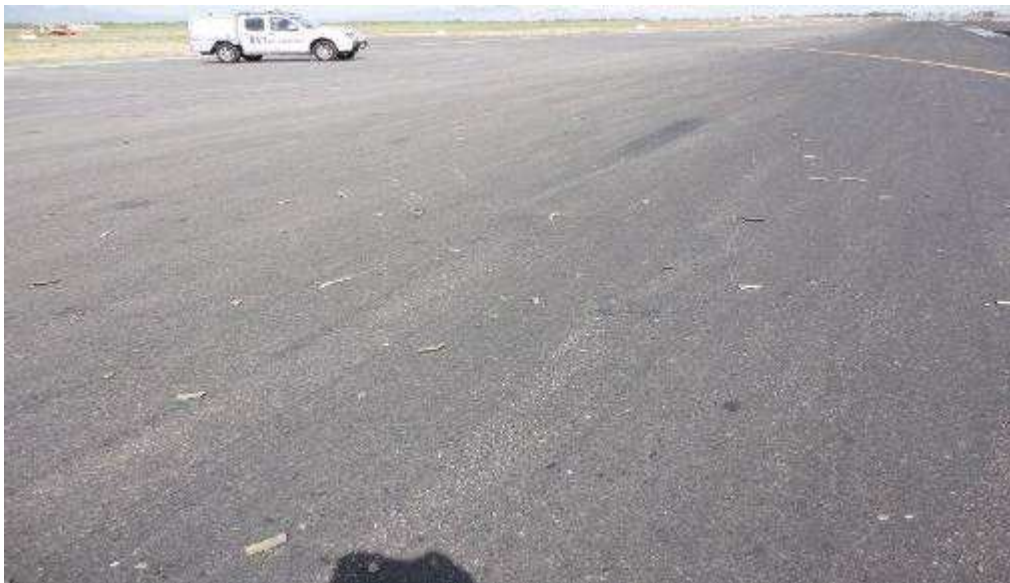
Figure 1: Engine debris found on the runway surface

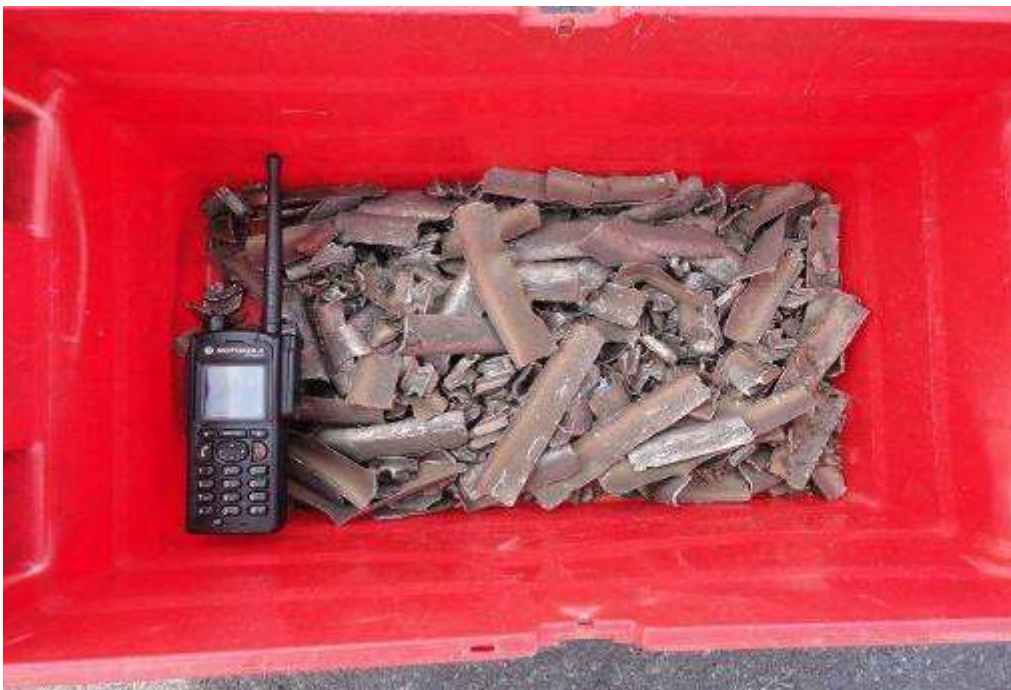
- 1.1.6 The runway was closed in order to conduct a proper clean-up of the surface. It was confirmed during the removal that the debris was parts of the turbine blades. The runway was re-opened at 1336Z.

Figure 2: Engine debris collected from the runway during the clean-up operation

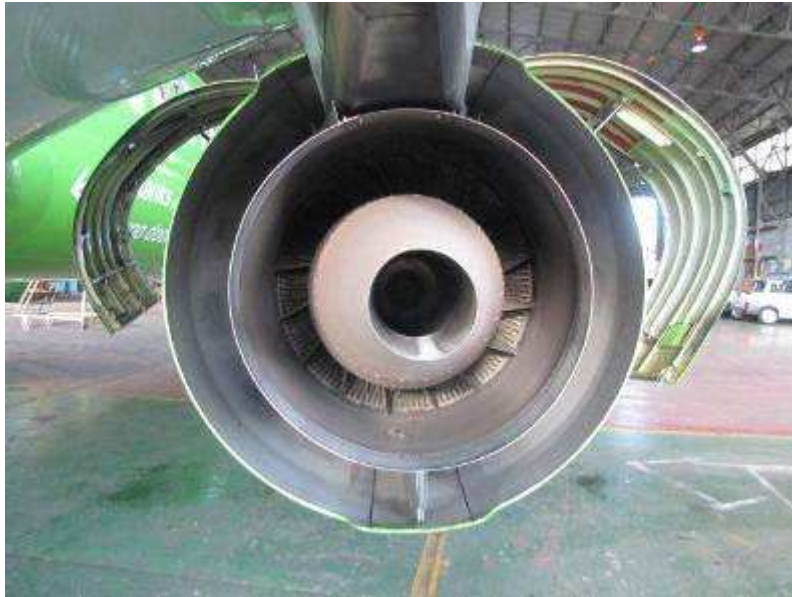
1.3.1 The damage was limited to the No. 2 engine.

Figure 4: The damaged engine before it was removed from the aircraft

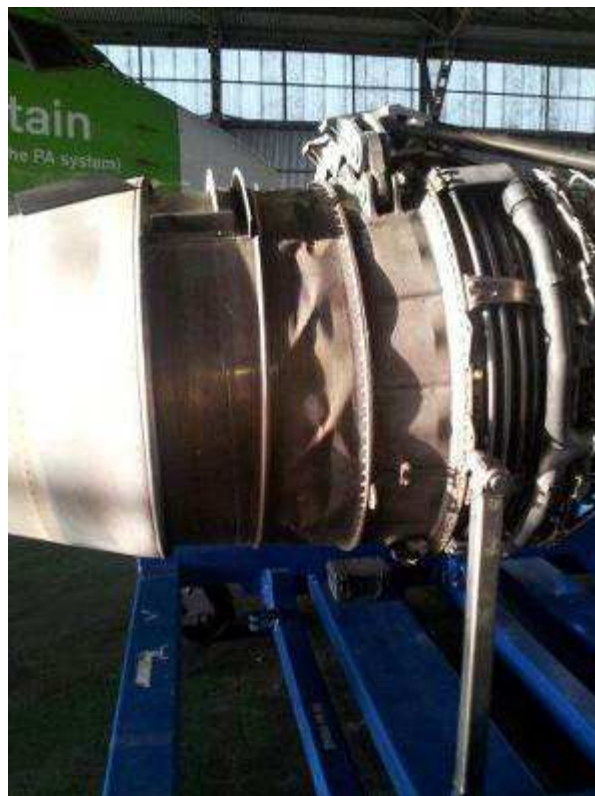
1.16.1 Inspection of the No. 2 engine revealed that the engine had sustained excessive damage, but that no other damage was caused to the aircraft

Figure 10: Deformed engine casing

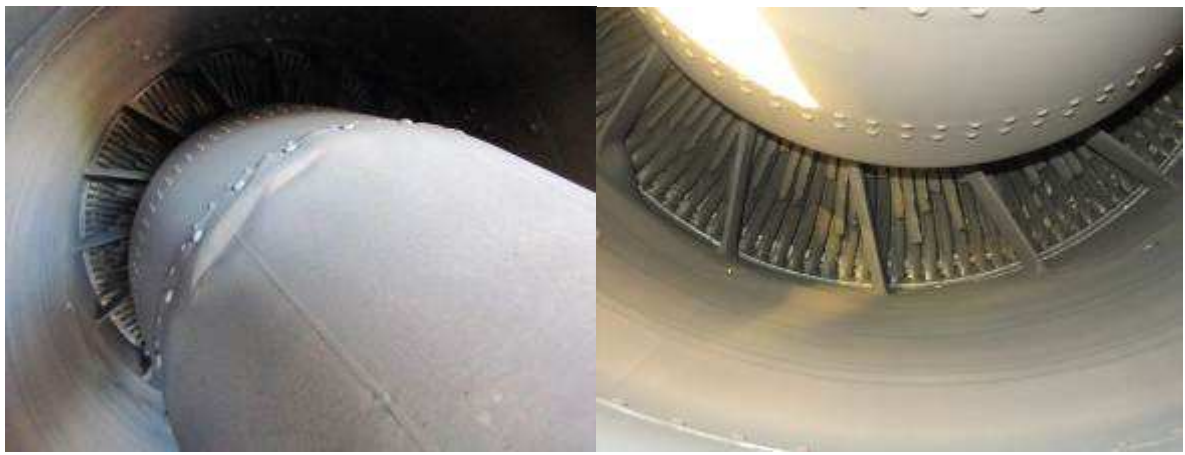
Figure 11: Damaged turbine blades viewed via the tailpipe

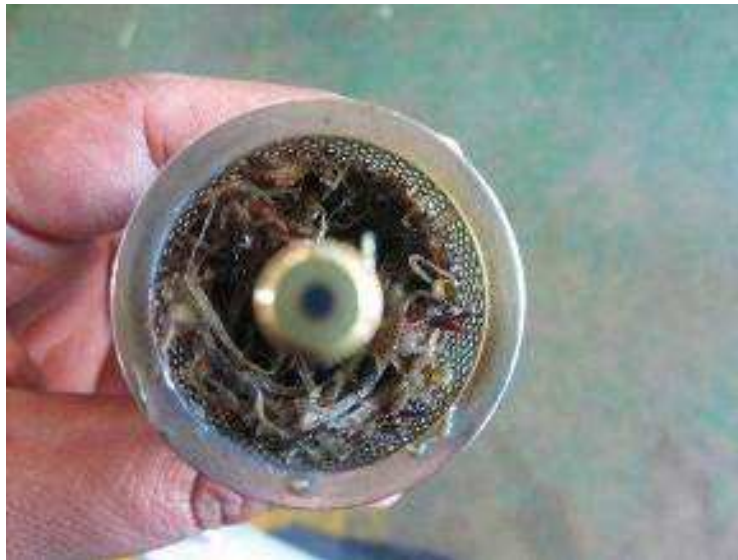
1.16.2 The engine forward sump scavenge strainer plug was removed and checked in the presence of the IIC by a CFM engine specialist. Upon investigation it was found that the plug was contaminated with a composite material from the high pressure turbine seal. The forward sump scavenge strainer plug along with the contaminated evidence was returned to its original position for transportation to an engine maintenance facility in Johannesburg.

Figure 12: Contaminated forward sump scavenge strainer plug

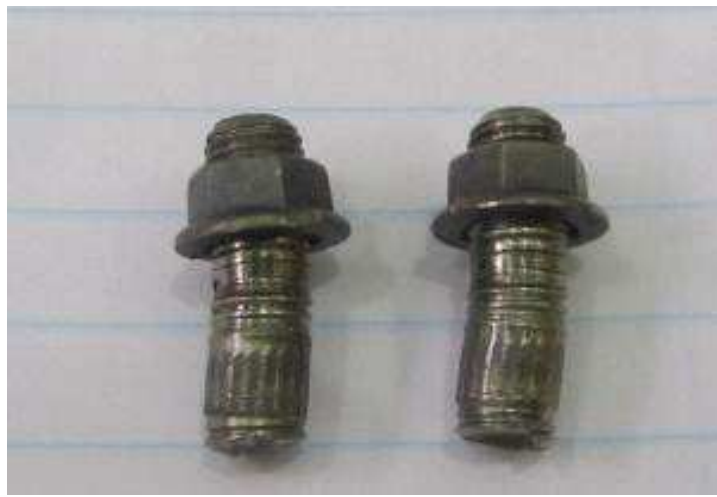
1.16.3 Figure 13 below shows two studs (part number J1074P10) were found lying at the bottom of the engine cowling. The nuts (part number J149P07) were still attached to the studs, which displayed evidence of deformation (bending) as well as shearing. The studs are made of a material called Inconel 718 and the nut is AMS 5735 which is Stainless Steel A268.

Figure 13: The loose studs with nuts attached found in the engine

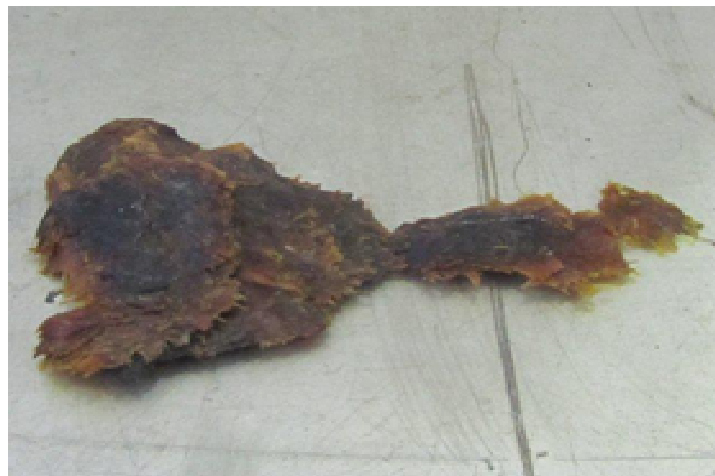
1.16.4 There were also pieces of composite material found in the engine. The material was the same colour as evidence found in the forward sump scavenge strainer.

Figure 14: Fragments of composite material found

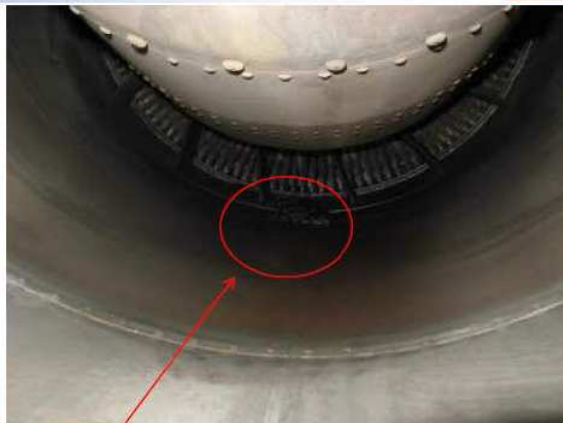
Debris outside the LPT in tailpipe.

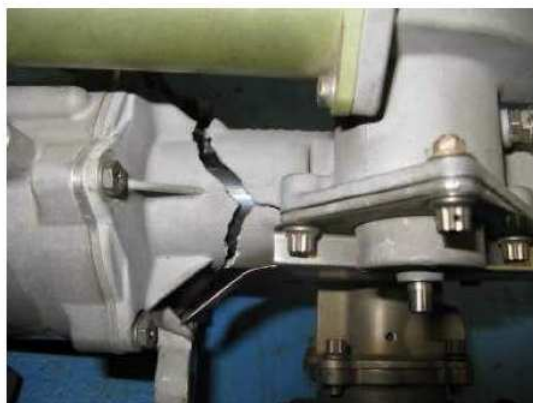
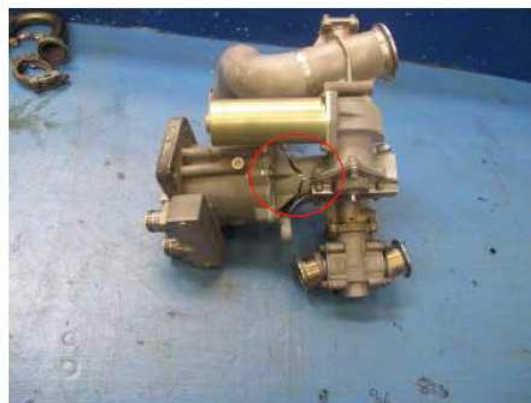
HPTACC housing cracked

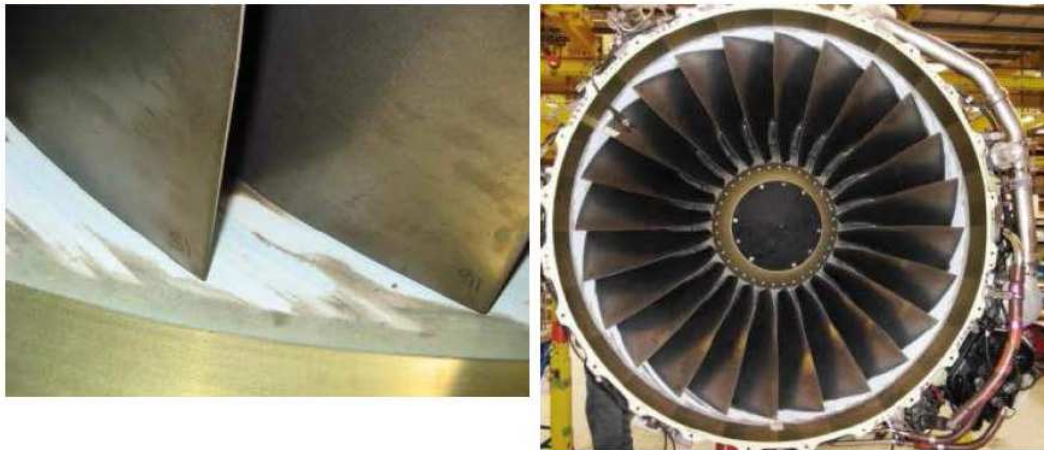
Fan module in general good condition. Damaged Abradable by the blades due to Fan case distortion

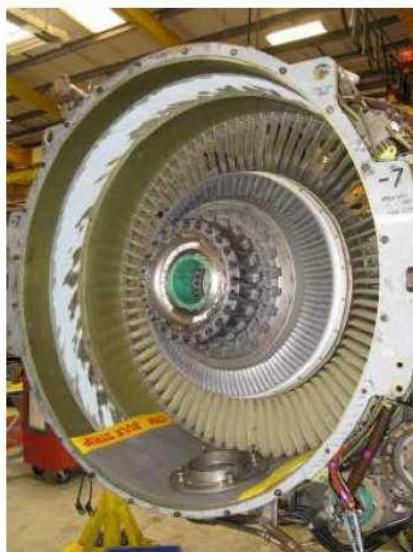
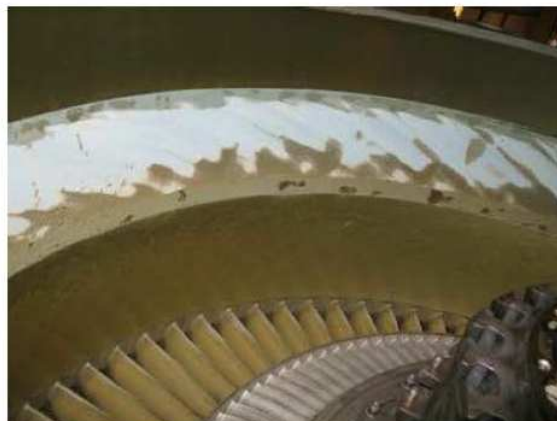
Booster in general good condition. Abradable damage visible after blades removal

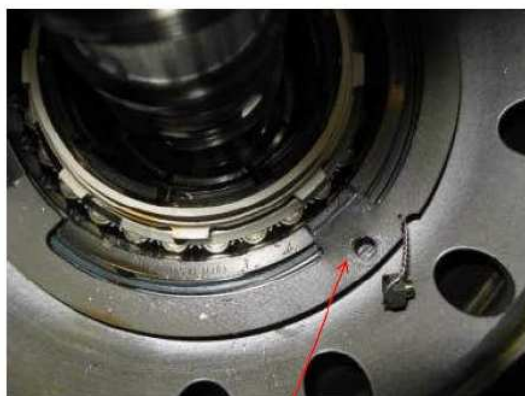
Deformation of #5 bearing retainer ring – one bolt sheared

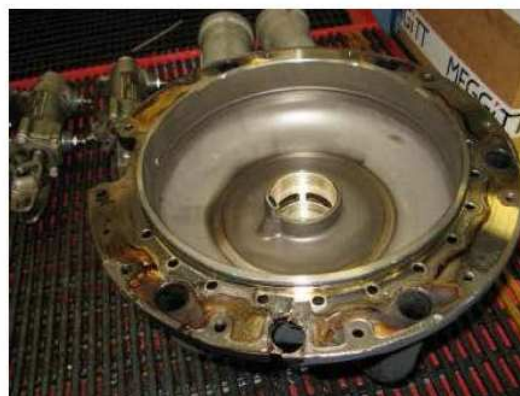
Silver seal on Oil inlet cover with wear

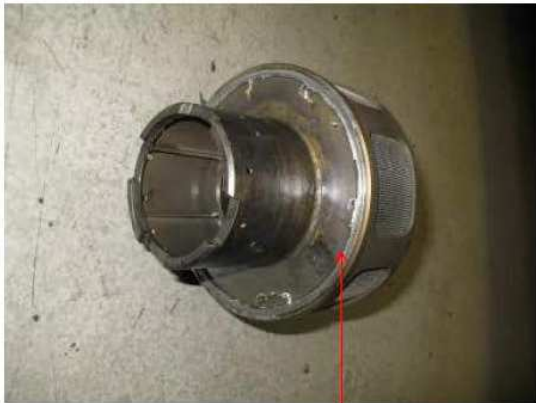
Air-Oil separator with wear

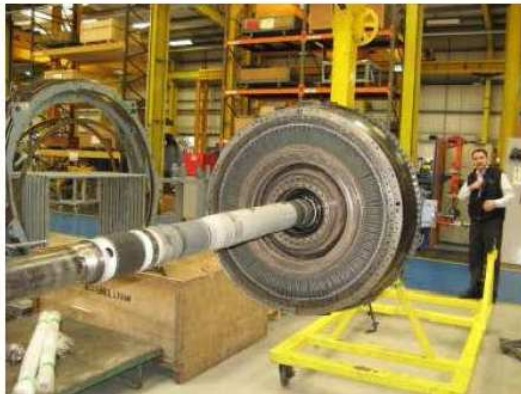
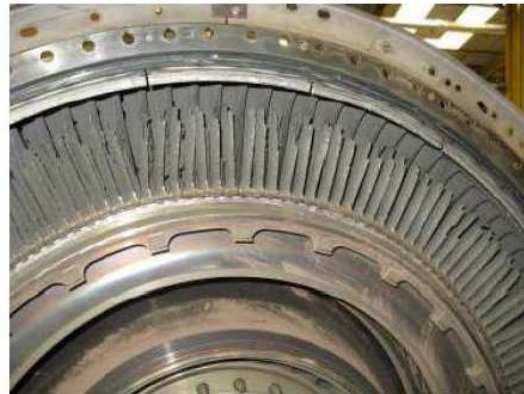
All LPT blades damaged – mostly close to blade tip

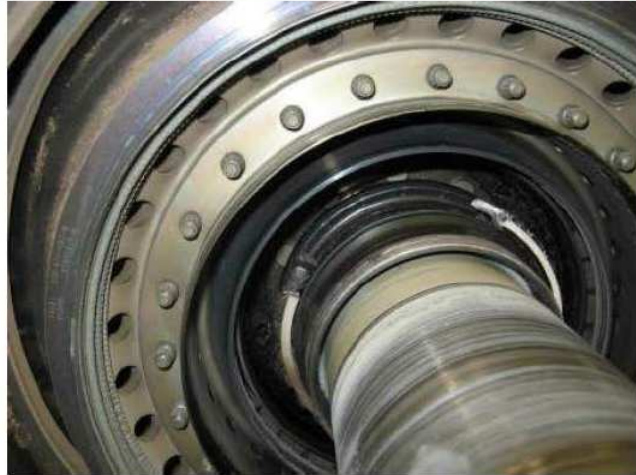
No 4 bearing rollers homogeneously damaged – flat wear spots on both sides inner and outer races. Rollers cage in two pieces, this condition can occurred during LPT disassembly process – fresh and clean condition of cage rail fracture surfaces.

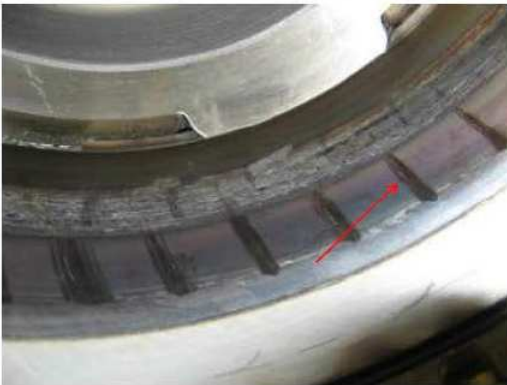
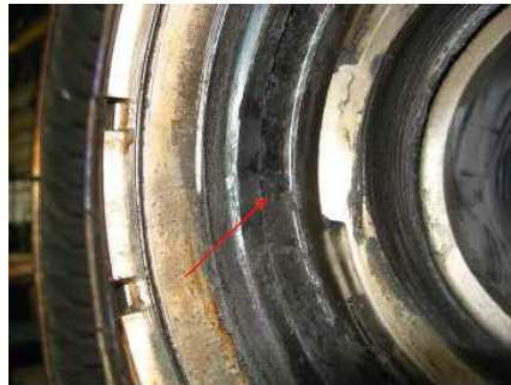
No 4 bearing outer race with tracers, and grooves from rollers. This condition with HPT shaft wear, has been concluded as a effect of HP rotor unbalance

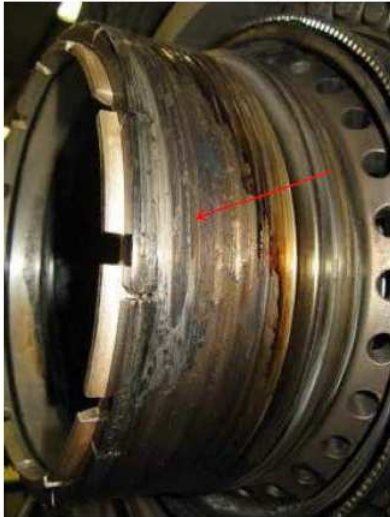
HPT shaft – wear on 3 o'clock position ALF

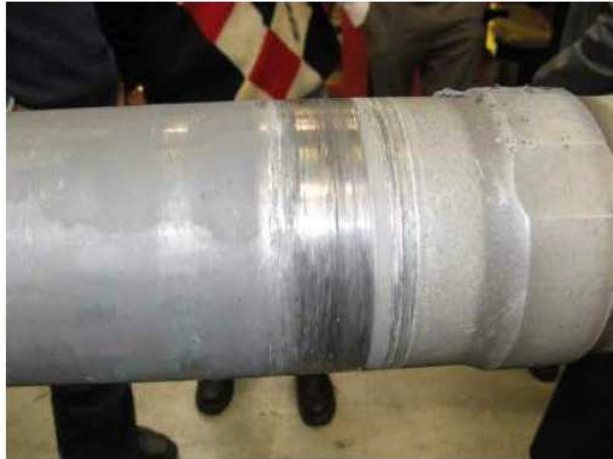
LPT shaft with wear

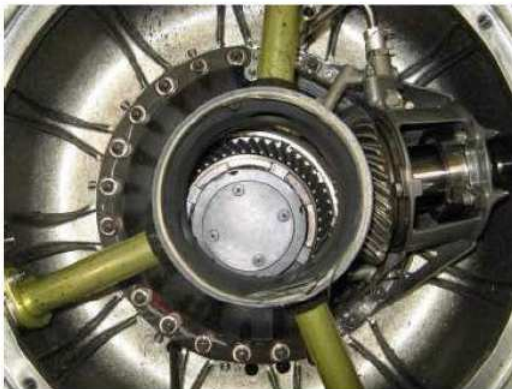
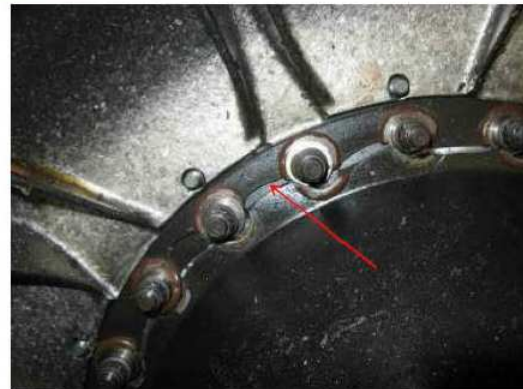
Fwd oil stationary seal cracked around 360 degree. Some parts missed

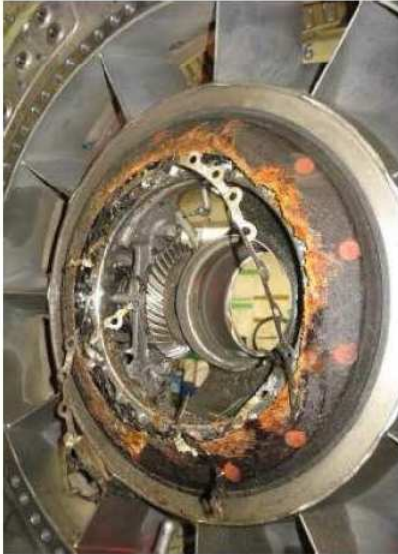
No 3 bearing rear stationary seal separated

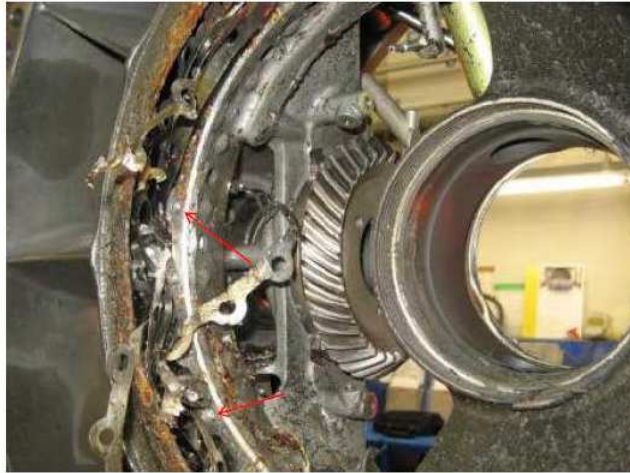
All 24 attachment studs
broken off

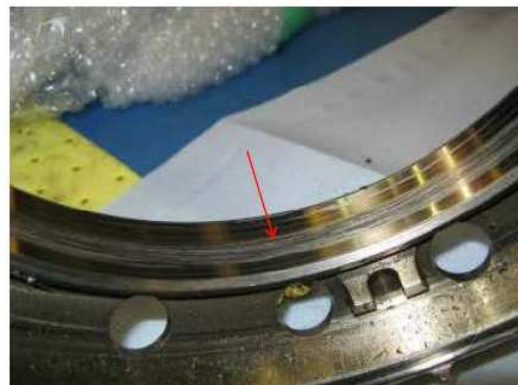
Wear from deflector

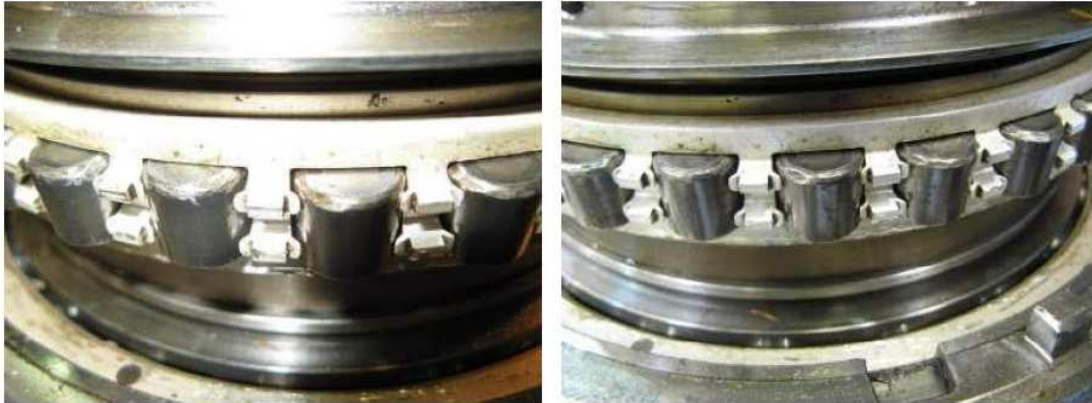
No 3 bearing rollers – general in good condition with small defects/deformation as a result of outer race replacement

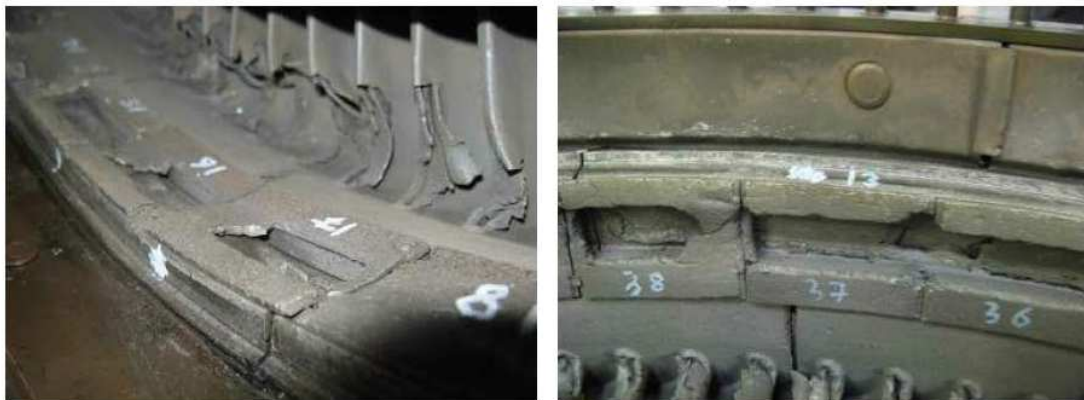
HPT shrouds with LPT St 1 nozzle damaged

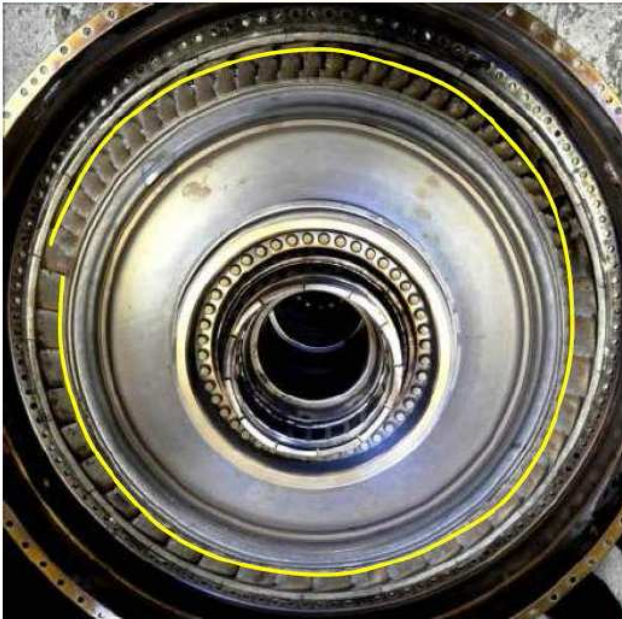
HPT disk rear view showing residual high unbalance induced by the snail shape rupture of the blades with max length measured ~31mm

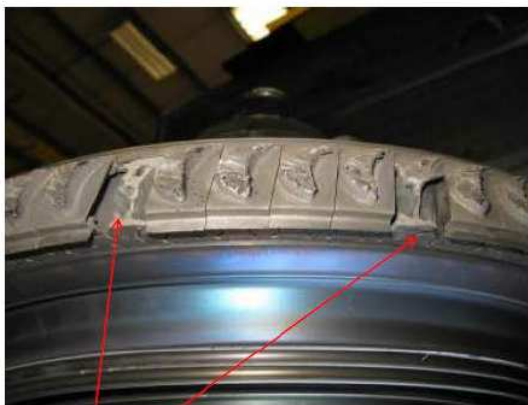
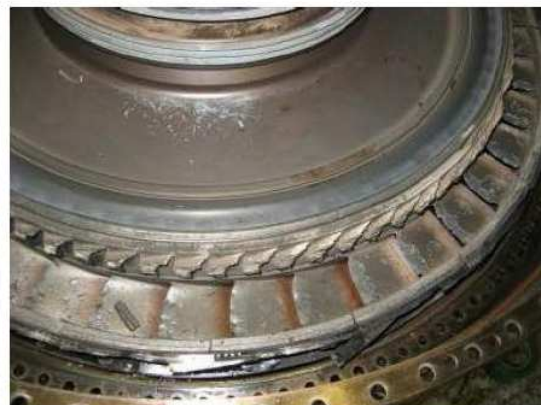
Below the platform

HPT blades liberation

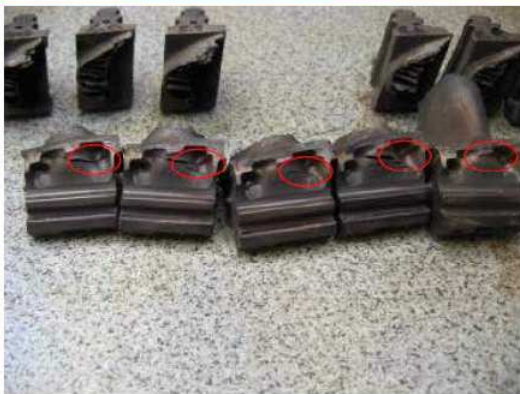
HPT blades with pre-existing cracks under the platform

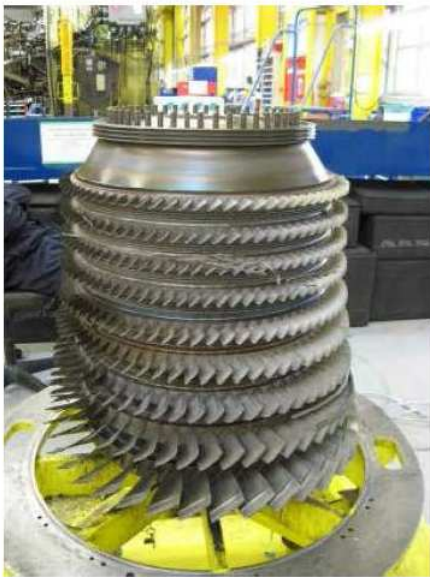
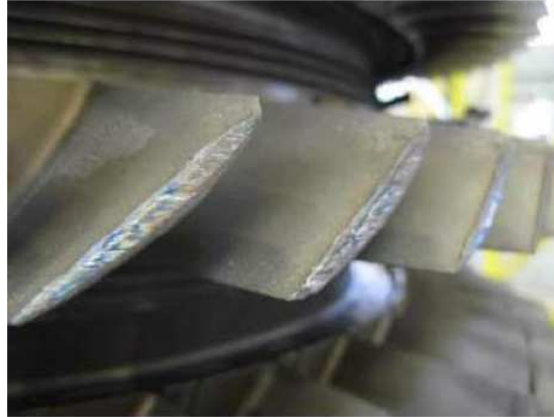
HPC blades with tip wear

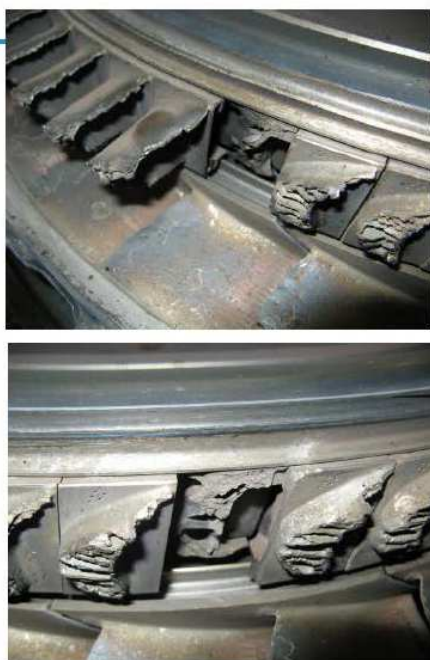
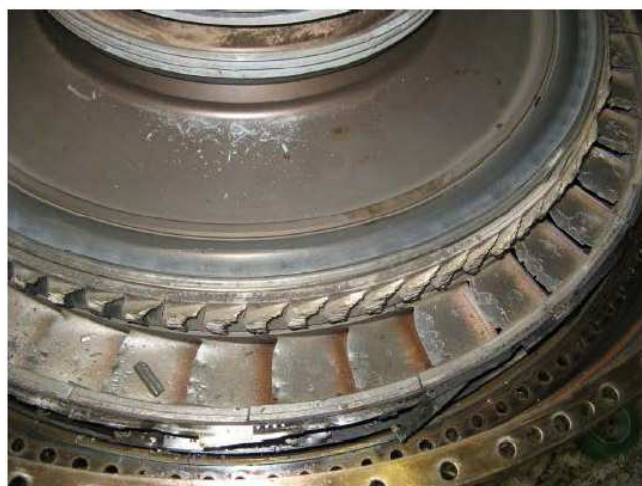
1.16.11 On disassembly at GE Wales 3 HPT blades P/N 1957M10P03 were found to have liberated below the platform. The engine had a shop visit for performance restoration in 2011 at GE Wales. Fracture analysis of the 3 HPT blades (S/N BWHN3C97; BWHN8C60 & BWHN9B89) revealed presence of fatigue characteristics on the fracture surface of all three blades. Blade BWHN3C97 was identified as the prime blade based on the extent of fatigue crack propagation on the fracture surface prior to blade eventual separation by tensile overload. The prime blade showed primary fatigue crack initiation via multiple origins from internal surface of cavity #1 shank transition zone. Evidence of secondary fatigue crack initiation was also observed from the internal surface of cavity #1 shank transition zone. Overall fracture morphology was consistent with a slower moving, higher stress low cycle fatigue mechanism progressing through the wall then crack propagation forward and aft until final separation by tensile overload. Fatigue crack propagation of the prime blade encompassed approximately 65% of the fracture surface prior to final separation. The other two blades also had primary fatigue cracking on cavity #1 transition zone wall. Majority of the fracture surface showed characteristics of tensile overload as a result of secondary impact damage. All 66 M10P03 blades in this blade set were coated by Coating 1 process while 14 M10P04 blades were coated with Coating 3 process.

Figure 1. Overviews of ESN890-816 HPT rotor assembly after removal from the event engine. Three HPT blades (two of them shown in the pictures above) had under platform separation. The remaining HPT blade set had missing/broken airfoil above platform as a result of secondary impact damage.

1.16.12 As a result, CFM revised Service Bulletin SB72-0821 in March 2013, where they reduced the recommended removal time from 25 000 CSN to 16 500 CSN for a specific population of 1957M10P03 blades. The number of blades in circulation is approximately 6 100. In addition, repairs for these serial numbers have been cancelled.

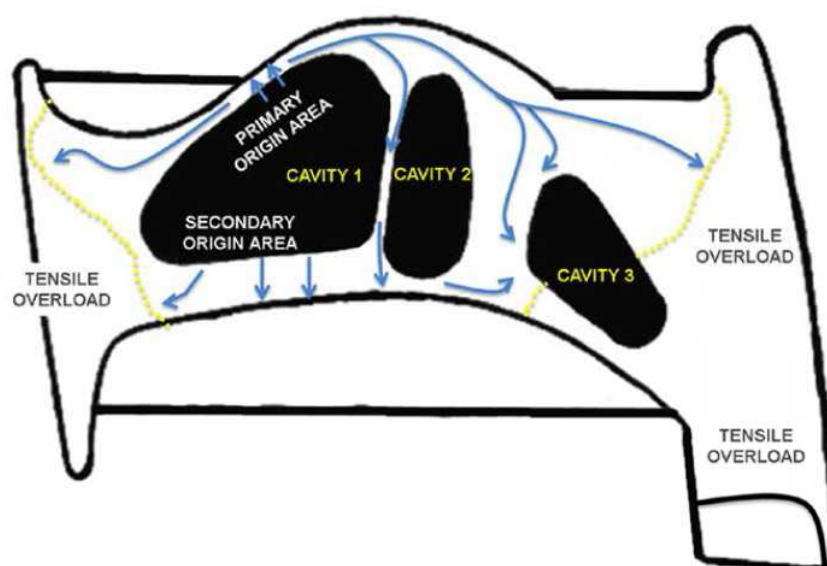
failed, based on the extent of fatigue crack propagation prior to eventual separation by tensile overload. Visual inspection of the remaining 77 blades (63 M10P03 and 14 M10P04 blades) found 11 additional M10P03 blades with visible through-wall transition zone cracks on the external wall.

Figure 5. Top view of blade BWHN3C97. Primary fatigue crack initiation occurred via multiple origins from internal CVX surface located within cavity #1 shank transition zone. Evidence of secondary fatigue crack initiation was also observed from internal CCV surface of cavity #1 shank transition zone. White arrows indicate fatigue crack propagation directions. This blade was identified as the prime blade based on the extent of fatigue crack propagation (~ 65% of fracture surface) prior to eventual separation by tensile overload.

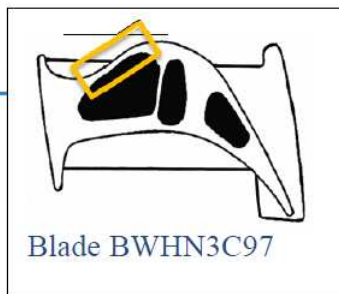
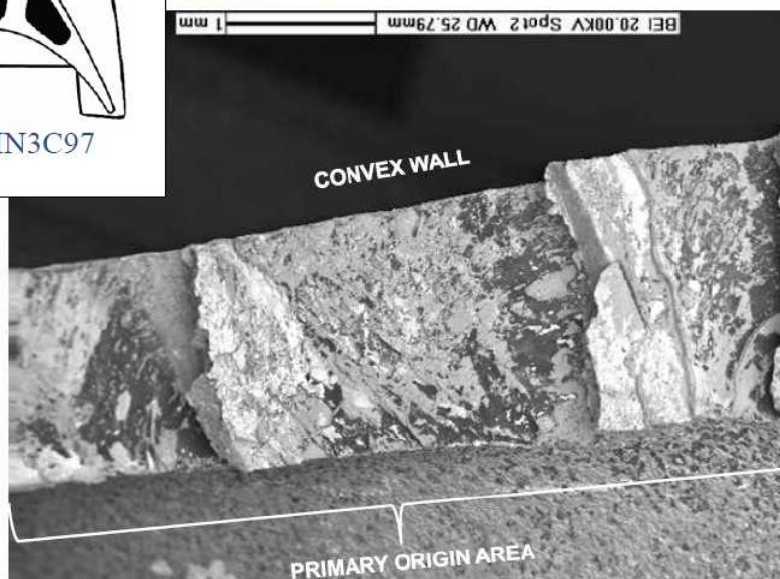
Figure 6. SEM photomicrographs showing primary fatigue crack initiation region on CVX internal surface located within cavity #1 shank transition zone of prime blade BWHN3C97. Fatigue cracks initiated via multiple origins from internal surface and propagated thru CVX wall. Heavy oxidation was observed on the crack surface.

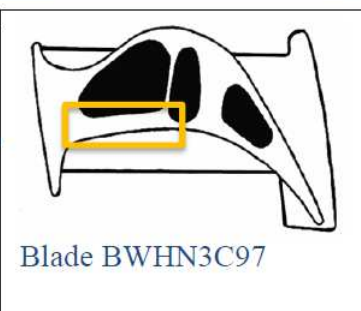
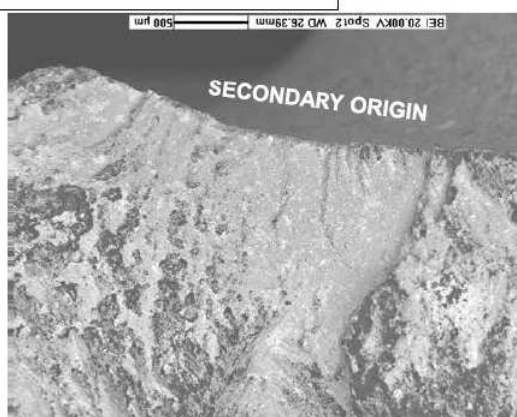
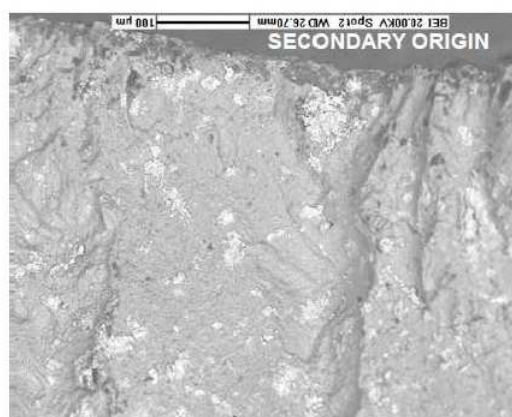
Figure 7. SEM photomicrographs showing secondary fatigue crack origins on CCV internal surface located within cavity #1 shank transition zone of prime blade BWHN3C97. Fatigue cracks initiated via multiple origins from internal surface and propagated thru CCV wall. Heavy oxidation was observed on the crack surface.

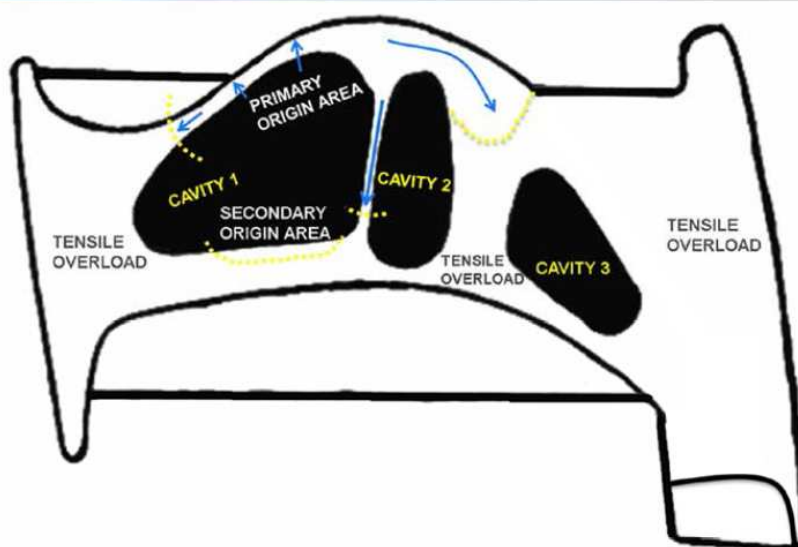
Figure 8. Top view of blade BWHN8C60. Primary fatigue crack initiation occurred via multiple origins from internal CVX surface located within cavity #1 shank transition zone. Fatigue cracks propagated thru cavities #1 & #2 CVX wall but the majority of the blade fracture surface showed characteristics of tensile overload as a result of secondary impact damage.

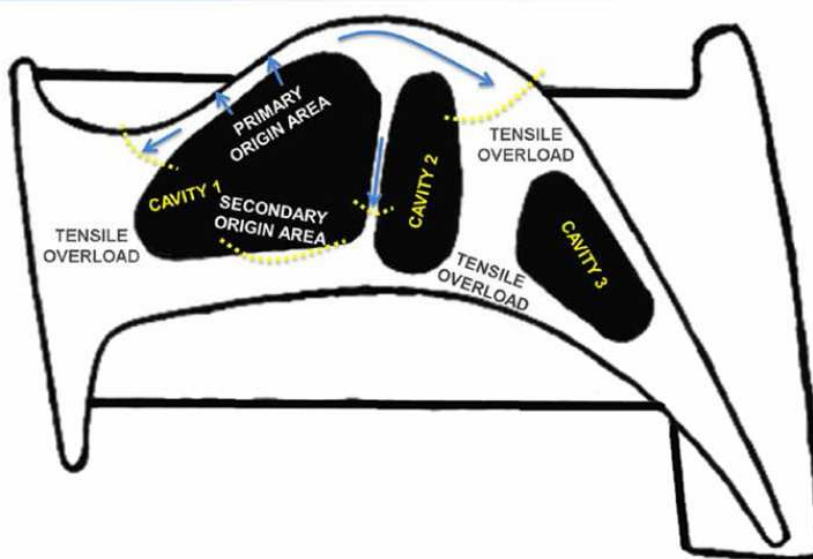
Figure 9. Top view of blade BWHN9B89. Primary fatigue crack initiation occurred via multiple origins from internal CVX surface located within cavity #1 shank transition zone. Fatigue cracks propagated thru cavities #1 & #2 CVX wall but the majority of the blade fracture surface showed characteristics of tensile overload as a result of secondary impact damage.

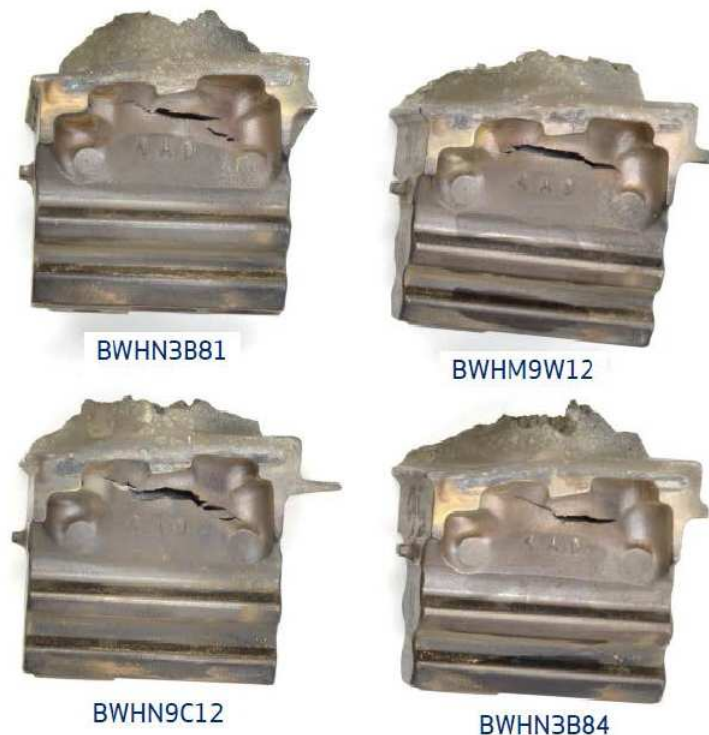
Figure 10. Macro photos showing additional M10P03 blades with visible thru wall transition zone cracks on CVX walls (S/N's BWHN3B81, BWHM9W12, BWHN9C12, and BWHN3B84).

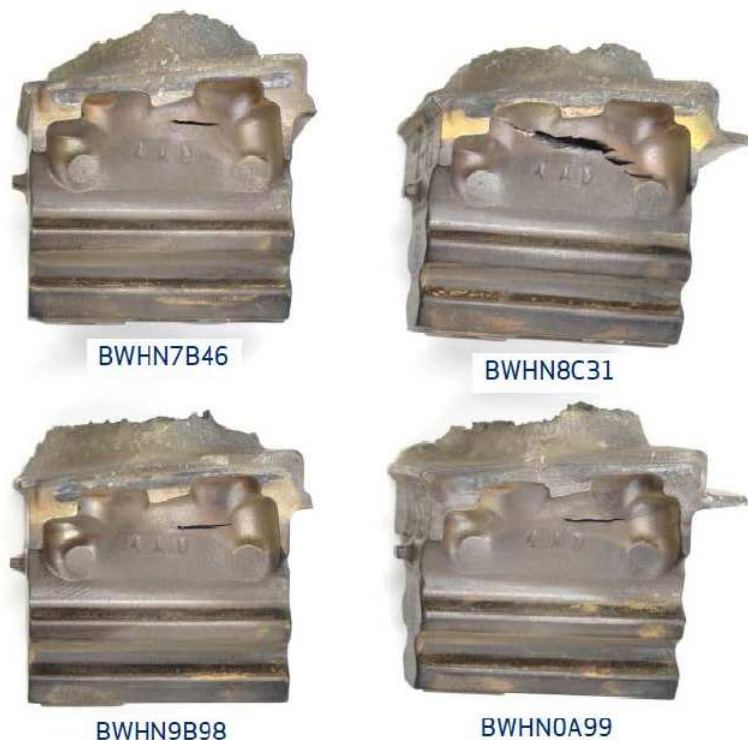
Figure 11. Macro photos showing additional M10P03 blades with visible thru wall transition zone cracks on CVX walls (S/N's BWHN7B46, BWHN8C31, BWHN9B98, and BWHN0A99).

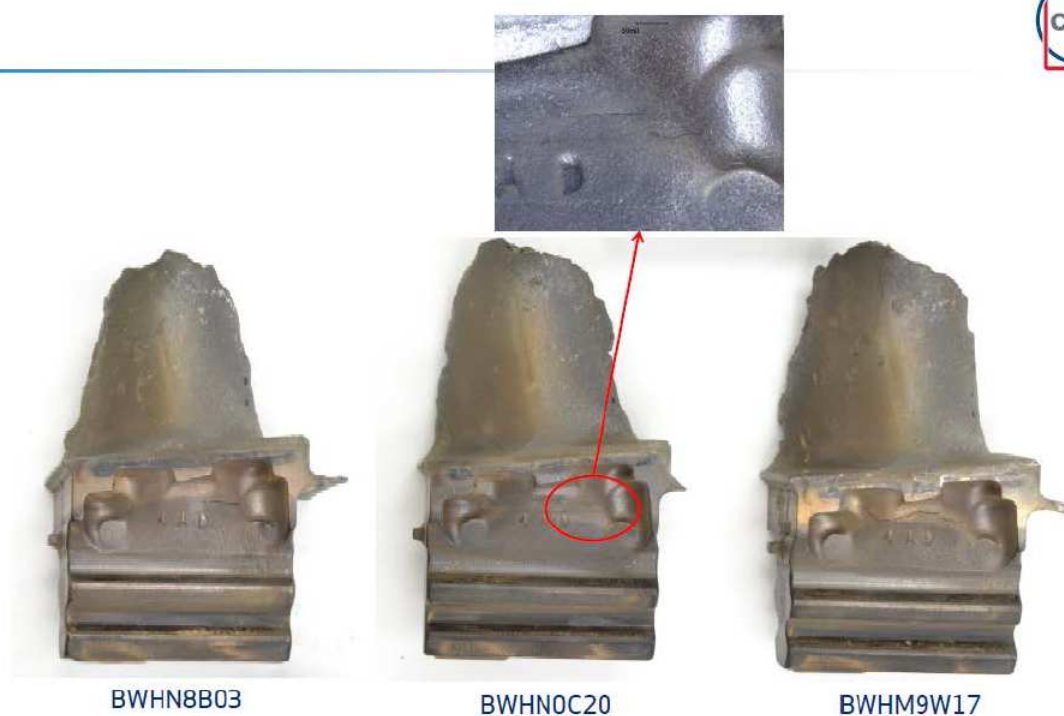
Figure 12. Macro photos showing additional M10P03 blades with visible thru wall transition zone cracks on CVX walls (S/N's BWHN8B03, BWHN0C20, and BWHM9W17).

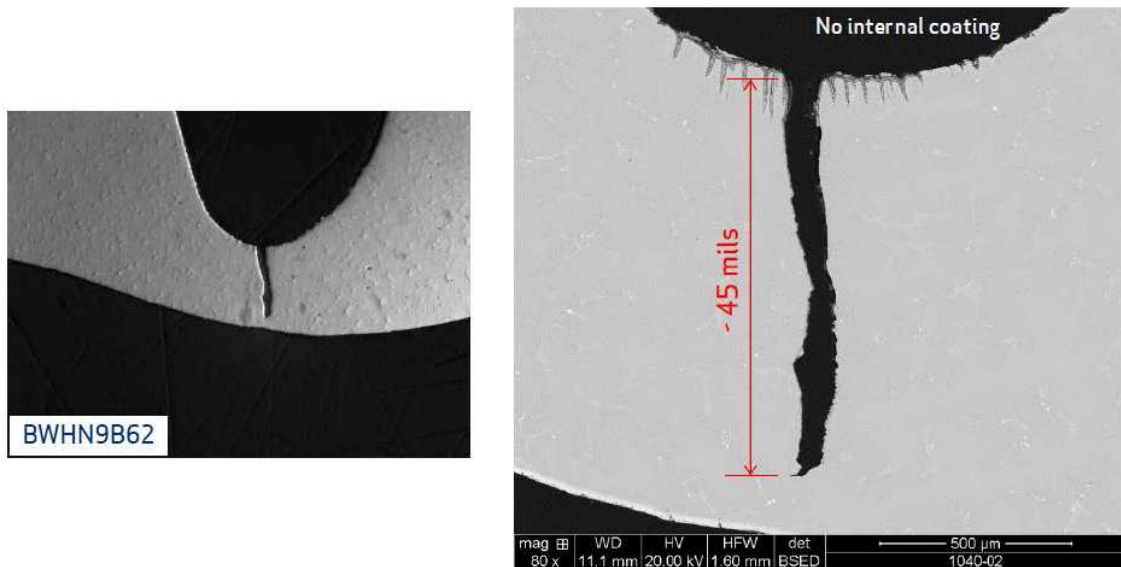
Figure 15. Optical and SEM photomicrographs showing a large size transition zone crack found in M10P03 blade BWHN9B62 that was sectioned in the shank transition zone. No internal coating was observed on internal cavity wall surface. See Figures 16 and 17 for detailed SEM/EDS analysis of the transition zone crack surface.

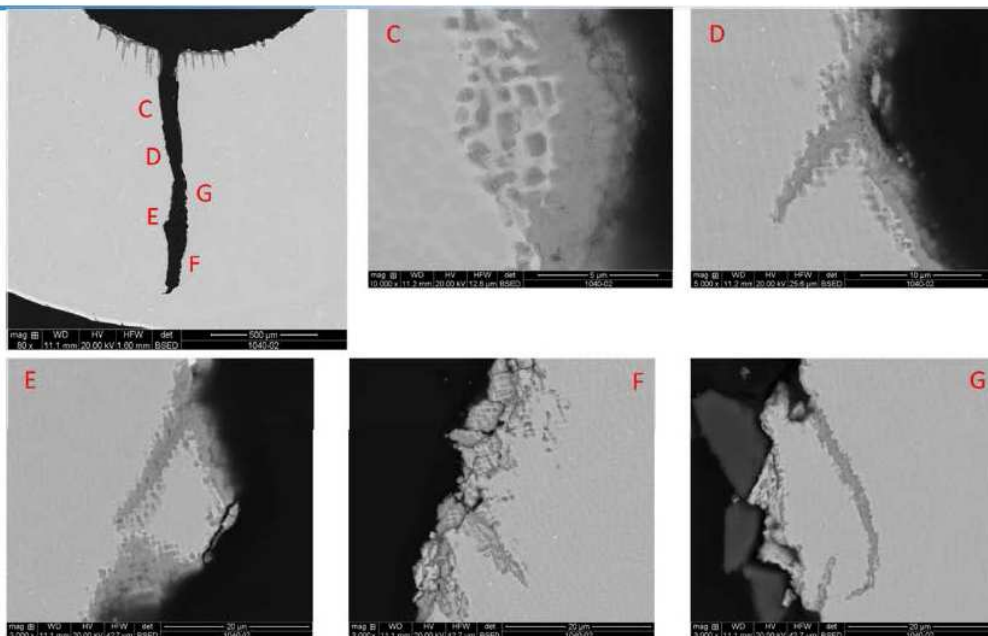
Figure 16. SEM photomicrographs showing oxidation at various locations of transition zone crack surface of M10P03 blade BWHN9B62. See Figure 17 for EDS chemistry analysis of the transition zone crack surface oxide layers.

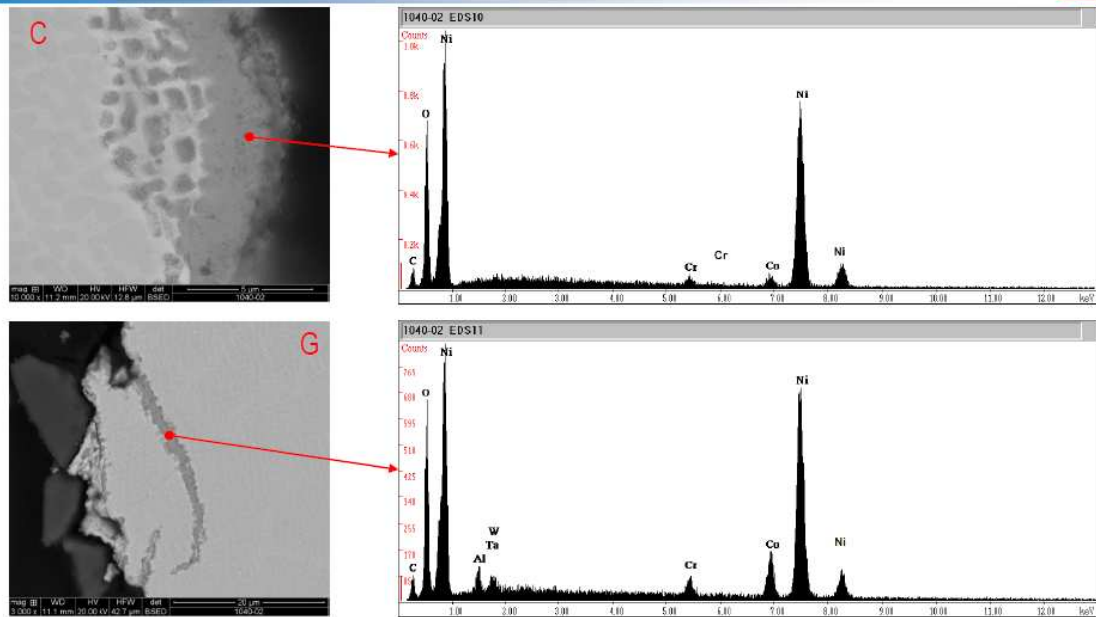
Figure 17. Representative EDS spectra of the transition zone crack surface oxide layers of M10P03 blade BWHN9B62. No evidence of corrosion elements (e.g. sulfur) was detected in the oxide layers.
