AIRCRAFT INCIDENT REPORT AND EXECUTIVE SUMMARY

Reference:	CA18/3/2/1010	
Aircraft Registration	ZU-ZDL	Date of Incident	25 February 2014		Time of Incident	0657Z
Type of Aircraft	Sling		Type of Operation	Training		
Pilot-in-command Licence Type	Student	Age	43	Licence Valid	Yes	
Pilot-in-command Flying Experience	Total Flying Hours	38.11		Hours on Type	38.11	
Last point of departure	Virginia Aerodrome (FAVG)					
Next point of intended landing	Pietermaritzburg Aerodrome (FAPM)					
Location of the Incident site with reference to easily defined geographical points (GPS readings if possible)						
Runway 16 at Pietermaritzburg Aerodrome						
Meteorological Information	Surface Wind: 230 at 03 knots. Visibility: Good. Temperature: 21C Cloud base: 6500 feet.					
Number of people on board	1 + 0	No. of people injured	0	No. of people killed	0	
Synopsis	<p>The student pilot, who was the owner of the aircraft, took off from FAVG on an illegal cross-country training flight to FAPM. The pilot has transgressed the South African Civil Aviation Technical Standards 61.02.5 as stated on paragraph 1.18.1 of this report. During the landing on runway 16 at FAPM the student pilot landed the plane hard,

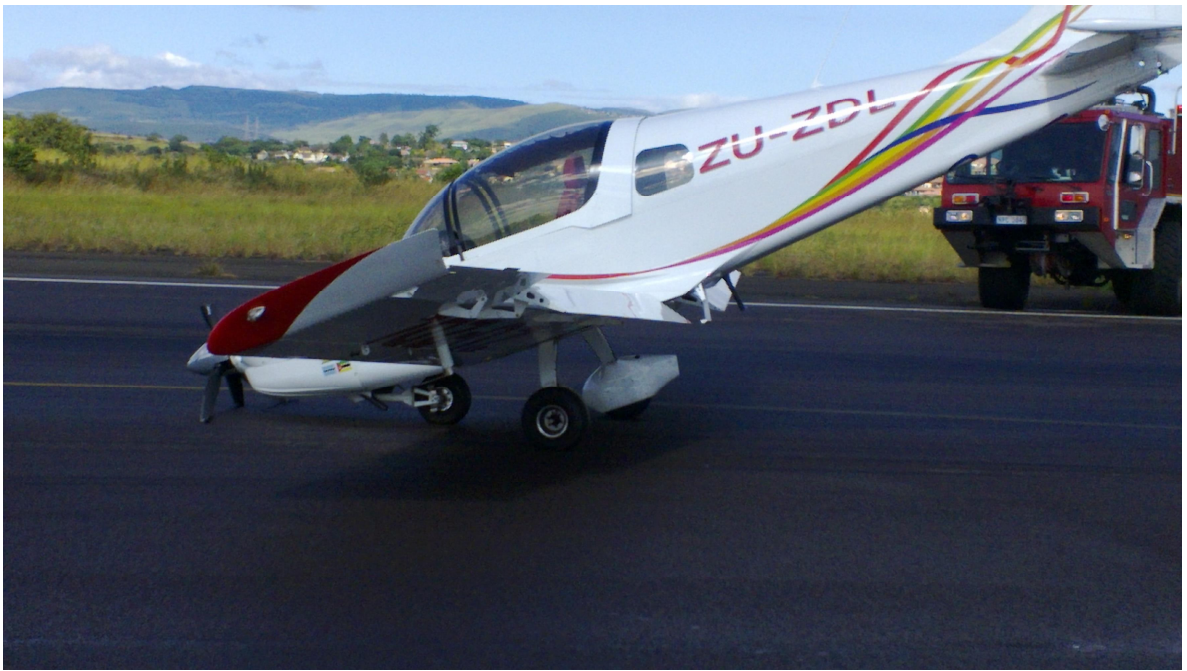
1.3.1 The aircraft sustained damage to the propeller and the nose wheel.

1.12.1 During the landing the student pilot landed the aircraft hard, the nose wheel collapsed.

Figure 1: The picture of the aircraft after the incident

- 2.2 The investigator is of the opinion that during landing, the student pilot flared too high and the student pushed the aircraft forward which caused the aircraft to touch the ground hard on the nose wheel and as a result the nose wheel collapsed. The inexperience of the student could have contributed to the fact that an incorrect landing technique was used.

3.2.1 The student pilot landed the aircraft hard and the nose wheel broke off.

NEW LGEAR INSTALLED - MOUNTS INSPECTED.

NEW PROP INSTALLED + INSPECTION DONE. IN ACCORDANCE WITH LOGAL REQUIREMENTS.
