AIRCRAFT INCIDENT REPORT AND EXECUTIVE SUMMARY

Reference:	CA18/2/3/1023	
Aircraft Registration	ZS-NFO	Date of Incident	28 November 2013		Time of Incident	14:30Z
Type of Aircraft	Beech F90 King Air		Type of Operation		International flight (Private)	
Pilot-in-command Licence Type		Commercial Pilot Licence (CPL)	Age	33	Licence Valid	Yes
Pilot-in-command Flying Experience		Total Flying Hours	4803.20		Hours on Type	68.25
Last point of departure		Beira Airport- FQBR (Mozambique)				
Next point of intended landing		Lanseria International Airport - FALA (Gauteng province, South Africa)				
Location of the Incident site with reference to easily defined geographical points (GPS readings if possible)						
About 20 miles north-west of Lanseria airport						
Meteorological Information		Surface wind: variable; Temperature: 22 °C; Dew point: 14°C; Cloud: overcast with hail and thunderstorm.				
Number of people on board	1 + 0	No. of people injured	0	No. of people killed	0

**AIRCRAFT INCIDENT REPORT**

Name of Owner : National Airway Corporation (Pty) Ltd
Name of Operator : Private
Manufacturer : Beech Aircraft Corporation
Model : F90
Nationality : South African
Registration Marks : ZS-NFO
Plac

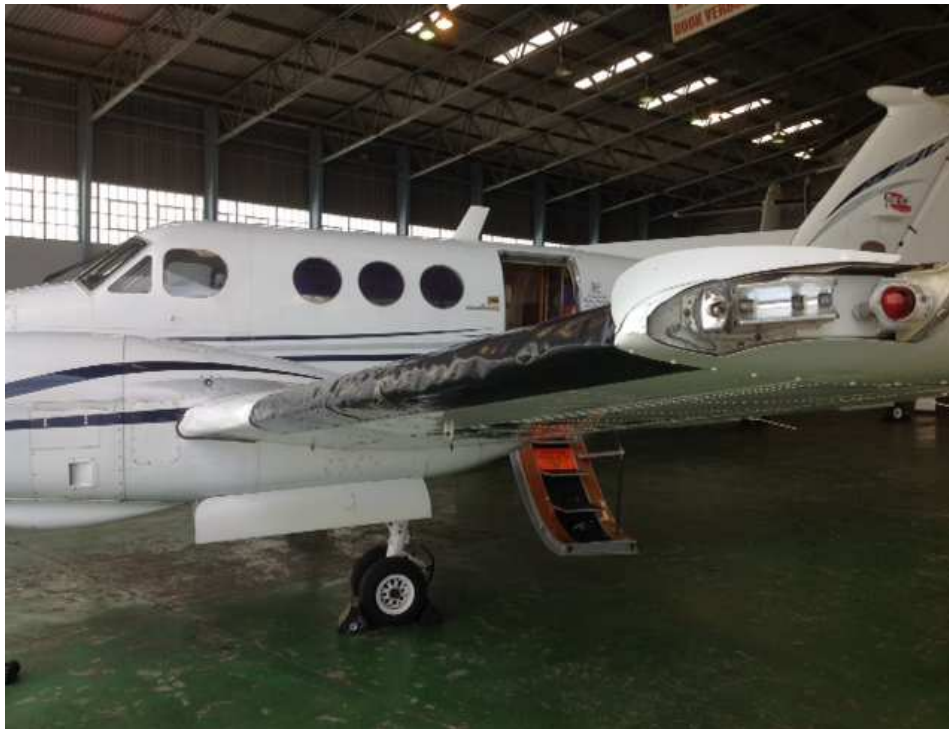
- 1.3.1 The aircraft sustained damage to the leading edges, spinners, exhaust, wing, fuselage and tail lights.

Figure 1: damage to the aircraft

3.2.1 The aircraft was hit by hail during flight.

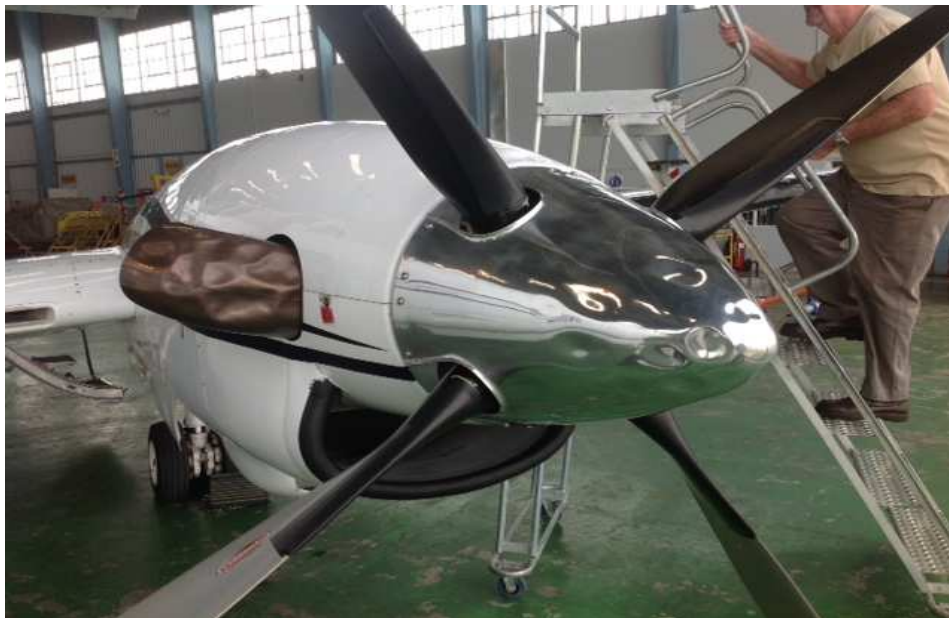
1.12.1 The aircraft was hit by hail while flying to FALA. The aircraft sustained damage to the leading edges, spinners, wing, exhaust, tail light and fuselage.

Figure 2: damage to the exhaust
