SHORT REPORT AND EXECUTIVE SUMMARY

Reference:	CA18/3/2/1168	
Aircraft registration	ZS-STW	Date of incident	13 November 2017		Time of incident	1700Z
Type of aircraft	Piper PA-32R		Type of operation		Private (Part 91)	
Pilot-in-command licence type		Private Pilot License (PPL)	Age	23	Licence valid	No
Pilot-in-command flying experience		Total flying hours	316.3		Hours on type	74.2
Last point of departure		Wonderboom Aerodrome (FAWB) Gauteng Province				
Next point of intended landing		Louis Trichardt Aerodrome (FALO) Limpopo Province				
Location of the incident site with reference to easily defined geographical points (GPS readings if possible)						
Louis Trichardt Aerodrome (FALO) GPS:23°03' 42.91"S 29°51' 51.38"E, Elevation: 3014ft AMSL						
Meteorological information		Surface wind: 45-54°/5kts Temperature: 29.8°C, CAVOK				
Number of people on board	1+1	No. of people injured	0	No. of people killed	0	
Synopsis						
<p>The pilot, accompanied by a passenger took off from Wonderboom Aerodrome (FAWB) at approximately 1500Z for a flight to Louis Trichardt Aerodrome (FALO). It was the second flight of the day as the aircraft was flown to FAWB from FALO earlier that morning. While on

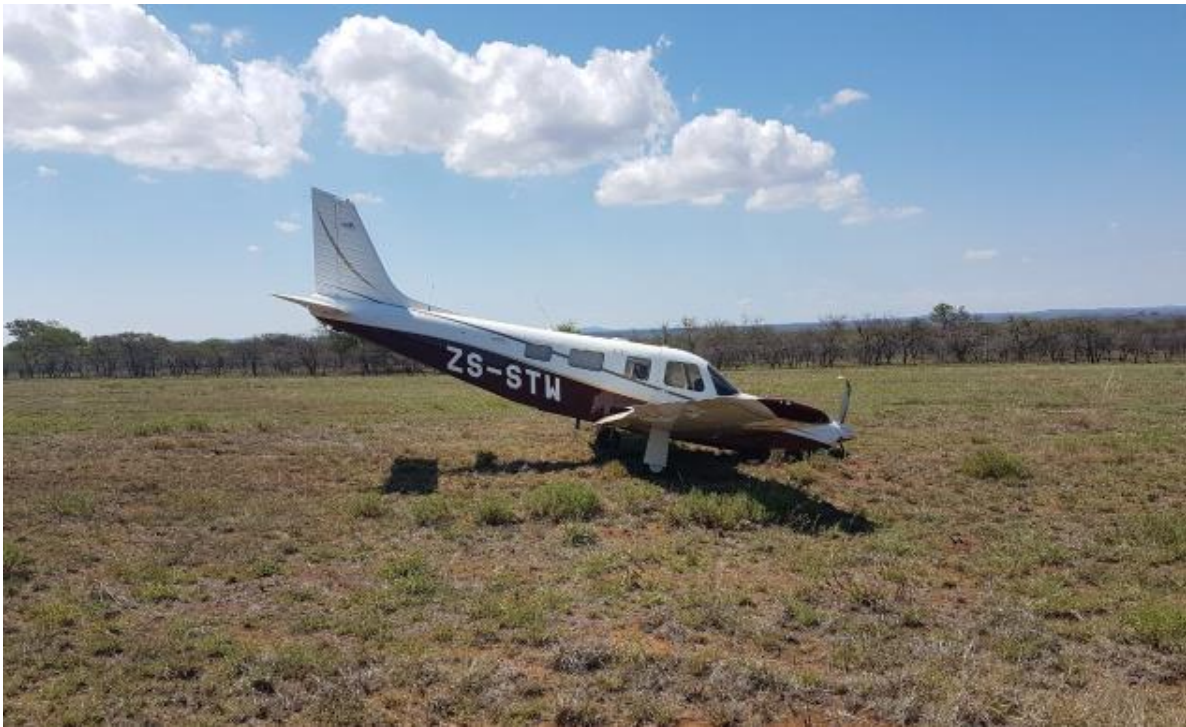
- 1.1.6 The pilot opted to proceed with the approach for runway 28. During the landing roll when brakes were applied the nose landing gear collapsed. Directional control was lost and the aircraft veered off of the runway to the left and came to rest on the grass next to the runway.

- 1.1.8 The aircraft came to rest with the two main gears in the extended position and the nose collapsed. The propeller was damaged as well as a lower engine cowling.

Figure 1: The aircraft as it came to rest beside the runway

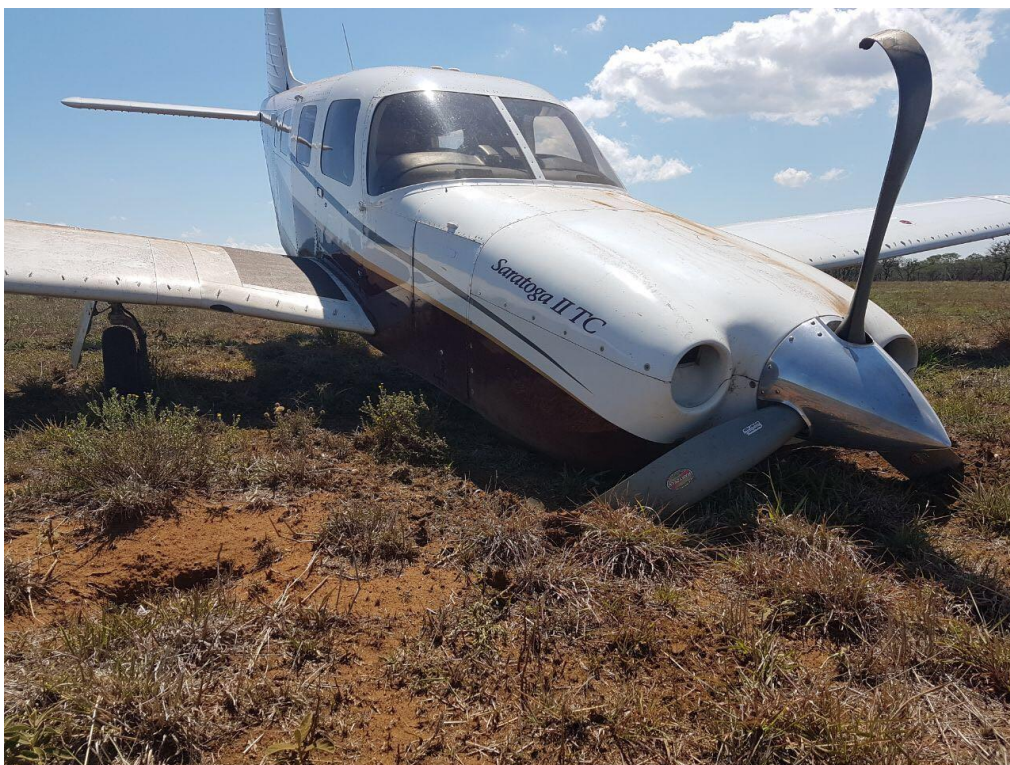
Figure 2: Damage to the propeller

- 1.2.5 The aircraft sustained damage to the propeller, lower cowling and to the nose gear actuator mounts.
- 1.2.6 The Surface wind at the time of the accident was 5kts from 045° to 054°. The temperature was 29.8°C.
- 1.2.7 The runway is equipped with runway lights that are activated by the pilot on approach.
- 1.2.8 The pilot and passenger were not injured in the occurrence.
