AIRCRAFT INCIDENT REPORT AND EXECUTIVE SUMMARY

Reference:		CA18/3/2/1185	
Aircraft Registration	ZS-ASW	Date of Accident	8 November 2017		Time of Incident	1738Z	
Type of Aircraft	Avro 146-RJ85A		Type of Operation		International Commercial		
Pilot-in-command Licence Type		Airline Transport Pilot's Licence (ATPL)		Age	36	Licence Valid	Yes
1st Officer Licence Type		ATPL		Age	29	Licence Valid	Yes
Pilot-in-command Flying Experience		Total Flying Hours	8 895.0		Hours on Type	7 035.8	
1st Officer Flying Experience		Total Flying Hours	4 157.1		Hours on Type	81.3	
Last point of departure		Harare International Airport (FVHA), Zimbabwe					
Next point of intended landing		OR Tambo International Airport (FAOR), South Africa					
Location of the accident site with reference to easily defined geographical points (GPS readings if possible)							
During flight at approximately 34 000 ft above mean sea level (AMSL), 240Nm north east of FAOR in the area of UTULI in Limpopo province

AIRCRAFT ACCIDENT REPORT

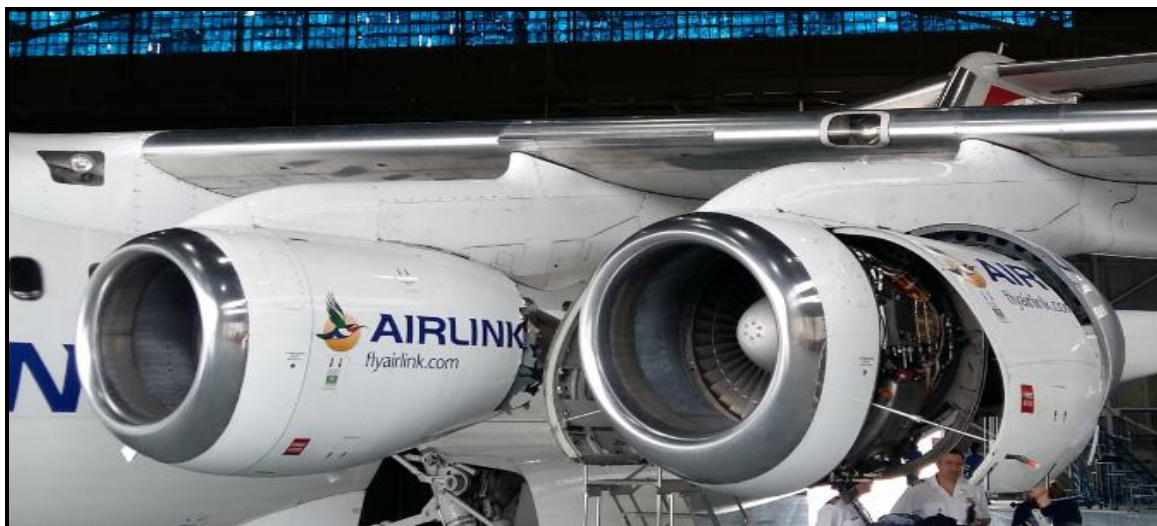
Figure 2: The two damaged port-side engines

1.3.1 The aircraft sustained damage to both no. 1 and 2 engines on the port side wing of the aircraft. In addition, the turbine blades of no. 2 engine struck the no. 1 engine assembly pylon covers.

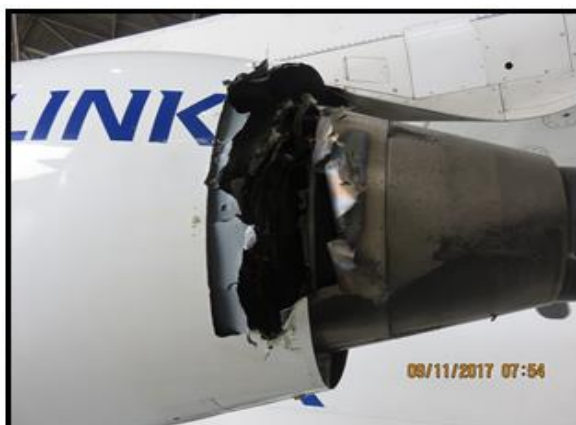
Figure 3: Damage to engine no. 2

After landing, the aircraft was inspected for damage. Regarding the No. 2 engine, the fourth-stage turbine rotor was lodged into the engine's tail pipe (Figure 3). The fourth stage turbine rotor and retaining nut were recovered. The lock cup was not recovered. Figure 4 illustrates a cross section of the parts discussed above. The No. 2 engine, along with the recovered components, were shipped to Honeywell Aerospace in Phoenix, Arizona, for an engine teardown examination. The teardown examination occurred on January 9-11, 2018.

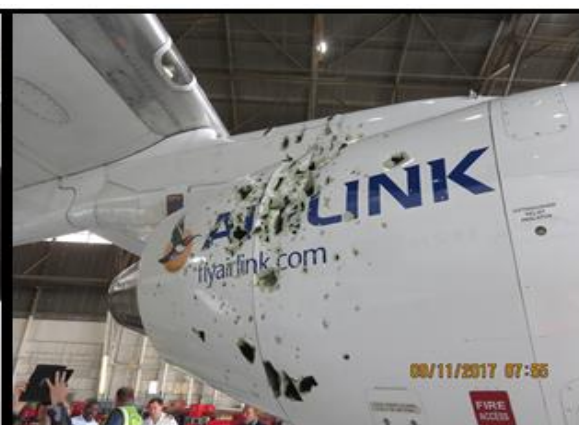
Figure 4: Damage to engine no. 1

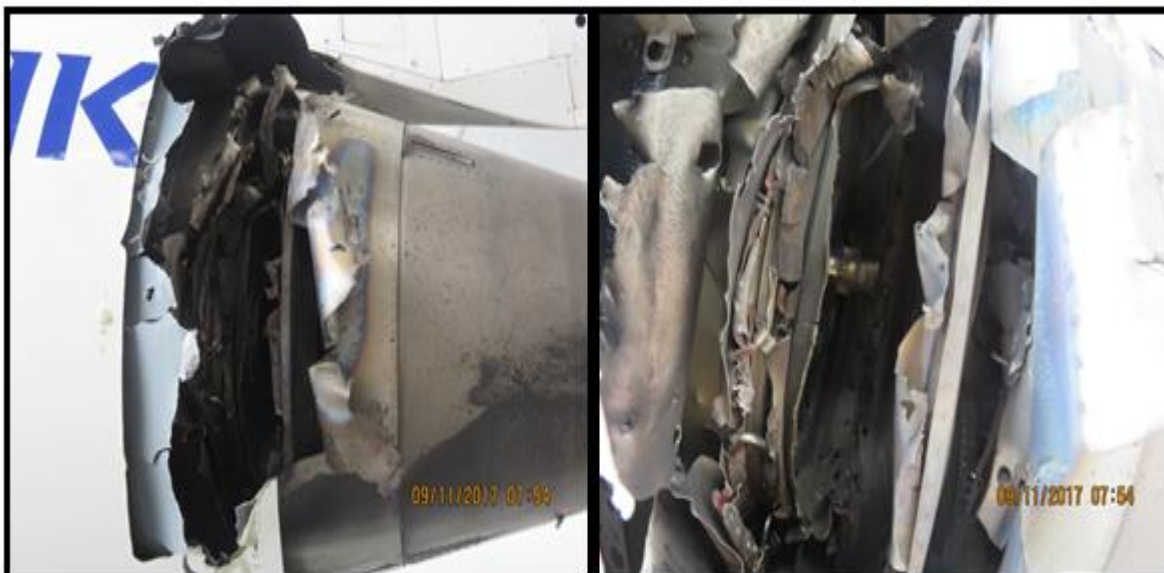
- 1.12.1 The incident occurred during flight at a height of approximately 34 000 ft AMSL during cruise phase. Damage to both engines was due to an uncontained engine failure that originated on the no. 2 engine. The no. 2 engine's left-hand side casing was ripped open by the fourth turbine wheel. The fourth turbine rotor wheel was found stuck on the exhausted casing with the retaining nut in between the turbine disc and the exhaust ribs. All turbine blades on the wheel assembly broke off and flew towards engine no. 1, striking it.

Figure 6: Damage to no. 2 engine's fourth-stage turbine casing

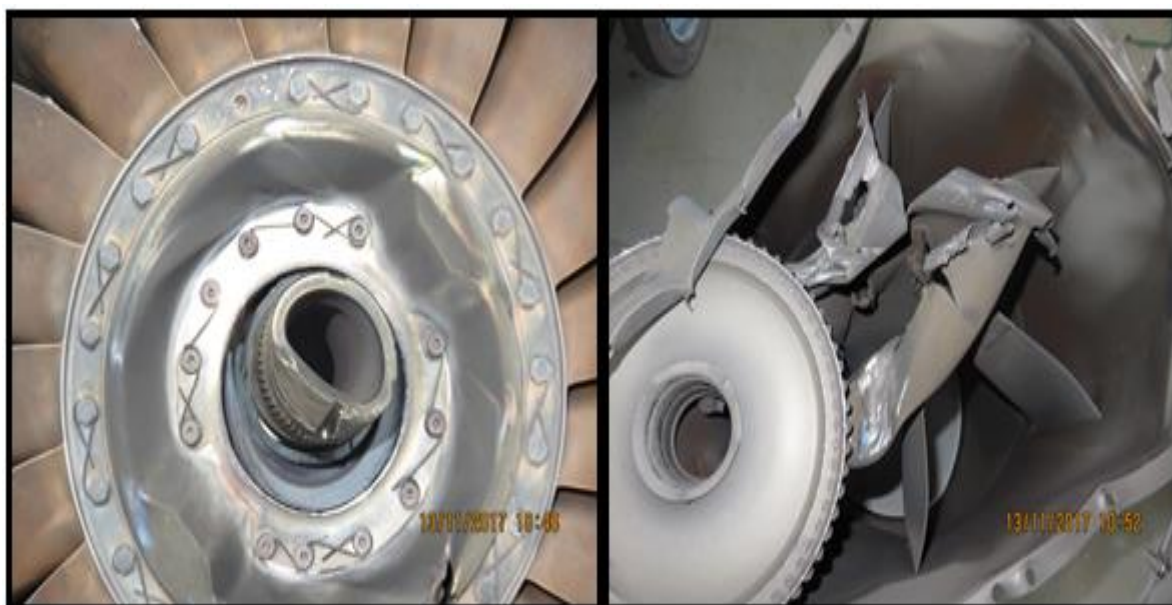
Figure 7: Damage to the shaft assembly and the fourth-stage turbine wheel, as it was found

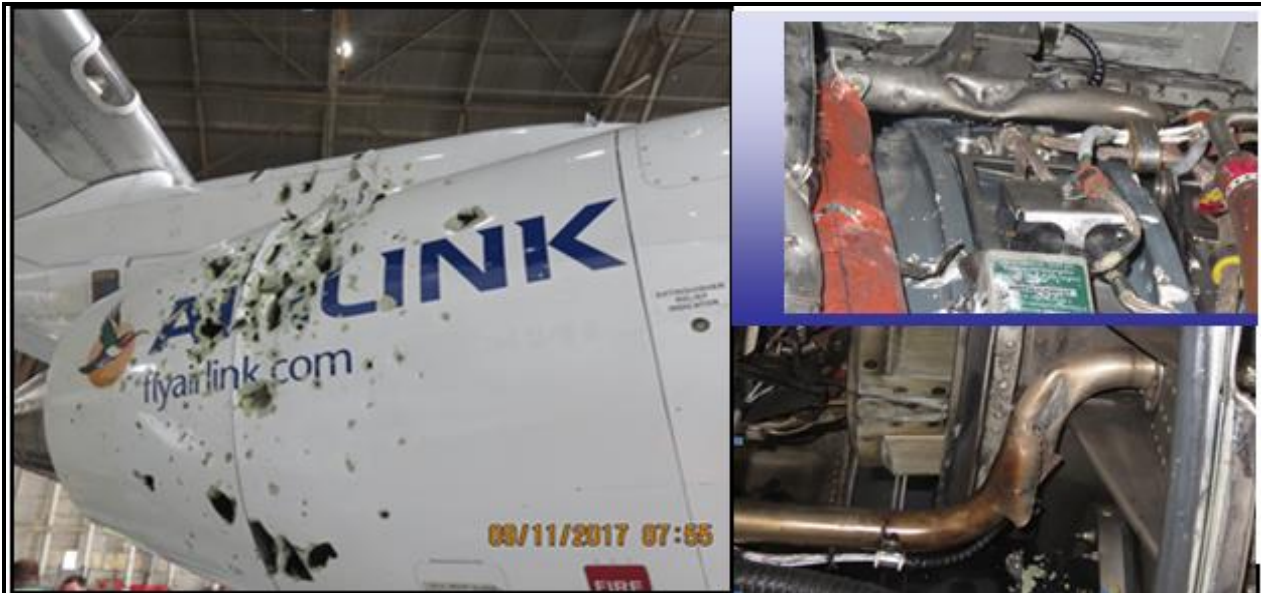
There was evidence of damage caused by flying objects on the no. 1 engine cowlings. In addition, the turbine blades were found within the cowlings, which caused damage to the engine components, and fuel, oil and pneumatic lines.

Figure 8: Damage to the engine cowlings, fuel and pneumatic lines, and FADEC box from engine no. 1

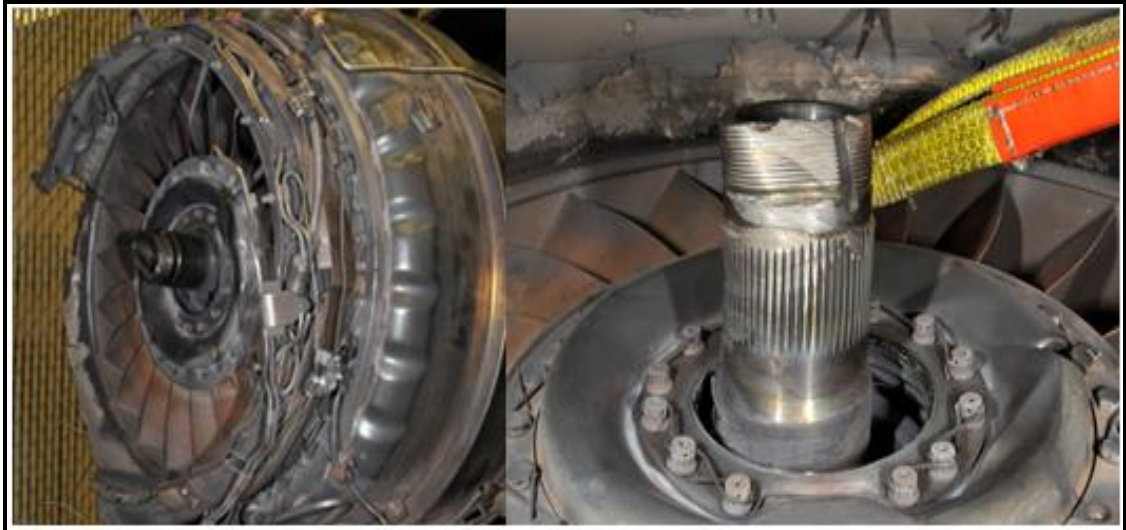
- The teardown revealed serious internal damage caused during the incident, which lead to an engine failure. Figure 9 shows some of the major engine drive components that sustained serious damage.

Figure 9: Damage to the drive shaft and the third stator assembly

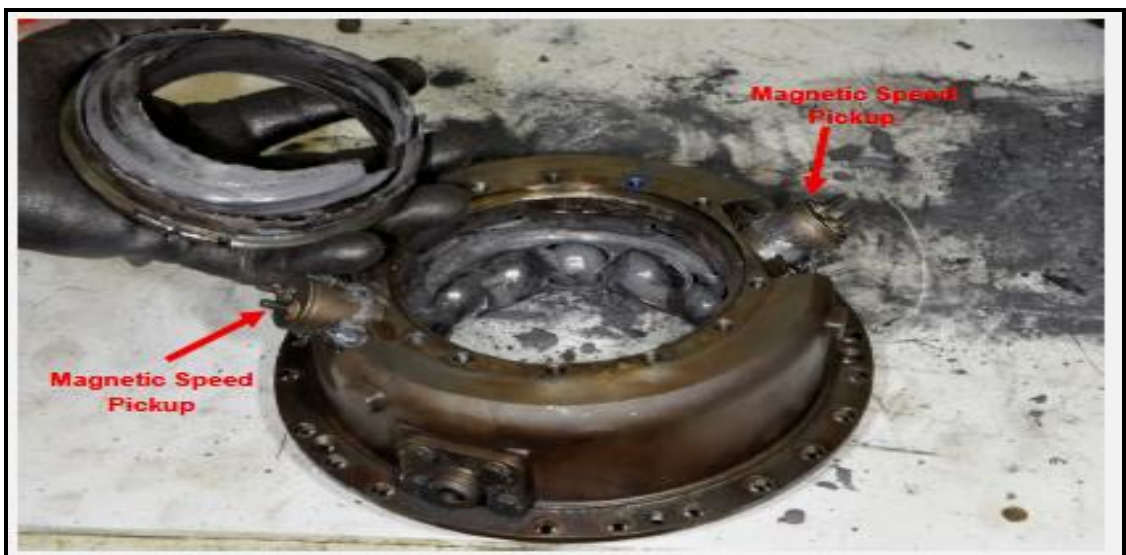
- The condition of the magnetic over speed pick-up found compromised (Figure 10).

Figure 10: Magnetic over-speed pick-up on the damaged bearing no. 4

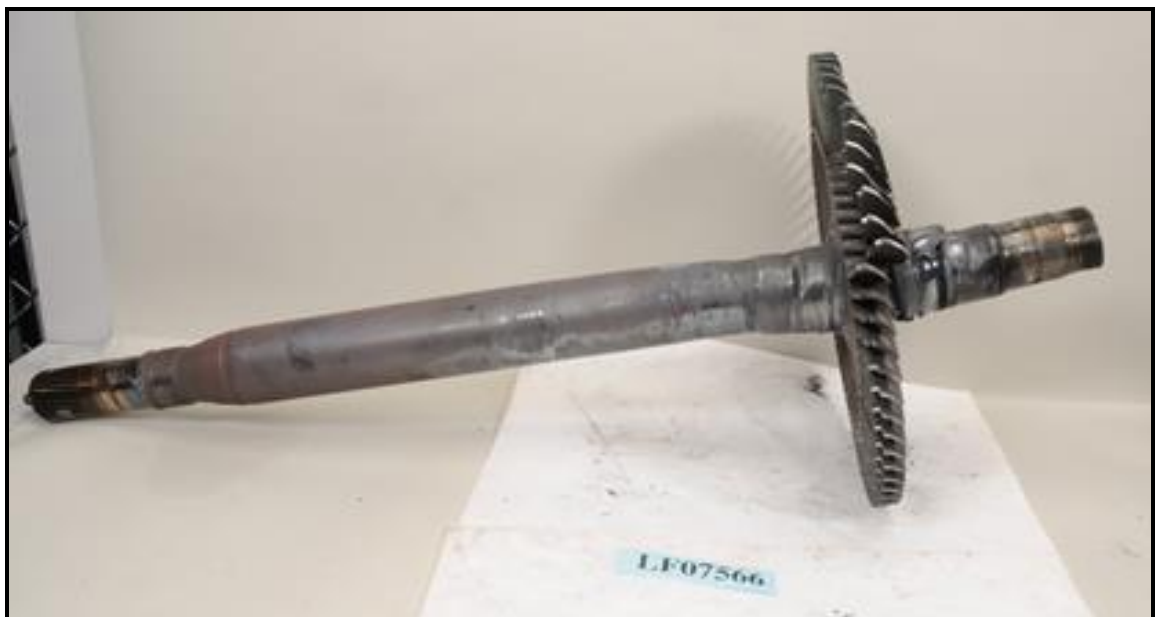
Figure 11: Damages to the LP turbine shaft (deformation)

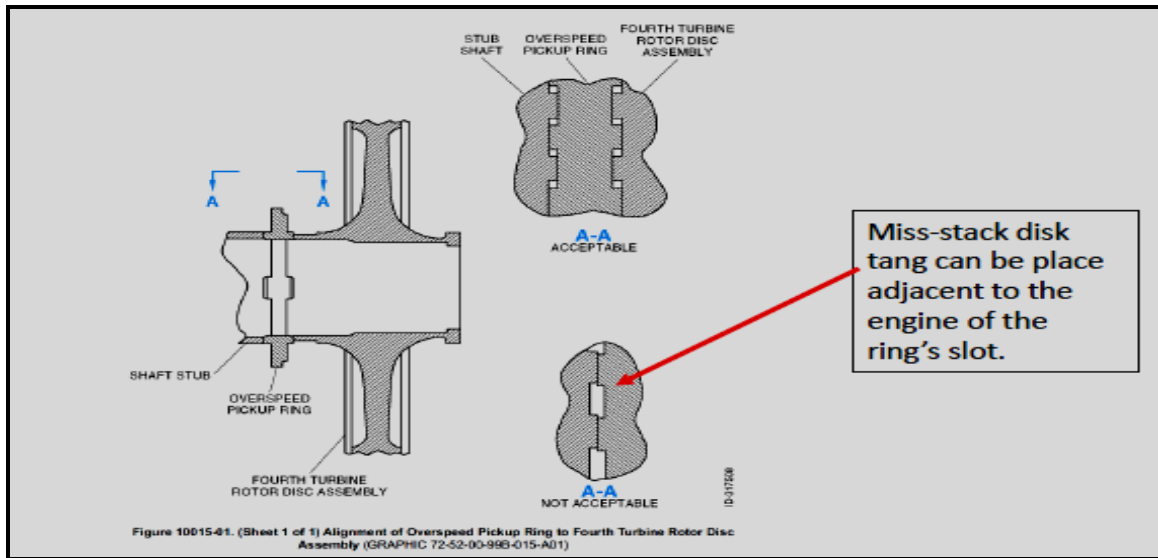
- The primary cause was the retention nut backing off, allowing the fourth-stage rotor to disengage from the LPT shaft.
- The root cause was narrowed down to two potential causes. The clamp load holding the fourth-stage turbine rotor onto the LPT shaft was relieved due to either:
 - mis-stack of the over-speed ring and the fourth-stage turbine rotor disk, or
 - the retention nut was not torqued to requirements.

Figure 13: Schematic illustration of the mis-stack and correct stacking of the over-speed ring

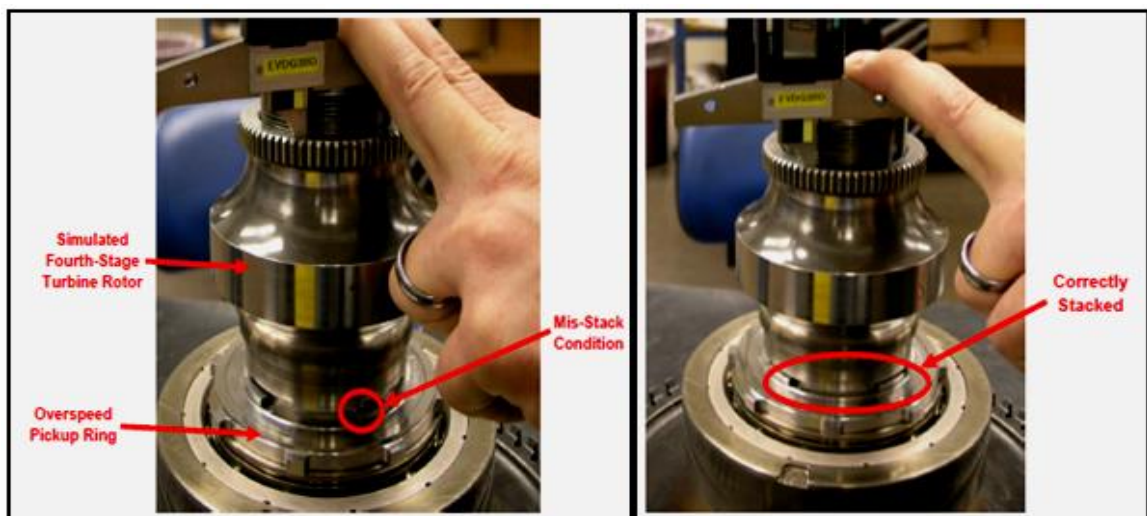
Figure 14: Simulated mis-stacking and correct stacking of the over-speed ring

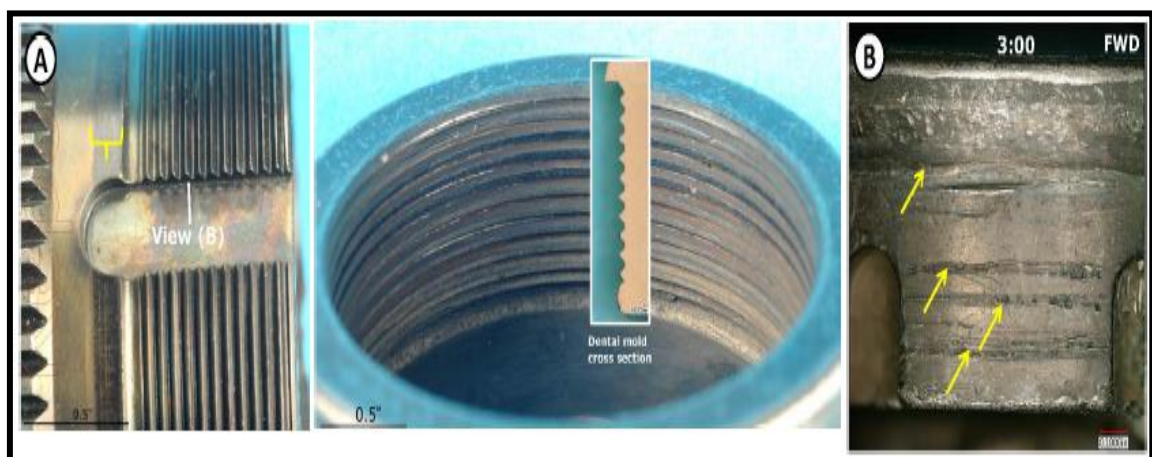
Figure 15: Shows the retaining nut
