CA18/2/3/7510					
		SOUTH AFRICAN CIVIL AVIATION AUTHORITY ACCIDENT REPORT – EXECUTIVE SUMMARY					
Aircraft Registration	ZS-OJU	Date of Accident	01/06/2002		Time of Accident	0515Z	
Type of Aircraft	HAWKER SIDDELEY 748		Type of Operation		Scheduled Freight		
Pilot-in-command Licence Type		Airline Transport	Age	69	Licence Valid	Yes	
Pilot-in-command Flying Experience		Total Flying Hours	20963.8 hrs		Hours on Type	1819.3 hrs	
Last point of departure		Bloemfontein Aerodrome					
Next point of intended landing		George Aerodrome					
Location of the accident site with reference to easily defined geographical points (GPS readings if possible)							
In Vandalenskloof, 7.6 nm from GGV on a bearing 065° Magnetic at a position S33° 54' 42" E022° 28' 33.6"							
Meteorological Information		Poor weather conditions with low cloud and rain.					
Number of people on board	2 + 1	No. of people injured	Nil		No. of people killed	2 + 1

AIRCRAFT ACCIDENT REPORT

Name of Owner : AirQuarius Contracts (PTY) LTD
Name of Operator : AirQuarius Air Charter (PTY) LTD trading as Airquarius Aviation
Manufacturer : Hawker Siddeley
Model : HS-748 2B
Nationality : South African
Registration Marks : ZS-OJU
Place

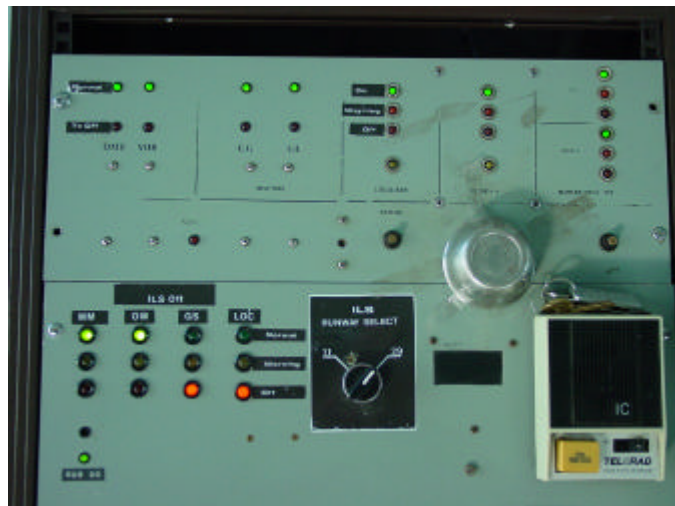
1.8.15 A control/warning panel (see photo on right) in the control tower provided information to the air traffic controller about the selected ILS and whether the different equipment, eg. localizer, glide path, VOR, DME's were operational. There were green lights indicating that the different equipment was serviceable and a red light if they were off. There was an audio warning

device fitted to the panel to provide an audio warning to the air traffic controller when the equipment becomes unserviceable. This audio warning horn was covered with a metal cup and the cup was taped to the panel with cellulose tape. Glue marks on the surface of the panel face suggested that this metal cup has been stuck to the panel for some time. It was obvious that the serviceability of the navigation equipment could only be monitored by means of this panel if the air traffic controller was on duty.

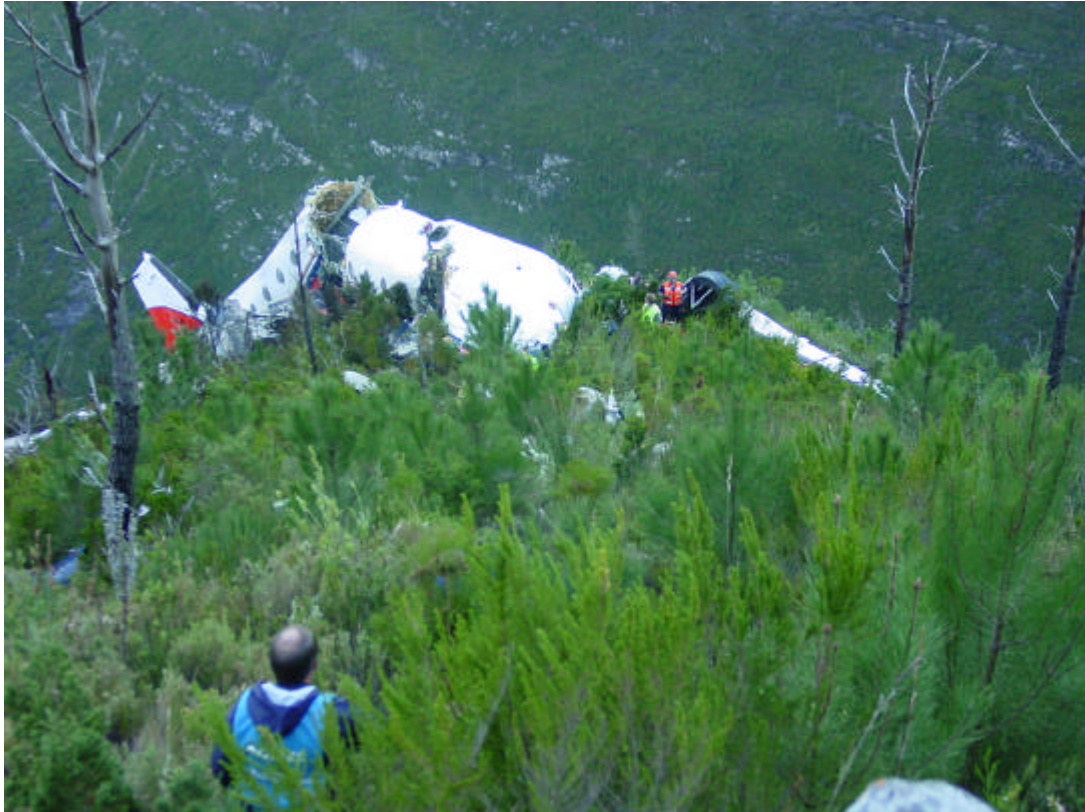
- 1.12.2 The aircraft impacted the side of the mountain in what appeared to be a small right wing low angle and with a nose up pitch angle of about 15° according to the FDR. The point where the aircraft impacted the mountain was at the top of a small about 70° cliff of about 5 to 7m high. The centre section of the wing and forward fuselage section came to rest on a fairly horizontal area on the top of the cliff, but from this position the mountain side again raised at about 60° for

another about 15 to 20m. At the top of this rise was another horizontal area where the rescue helicopters landed. The estimated magnetic direction of the aircraft at or just before the impact was North-Westerly. The nose of the aircraft rolled in underneath the forward part of the wreck and burst open during the impact with the mountain (refer to the photo). The outsides of the windshields and associated area of the cockpit were found in contact of the surface of the mountain side and the lower areas of the cockpit including the main instrument panels was scattered underneath and to the left of the forward wreckage. The nose landing gear, cockpit centre pedestal and pilot-in-command's body was found in the area to the left of the nose wreckage. The co-pilot's body was stuck in the left-hand inside area of the cockpit wreckage.

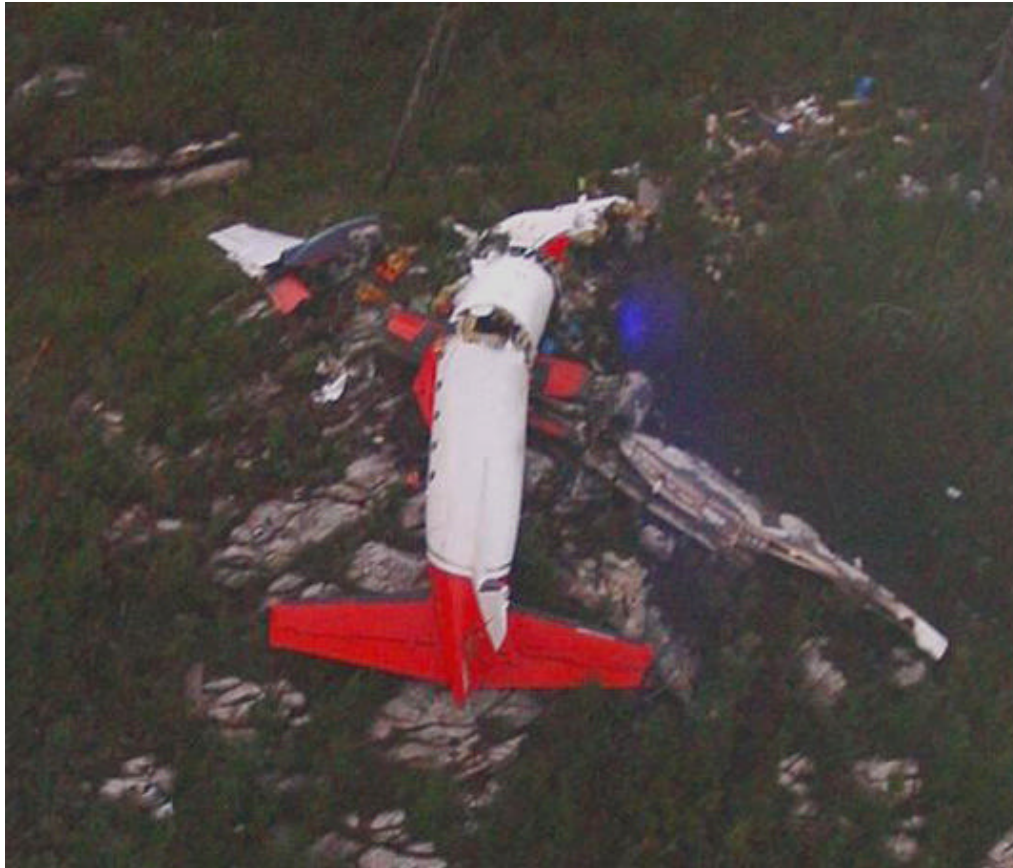
fuselage separated from the rest of the fuselage in front of the wing centre section. Similarly the rear fuselage/empennage separated from the rest of the fuselage in the rear section of the wing centre section. The rear fuselage/empennage of the wreck swung to the right after the impact, but was still attached to the rest of the wreck by the control cables and electrical wire bundles. It was pivoting on a rock that had penetrated the lower rear fuselage area.

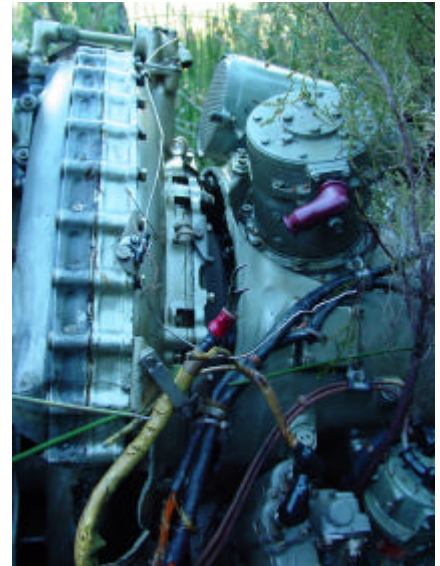
1.12.6 The forward sections of the right-hand engine separated from the rest of the engine just behind the combustion chambers. The forward part of the engine carried on a few meters to the foot of the 10 to 15m rise of the mountain. The combustion chambers were spread over this area between the rear and the forward sections of the engine. The right-hand propeller blades had separated from the propeller hub and were also found in the area in front of the main wreckage. All propeller blades found had severe damage to the leading edges of the blades.

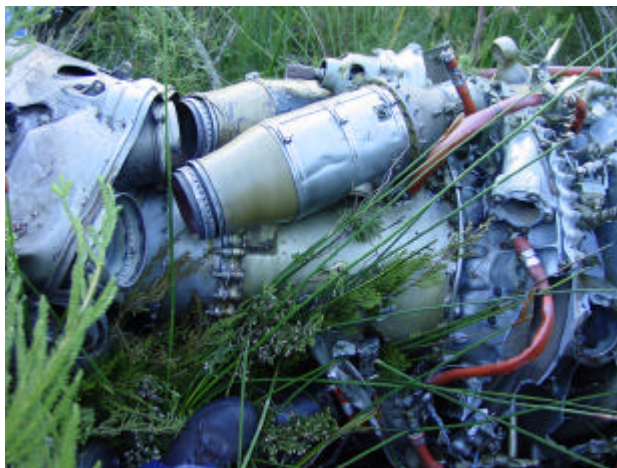
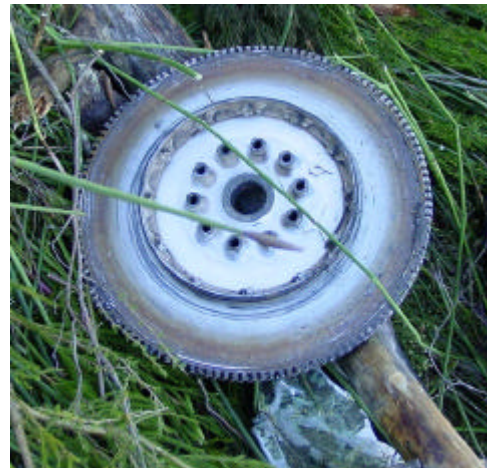
1.12.7 The left-hand engine mountings failed during the impact sequence and engine departed from the wing mounting points. The engine failed in different areas along its longitudinal axis with the most severe failures in the area between the reduction gearbox and the first stage centrifugal compressor, the area behind the combustion chambers and in the turbine section case. One of the turbine wheels departed from the engine and was recovered in the area forward of the engine. All the turbine blades were stripped from the turbine wheel.

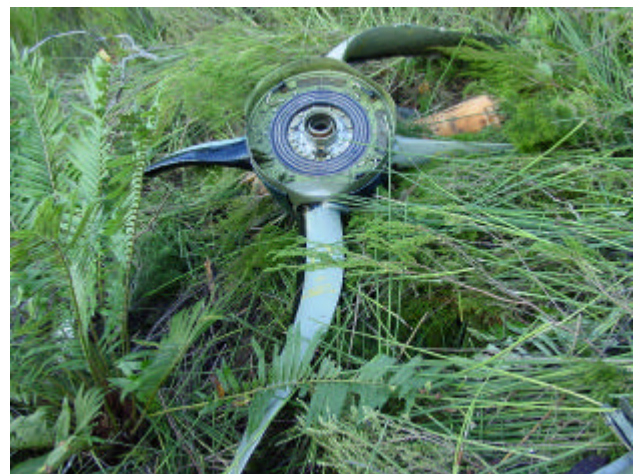
1.12.8 What appeared to be the left-hand propeller separated from the engine and was found in the area immediately forward of where the left-hand wing was found. The propeller blades were attached to the propeller hub, but the blades were severely bent and damaged by the impact. Especially the leading edges of the blades had severe impact damage as it had impacted the rock surfaces of the mountain. The blades that did not break loose from the pitch change mechanism appeared to be in a flight pitch condition. The propeller shaft failed at the rear of the propeller hub.

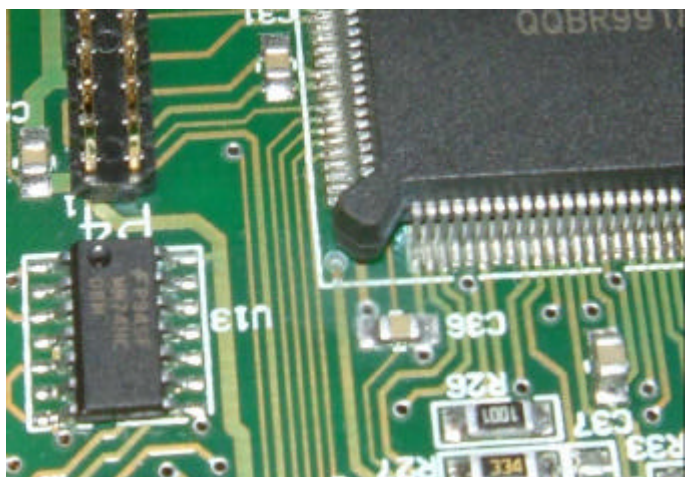
Unfortunately some corrosion was discovered upon disassembly at the corner of the main processor. The result was that one of the printed circuit board vias has been 'eaten away'. This in itself would not have proved a problem had the circuit trace in question not been the main 5V supply to the memory. As a consequence there was no data retained in the RAM chips to retrieve.

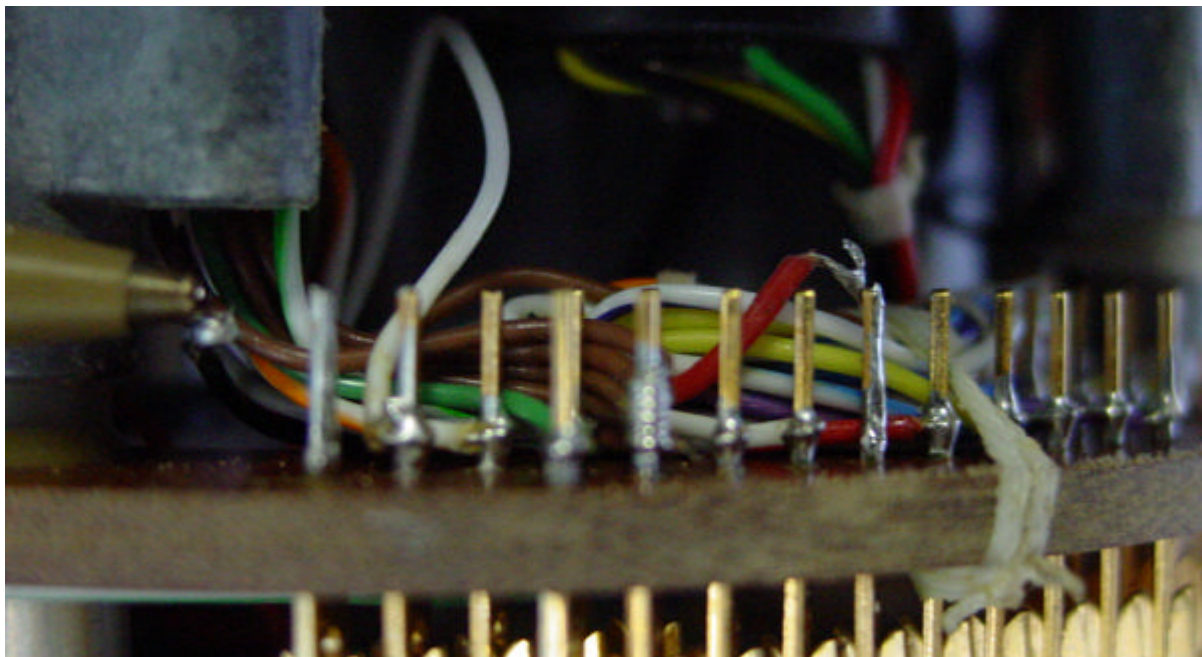
- The gyro rotor was locked up. A broken gimbal stop implies that the rotor was providing significant inertial momentum.
- The gimbal stop was broken. This suggests that the gyro rotor was rotating to create a high gyroscopic inertia.
- Both heading synchros were operational.
- Examination of internal wiring revealed two wires were not connected (refer to photo below):

- These two wires were for the field excitation of the levelling motor
- The wires do not appear to have been disconnected by impact
- The levelling motor is designed to keep the gyro rotor level relative to the aircraft vertical axis
- With the levelling motor disconnected the gyroscope will not operate properly
 - With the aircraft stationary, the C-14A may align and set its output valid
 - Depending on the friction in the gyroscope, the gyro rotor will precess. Eventually the precession may reach a point where the rotor aligns with the gimbals and the gyroscope “dumps”, ie. The output starts spinning.
 - Errors between this C-14A and the cross side compass system should be evident in turns
 - The C-14A with levelling motor disconnected will not pass the Honeywell IT:
 - drift rate tests will fail
 - levelling rate tests will fail

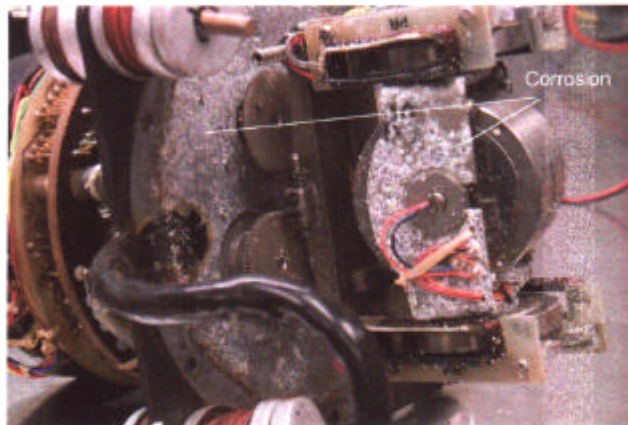
Figure 2: Internal Components of C-14A Directional Gyroscope

Opening the gyro can revealed heavy corrosion of the gyroscopic components (Figure 2).

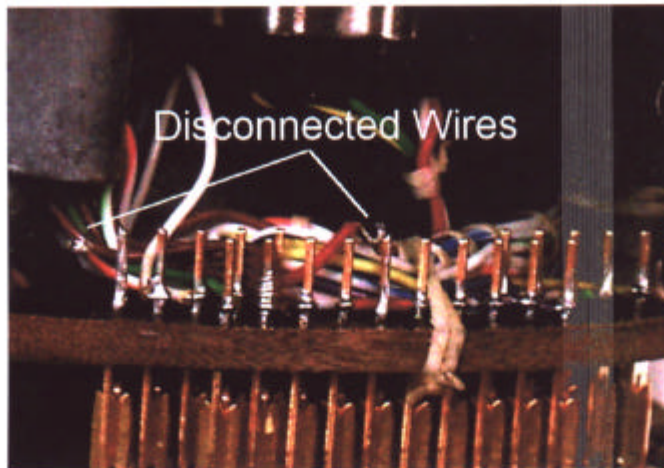
Figure 3: C-14A Directional Gyroscope showing disconnected wires

- Errors between this C-14A and the cross side compass system should be evident in turns
- The C-14A with leveling motor disconnected will not pass the Honeywell IT
 - ~~Seoresby-Drift rate~~ tests will fail
 - Leveling rate tests will fail

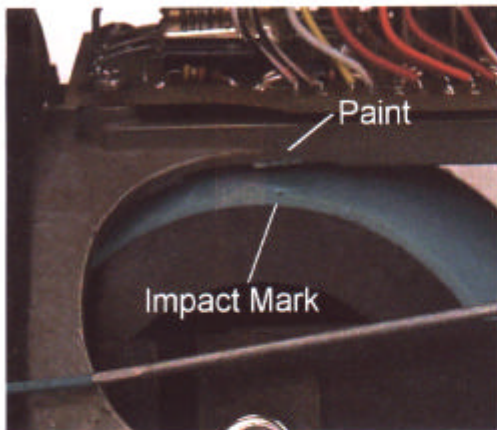
Figure 7: Impact Mark and Paint

- The cord tying the attitude sphere to the gyro assembly was broken loose, allowing the sphere to rotate in pitch.
- The attitude sphere displayed pitch was approximately 80° off from the pitch attitude of the gyro assembly
- The gyro was out of balance despite the presence of a large number of balance weights
- The "Valid Interlock" relay had broken loose
- The movement of the localizer ~~motor~~ meter movement seemed un-impeded
- The movement of the glideslope ~~motor~~ meter movement seemed un-impeded.
- There is an impact mark on the attitude sphere and corresponding blue paint on the indicator frame (Figure 7).
- Aligning these marks gives an attitude of 25° pitch up and 67° right bank.

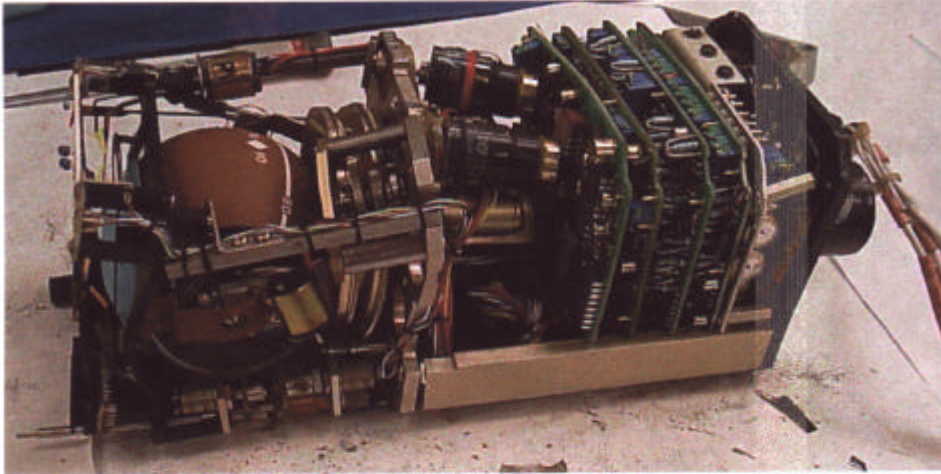
Figure 13: Interior of AD-550

- The Flight Director flag was found loose in the case.
- The attitude sphere was jammed
- The Glideslope pointer had moved to the top of the scale (spring loaded to bias out of view)
- The CCA A4 showed substandard repair
- The mechanical components were significantly mis-aligned.

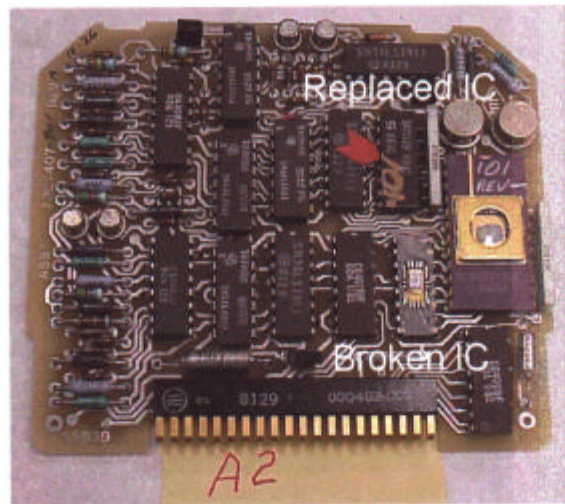
Figure 16: RD-550 CCA A2

- Three loose screws and a loose board retainer were found.
- The heading flag was broken off from the heading flag motor.
- The glideslope motor was free to move, but the pointer was slightly bent upward.
- The compass sync (X-O) motor was free to move.
- A broken IC and a replaced IC, which doesn't appear to be a Honeywell part, were found on CCA A2 (Figure 16). The quality of repair on A2 appears substandard.
- A broken IC was found on CCA A3.

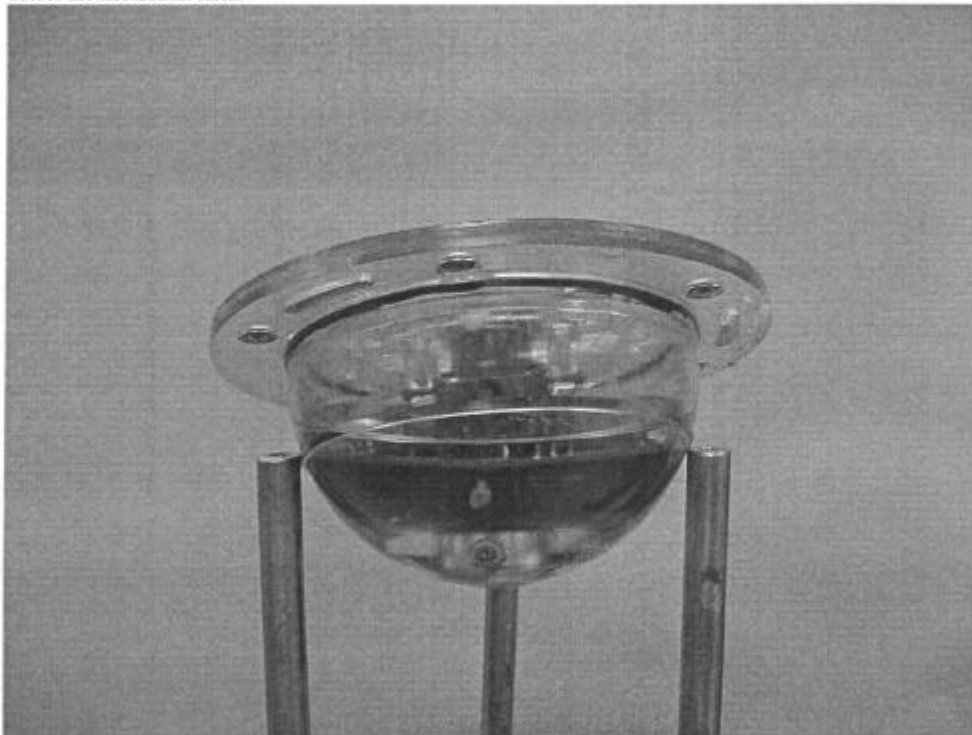
To determine the actual failure the FDU would need to be opened up and examined.
