Report No. 001-2005-TMA
Date: 23-Oct-05
Page: 1 of 11

Investigation Report

1. Material P/N 0292005270	2. Material S/N 16077	3. Material Description ENGINE
4. Engine / Component Type Arriel 1k1	5. Aircraft Type Agusta 109 K2	6. Customer Acher Aviation
7. Customer Complaint Yes <input type="checkbox"/> No <input checked="" type="checkbox"/>	Number <input type="text" value="N/A"/>	
8. Customer Reference		<input type="text" value="N/A"/>

EXAMINATION OF FRACTURED COMPONENTS FROM A SALVAGED HELICOPTER (Registration number: ZS-RRB)

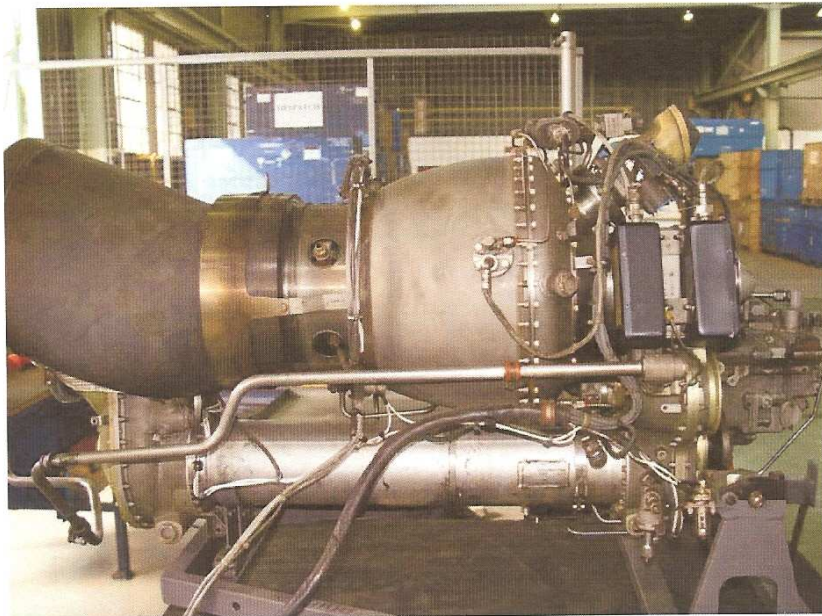
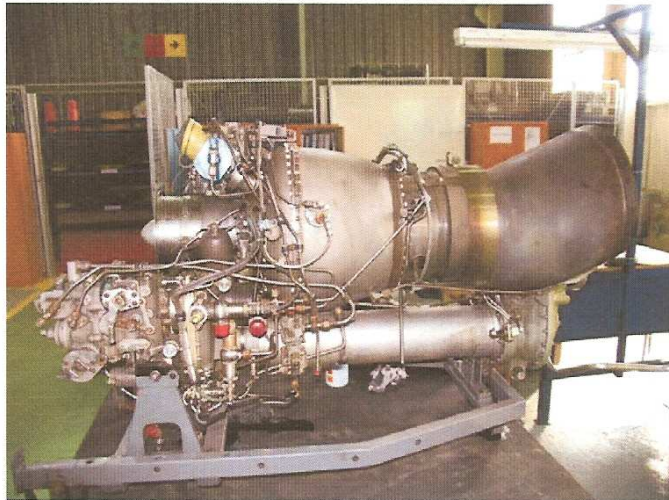
- Receipt inspection confirmed, no accident impact damage to engine, see figures 1 and 2.

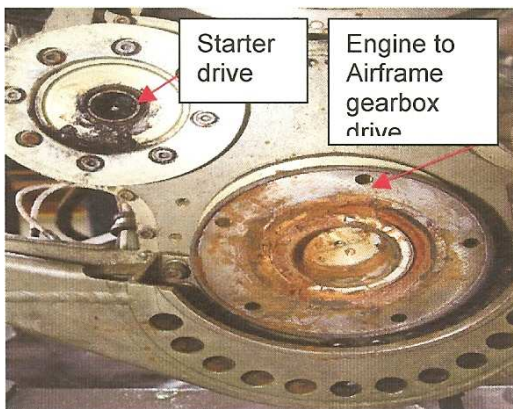
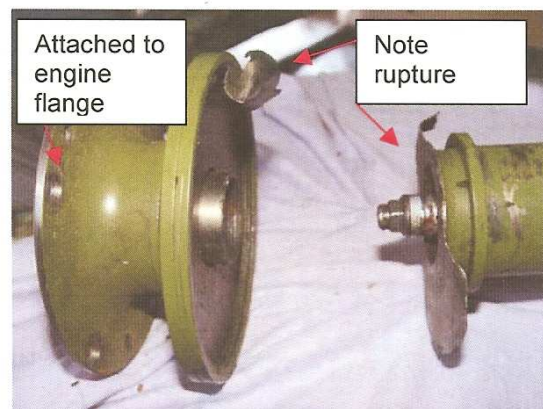
- Apart from showing evidence of progressing corrosion, all external components and items were intact and properly secured.
- The free turbine and gas generator were not free to rotate radially by hand.
- The engine to airframe gearbox drive shaft had ruptured, but the engine side flange was still intact, although severely corroded, see figure 3 and 4. It was noted that this drive shaft was fitted with the "engine side" attached to the main rotor gearbox flange.

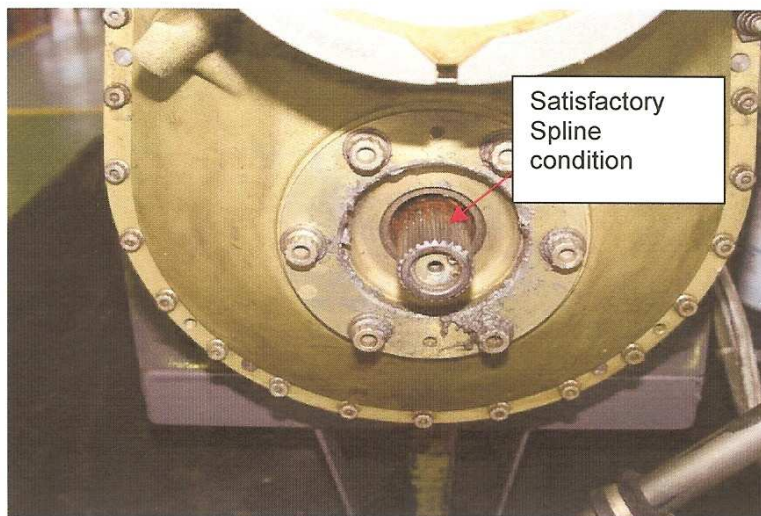
FIGURE 5

- The cooler drive shaft splines were in a satisfactory condition although showing signs of slight corrosion see figure 5.

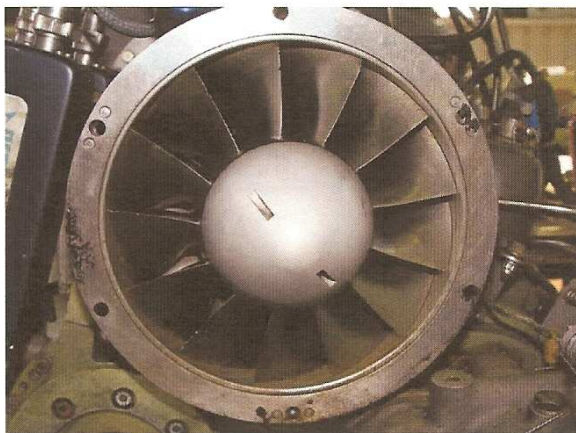
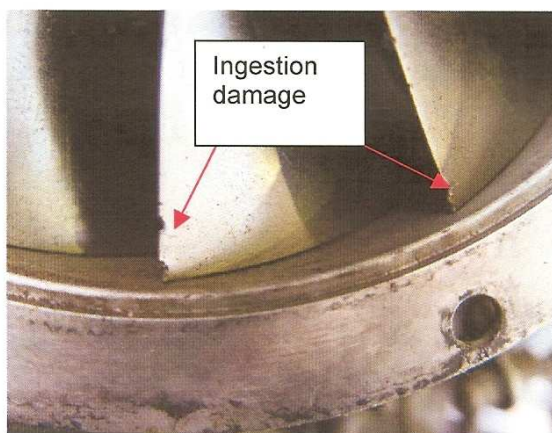
- Inspection of the axial compressor blades did not reveal significant erosion to the leading edges or any blade distortion due to accident impact. However, small ingestion damage could be seen on the leading edges of various blades, see figures 6 and 7.

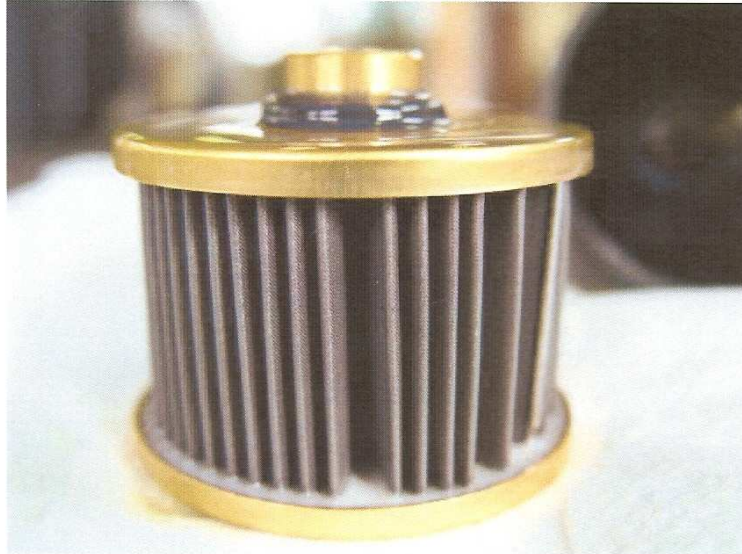
FIGURE 8

- Removal and inspection of the oil filter showed the filter to be free from any contamination, see figure 8

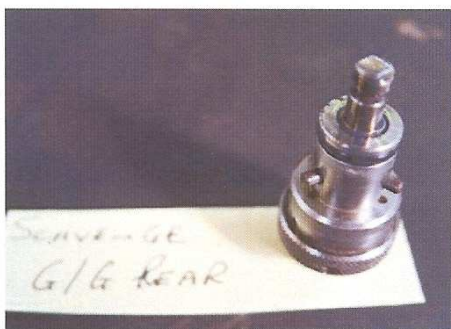
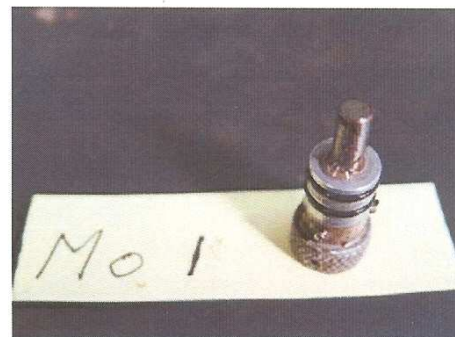
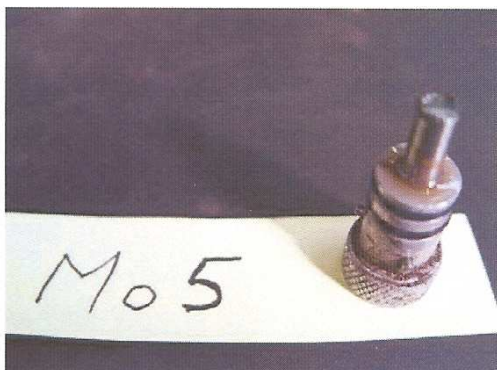
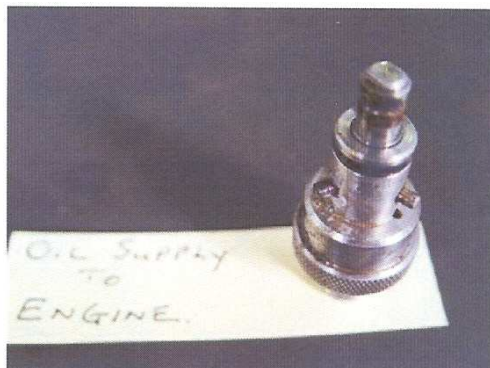
- Visual examination of the magnetic plugs fitted to the oil scavenge system from the gas generator rear bearing, the module 1, the module 5 and oil supply line showed no evidence of Ferrous material collection. Only oil/water sludge could be seen on the items, see figures 9 to 12 (oil sample taken from MO5 severely contaminated with water).

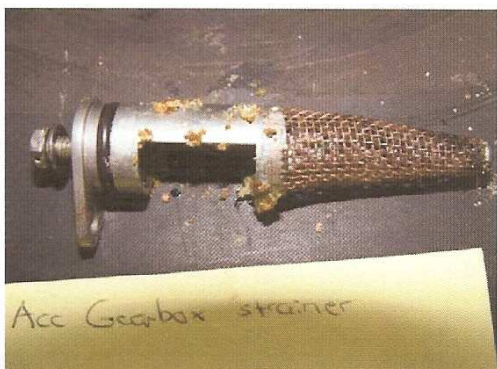
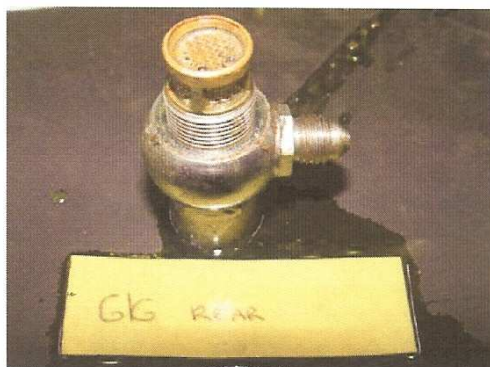
- Removal and inspection showed the accessory gearbox strainer and the gas generator strainer to be free from metallic contamination although polluted with oil/water sludge, see figures 13 and 14.

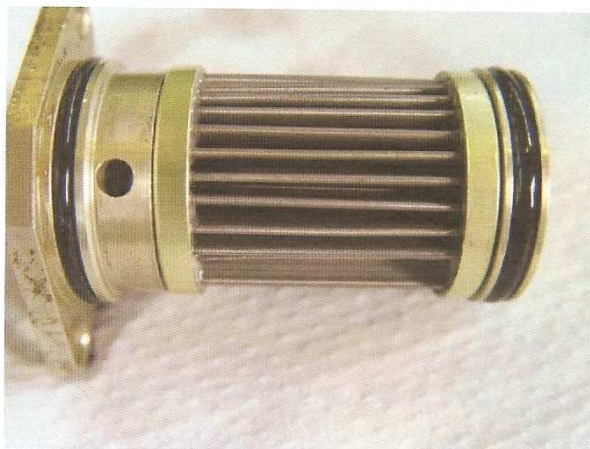
FIGURE 15

- Removal of the FCU was initiated with fuel sampling collection and removal inspection of the filter. This operation showed the fuel sample and filter to be free from contamination, see figure 15.

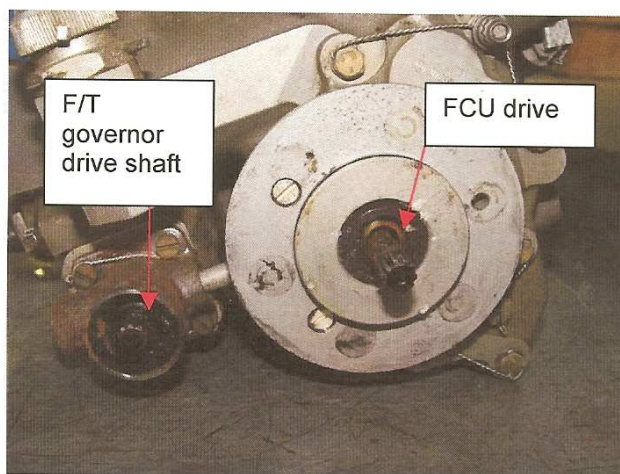
FIGURE 16

- The FCU and free turbine governor drive shafts were intact, see figure 16 and although the free turbine could not be rotated by hand to verify a positive drive connection to the FCU, shaft condition was such to suggest satisfactory drive connection.

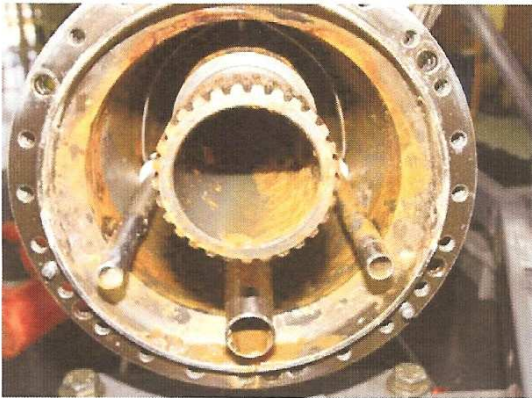
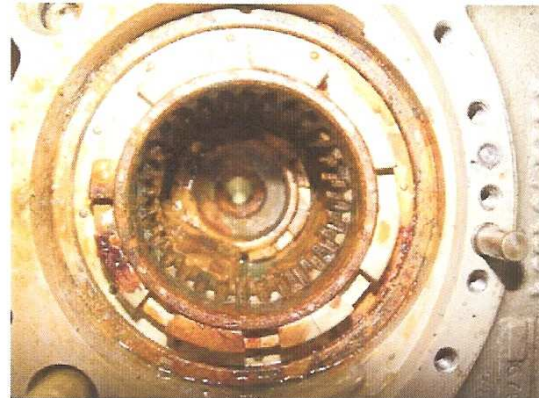
- Removal of the module 5 showed severe corrosion damage to the bearings and drive train assembly, however no significant condition with regards to the integrity of this assembly could be established, see figures 17 and 18 on page 9 (rotation of module 5 still not possible).

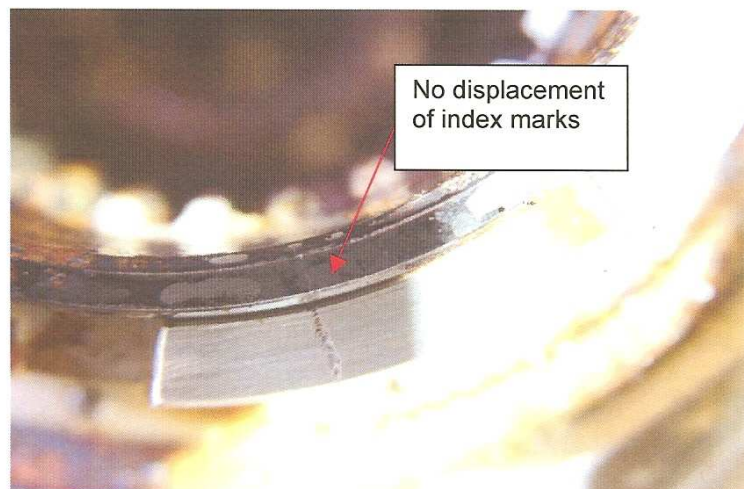
FIGURE 19

- Close inspection of the reduction gearbox drive gear and securing nut showed severe corrosion contamination on the face adjacent to the index marks. Clean-up with abrasive paper had to be performed to facilitate inspection of the said marks. By reference to figure 19 the index marks in position on the shaft and nut can be observed. No mark displacement could be confirmed.

- 5.2 Strip inspection performed on this engine showed no displacement of the drive gear and nut assembly. However, detailed examination of the various engine systems as described in paragraph 5.1 showed no significant evidence to suspect that engine operation was other than normal at the time of the mishap.

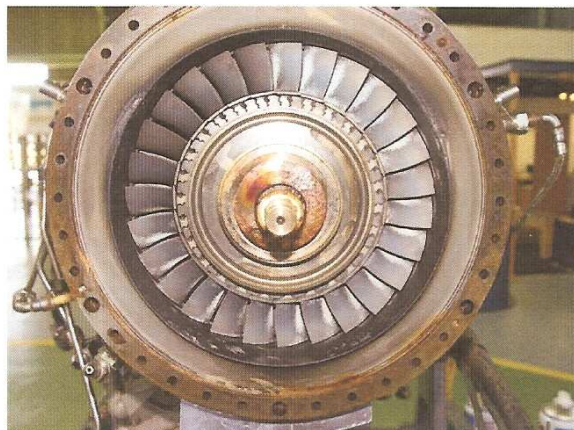
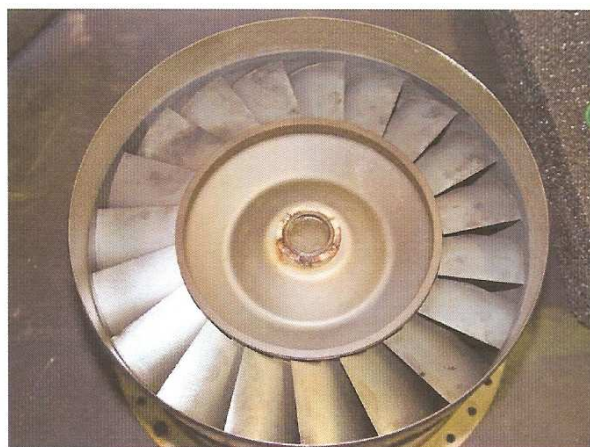
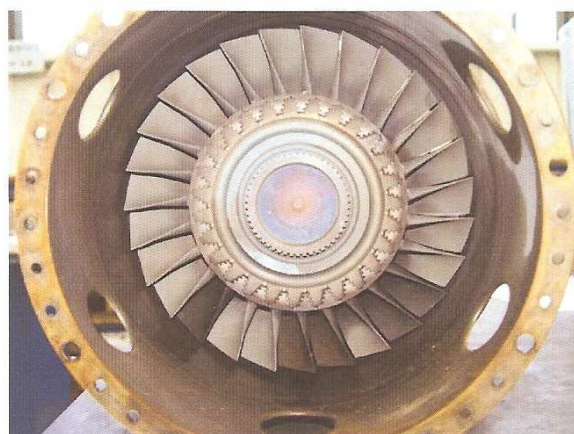
- As no displacement could be confirmed on the drive gear and nut, it was decided to remove the module to facilitate inspection of the gas generator second stage turbine (T2), the free turbine NGV and turbine wheel. By reference to figures 20, 21 and 22 it can be noted that these assemblies are all free from any evidence to indicate a possible over-temperature operation or mechanical deterioration that could have impaired satisfactory engine operation.

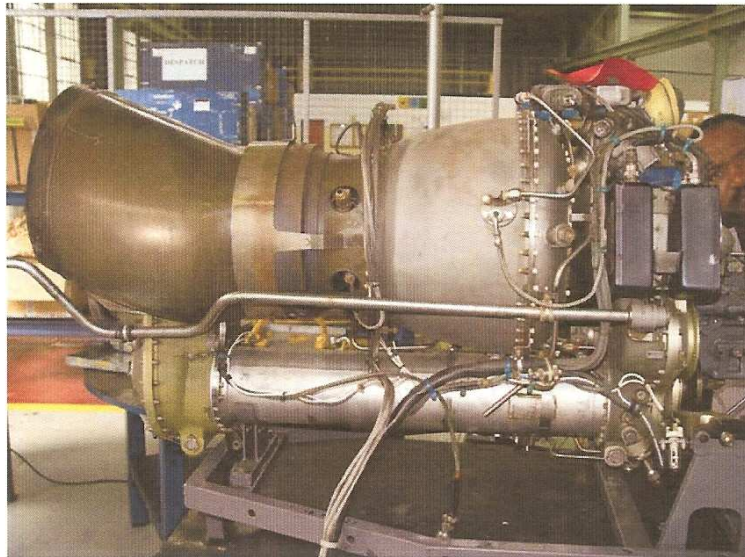
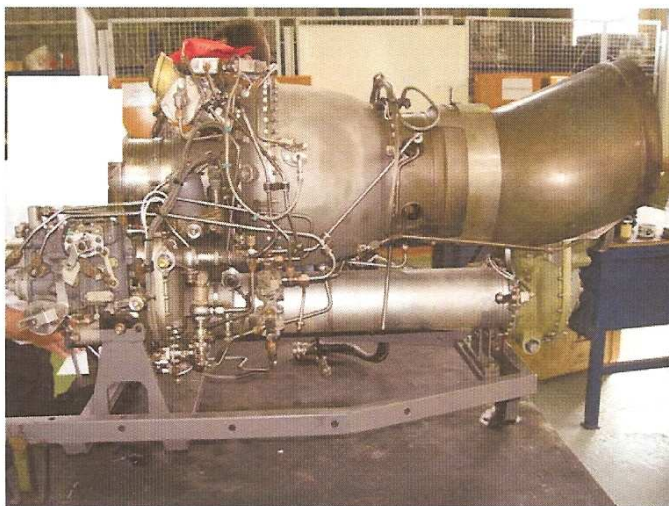
- Receipt inspection confirmed, no accident impact damage to engine, see figures 1 and 2.

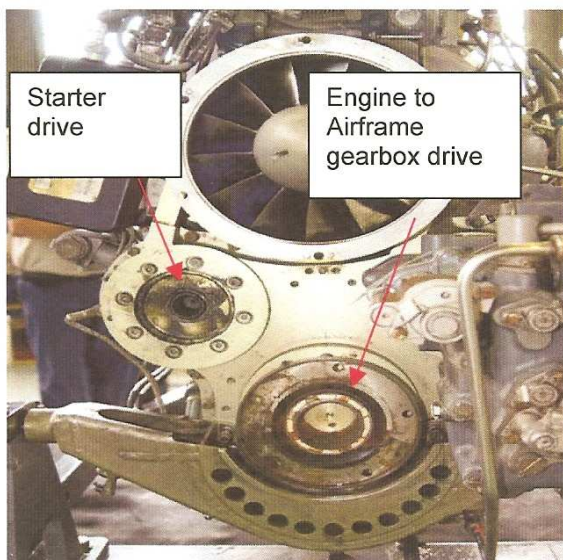
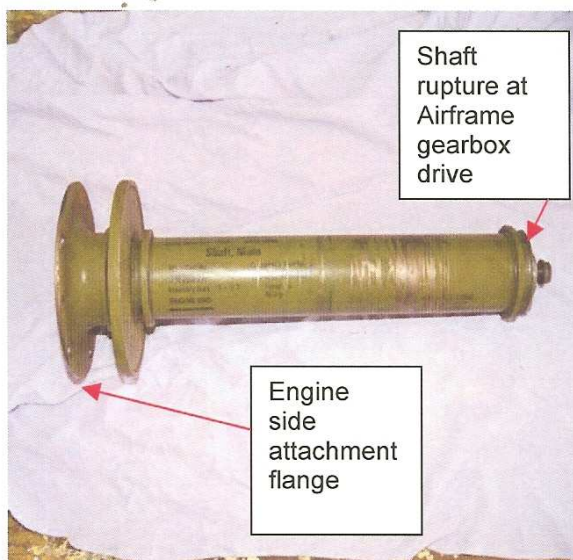
- Apart from showing evidence of progressing corrosion, all external components and items were intact and properly secured.
- Although the gas generator could be rotated by hand during the initial investigation done on 12 September 2005, no rotation was now possible. The free turbine was also not free to be rotated radially by hand.
- The engine to airframe gearbox drive shaft had ruptured at the gear box side, but the engine side flange was still intact, although severely corroded, see figures 3 and 4.

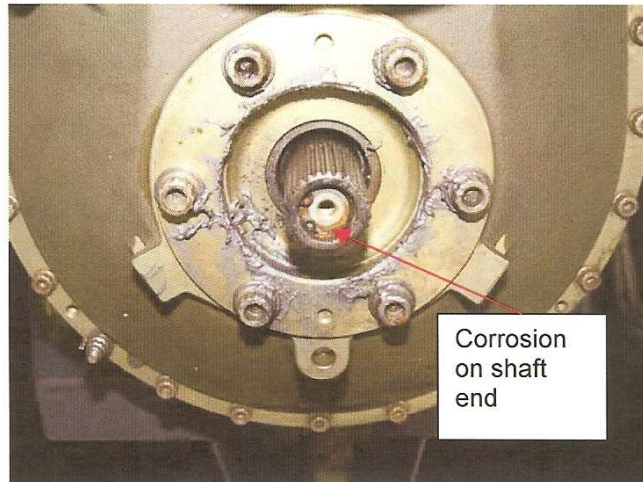
FIGURE 5

- The cooler drive shaft splines were in a satisfactory condition although the shaft end showed signs of slight corrosion see figure 5.

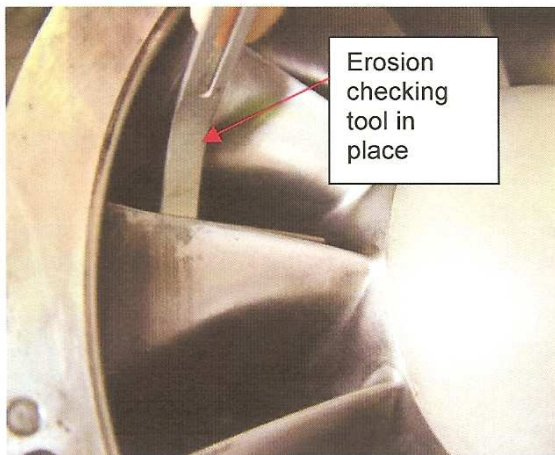
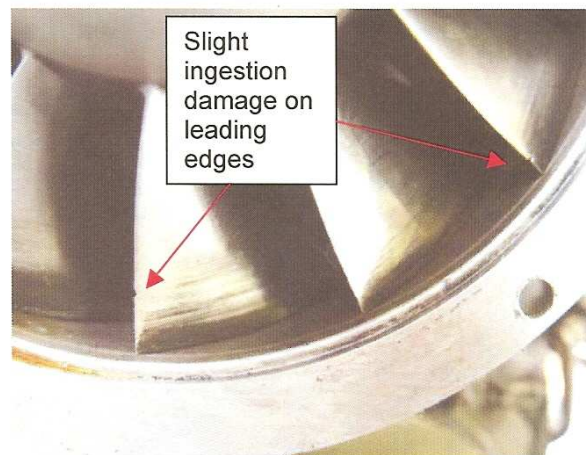
- Inspection of the axial compressor blades revealed no significant blade erosion to the leading edges (less than 1mm was the average recorded as opposed to the limit of 3mm maximum) see figure 6. Small ingestion damage could be seen on the leading edges of various blades, but no blade distortion due to accident impact could be found, see figure 7.

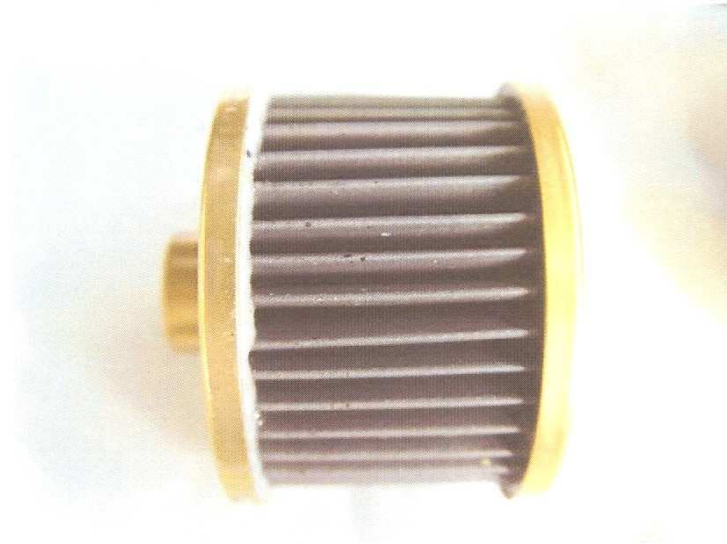
FIGURE 8

- Examination of the compressor bleed valve confirmed the valve to be in the "OPEN" position
- Removal and inspection of the oil filter showed the filter to be free from any contamination, see figure 8

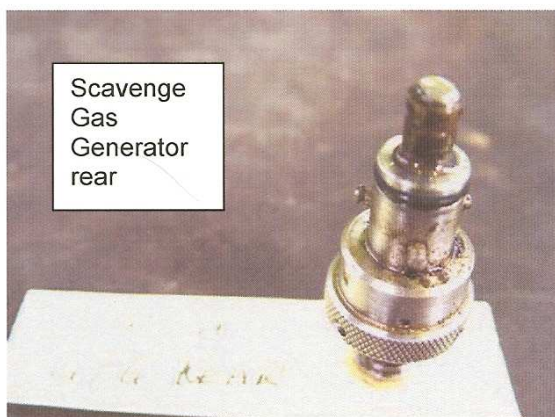
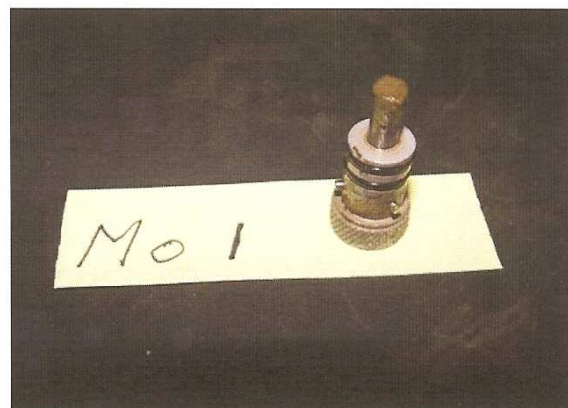
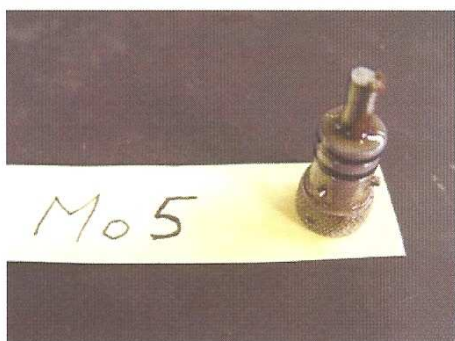
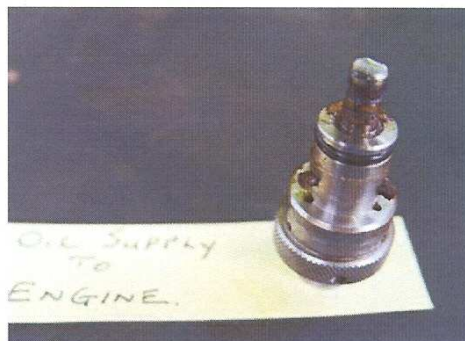
- Visual examination of the magnetic plugs fitted to the oil scavenge system from the gas generator rear bearing, the module 1, the module 5 and oil supply line showed no evidence of Ferrous material collection. Only oil/water sludge could be seen on the items, see figures 9 to 12 (oil sample taken from MO5 severely contaminated with water).

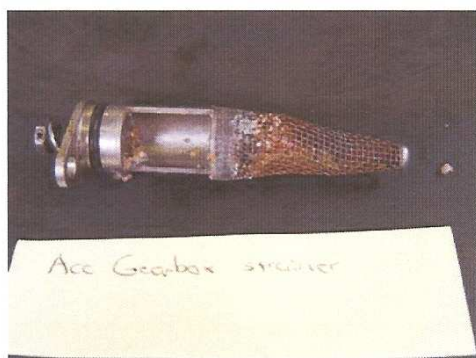
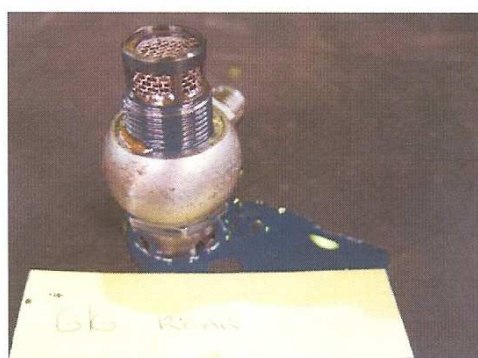
- Removal and inspection showed the accessory gearbox strainer and the gas generator strainer to be free from metallic contamination although polluted with oil/water sludge, see figures 13 and 14.

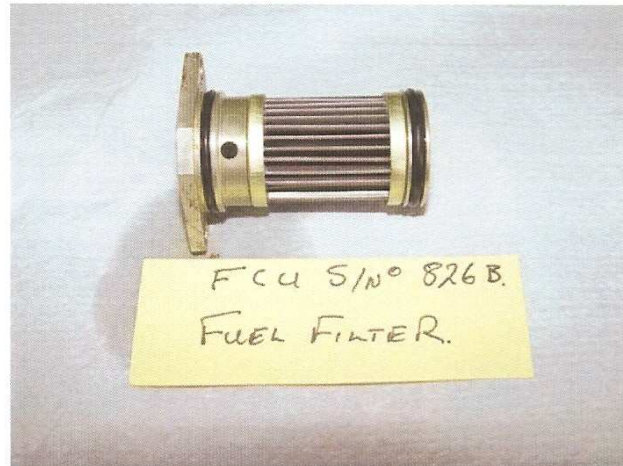
FIGURE 15

- Removal of the FCU was initiated with fuel sampling collection and removal inspection of the filter. This operation showed the fuel sample and filter to be free from contamination, see figure 15.

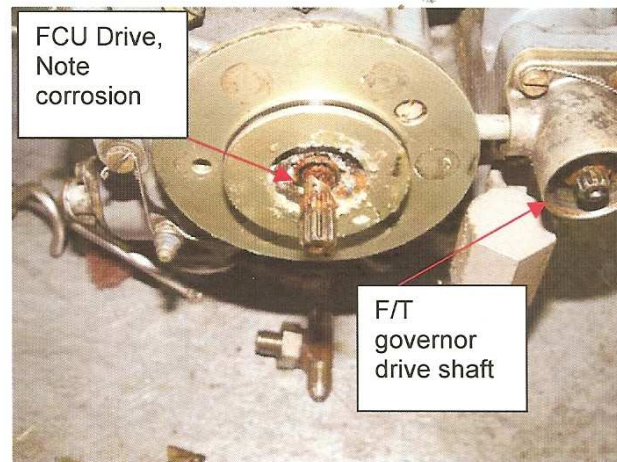
FIGURE 16

- The FCU and free turbine governor drive shafts were intact, see figure 16 and although the free turbine could not be rotated by hand to verify a positive drive connection to the FCU, shaft condition was such to suggest satisfactory drive connection.

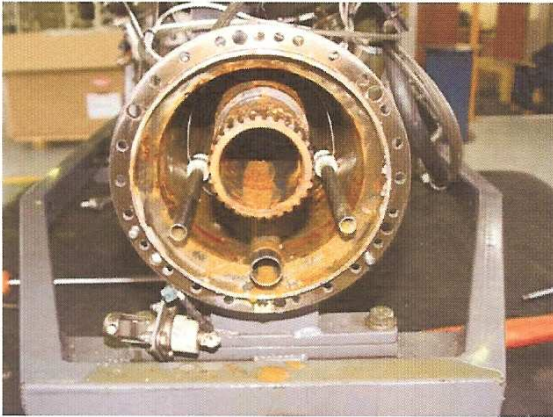
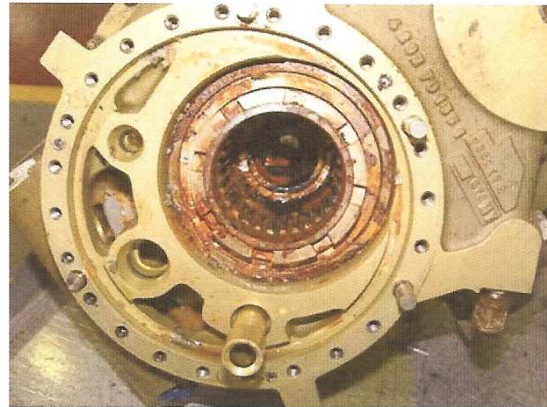
- Removal of the module 5 showed severe corrosion damage to the bearings and drive train assembly, however no significant condition with regards to the integrity of this assembly could be established, see figures 17 and 18 on page 9 (rotation of module 5 still not possible).

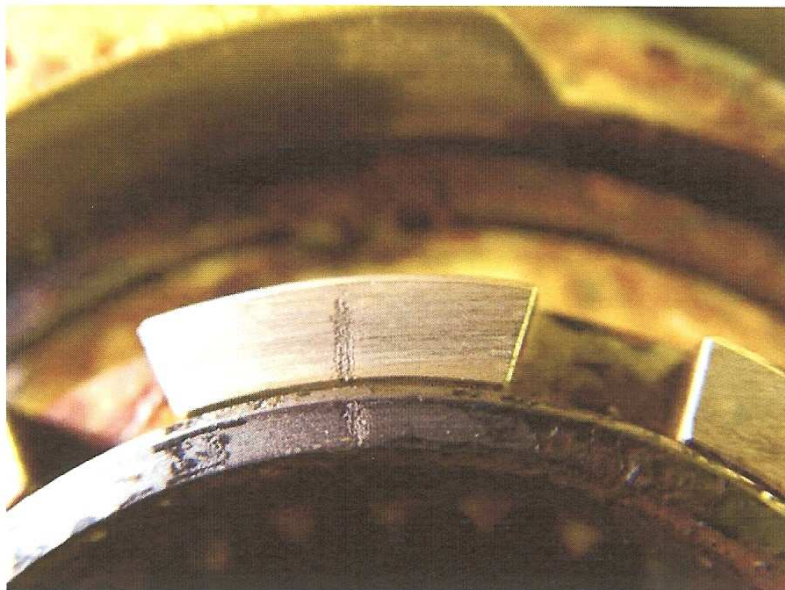
FIGURE 19

- Close inspection of the reduction gearbox drive gear and securing nut showed severe corrosion contamination on the face adjacent to the index marks. Clean-up with abrasive paper had to be performed to facilitate inspection of the said marks. By reference to figure 19 the index marks in position on the shaft and nut can be observed. Slight mark displacement could be confirmed.

- 5.2 Strip inspection performed on this engine showed slight displacement of the drive gear and nut assembly. This evidence together with the condition of the various engine systems as described in paragraph 5.1 would suggest that engine operation was normal at the time of the mishap.

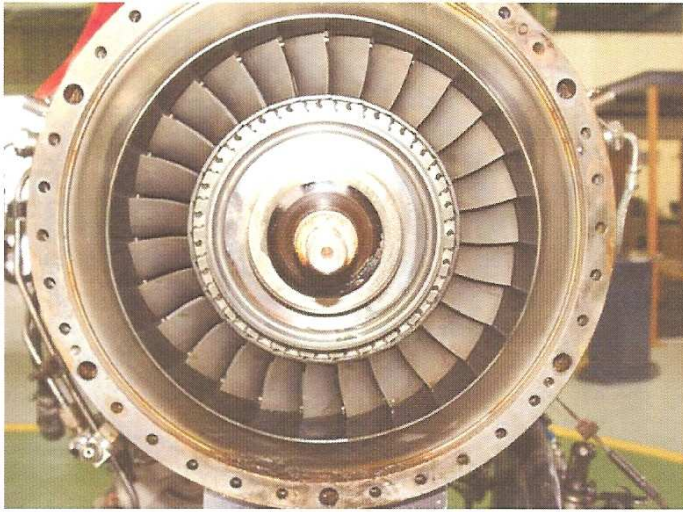
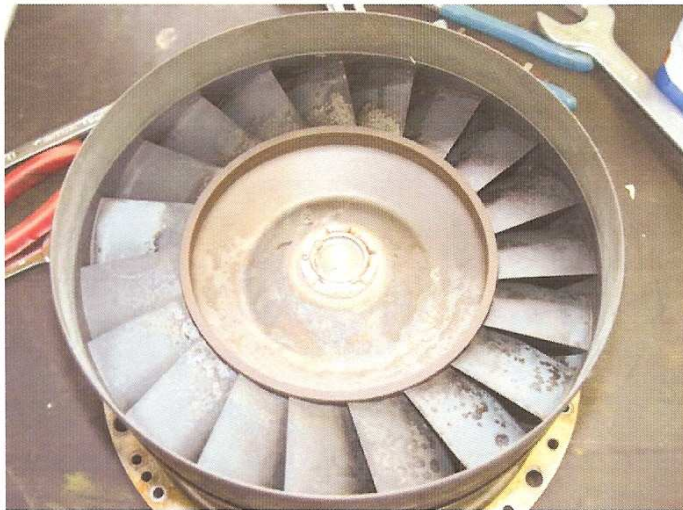
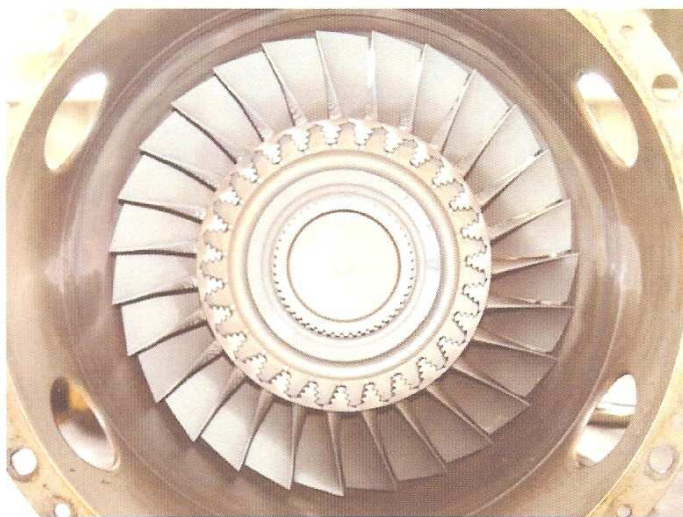
- Although displacement was confirmed on the drive gear and nut, it was decided to remove the module to facilitate inspection of the gas generator second stage turbine (T2), the free turbine NGV and turbine wheel. By reference to figures 20, 21 and 22 it can be noted that these assemblies are all free from any evidence to indicate a possible over-temperature operation or mechanical deterioration that could have impaired satisfactory engine operation.

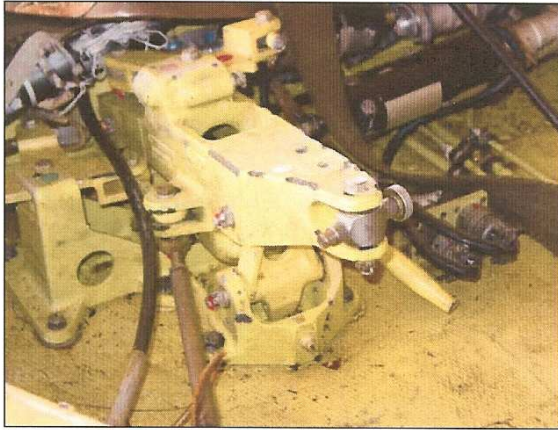
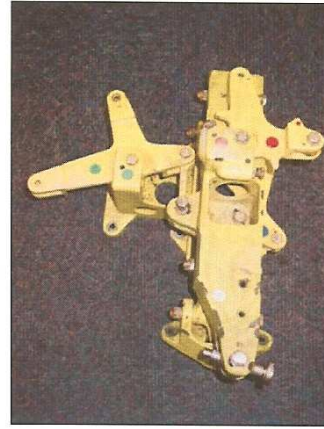
Photographs of the damaged mixing unit *in-situ* in the wreck of the helicopter and after removal are shown in Figures 1(a) and (b), respectively. Visual examination of the mixing unit revealed four separate cracks (highlighted by the arrows in Figures 2(a) and (b)). Enlarged views of these cracks are shown in Figures 2(c) and (d). All the cracks are associated with the inherent stress concentrations caused by integral holes in the mixing unit. The fracture surfaces of these cracks were examined visually and at low magnification and were found to be similar in appearance, with coarse, granular surfaces, uniform dark gray colouration and well-defined chevron markings. Significant plastic deformation did not occur prior to final fracture. The appearance of the fractures is therefore consistent with rapid, brittle failure under impact loading conditions. No evidence of any pre-existing cracks, that may have caused or accelerated failure, was observed during the examination of the cracks in the mixing unit.

Figure 1. Photographs of the damaged mixing unit: (a) *in-situ* in the wreck of the helicopter (magnification: approximately 0,22x), and (b) after removal (magnification: 0,15x).

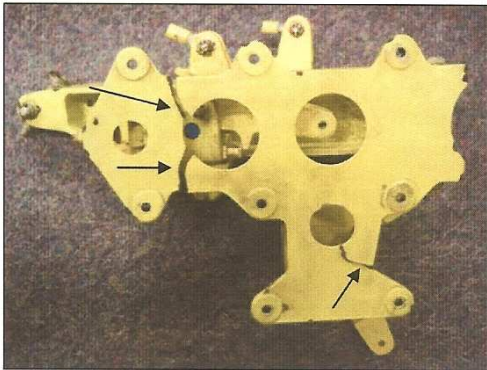
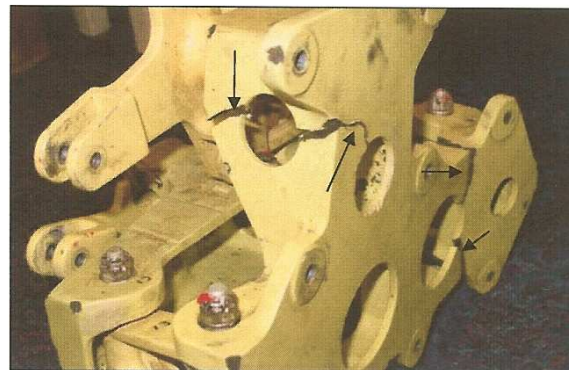
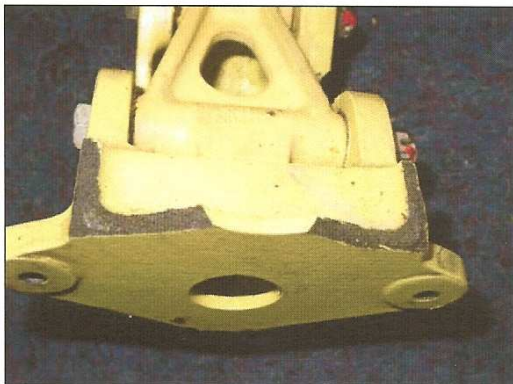
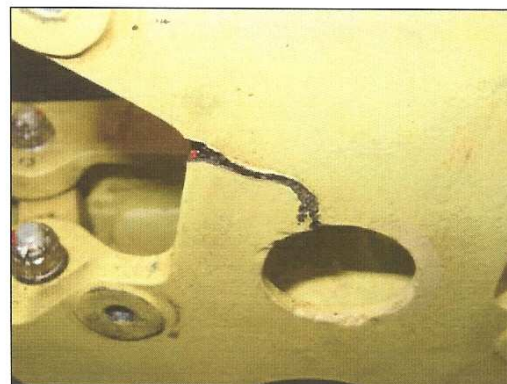
Figure 2. Cracks observed in the mixing unit: (a) magnification: 0,23x; (b) magnification: approximately 0,37x; (c) magnification: 0,7x; and (d) magnification: 0,8x.

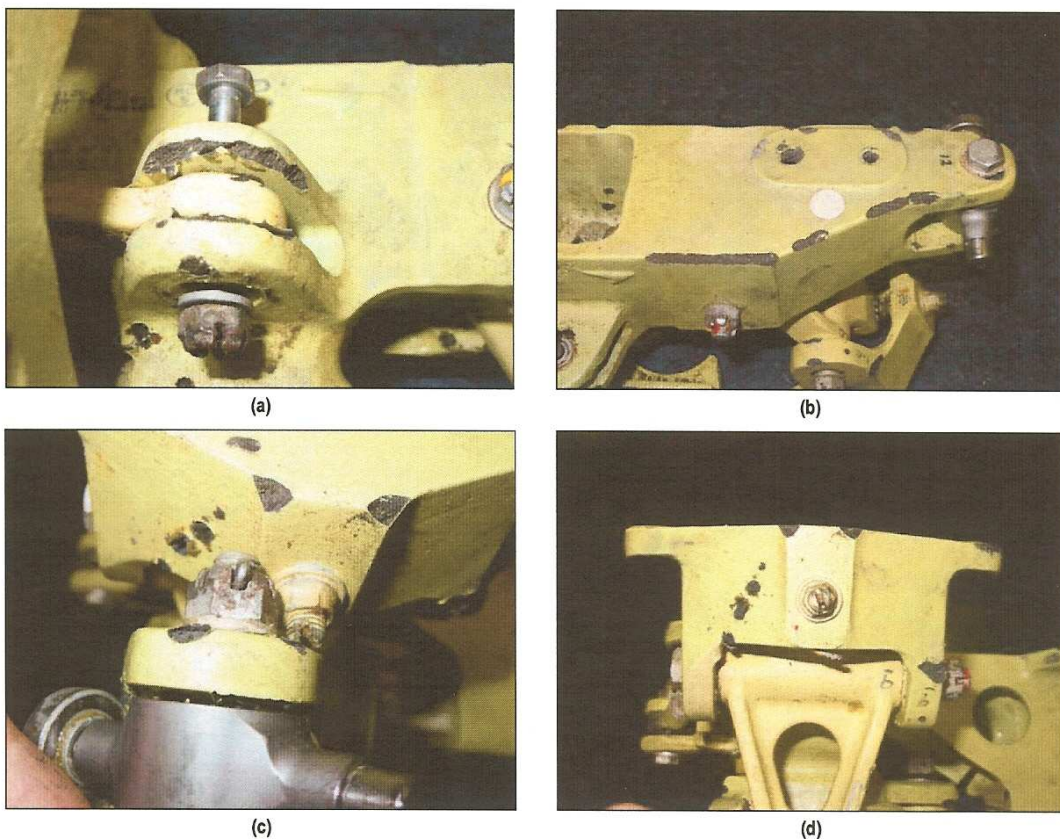
More superficial damage to the surface of the mixing unit was observed in the form of a number of single or overlapping chips, examples of which are shown in Figures 3(a) to (d). The fracture surfaces of these defects are in all cases similar to those of the cracks observed in the same unit, and display the typical features characteristic of brittle failure caused by impact loading (i.e. a coarse granular appearance with little plastic deformation). The majority of these defects were observed on the top surface of the unit, suggesting an impact or impacts originating from above the mixing unit.

Figure 3. Damage to the surface of the mixing unit: (a) magnification: 0,9x; (b) magnification: 0,5x; (c) magnification: 1x; and (d) magnification: 0,6x.

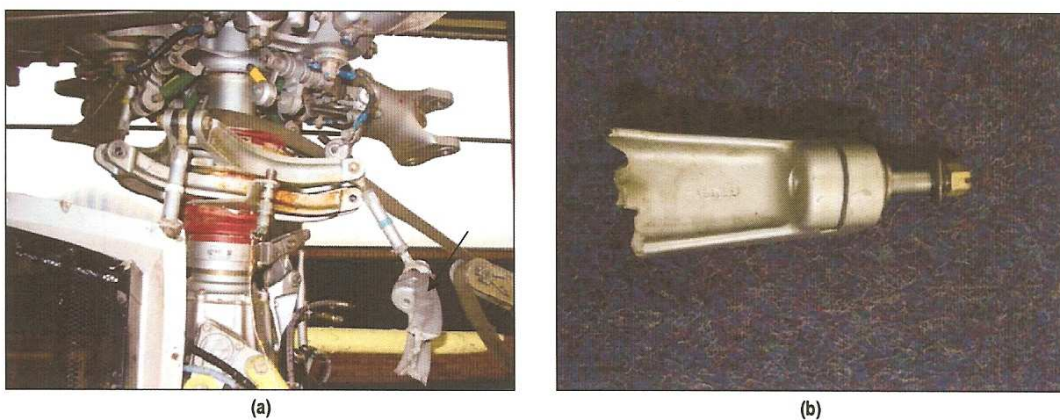
Photographs of the fractured main rotor blade horn *in-situ* in the helicopter wreck, and after removal, are shown in Figures 5(a) and (b), respectively.

Figure 5. The fractured main rotor blade horn: (a) *in-situ* in the helicopter wreck (magnification: approximately 0,01x); and (b) after removal (magnification: 0,25x).

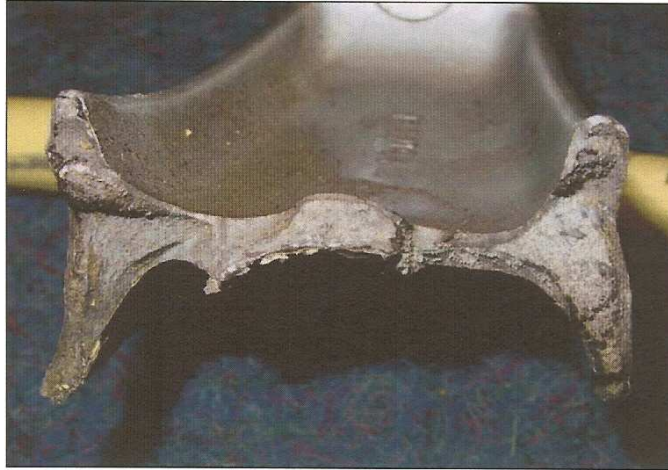
An enlarged view of the fracture surface of the blade horn is shown in Figure 6. The fracture surface is coarse and uneven, with a uniform gray colour, shallow 45° shear lips and distinct chevron markings. Little evidence

of plastic deformation prior to failure was observed and no pre-existing cracks could be identified. These features of the fracture surface are consistent with a predominantly brittle failure mode under impact loading conditions. This conclusion is corroborated by the absence of any visible plastic deformation in the vicinity of the fracture site.

Figure 6. Fracture surface of the fractured blade horn (magnification: 1,2x).

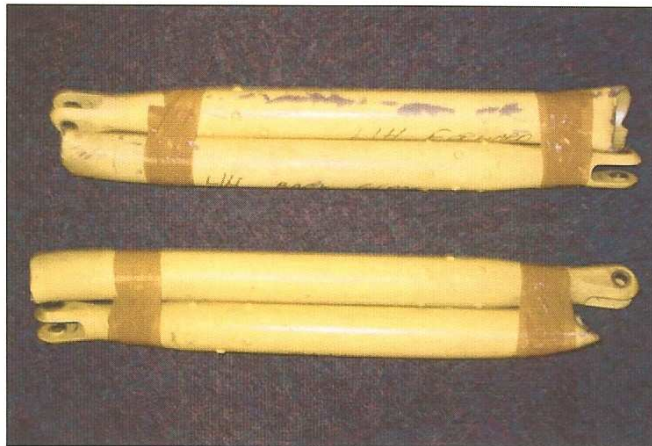
As shown in Figure 7, the two main rotor gear box supports are tubular aluminium components with diameters of approximately 51 mm, and wall thicknesses of about 2,4 mm. Both the left and right supports fractured approximately halfway along the length of each component. Enlarged views of the fractures surfaces of both supports are shown in Figures 8(a) and (b). Significant plastic deformation is evident in the vicinity of the fracture sites, with both supports being flattened into roughly oval shapes. When the two halves of the fractured supports are lined up (as illustrated in Figure 9), it is clear that significant bending occurred prior to final failure. Bending appears to be localised, with damage limited to the central region of the supports. Initial fracture apparently occurred as a result of an excessive bending stress, which resulted in an overload shear failure at an angle of approximately 45° to the wall thickness of the tube (hemispherical part of the fracture surface). The remainder of the fracture surface of each support displays predominantly brittle failure. No evidence of any pre-existing defects, that may have contributed to the failure of the supports, was observed.

Figure 7. The main rotor gear box supports after removal from the salvaged wreck (top: left hand support; bottom: right hand support) (magnification: 0,16x).

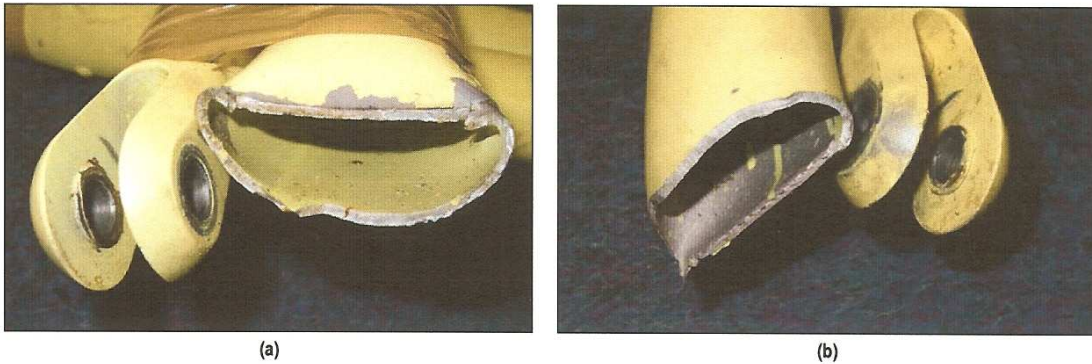
Figure 8. Enlarged views of the fracture surfaces of the (a) left hand support; and (b) right hand support (magnification: approximately 0,7x).

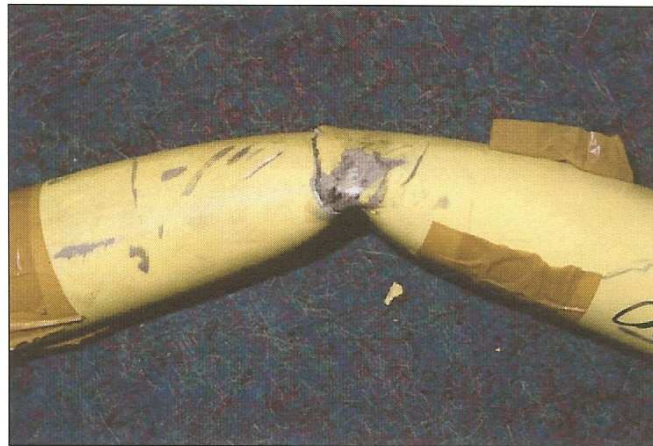
Figure 9. The two parts of the fractured left hand support lined up to illustrate that significant bending occurred prior to final failure (magnification: 0,47x).

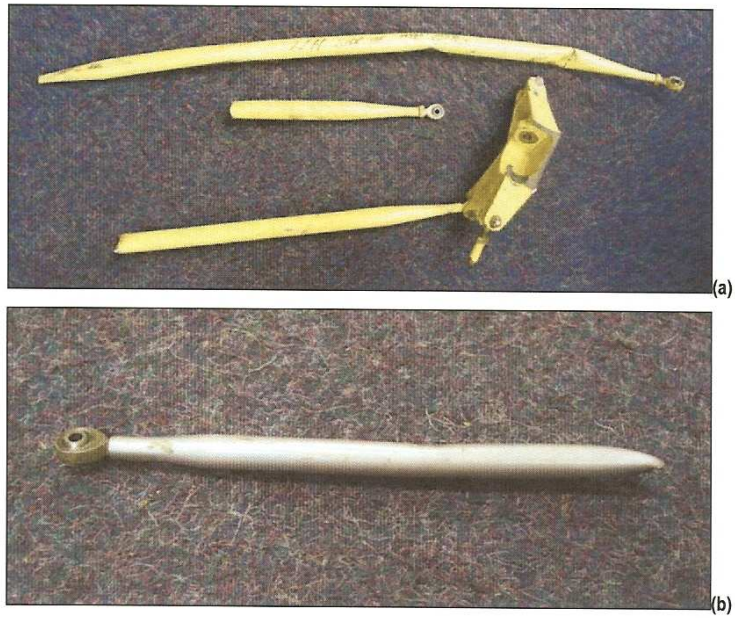
The first control rod (top of Figure 10(a)) exhibits damage along its length consistent with localised bending and compression. Fracture occurred at one of the reduced diameter ends of the control rod, resulting in the fracture surface shown in Figure 11(a). Failure occurred at an angle of approximately 45° to the wall thickness of the rod over most of the circumference, which signifies that the rod cracked as a result of overloading, resulting in an overload shear stress in the thin walled component. Scratches and damaged paint are visible on the surface of the rod adjacent to the fracture site. It is not clear whether this damage was caused during removal of the rod from the wreck, or from an object that may have contributed to the failure.

The second control rod, the two sections of which are shown in Figure 10(a), fractured at a location approximately two thirds along the length of the rod. The fracture surface is shown in Figure 11(b), and appears similar to the fracture surfaces of the gear box supports shown in Figures 8(a) and (b). Considerable plastic deformation occurred in the vicinity of the fracture surface and the available evidence suggests that failure was caused by localised bending, which resulted in predominantly shear failure of the control rod.

Figure 10. The fractured control rods supplied for examination: (a) magnification: 0,13x; and (b) magnification: 0,34x.

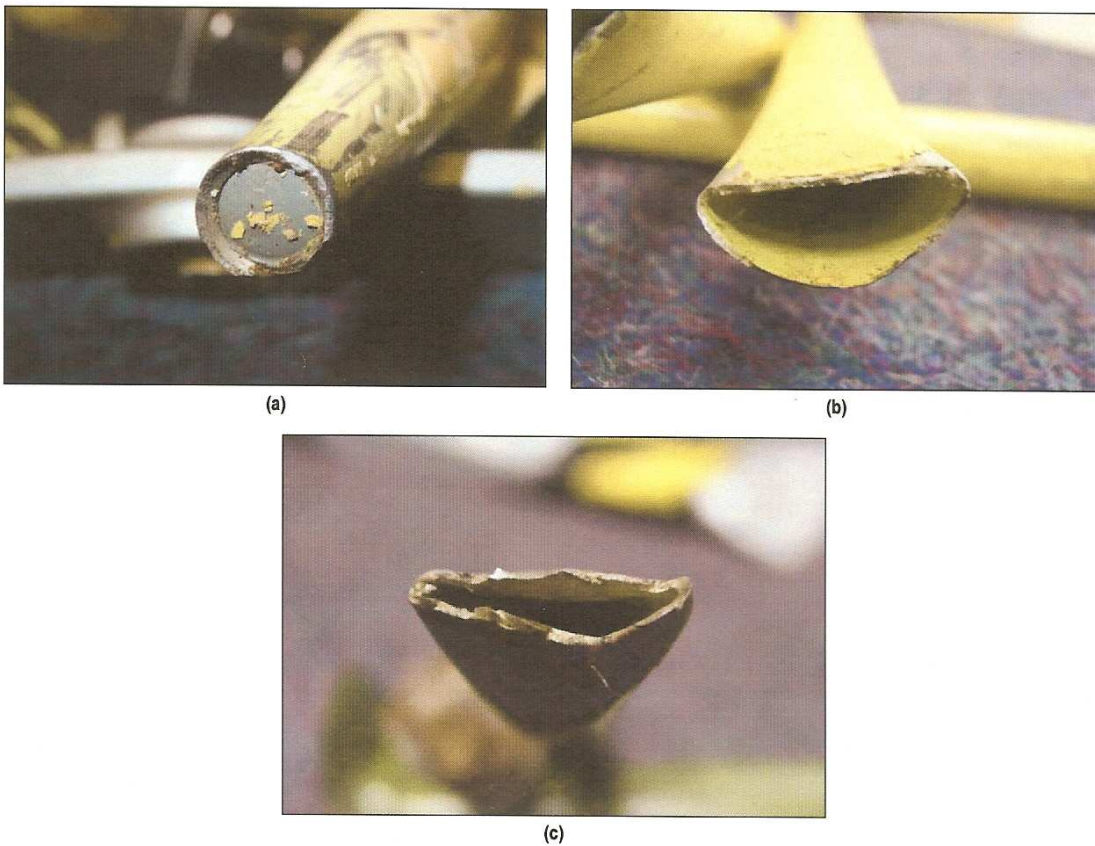
Figure 11. Enlarged views of the connecting rod fracture surfaces: (a) magnification: 2x; (b) magnification: 1x; and (c) magnification: 1,9x.

The third control rod supplied for examination is shown in Figure 10(b). Evidence of bending and compression is visible along the length of this component, and the fracture surface, shown in Figure 11(c), is similar in appearance to the fracture surface shown in Figure 11(b). The appearance of the rod and the fracture surface implies that fracture of this control rod was caused by bending, which resulted in predominantly overload shear failure.

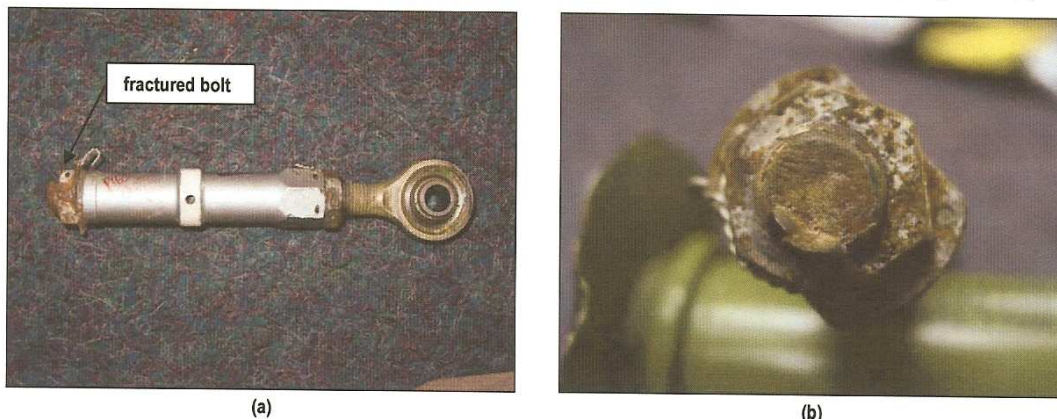
The main rotor pitch change link is a steel component, and contained a fractured steel bolt on one side in the as-supplied condition (Figure 12(a)). An enlarged view of the bolt fracture surface is shown in Figure 12(b).

Figure 12. (a) The main rotor pitch change link in the as-supplied condition (magnification: 0,4x); and (b) an enlarged view of the fracture surface of the fractured pitch change link bolt (magnification: 1,5x).

Immersion in sea water after the accident resulted in corrosion of the uncoated steel parts of the pitch change link. One of the areas that suffered considerable corrosion damage is the fractured bolt. In the as-supplied condition, the rust deposit that formed on the cracked bolt obscured many of the underlying features of the fracture surface. In order to examine the fracture surface, the bolt was first cleaned using ethanol and a soft brush. This treatment dislodged loose rust particles, but did not remove all the corrosion product (see Figure 12(b)). The fracture surface of the bolt was observed to be largely flat and perpendicular to the shaft of the bolt, and contained a well-defined 45° shear lip on one side. The appearance of this fracture surface has some features in common with fatigue damage, and therefore the fracture surface was thoroughly cleaned using Hibatex™ solution to reveal more detail. Although this treatment removes all the corrosion product, it also damages the underlying metal and should be performed with care. The resulting fracture surface was shown to contain some linear features, but these features appeared to be chevron markings, rather than fatigue beach marks. Visual examination also revealed that the bolt apparently bent prior to failure (as shown in Figure 13), which precludes fatigue or a pre-existing defect as the primary cause of failure. The conclusion can therefore be drawn that the bolt failed as a result of overload bending stresses.

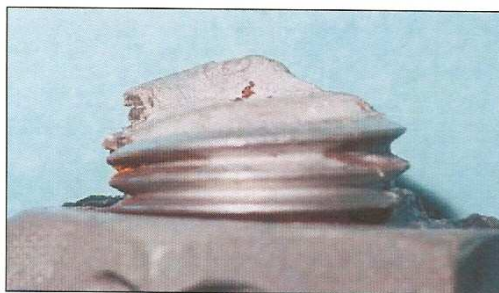
Figure 13. A side view of the pitch change link bolt, demonstrating that the bolt apparently bent prior to failure (magnification: 3,3x).
