Report No. 001-2005-TMA
Date: 23-Oct-05
Page: 1 of 11

Investigation Report

1. Material P/N 0292005270	2. Material S/N 16077	3. Material Description ENGINE
4. Engine / Component Type Arriel 1k1	5. Aircraft Type Agusta 109 K2	6. Customer Acher Aviation
7. Customer Complaint Yes <input type="checkbox"/> No <input checked="" type="checkbox"/>	Number <input type="text" value="N/A"/>	
8. Customer Reference		<input type="text" value="N/A"/>

EXAMINATION OF FRACTURED COMPONENTS FROM A SALVAGED HELICOPTER (Registration number: ZS-RRB)

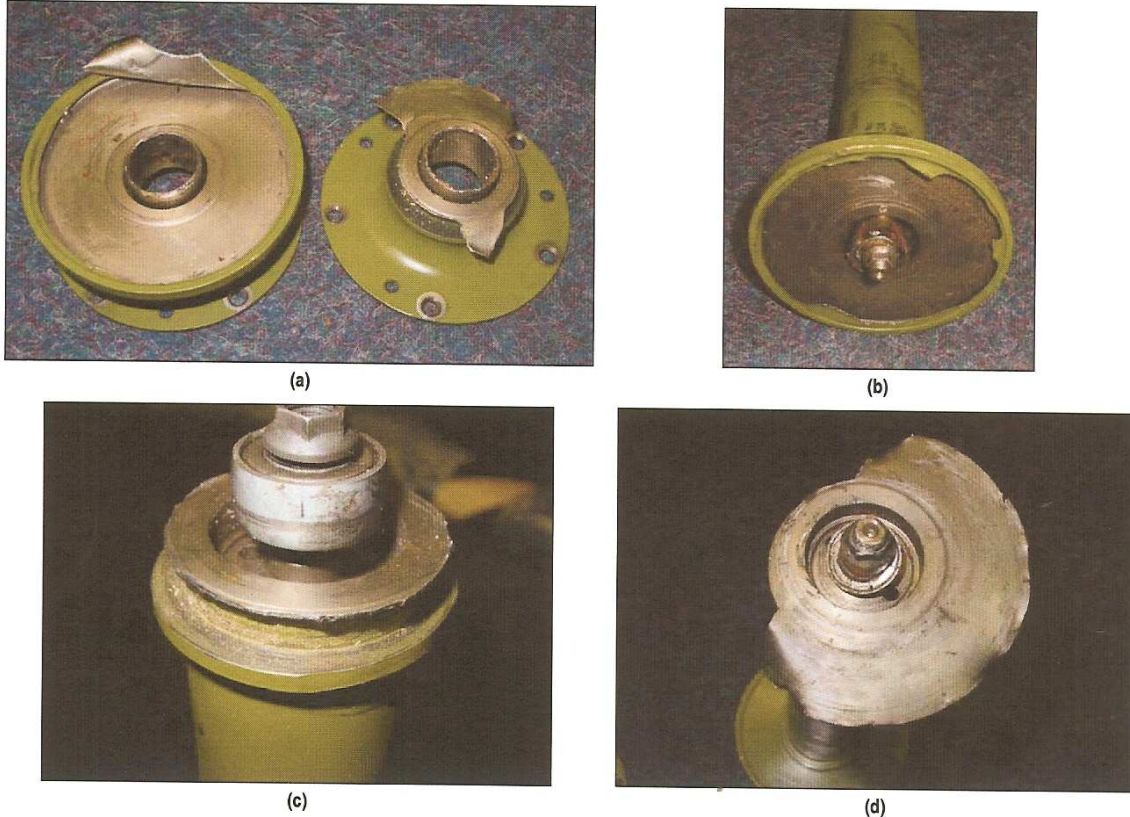
The damaged main drive shaft couplings are shown in Figures 14(a) to (d). Extensive plastic deformation is evident in the vicinity of the fracture surfaces. In all instances, the observed damage appears to be consistent with bending and tearing of the thin sheet metal under overload conditions, resulting in ductile shear failure. No evidence of any pre-existing defect that may have accelerated failure was observed on any of the fracture surfaces.

Figure 14. The damaged main drive shaft couplings in the as-supplied condition: (a) magnification: 0,35x; (b) magnification: 0,36x; (c) magnification: 1x; and (d) magnification: 0,5x.

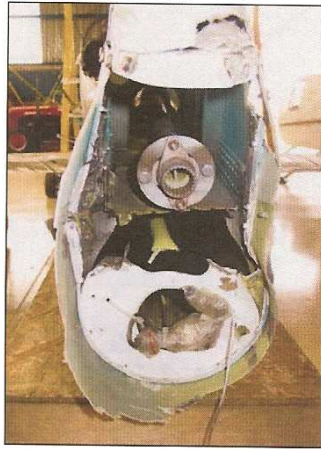
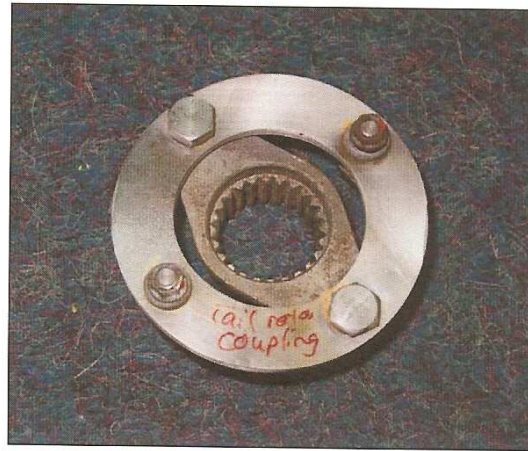
Photographs of the tail rotor coupling *in-situ* in the wreck and after removal are shown in Figures 15(a) and (b), respectively. The component appears to be largely undamaged, except for minor localised corrosive damage, probably sustained during the period in which the helicopter was submerged in sea water after the accident. Examination of the gear teeth inside the coupling revealed no evidence of overheating, excessive or uneven wear, contact fatigue damage or tooth chipping. The available evidence therefore suggests that insufficient lubrication during service, misalignment, excessive adhesive or abrasive wear, or contact fatigue damage of the tail rotor coupling gear did not cause or hasten the accident. The gear material appears to have performed well in the application. The tail rotor coupling supplied for examination also appears to have suffered very little damage during the accident itself. Since the tail rotor and a large piece of the tail section of the helicopter were not recovered during the salvage operation, further conclusions are not currently justified.

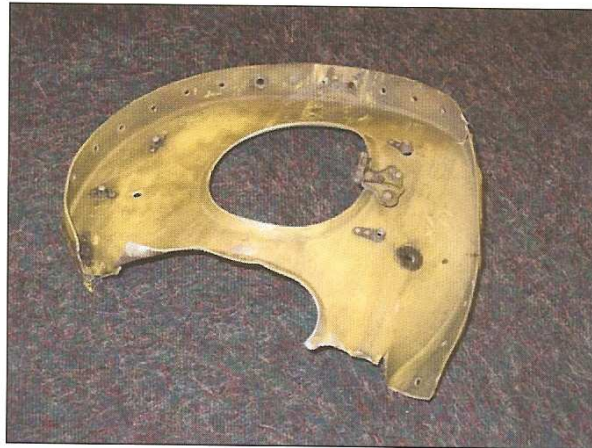
Figure 16. The damaged tail rotor gear box assembly in the as-supplied condition after removal from the wreck (magnification: approximately 0,2x).

Considerable plastic deformation is evident, resulting in bending in several areas. This damage was not caused during removal of the attachment from the wreck, as is evident from Figure 15(a) which shows the attachment in position in the helicopter prior to removal. Bending of the component resulted in the thin sheet metal tearing through the centre of one of the rivet holes, and caused damage to a threaded screw hole (as shown in Figure 17). Some of the rivets used to secure an attachment in this area also display evidence of bending.

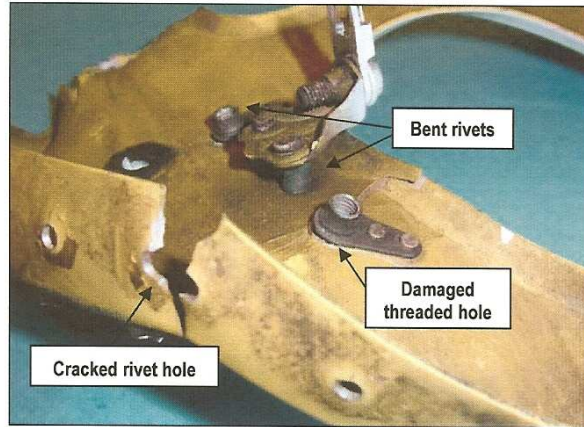
Figure 17. Damage observed in one area of the tail rotor gear box attachment (magnification: approximately 1x).

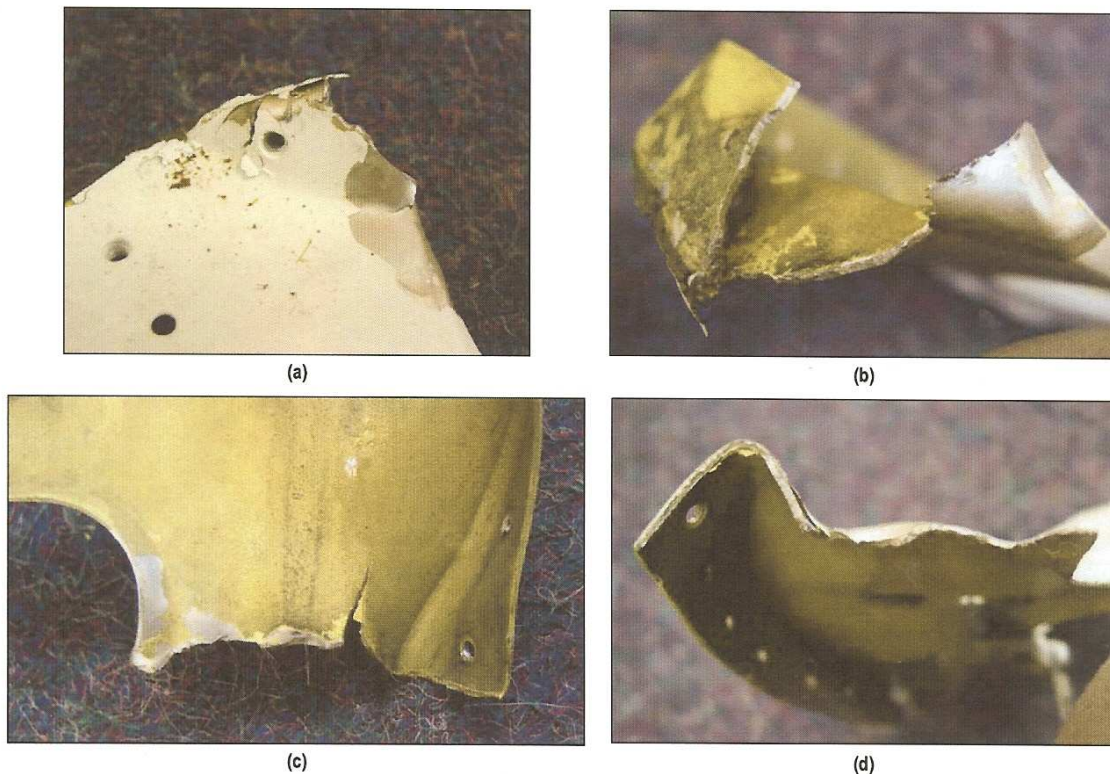
The top section of the component had apparently been torn off (see Figure 15(a)), and was presumably not recovered during the salvage operation. The metal surrounding the fracture surfaces appears deformed and bent, and examination of the fracture sites suggests that failure was caused by tearing under the influence of

an overload shear stress (see Figures 18(a) to (d)). This was confirmed by the appearance of the fracture surfaces, which displays predominantly ductile shear failure, with the fracture surfaces orientated at an angle of approximately 45° to the sheet metal surface. With the exception of the single fractured rivet hole shown in Figure 17 and very slight deformation to ovality in a number of cases, none of the rivet holes around the circumference of the attachment sustained significant damage. This implies that the rivets in the damaged section of the attachment (where the component was partly detached from the tail section) must have fractured, probably as a result of an impact load.

Figure 18. Views of the fracture surfaces of the tail rotor gear box attachment: (a) Left hand fracture surface as shown in Figure 16 (magnification: 0,9x); (b) left hand fracture surface as shown in Figure 16 (magnification: 1,3x); (c) right hand fracture surface as shown in Figure 16 (magnification: 0,76x); and (d) right hand fracture surface as shown in Figure 16 (magnification: 1x).
