TECHNICAL NOTE N. PBE/A109/03/2005

SUBJECT: Analysis on the possible effects of the main rotor servo actuator dynamics on the flight mechanics behaviour of the A109K2 helicopter

TECHNICAL NOTE
PBE/A109/03/2005

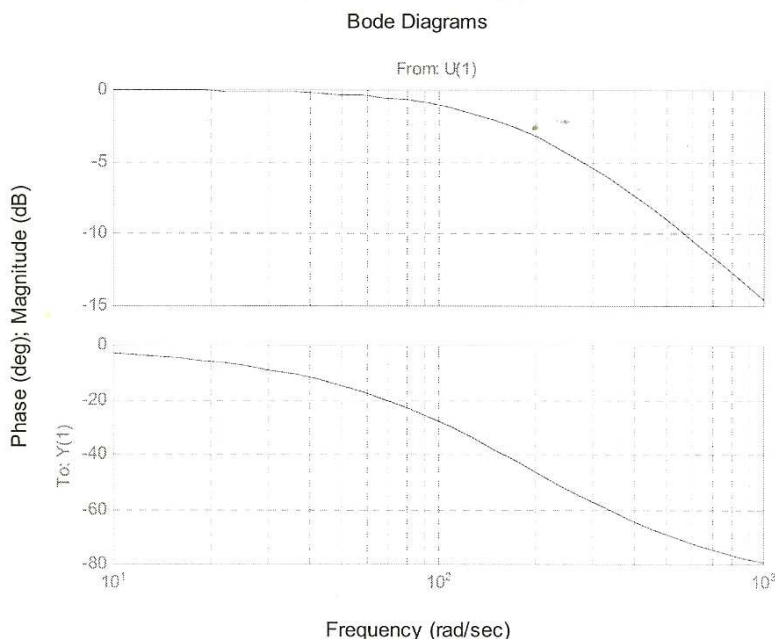
The transfer function used to represent the servo actuator identified by the P/N 01-28007 is:

$$L(s) = 190/(s+190).$$

Its amplitude and phase are reported in Figure 1. The above transfer function guarantees the bandwidth of 190 rad/s (= 30 Hz) reported in ref. [2].

Figure 1 – P/N 01-28007 transfer function, amplitude and phase

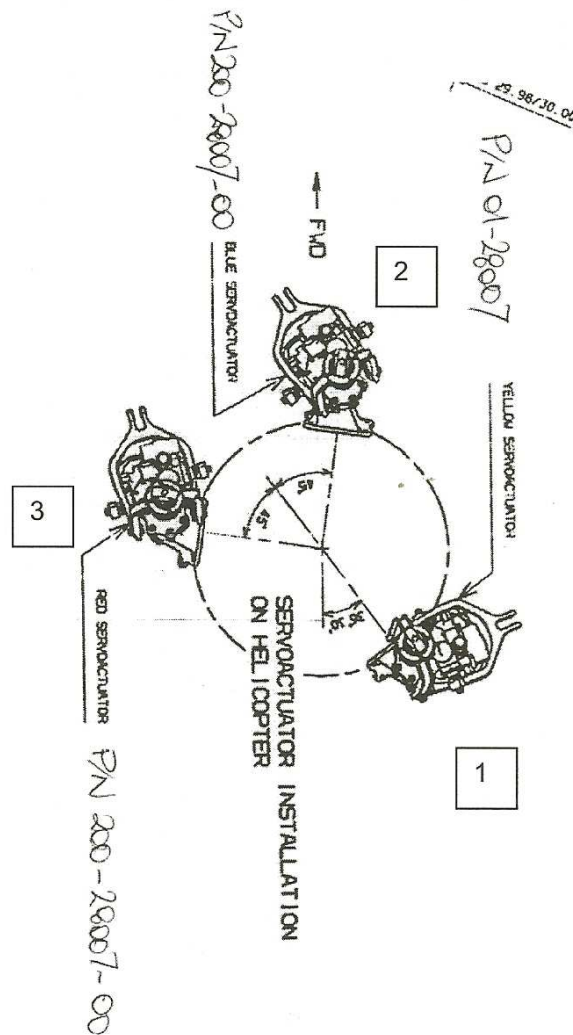
The investigation performed by MICROTECNICA (ref. [1]) resulted in discovering that the main rotor servo actuators installed on the helicopter were of two different models (i.e. P/N 01-28007 and P/N 200-28007-00), the main differences lying in their frequency response (ref. [2]). This report is aimed at investigating the possible effects of the servo dynamics on the flight mechanics behaviour of the A109K2 helicopter.

1. three ideal servo actuators. The transfer function of the actuator is $L(s)=1$;
2. three servo actuators with P/N 200-28007-00.
3. three servo actuators reproducing the configuration of the crashed helicopter, that is to say servo 2 and 3 of the P/N 200-28007-00 type and servo 1 of the P/N 01-28007 type (see Figure 3 for details).

Figure 3 – A109K2 S/N 10035 servo actuators configuration

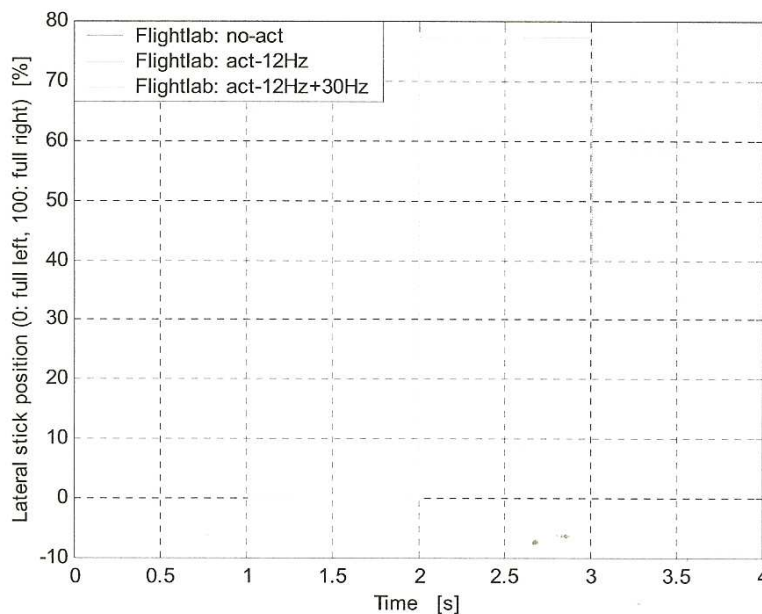
Figure 4 represents the cyclic doublet applied to the aircraft. Longitudinal cyclic, collective and pedal are maintained in the trim position. The trim lateral cyclic position is approximately 40 % of the control travel, where 0 % corresponds to full left cyclic, while 100 % to full right cyclic. From this initial position the stick is moved first to the left for all the available control travel and then, for the same quantity, to the right for another second.

Figure 4 – Response to doublet, lateral cyclic position

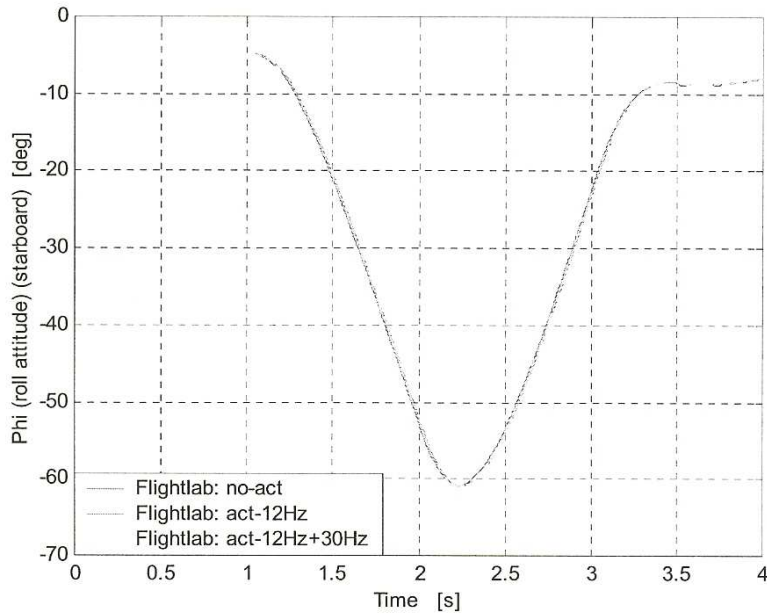
Figure 5 – Response to doublet, phi

From the analysis of the above figures it can be seen that the aircraft flight mechanics behaviour is not significantly influenced by the servo actuator configuration, in fact indicated air speed, aircraft position and attitude angles vary only slightly from one servo actuator configuration to the other for the same input time history. In particular in all three cases a left command does result in a powerful roll to portboard and in a rapid translation to the left.

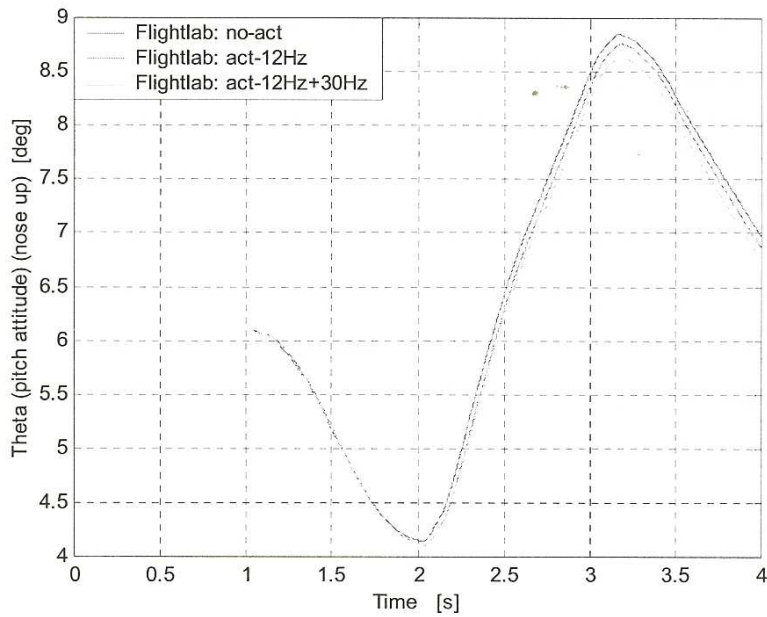
Figure 6 – Response to doublet, theta

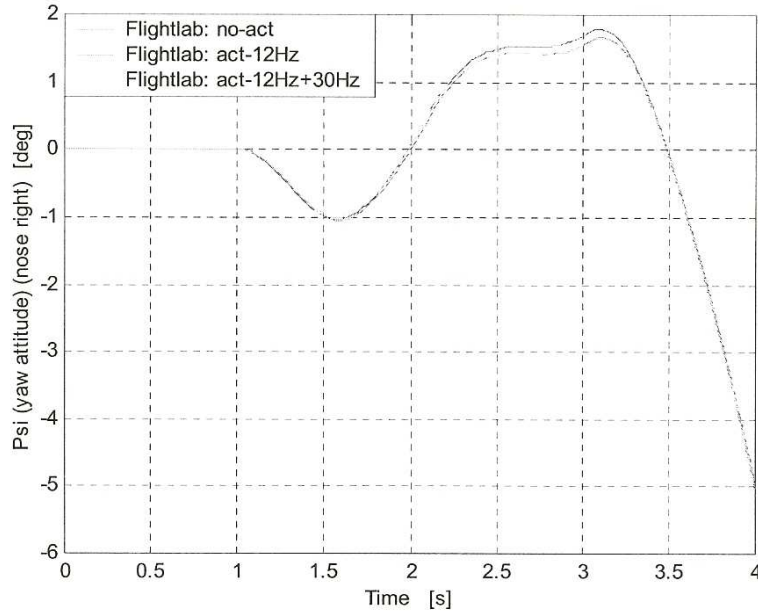
Figure 7 – Response to doublet, psi

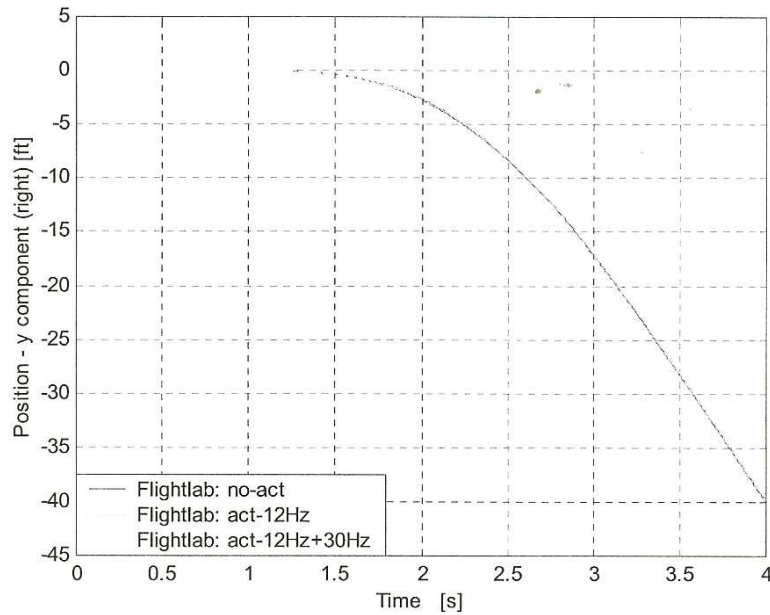
Figure 8 – Response to doublet, position, y component

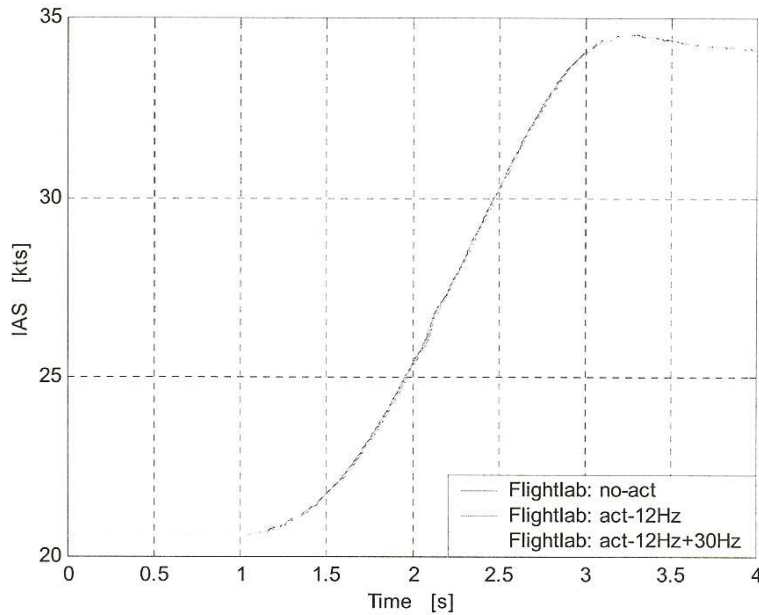
Figure 9 – Response to doublet, IAS

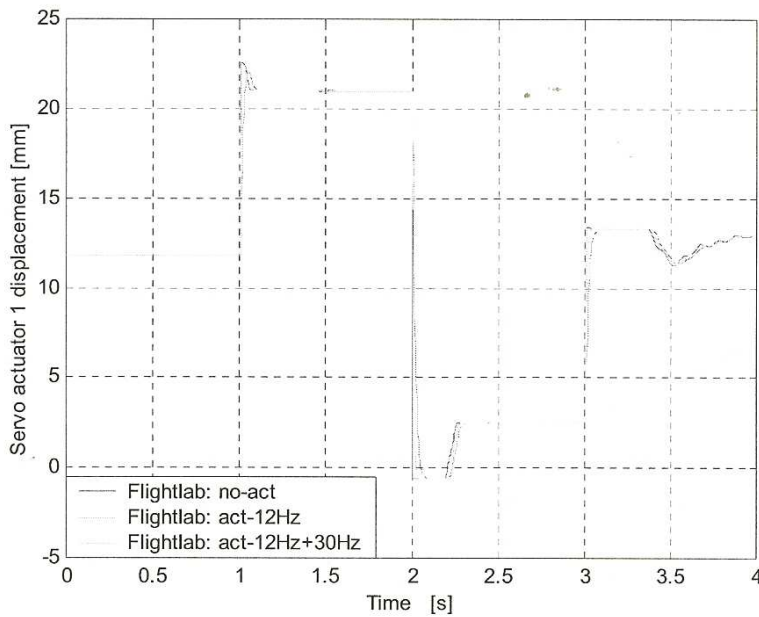
Figure 10 – Response to doublet, servo actuator 1 displacement

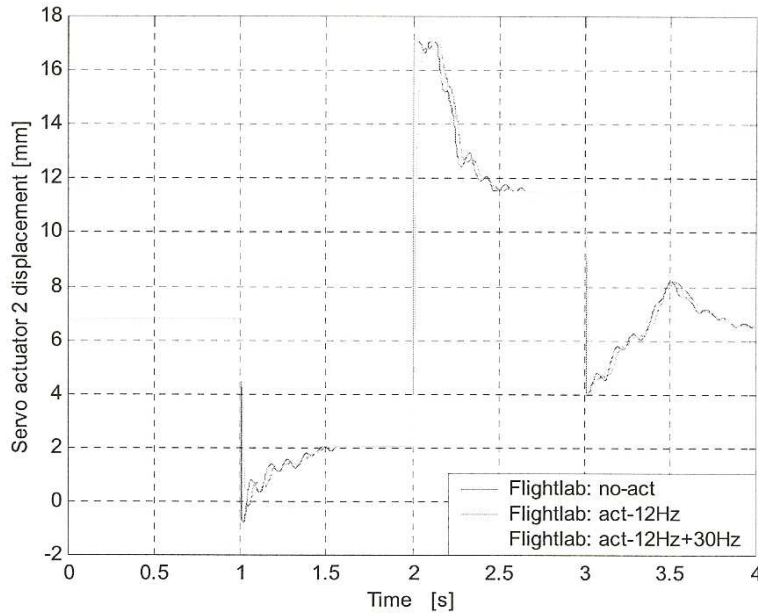
Figure 11 – Response to doublet, servo actuator 2 displacement

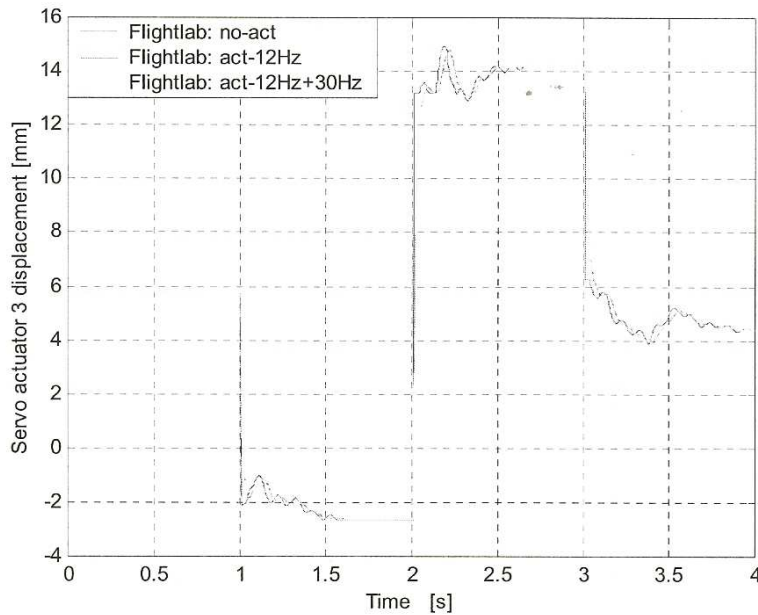
Figure 12 – Response to doublet, servo actuator 3 displacement
