CA18/2/3/8017			
		SOUTH AFRICAN CIVIL AVIATION AUTHORITY ACCIDENT REPORT – EXECUTIVE SUMMARY			
Aircraft Registration	ZS-RMR	Date of Accident	2 October 2005	Time of Accident	1830Z
Type of Aircraft	Messerschmitt Bolkow Blohm GMBH MBB BO 105-S		Type of Operation	Medivac	
Pilot-in-command Licence Type	Commercial	Age	35	Licence Valid	Yes
Pilot-in-command Flying Experience	Total Flying Hours	1779.42	Hours on Type	4.6	
Last point of departure	GPS position S 33° 43.645' E023° 19.355', near the town of Haarlem				
Next point of intended landing	FAGG				
Location of the accident site with reference to easily defined geographical points (GPS readings if possible)					
GPS position S 33° 47.56' E023° 19.97', near the town of Haarlem					
Meteorological Information	According to the official weather report, partly cloudy conditions, with isolated thunderstorms which were most likely at the time and place of the accident.

AIRCRAFT ACCIDENT REPORT

Name of Owner/Operator : Air Ambulance Service (Red Cross)
Manufacturer : Messerschmitt Bolkow Blohm
Model : GMBH MBB BO 105-S
Nationality : South African
Registration Marks : ZS-RMR
Place : Haarlem
Date : 2 October 2005
Time : 1830Z

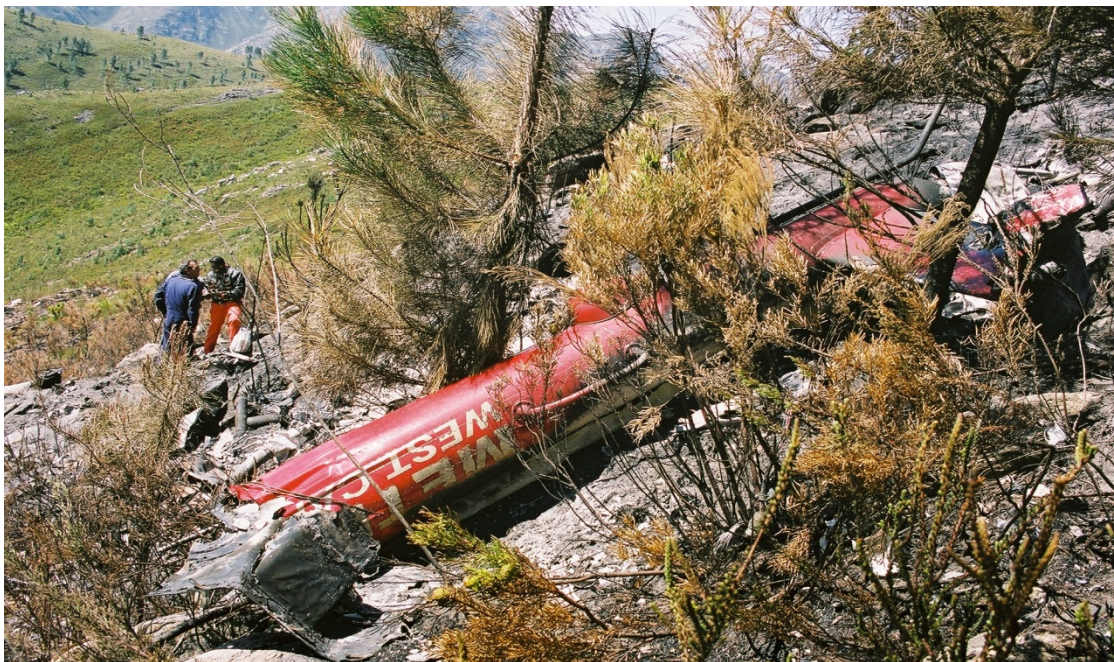
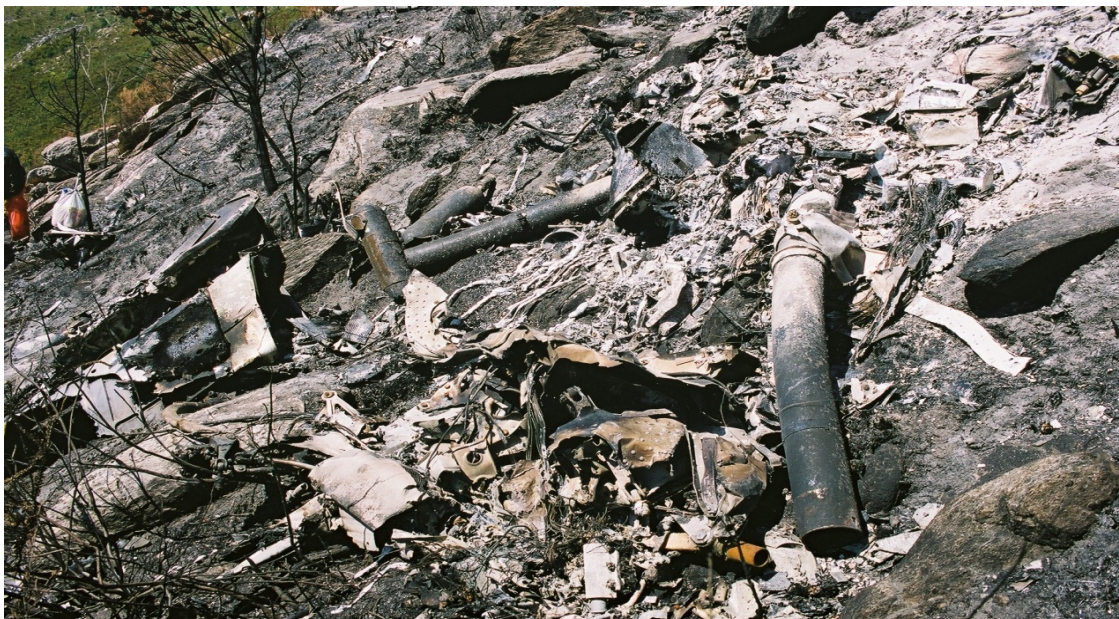
1.3.1 The helicopter was destroyed by the impact forces and the post-impact fire.

The picture above shows the tail-boom of the helicopter and below it can be seen that the helicopter was destroyed by the impact forces and the post-impact fire.

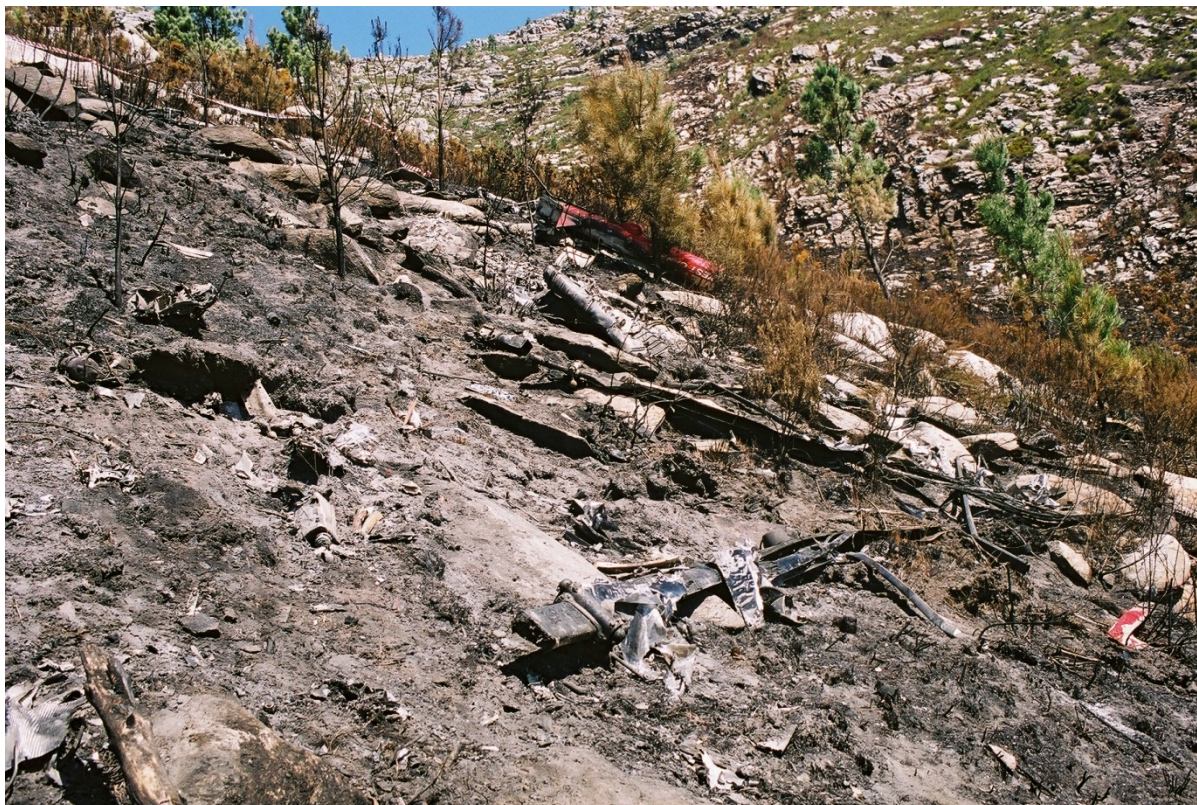
- 1.4.1 Apart from fire damage to the surrounding vegetation, there was no other damage.

Fire damage caused to the vegetation in the immediate area of the accident.

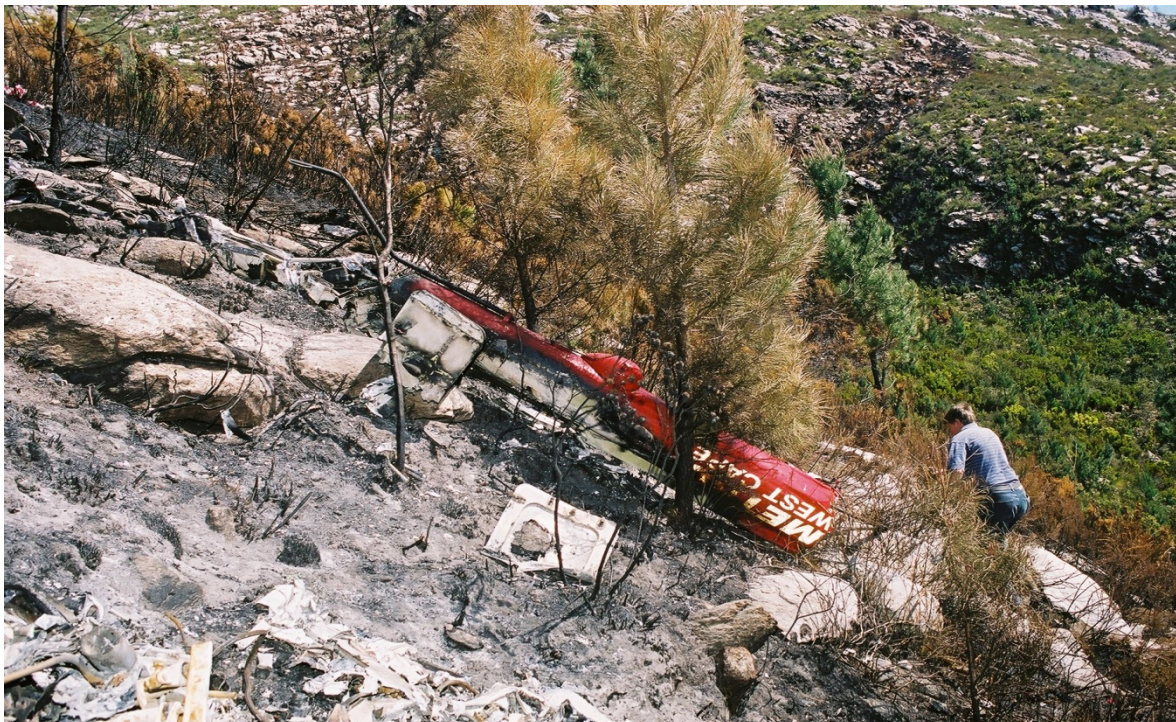
- 1.12.1 The slope of the terrain where the aircraft impacted the terrain, varies between 30° to 45° and the site elevation averaged at approximately 4600' AMSL.

The picture above shows the terrain gradient which averaged between 30° to 45°

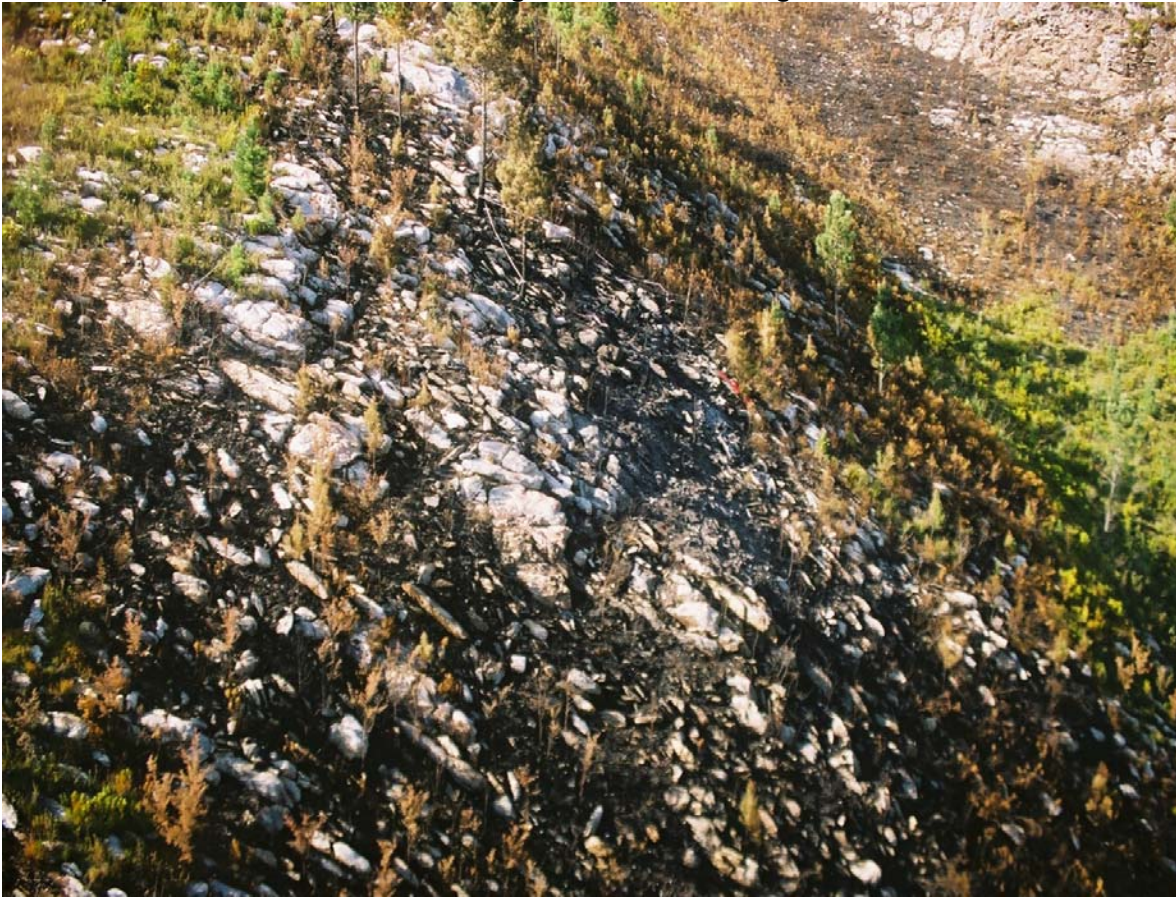
The picture above shows the terrain gradient which averaged between 30° to 45°

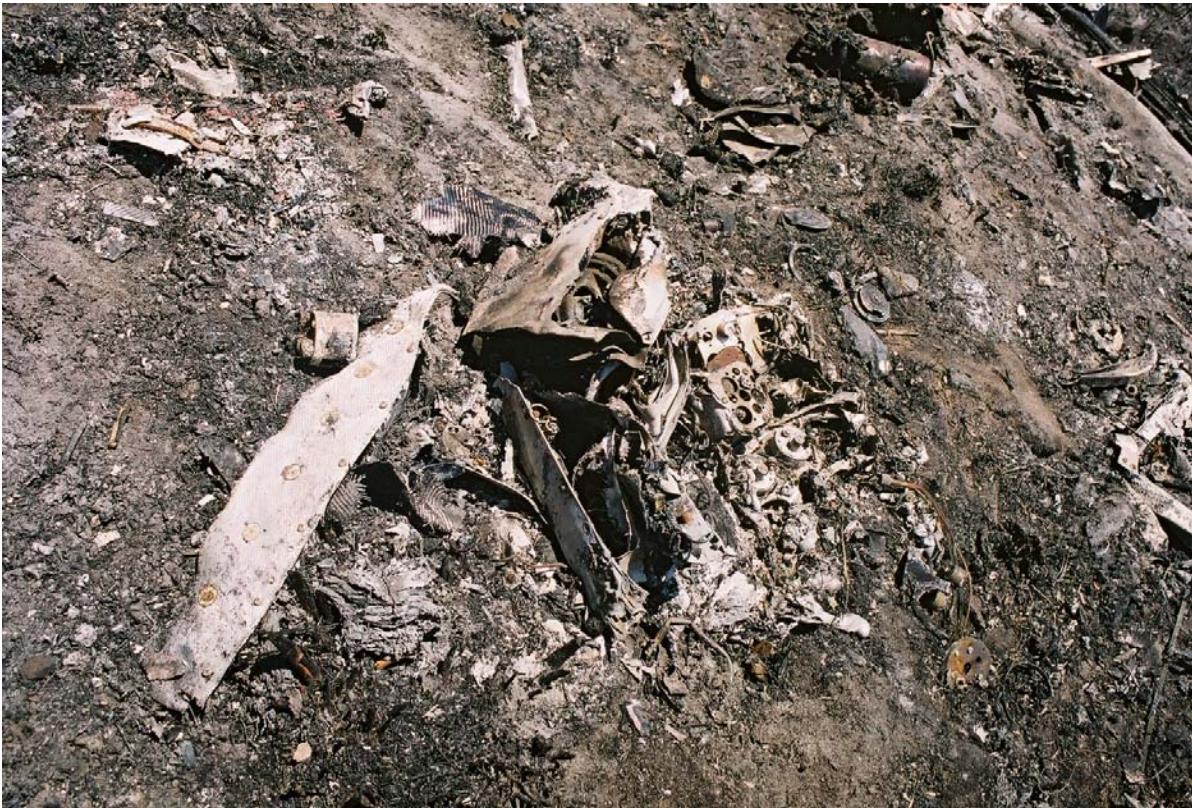
The helicopter was destroyed during the initial impact and the post-impact fire.

- 1.12.2 The helicopter impacted the terrain on a heading of 102°M at an altitude of 4600' AMSL.
- 1.12.3 The remains of the main rotor, the landing gear skids, the tail boom, the tail rotor and various pieces of the instrumentation were located at the initial impact point.
- 1.12.4 Some medical equipment, e.g.: oxygen bottle, stretchers etc. and the bodies of the occupants were recovered on an average of 45m further uphill from the initial impact point, spread out in an arc of approximately 30°.
- 1.12.5 Various minor parts of the helicopter were located between the initial impact point to a distance of approximately 75m downhill from the initial impact point.
- 1.12.6 During the impact sequence, the engines separated from the helicopter and rolled a distance of approximately 85m down the mountainside, into a valley from where it was not possible to safely recover these engines.
