EXECUTIVE SUMMARY AND AIRCRAFT ACCIDENT REPORT

Reference:	CA18/2/3/8142	
Aircraft Registration	ZU-DYF	Date of Accident	16 June 2006		Time of Accident	0935Z
Type of Aircraft	Dragonfly MK3		Type of Operation		Ferry Flight	
Pilot-in-command Licence Type		Airline Transport	Age	27	Licence Valid	Yes
Pilot-in-command Flying Experience		Total Flying Hours	3500.0		Hours on Type	2.0
Last point of departure		Virginia Aerodrome. (FAVG)				
Next point of intended landing		East London Aerodrome. (FAEL)				
Location of the accident site with reference to easily defined geographical points (GPS readings if possible)						
In the Sawoti area approximately 35 nm south-west of Durban (GPS position: S30° 16'09" E030° 31'31").						
Meteorological Information		Surface wind: Light and Variable, Temperature: 19°C, Visibility: CAVOK				
Number of people on board	1 + 0	No. of people injured	1 + 0	No. of people killed	0	
Synopsis						
<p>The pilot, as the sole occupant, departed from Virginia Aerodrome on a ferry flight to East London via Cato Ridge. The pilot avoided FADN Terminal Control Area (TMA) en-route to East London and climbed to 5500ft AMSL at an indicated air speed of 145kt. At that stage, the

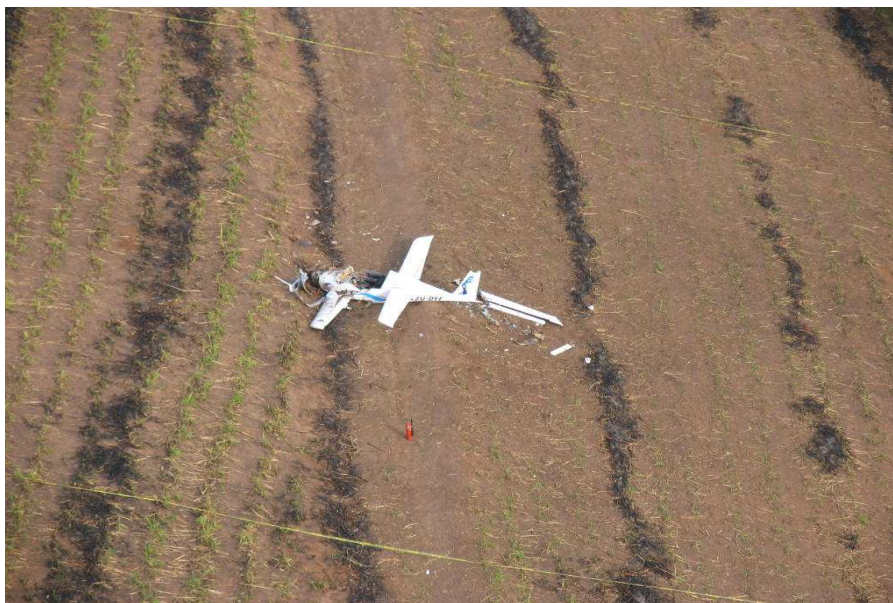
- 1.3.1 The aircraft was destroyed on impact with the ground surface.

PHOTO 1: AERIAL VIEW OF WRECKAGE IN THE SUGAR CANE FIELD.

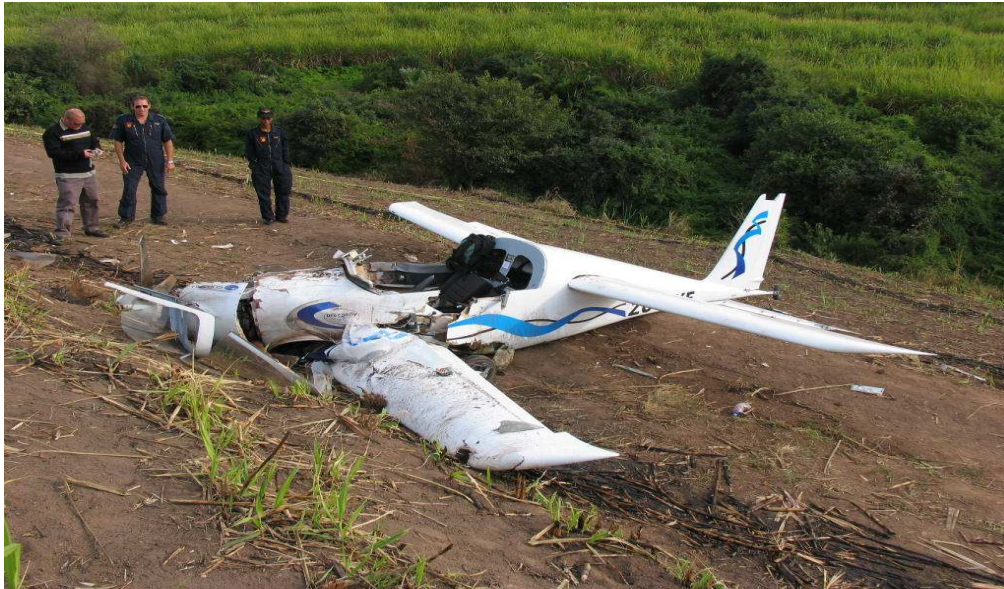
landing gear wheel and right-hand wing-tip impacted a hill. After the initial impact, the aircraft still flew a further 600 to 700 metres and impacted with another hill. During the impact sequence, the firewall, forward of the instrument panel, canopy and the left- and right-hand wing were extensively damaged. The aircraft came to rest in an upright position following the impact.

PHOTO 2: VIEW OF AIRCRAFT WRECKAGE SHOWING DAMAGE TO WINGS & FUSELAGE.

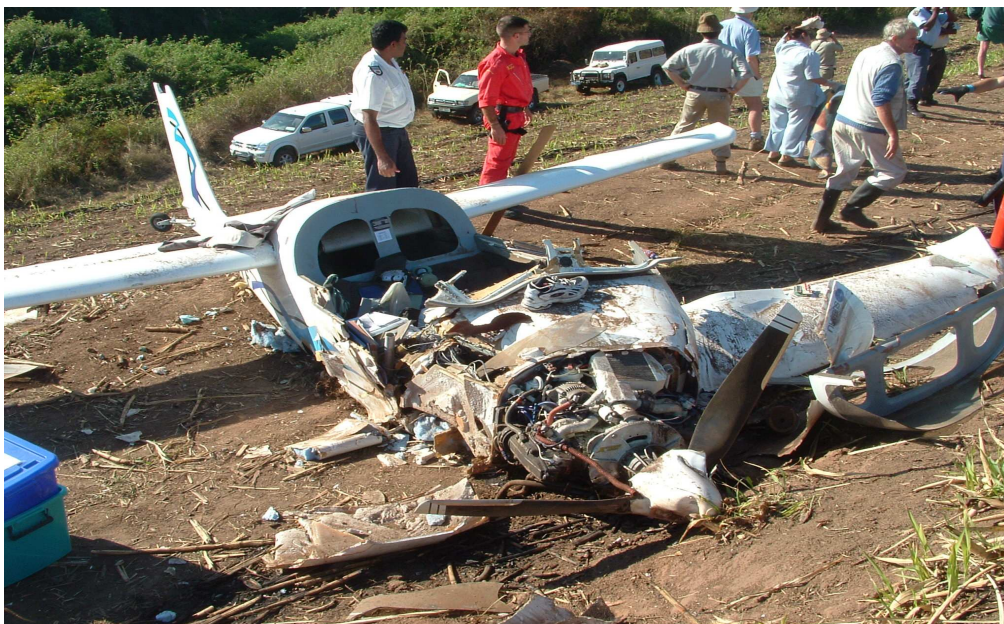
PHOTO 3: FRONT VIEW OF WRECKAGE SHOWING EXTENSIVE DAMAGE TO AIRCRAFT.

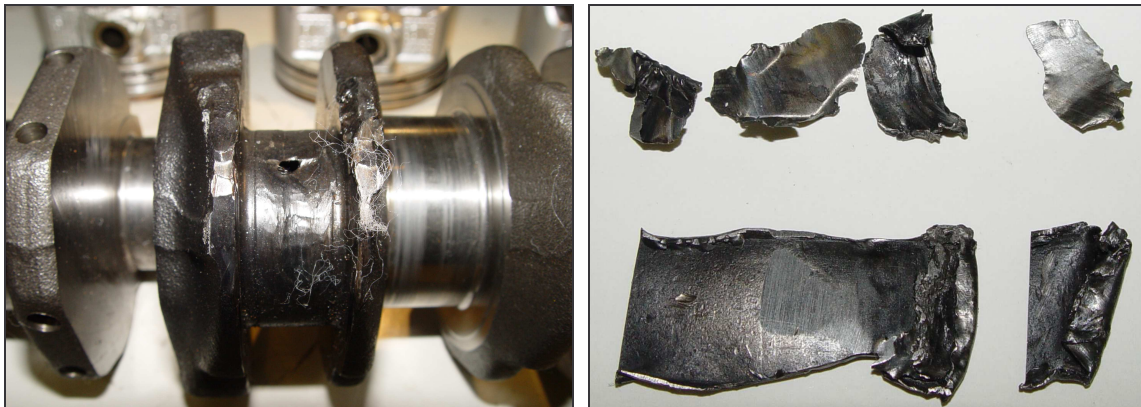
The visual inspection revealed localized, but severe impact and heat damage at the position of failure. The remainder of the crankshaft, including contact surfaces, appeared to be in a serviceable condition. The serviceable big-end bearings showed only post-failure impregnation damage. Originally, the layered platelets that had impregnated the con-rod side of the big-end were considered to be the remains from a peel-type shim. Although this could not be ascertained beyond a doubt, it appears that the impregnated layered platelets originate from the extensively damaged upper half of the big-end bearing. No other remnants from the upper half (con-rod side) of the big-end bearing were retrieved. No clear explanation exists as to why the lower half (cap side) of the bearing was not damaged to the same extent. The softer aluminium layer from the lower half of the failed bearing was completely removed while the Scanning Electron Microscope (SEM) investigation showed some sub-surface diffusion due to the extreme temperatures. The SEM EDS analysis revealed that the material composition of the impregnated platelets compares to that of the base metal from the bearing. No obstructions were detected in the crankshaft oil feeding tubes.

PHOTOS 5 & 6: SHOWING CRANKSHAFT AT POSITION OF FAILURE & REMAINDER OF BIG-END BEARING.

1.16.4.2 The investigation of the remainder of the relevant engine confirmed that the failure had occurred over an undeterminable period of time and not catastrophically. Taking into account the condition of the remainder of the engine bearings as well as the localized nature of the heat damages, it can be derived that general oil starvation and/or other lubrication discrepancies cannot be considered as a primary cause of this failure. All evidence points to the breakdown of the con-rod bearing as the primary cause of the catastrophic failure of the engine during operation.

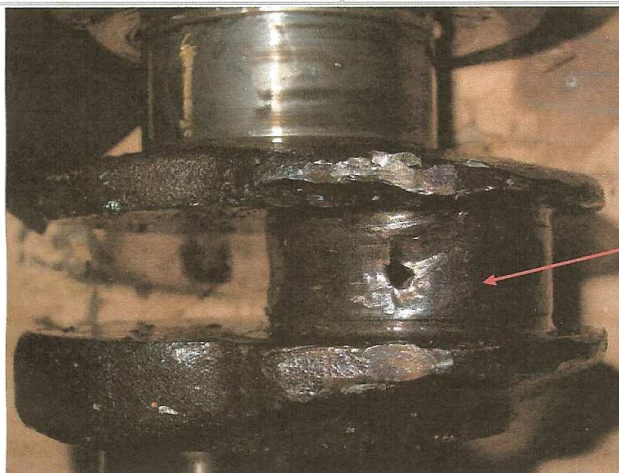
6.1. **Visual and Stereo-microscope Investigation.** The visual inspection revealed high temperature exposure on the crankshaft in the relative position (Photo 2). Extensive impact damage in the relevant areas is also evident (Photo 2). The impact damages resulted in the bending damages to the con-rod (Photo 3). The bottom area of the con-rod (Photo 4) showed signs of extensive impact damages, ductile extrusion, damaged fracture surfaces and deformed remains from what appeared to be a shim as well as high temperature induced discoloring. The con-rod fracture surfaces A and B (Photo 5) revealed some discoloring and foreign material deposit. The remainder of the cap fastener (Photo 5) showed signs of impact damages and two fracture surfaces C and D (Photo 7). The cap fastener bolt revealed signs of bending damages (Photo 6). Fracture surfaces C and D revealed no clear signs of pre-failure crack formation (Photo 7) but high temperature induced discoloring. The contact faces between the fastening bolt and nut and the remainder of the cap fastener (Photo 7) showed signs of multiple mechanically induced impact marks. This is most probably due to the disintegrating of the opposite fastener first leaving the remainder of the assembly exposed to some movement for an amount of cycles before final failure. The contact faces between the cap and con-rod (Photo 8) revealed extensive fretting wear that may be attributed to this movement. The remainder of the shims (Photo 9) for the sliding bearing showed signs of impact and severe sliding wear damages and evidence of carbon flake deposits formed under conditions of high temperatures. This is an indication that the assembly did not fail catastrophically but over a period of time. This amount of high temperature discoloring (Photo's 2, 4, 7, 8, 9 and 12) of the relevant components close to the bearing/journal contact area correlates with this notion.

Photo 2: Crankshaft showing temperature exposure and severe damages (courtesy CAA)

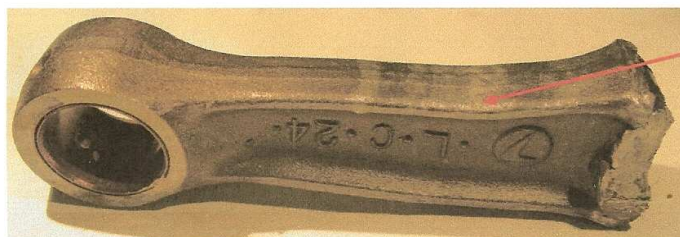
Photo 3: Con-rod showing bending and surface damages (digital)

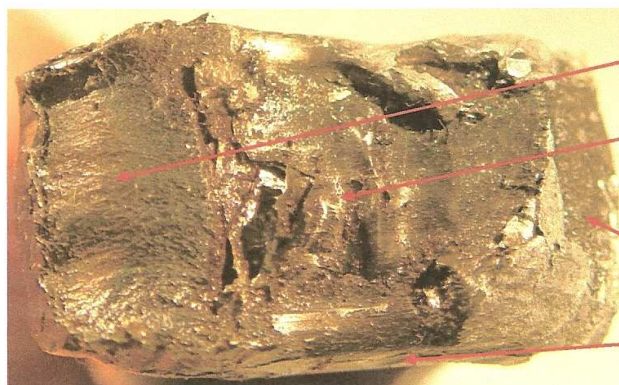
Discoloured fracture surface A

Remainder of bearing shim

Fracture surface B

Ductile extrusion due to impact wear

Photo 4: Con-rod fracture surface (digital)

7.4.4. The con-rod became part of the crankshaft after seizure and fractured at point A. Fractures B, C and D followed with more in between. Subsequently the con-rod was forced through the crankcase.

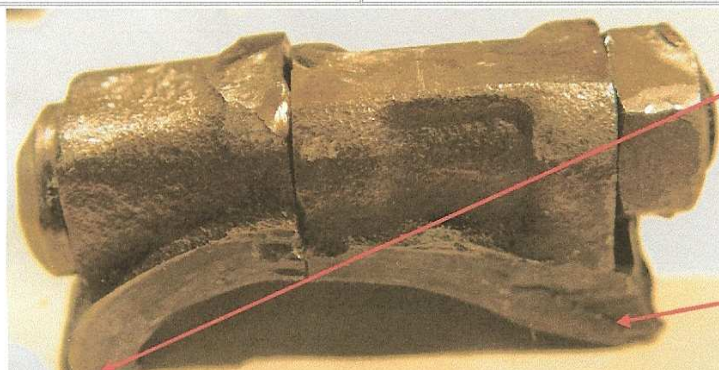
Photo 5: Remainder of cap fastener from big-end (digital)

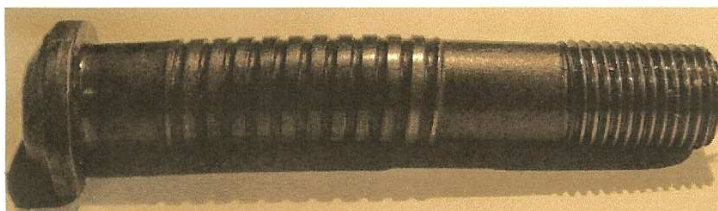
Photo 6: Big-end cap fastener bolt showing some bending damages (digital)

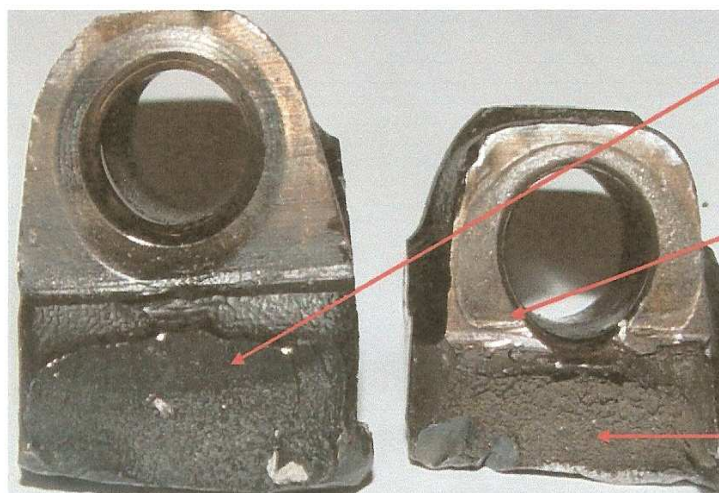
Photo 7: Fracture surfaces from cap fastener (digital)

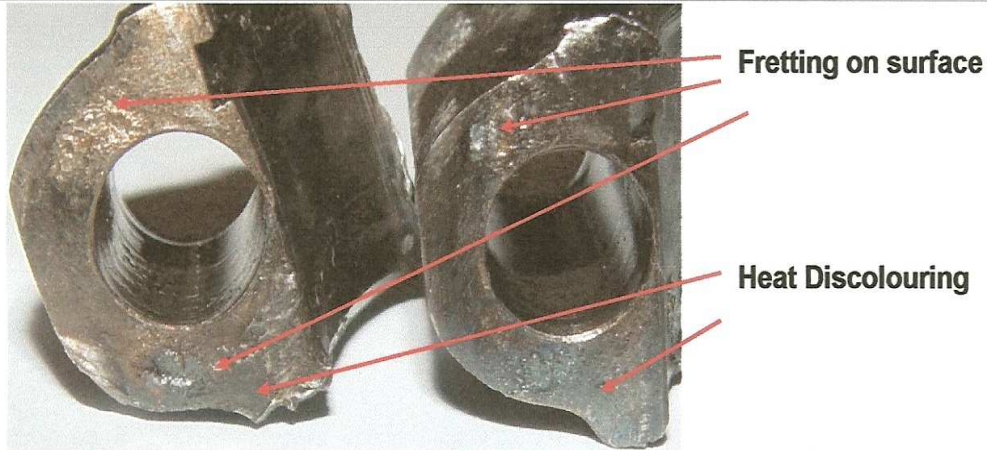
Photo 8: Contact face areas from cap fastener showing fretting and discoloring (digital)

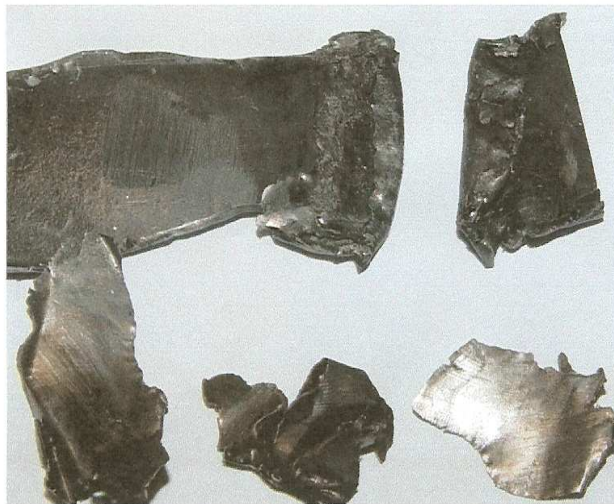
Photo 9: Remainder of the shim (digital)

7.4.1. The breakdown of the shim seems to be the primary cause for failure of the assembly. The causable factors for the failure of the shim can be oil starvation/breakdown and/or the mechanical breakdown of the shim itself due to incorrect fitment. Although the former could not be determined inconclusively due to the unavailability of oil samples, it is unlikely as the journal/bearing assemblies, downstream from the oil flow as well as others, seems to in relative good condition (determined from photographs courtesy CAA). The latter is the most probable cause for failure of the shim.

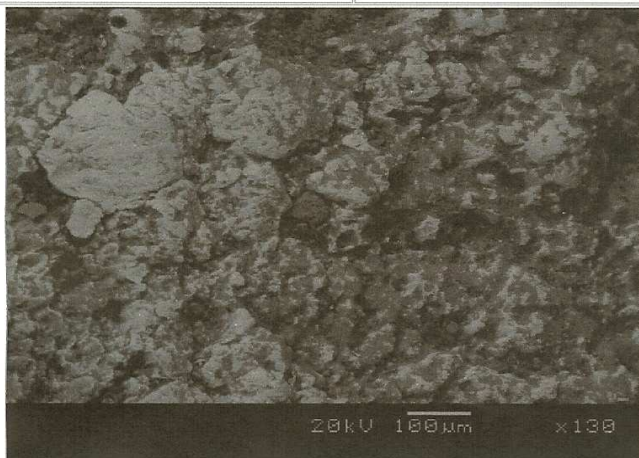
6.2. Microscopic Investigation. The SEM investigation at higher magnifications revealed extensive damages to most of the fracture surfaces. Fracture surface B also showed some signs of deposits (Photo 10) from a foreign metal (Table 2) with some traces of aluminium. This can be attributed to the impact with the aluminium based crankcase. Fracture surface A (Photo 11) exposed signs of a ductile fracture combined with high temperature exposure. The surface geometry (Photo 12) corroborate with the high temperature exposure showing some surface cracking.

Photo 10: Fracture surface B showing signs of foreign deposits (x130, SEM, backscatter image)

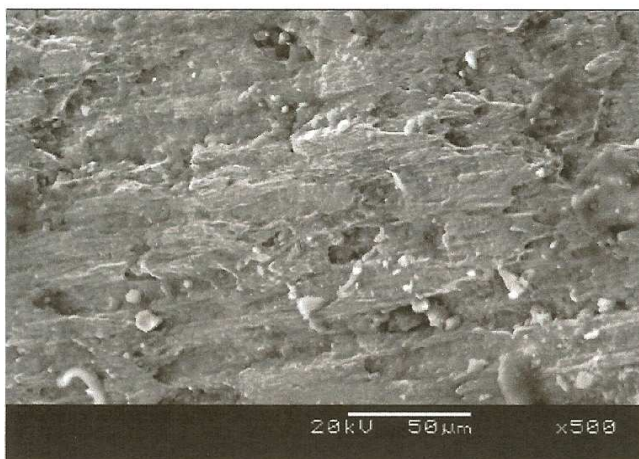
Photo 11: Fracture surface area A showing shear type failure geometry (x500, SEM)

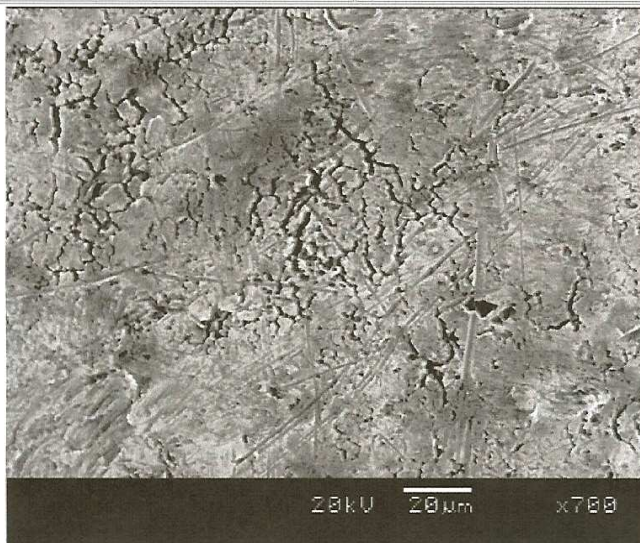
Photo 12: Surface geometry from remainder of shim (x700, SEM)

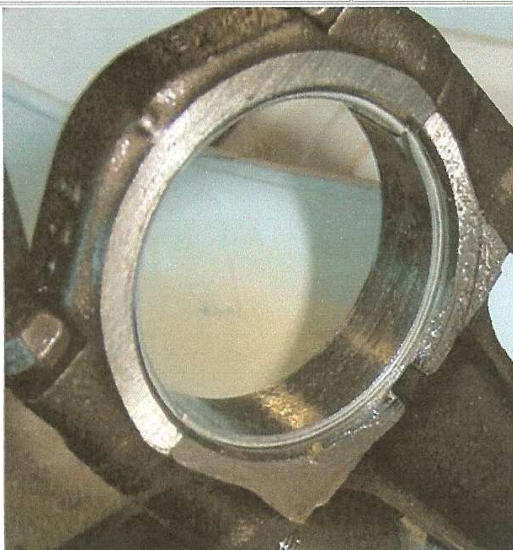
7.3. The supplied parts contained the remainder of what appears to be a peel-shim. Although not supplied for this investigation, it appears from photographs courtesy of CAA that the remainder of the con-rods from the same engine (Photo 13) is fitted with the same peel-shims. Generally peel-shims are utilized to enhance the clearances conformation during assembly between the con-rod and sliding bearing contact surfaces. This practice may increase the risk for failure of the assembly if not correctly installed.

Photo 13: Intact con-rod from same engine (courtesy CAA)

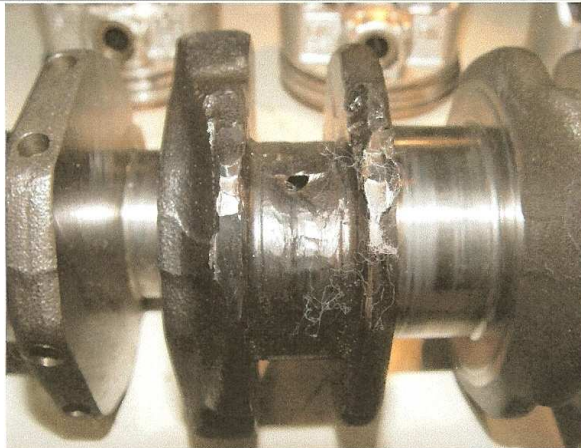
6.1. **Visual and Stereo-microscope Investigation.** The visual inspection revealed localized but severe impact and heat damages to the position of failure (Photo 2). The remainder of the crankshaft including contact surfaces, appeared to be in serviceable condition. The serviceable big-end bearings showed only post-failure impregnation damages (Photo 4). Originally the layered platelets impregnated onto the con-rod side of the big-end (Photo 5), was considered to be the remains from a peel-type shim. Although this could not be ascertained beyond doubt, it appears that the impregnated layered platelets (Photo's 5 and 6) originate from the extensively damaged upper half of the big-end bearing. No other remnants from the upper half (con-rod side) of the big-end bearing was retrieved. No clear explanation exist why the lower half (cap side) of the bearing (Photo 3) was not damaged to the same extend. The softer aluminium layer (Photo 7) from the lower half of the failed bearing (Photo 8) was completely removed while the SEM investigation showed some sub-surface diffusion due to the extreme temperatures. The SEM EDS analysis revealed that the material composition of the impregnated platelets compares to that of the base metal from the bearing. No obstructions in the crankshaft oil feeding tubes were detected.

Photo 2: Crankshaft position of failure (digital)

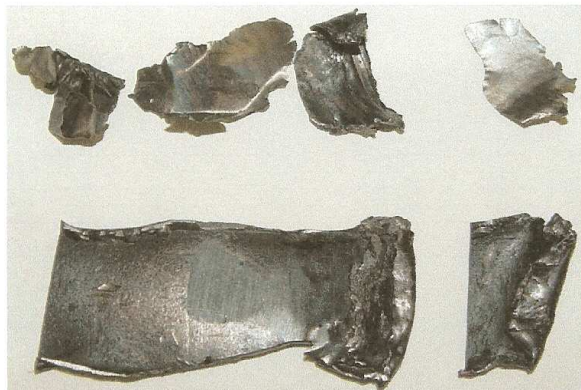
Photo 3: Remainder of big-end bearing (digital)

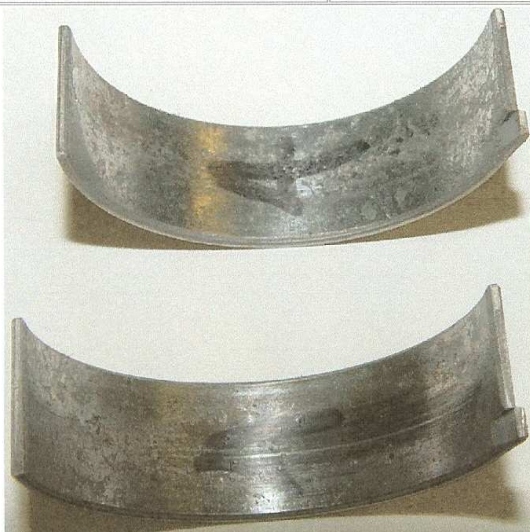
Photo 4: No 4 big-end bearing showing impregnation (digital)

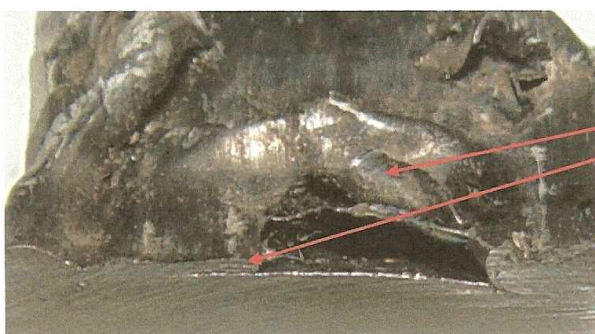
Photo 5: Failed con-rod end, sectioned to reveal layered bearing (digital)

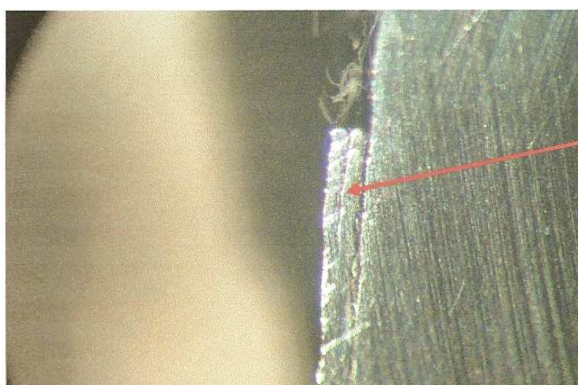
Photo 6: Layered bearing on failed con-rod big end (stereo)

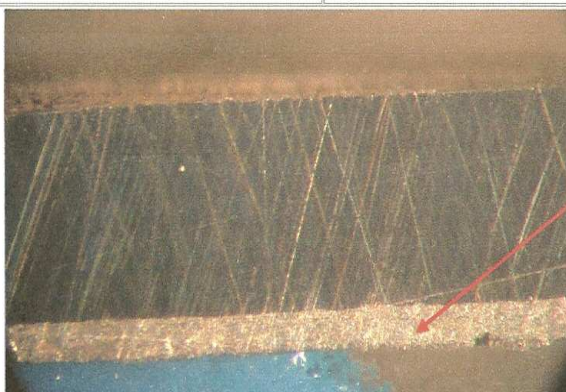
Photo 7: Section of serviceable bearing showing aluminium layer (stereo)

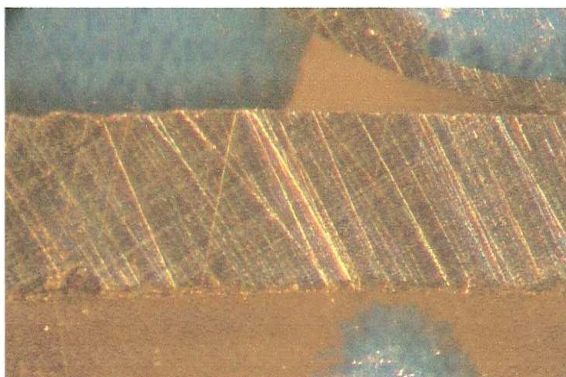
Photo 8: Section of failed bearing (stereo)
