AIRCRAFT ACCIDENT REPORT AND EXECUTIVE SUMMARY

Reference:	CA18/2/3/8278	
Aircraft Registration	ZS-RSW	Date of Accident	28 March 2007		Time of Accident	0900Z
Type of Aircraft	Aerospatiale AS 350 B (Helicopter)		Type of Operation	Domestic Flight		
Pilot-in-command Licence Type	Airline Transport (H)	Age	40	Licence Valid	Yes	
Pilot-in-command Flying Experience	Total Flying Hours	5070		Hours on Type	280	
Last point of departure	Simmerpan Eskom Yard, Germiston					
Next point of intended landing	Grand Central Aerodrome, FAGC.					
Location of the accident site with reference to easily defined geographical points (GPS readings if possible)						
Simmerpan Eskom Yard, Germiston; (GPS Position: S 26 13.544' E028 09.487')						
Meteorological Information	Temperature 18°C; Wind 010°/5kts; Visibility 8km; Cloud FEW at 1000ft and OVC at 2000ft.					
Number of people on board	1 + 3	No. of people injured	1	No. of people killed	1	
Synopsis						
<p>The pilot was tasked by the operator to uplift three (3) technicians at the Simmerpan Eskom Yard, Germiston, in order for them to carry out field work on electrical conductors for Eskom. The helicopter landed on an open grass area near some high rise b

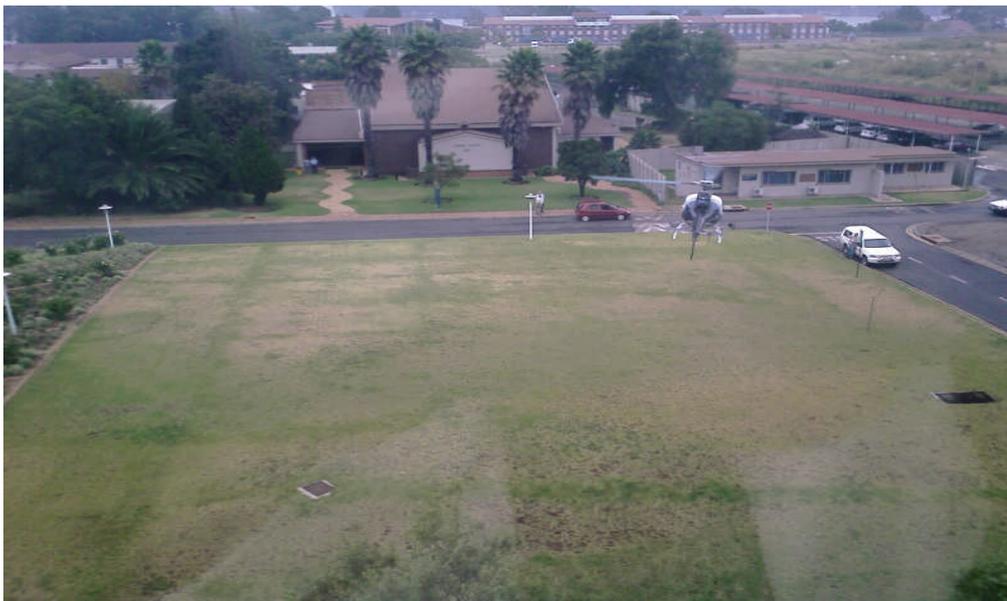
- 1.1.2 According to available video footage, the helicopter started to ascend into an Out of Ground Effect (OGE) hover at a height of approximately 22-25 ft above ground level (AGL), the pilot then performed an OGE power check and obtained 99% N1 engine indication and 100% torque indication on the main rotor gearbox. The helicopter then proceeded into forward flight, at a speed of between 10-15kt, when the low main rotor rpm aural warning sounded. In an attempt to regain rotor rpm, the pilot reduced the collective pitch lever and descended towards the road intersection ahead. He regained the rotor rpm momentarily, but as he increased the power in order to accelerate and climb away, the low rotor rpm aural warning sounded again.

FIGURE 1: ELEVATED VIEW OF HELICOPTER ZS-RSW IN FORWARD FLIGHT TOWARDS INTERSECTION

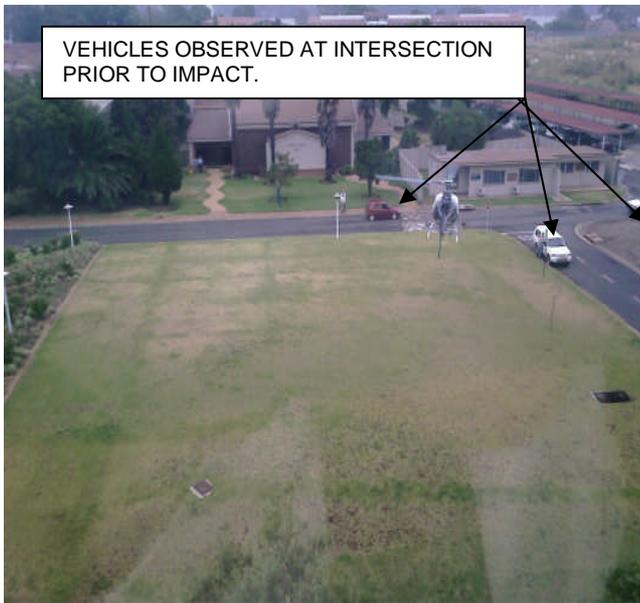
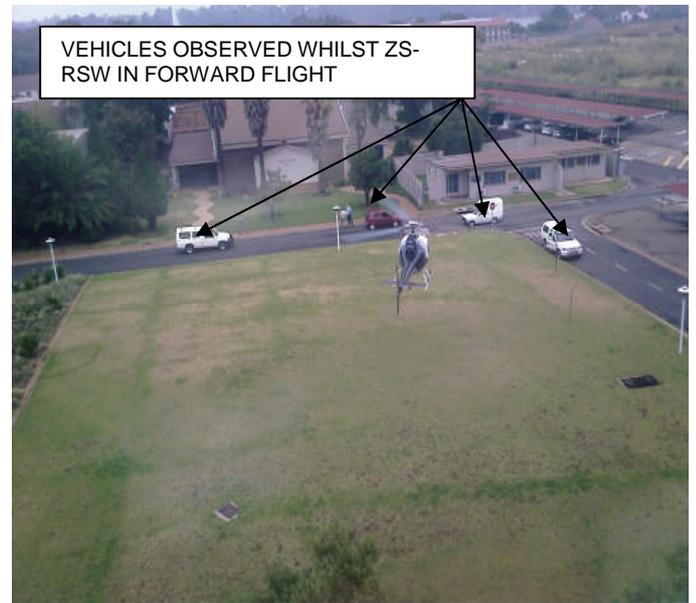
1.12.1 During take-off, the right-hand skid-gear penetrated the windscreen of a light delivery vehicle at the road intersection as can be seen in figure 3 (a) and (b) below, causing the helicopter to pitch down and roll over onto the left-hand side. During the accident sequence, the main rotor blades of the helicopter then impacted a second vehicle at the road intersection.

FIGURE 2: (a) & (b) ELEVATED VIEW OF ZS-RSW IN FWD FLIGHT JUST PRIOR TO IMPACT WITH TWO VEHICLES AT ROAD INTERSECTION.

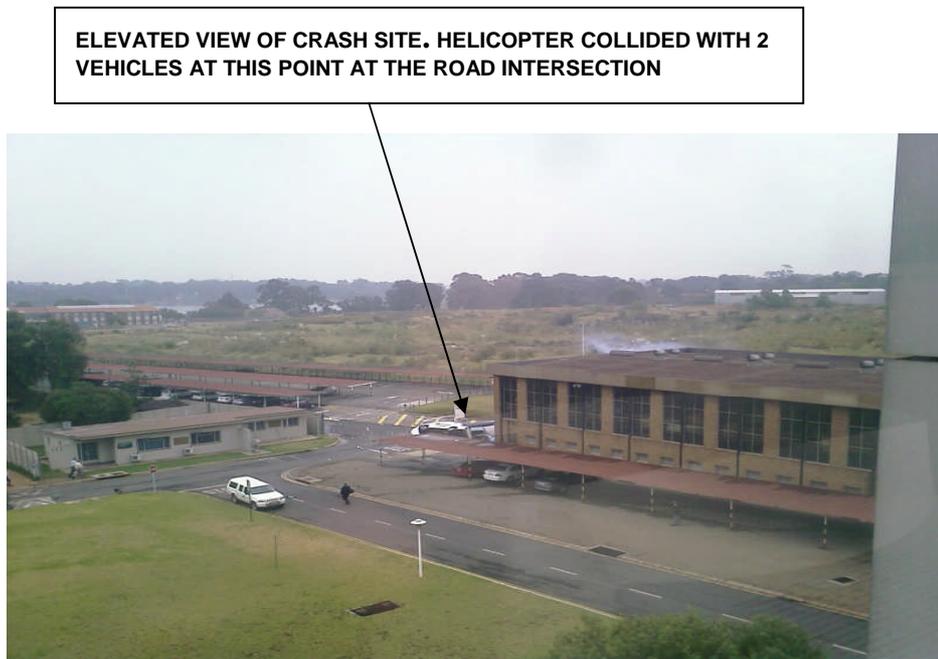
1.10.1 The helicopter landed and took off from a grass-covered area with high rise buildings located next to the take-off and landing area, as evident on the video footage available in this report.

1.10.2 This located helipad area was not approved by the CAA. There was only a piece of rag on a pole and no proper windsock to indicate the proper wind direction and wind speeds. There was also no safe escape route in case of an emergency.

FIGURE 3: VIEW OF WHERE THE ACCIDENT OCCURRED.

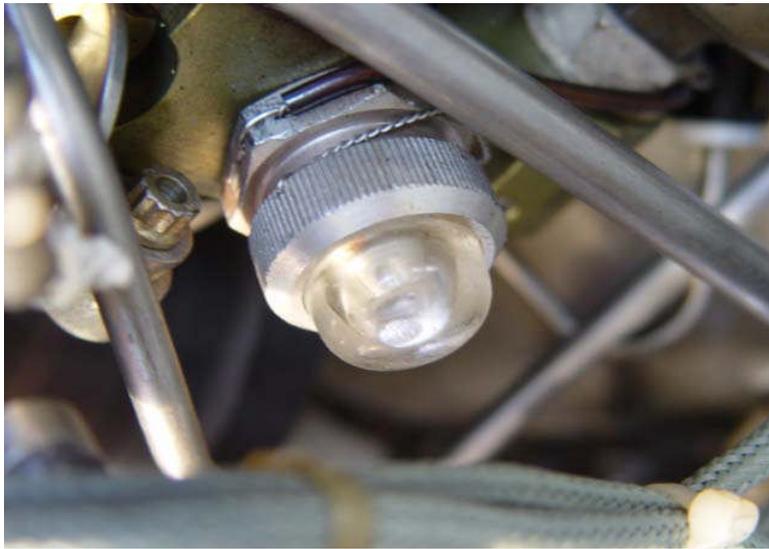
- All engine electrical and fuel/oil fittings and fuel control linkages appeared correctly installed and properly secured.
- The engine main oil filter pre-blockage warning (pop out) indicator had not been activated, suggesting a contamination free condition of the engine oil system, refer figure 01.

Figure 01: Main oil filter pre-blockage indicator not activated

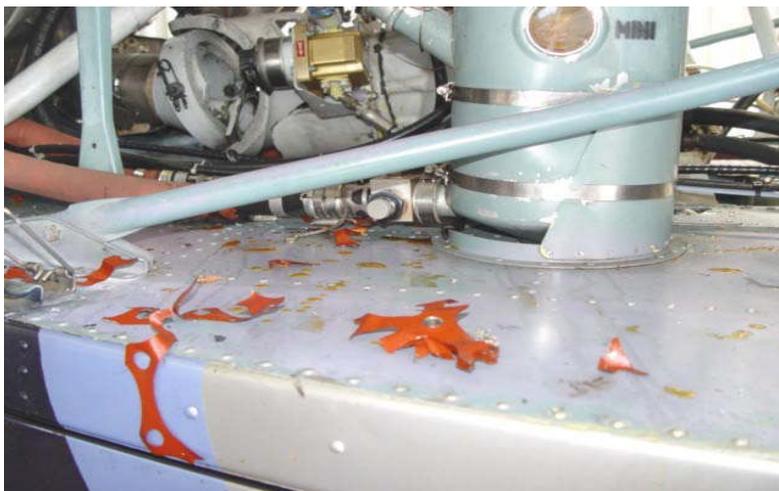
- By reference to figure 02 it can be observed that accident impact force had moved the engine rearward, causing separation between the engine and airframe intake casing.
- Engine power shaft to main gearbox was ruptured disconnected at the level of the flex coupling with total destruction of the coupling and drive assembly, see figures 02 and 03.
- The tail rotor drive coupling at the level of the engine flex coupling was still intact.
- Although no post impact fire occurred, fuel vapour suppression agent had been discharged into the engine.
- Power turbine rotation was free without obvious blade rubbing evidence and a positive connection to the tail rotor drive and main drive free wheel was confirmed.

Figure 02 Flex coupling destruction

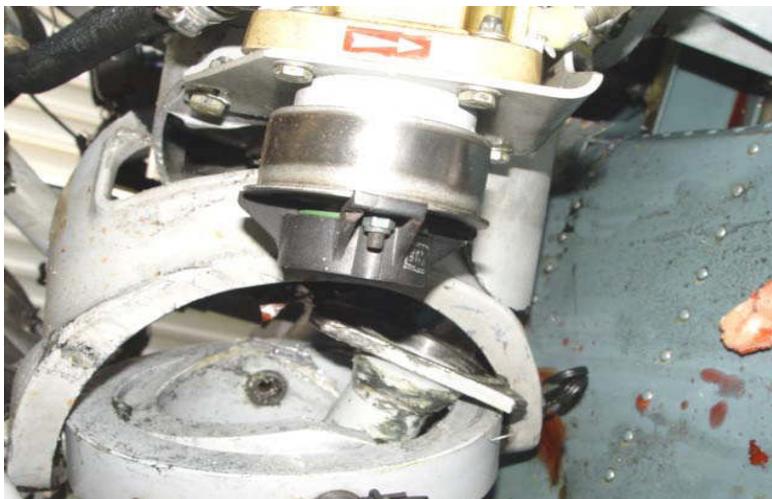
Main gearbox drive shaft impact ruptured disconnected

Figure 03: Main gearbox drive shaft impact ruptured disconnected.

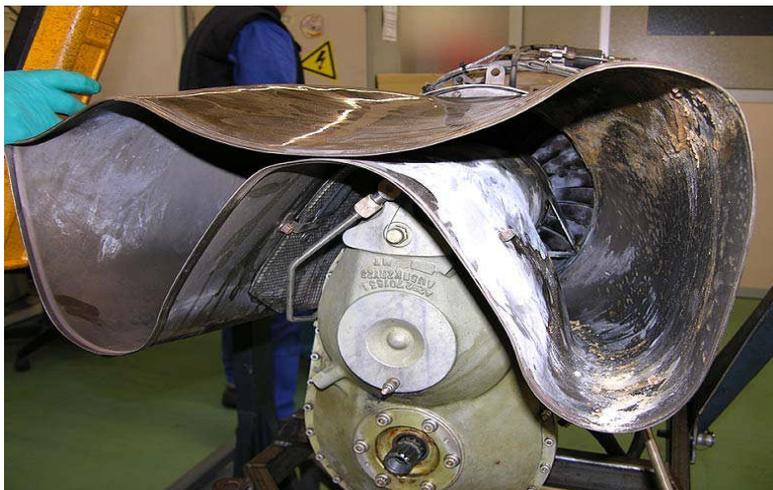
- The engine was received sealed in a wooden engine transport box and stand assembly, see figures 14.
- Receipt inspection of the engine, after removal from the transportation box, revealed accident impact damage to the engine exhaust, refer figure 15.

Impact damage to engine exhaust

Figure 15: Impact damage to engine exhaust.

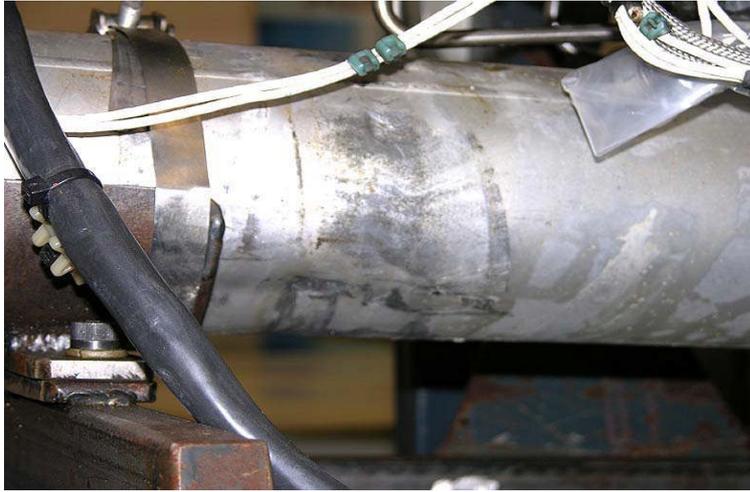
- The Mo1 liaison tube also showed impact damage at the level close to the rear support, see figure 16.
- By reference to figure 17, axial compressor casing attachment to air intake housing flange separation/fracture due to engine crash impact movement can be noticed.

Impact damage to liaison tube

Figure 16 Impact damage to liaison tube

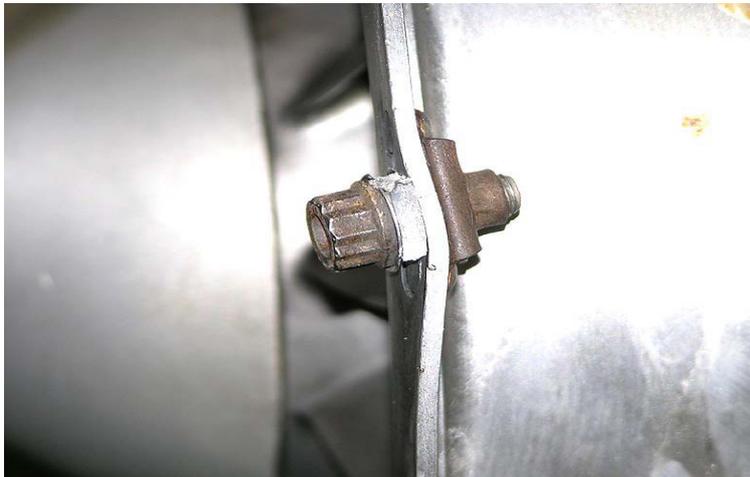
Figure 17 Axial compressor casing to air intake housing flange showing impact displacement

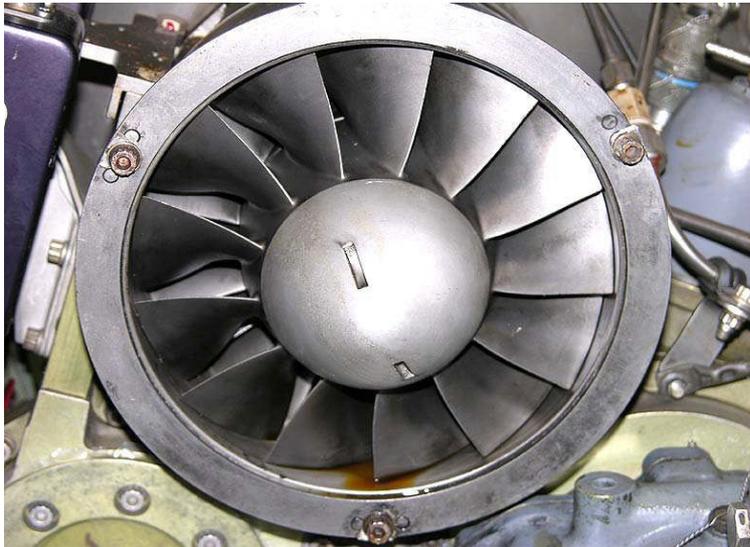
- All pipes appeared to be correctly installed and properly tightened. The FCU N1/N2 drainpipe did however show some impact bending distortion.
- Inspection of the axial compressor confirmed no ingestion or impact damage to the blade surfaces and blade erosion appeared to be satisfactory at 1mm, see figure 18.

Axial compressor, no impact damage and erosion level satisfactory

Figure 18 Axial compressor, no impact damage and erosion level satisfactory.

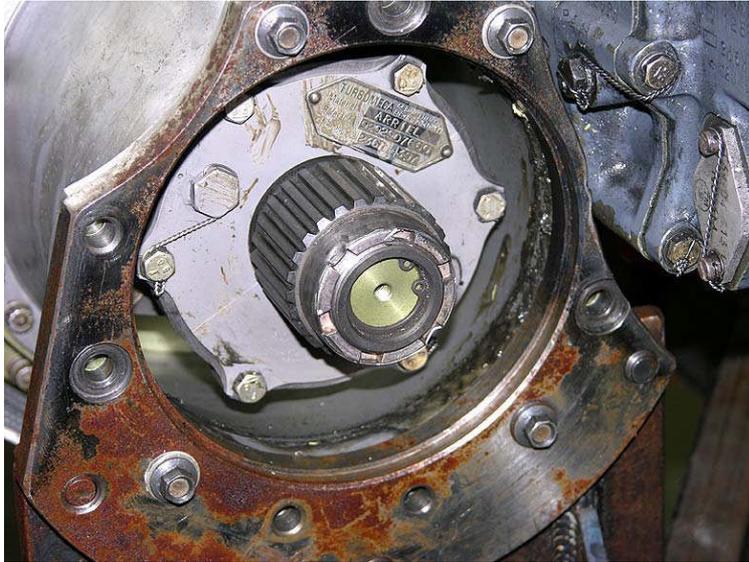
- Visual inspection of the main power drive (fig 19) and of the tail rotor drive (fig 20) showed both splined gear drive shafts to be free from any spline rupture or abnormal wear.

Main power drive spline in a serviceable condition

Figure 19 Main power drive spline in a serviceable condition

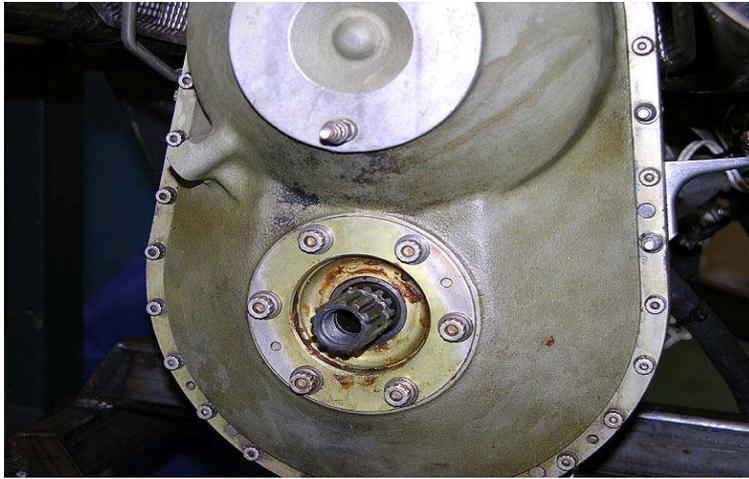
Tail rotor drive spline in a serviceable condition

Figure 20 Tail rotor drive spline in a serviceable condition

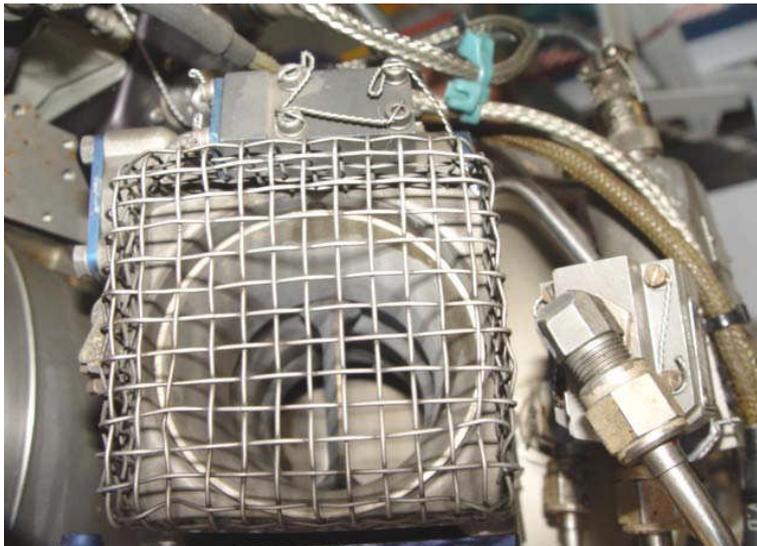
- Visual inspection of the compressor bleed valve confirmed the butterfly valve to be in the "OPEN" position, see figure 21. It was however noticed that the P3 air supply union pipe connection was loose and it required approximately 10° rotation of the torque wrench to obtain a satisfactory torque tightening value, see figure 22.

Figure 21: Compressor bleed valve in the open position.

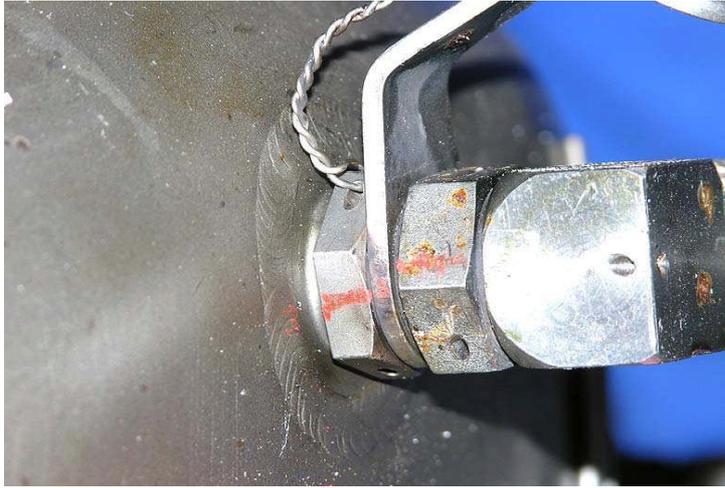
- Rig testing of the compressor bleed valve disclosed the item to operate within the test specification, even when the P2 pipe securing union was slightly loosened as was found on the engine, refer paragraph 1.4.

Figure 22: P3 air supply union to bleed valve

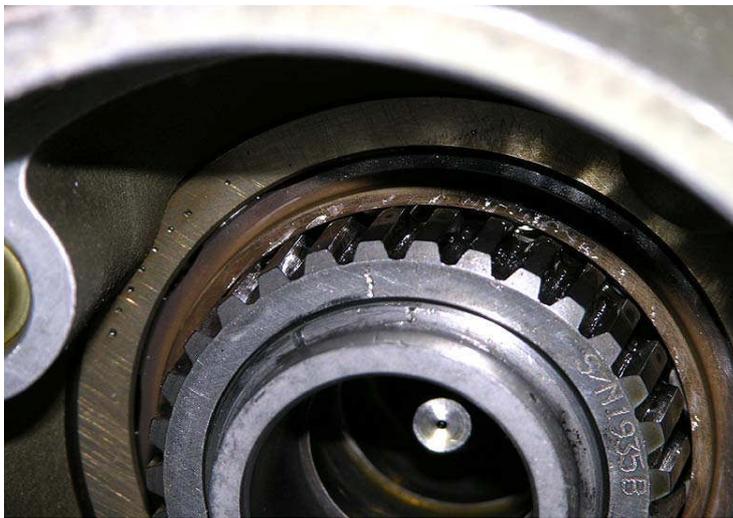
1.16.1.1 During the investigation, no evidence could be found to suspect that the engine was not capable of delivering the design power. During the strip-down inspection of the engine, it was noticed that the drive gear-securing nut had a rotational displacement of approximately 3mm. This phenomenon is normally experienced during main rotor strike/impact while the engine is producing power.

- The module was free to rotate and the gears and gear securing nuts all appeared to be in a satisfactory mechanical condition and properly secured.
- The drive gear and securing nut disclosed a rotational displacement of the index marks of approximately 3mm, see figure 23. This displacement of the securing nut is indicative of the engine having produced power at the time of the main rotor accident impact.

- Examination of the core engine did not disclose any evidence to suspect that the engine was not capable to deliver the designed power. The observed drive gear and securing nut rotational displacement (fig 23) is a phenomenon normally associated with main rotor blade strike/impact while the engine is producing power.

Figure 23: Drive gear securing nut rotational displacement of index marks

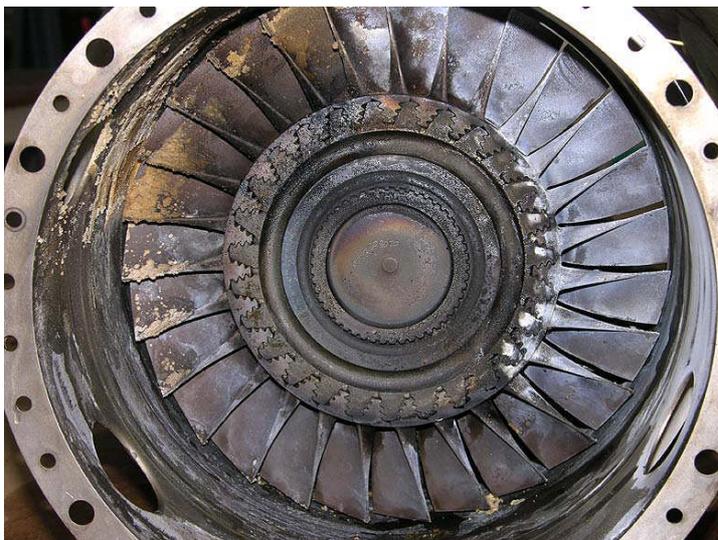
- The power turbine was free to rotate without any evidence on the turbine blade profiles to suspect abnormal operating temperature. By reference to figure 24 the fire extinguisher contaminated condition of the assembly can be seen.
- Removal of the power turbine nozzle did not show any deterioration or abnormal carbon build-up of the assembly. All pipes were found properly tightened and the oil-serviced items contained a level of oil wetness.

Figure 24: Power turbine contaminated with fire extinguisher powder

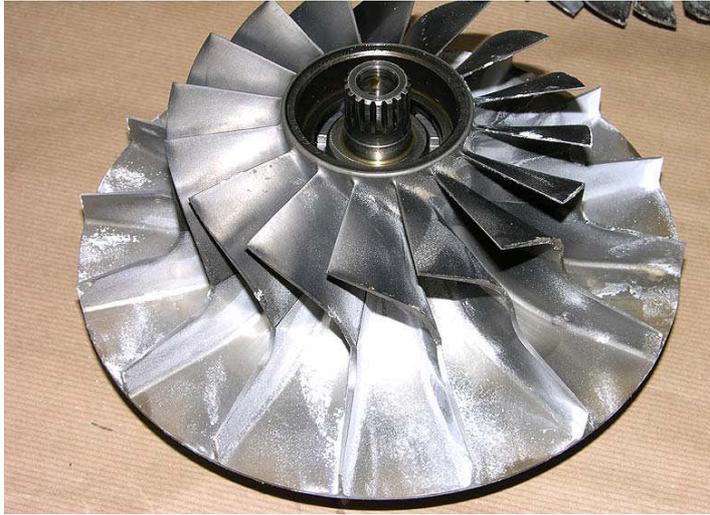
- The centrifugal compressor assembly was contaminated with fire extinguisher powder, but showed no pre or post impact damage, see figure 25.
- Slight rubbing was evident on the centrifugal casing at the bottom level, see figure 26.

Centrifugal compressor showing fire extinguisher powder

Figure 25: Centrifugal compressor showing fire extinguisher powder.

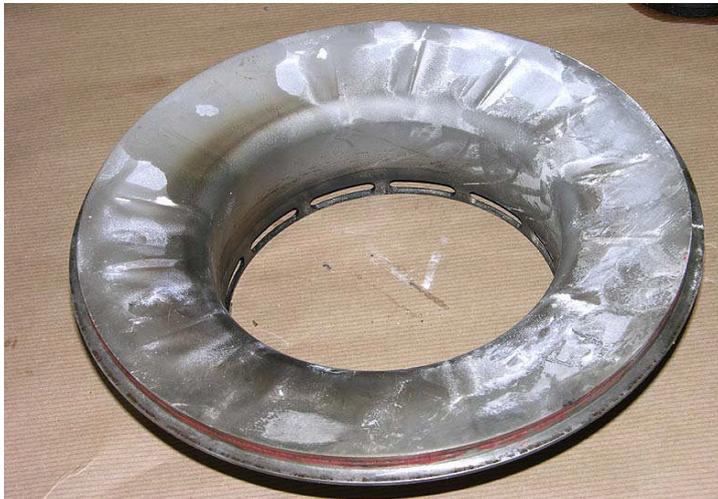
Centrifugal compressor casing showing slight rubbing

Figure 26: Centrifugal compressor casing showing slight rubbing

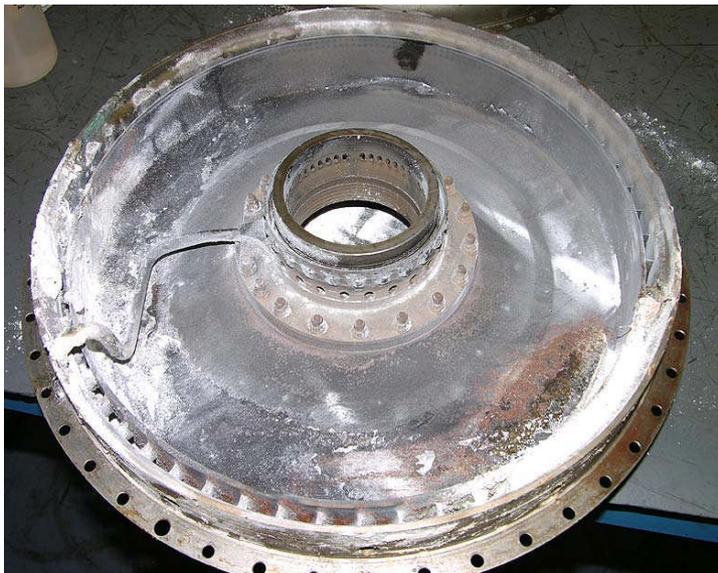
- The centrifugal compressor diffuser and injection manifold assembly did not disclosed any anomaly that could be related to the reported power loss, and only showed some fire extinguisher powder contamination, see figure 27.

Centrifugal compressor diffuser and injection manifold assembly

Figure 27: Centrifugal compressor diffuser and injection manifold assembly.

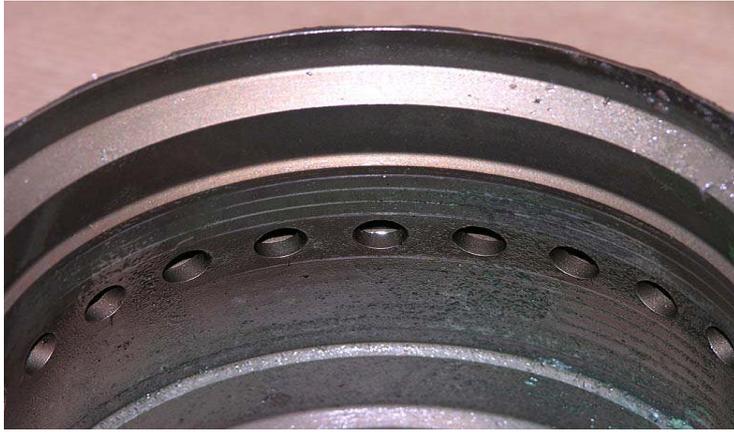
- Slight rotational contact was visible on the turbine shaft labyrinth seal bottom, see figure 28. All curvic-couplings appeared to be in a satisfactory condition without abnormal wear evidence on the couplings.

Figure 28 Turbine shaft labyrinth showing slight rubbing at the bottom plane

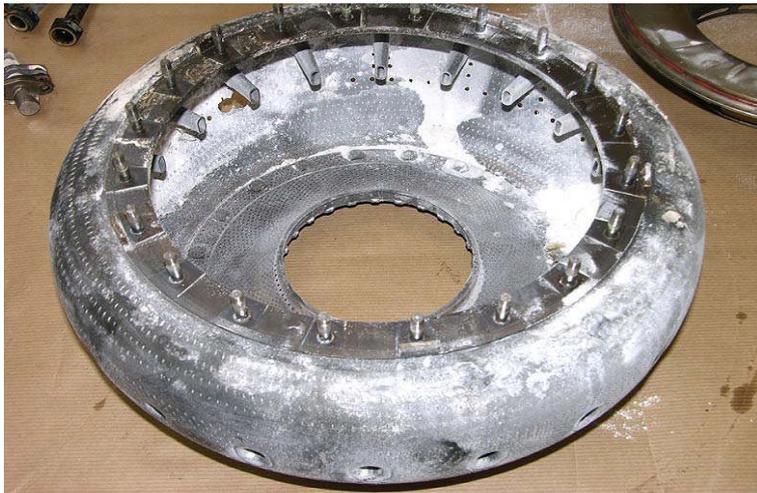
- The combustion chamber appeared generally in a serviceable condition without heat erosion degradation being evident on the dilution tubes or any other part. The assembly was severely contaminated with fire extinguisher powder, see figure 29.

Figure 29: Combustion chamber

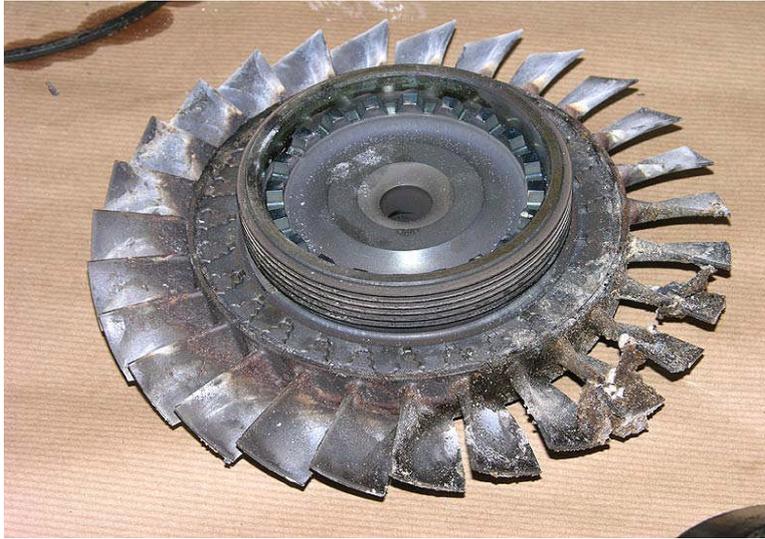
Figure 31: Gas generator turbine showing fire extinguisher powder contamination

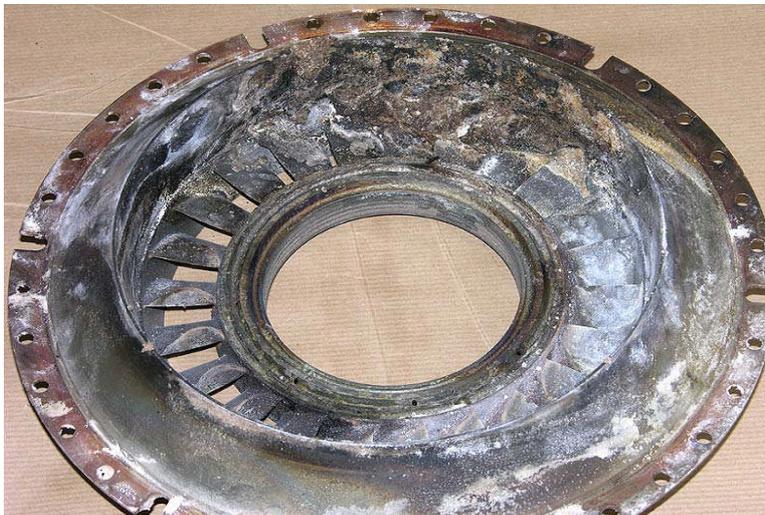
Figure 32: Axial compressor diffuser, contaminated, but free from operational anomalies.

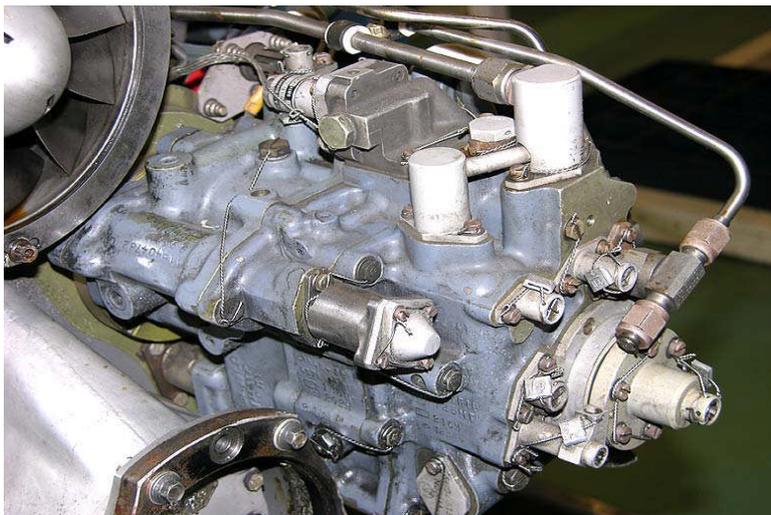
- Although testing of the fuel control unit showed that the FCU NG maximum controlling rpm to be 4 720 as opposed to the rig requirement of 4786 ± 3 rpm, it was calculated to be sufficient to permit maximum engine take off power according to the aircraft weight and environmental conditions as reported. The adjustment of the temperature compensator that controls this rpm, may be performed by the operator within the range not exceeding $+90^\circ$ to -90° from the manufacturer's original rig setting. During the investigation rig testing the required NG maximum rpm could be achieved with a 90° clockwise turn of the adjuster, indicating satisfactory unit response to adjustment. Figure 33 shows receipt inspection of the FCU, depicting locking of the temperature compensator adjuster cover without the manufacturer's seal, suggesting some operator intervention during service operation, which is permitted in accordance with the Maintenance Manual Chapter 73-21-00. It is however a point of concern that no log card or history adjustment for the FCU was available for inspection during the investigation.

Figure 33: FCU showing the temperature compensator adjuster cover without the manufacturers Seal.
