AIRCRAFT ACCIDENT REPORT AND EXECUTIVE SUMMARY

Reference:	CA18/2/3/8500	
Aircraft Registration	ZS-SCV	Date of Accident	24 May 2008	Time of Accident	1330Z	
Type of Aircraft	Robinson R44 Raven II		Type of Operation	Private		
Pilot-in-command Licence Type		Private pilot	Age	52	Licence Valid	Yes
Pilot-in-command Flying Experience		Total Flying Hours	1471,6		Hours on Type	71,6
Last point of departure		Pietersburg Civil Aerodrome(FAPI)				
Next point of intended landing		Pietersburg Civil Aerodrome(FAPI)				
Location of the accident site with reference to easily defined geographical points (GPS readings if possible)						
Pietersburg Civil Aerodrome S23°55' 54.79" E29°28 ' 22.25"						
Meteorological Information		Surface wind 360/05 knots; temperature 23°C; visibility: CAVOK				
Number of people on board	1 + 3	No. of people injured	4	No. of people killed	0	
Synopsis						
<p>The pilot, with 3 passengers on board, was conducting pleasure rides (flips) near the SAPS hangar on the Annual Polokwane Fly-In day. The helicopter had 40 US gallons of usable fuel prior to take-off (100 LL Avgas).</p> <p>The helicopter came into a hover on a left crosswind near the SAPS hangar and turned into wind

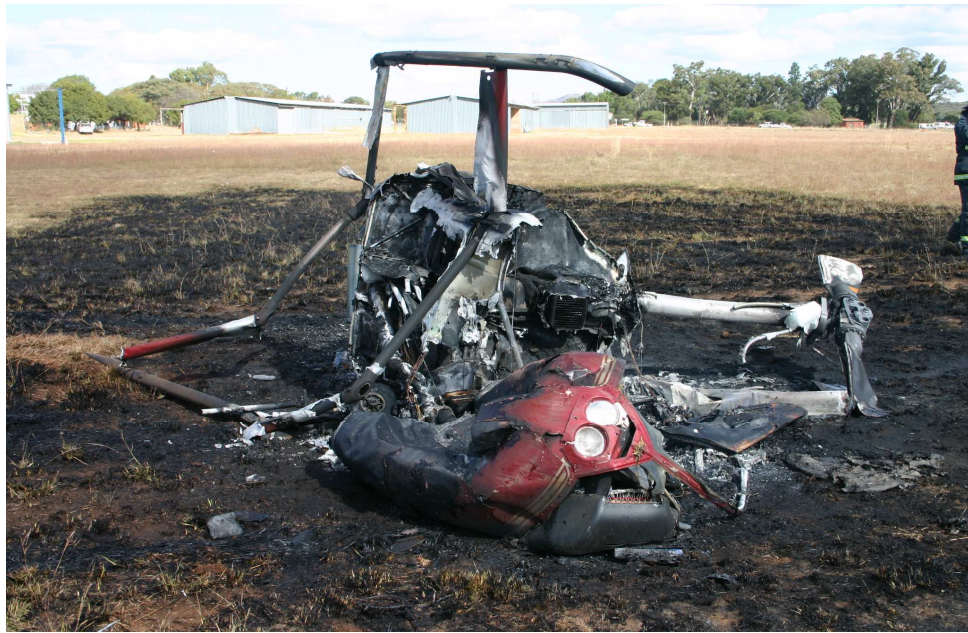
1.3.1 The helicopter was destroyed by post-impact fire.

Figure 2: *Helicopter destroyed by fire*

1.14.1 After ground impact, the helicopter caught fire and the helicopter was destroyed.

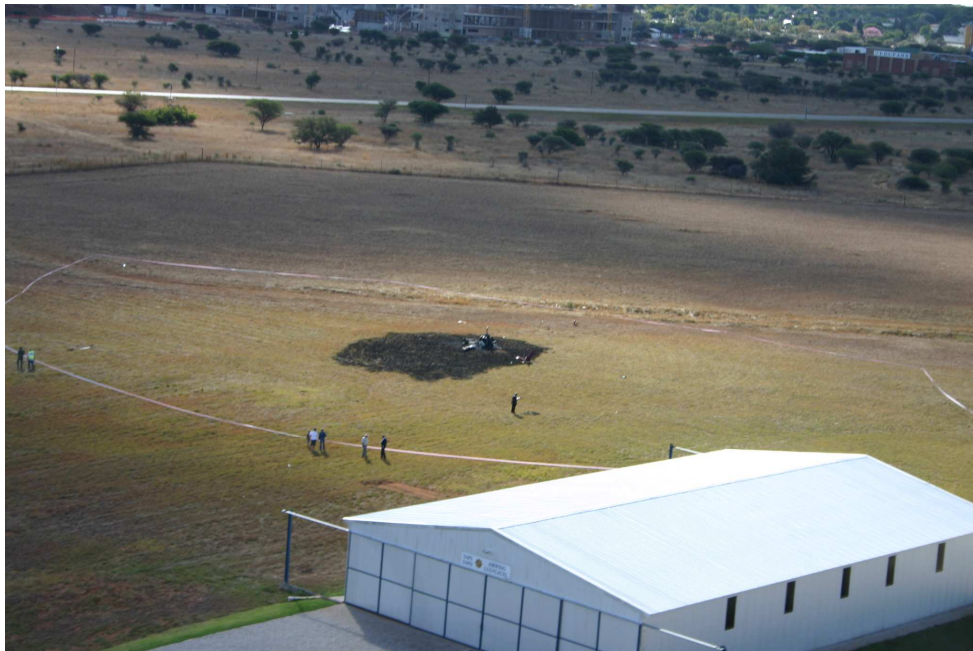
1.4.1 A grass area around the wreckage within a diameter of approximately 10 metres was burnt following the accident.

Figure 3: *Burnt area of approximately 10 m diameter*

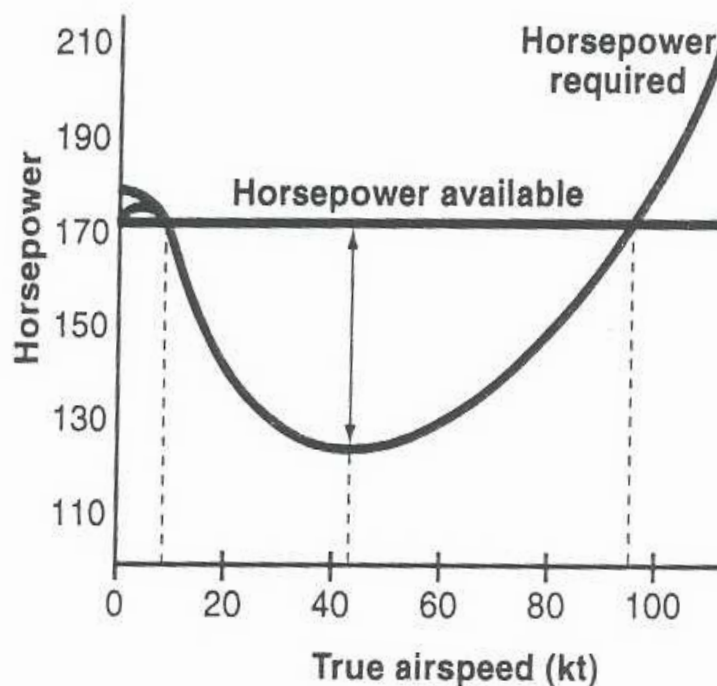
- 1.18.1 The graph below shows the curve for the power available and power required. The horsepower available is the power available for the aircraft for a specific day, altitude and temperature. The horsepower required is the power required during normal operations of the aircraft and can be changed by manipulating the flight controls, e.g. raising the collective.

Figure4: Power available vs. power required

- 1.16.2 If the horsepower required exceeds the horsepower available, a descent follows. The immediate reaction would be to pull up the collective to counteract the descent; the main rotor rpm will start to decrease because the power required has exceeded the power available. The correct technique would be to lower the collective and gain more speed or transition.
- 1.16.3 The pilot may use a wrong technique during take-off which can demand more power. Excessive manoeuvring of the aircraft can also result in a power demand. Take-offs are preceded by a hover. Since the power required to hover is more than that required during forward flight, special care is required for operations in high altitude/high gross weight situations where power use is relatively high.

- 2.6 Referring to paragraph 1.16.2, if the horsepower required exceeds the horsepower available, a descent follows. The immediate reaction would be to pull up the collective to counteract the descent; the main rotor rpm will then decrease because the power required has exceeded the power available. The correct technique would be to lower the collective and gain more speed or transition.
