# AIRCRAFT ACCIDENT REPORT AND EXECUTIVE SUMMARY

Reference:	CA18/2/3/8501	
<b>Aircraft Registration</b>	ZS-LBP	<b>Date of Accident</b>	26 May 2008		<b>Time of Accident</b>	0730Z
<b>Type of Aircraft</b>	Cessna R182 (Aeroplane)		<b>Type of Operation</b>		Training	
<b>Pilot-in-command Licence Type</b>		Commercial Pilot	<b>Age</b>	63	<b>Licence Valid</b>	Yes
<b>Pilot-in-command Flying Experience</b>		Total Flying Hours	4300		Hours on Type	150
<b>Last point of departure</b>		Vereeniging Aerodrome (FAVV) – Gauteng Province				
<b>Next point of intended landing</b>		Rustenburg Aerodrome ( FARG) – North West Province				
<b>Location of the accident site with reference to easily defined geographical points (GPS readings if possible)</b>						
Runway 16 at Rustenburg Aerodrome (GPS position: South 25°38.564 East 027° 28.226)						
<b>Meteorological Information</b>		Surface wind: 220-240°/5-10knots, Temperature:18°C, Cloud cover: None				
<b>Number of people on board</b>	1+1	<b>No. of people injured</b>	1	<b>No. of people killed</b>	0

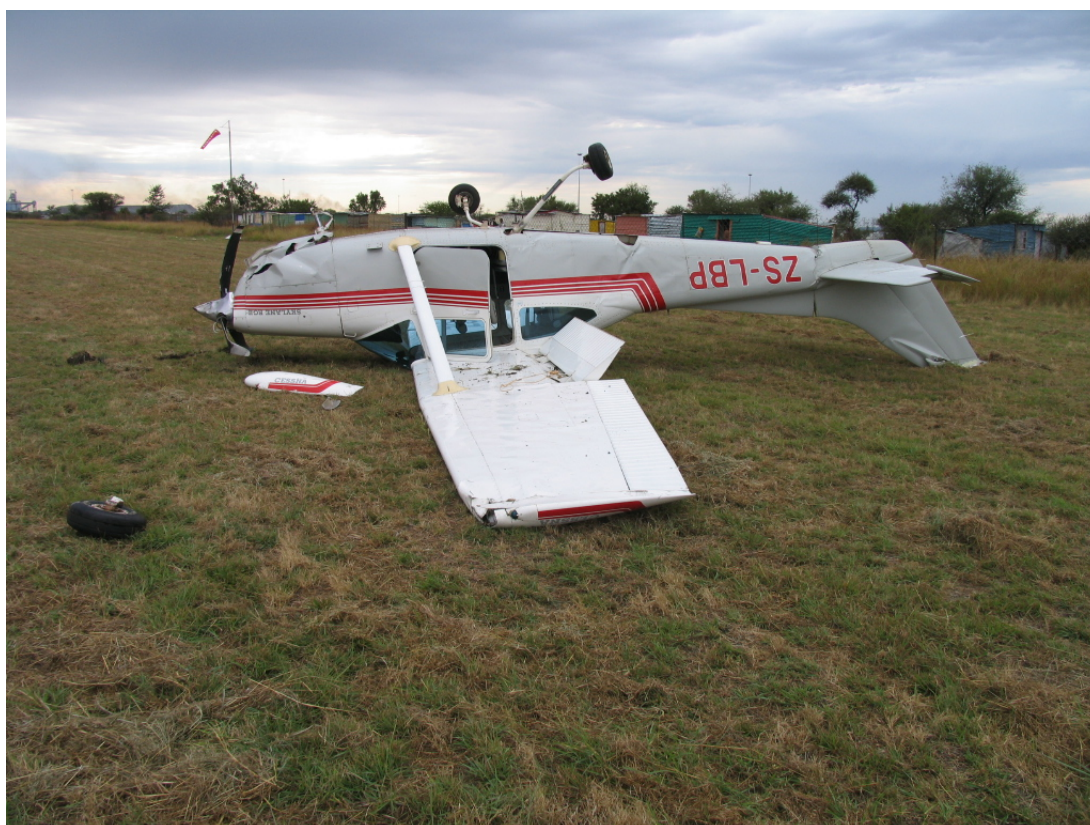
1.12.1 On touchdown on Runway 16 the aircraft bounced and stalled. The left wing dropped and impacted the grass surface to the left of Runway 16. The aircraft nosed over and came to rest in an inverted attitude approximately 30 metres from the runway's edge.

1.12.2 The nose wheel of the aircraft broke off at the impact with the grass surface. The aircraft sustained damage to the landing gear, propeller, left wing, right wing, vertical stabilizer, rudder and fuselage. The nose wheel was located approximately 4 metres from the wreckage.

**Figure 1.** A view of the wreckage in an inverted attitude on the grass surface next to the runway.
