# AIRCRAFT ACCIDENT REPORT AND EXECUTIVE SUMMARY

| | | | | Reference: | CA18/2/3/8511 | |
| <b>Aircraft Registration</b> | <b>ZS-KIA</b> | <b>Date of Accident</b> | 28 June 2008 | | <b>Time of Accident</b> | 1530Z |
| <b>Type of Aircraft</b> | Piper PA 28-236 | | <b>Type of Operation</b> | | Private | |

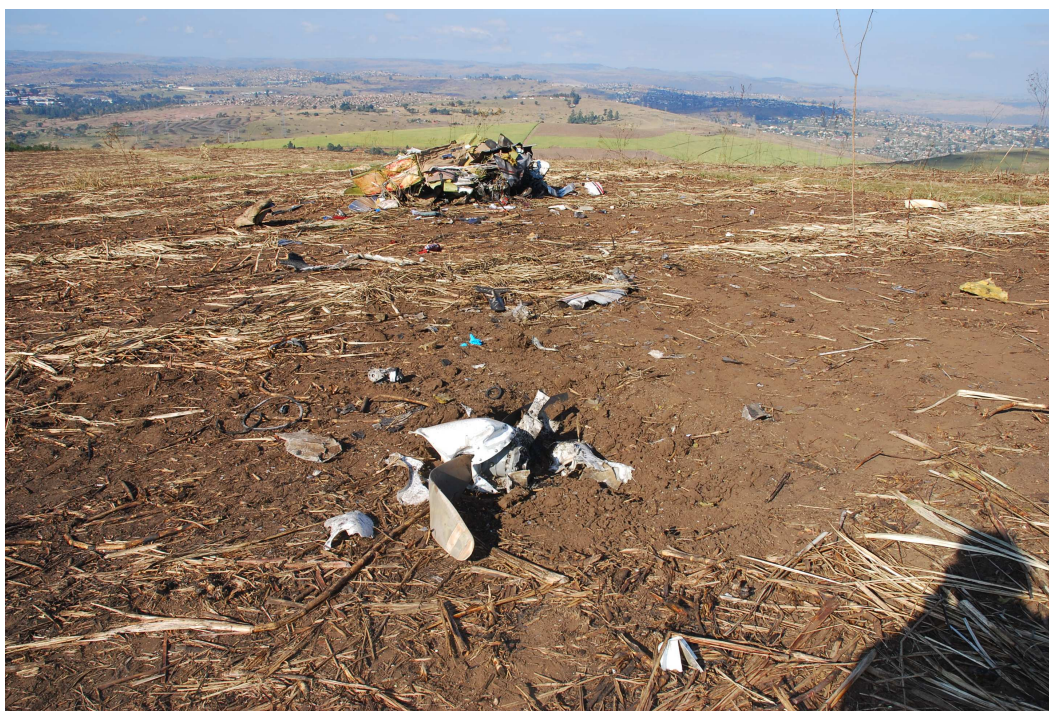
- 1.3.1 The aircraft was destroyed on impact with the ground.

**Photo 1:** Indicates the damages that the aircraft sustained.

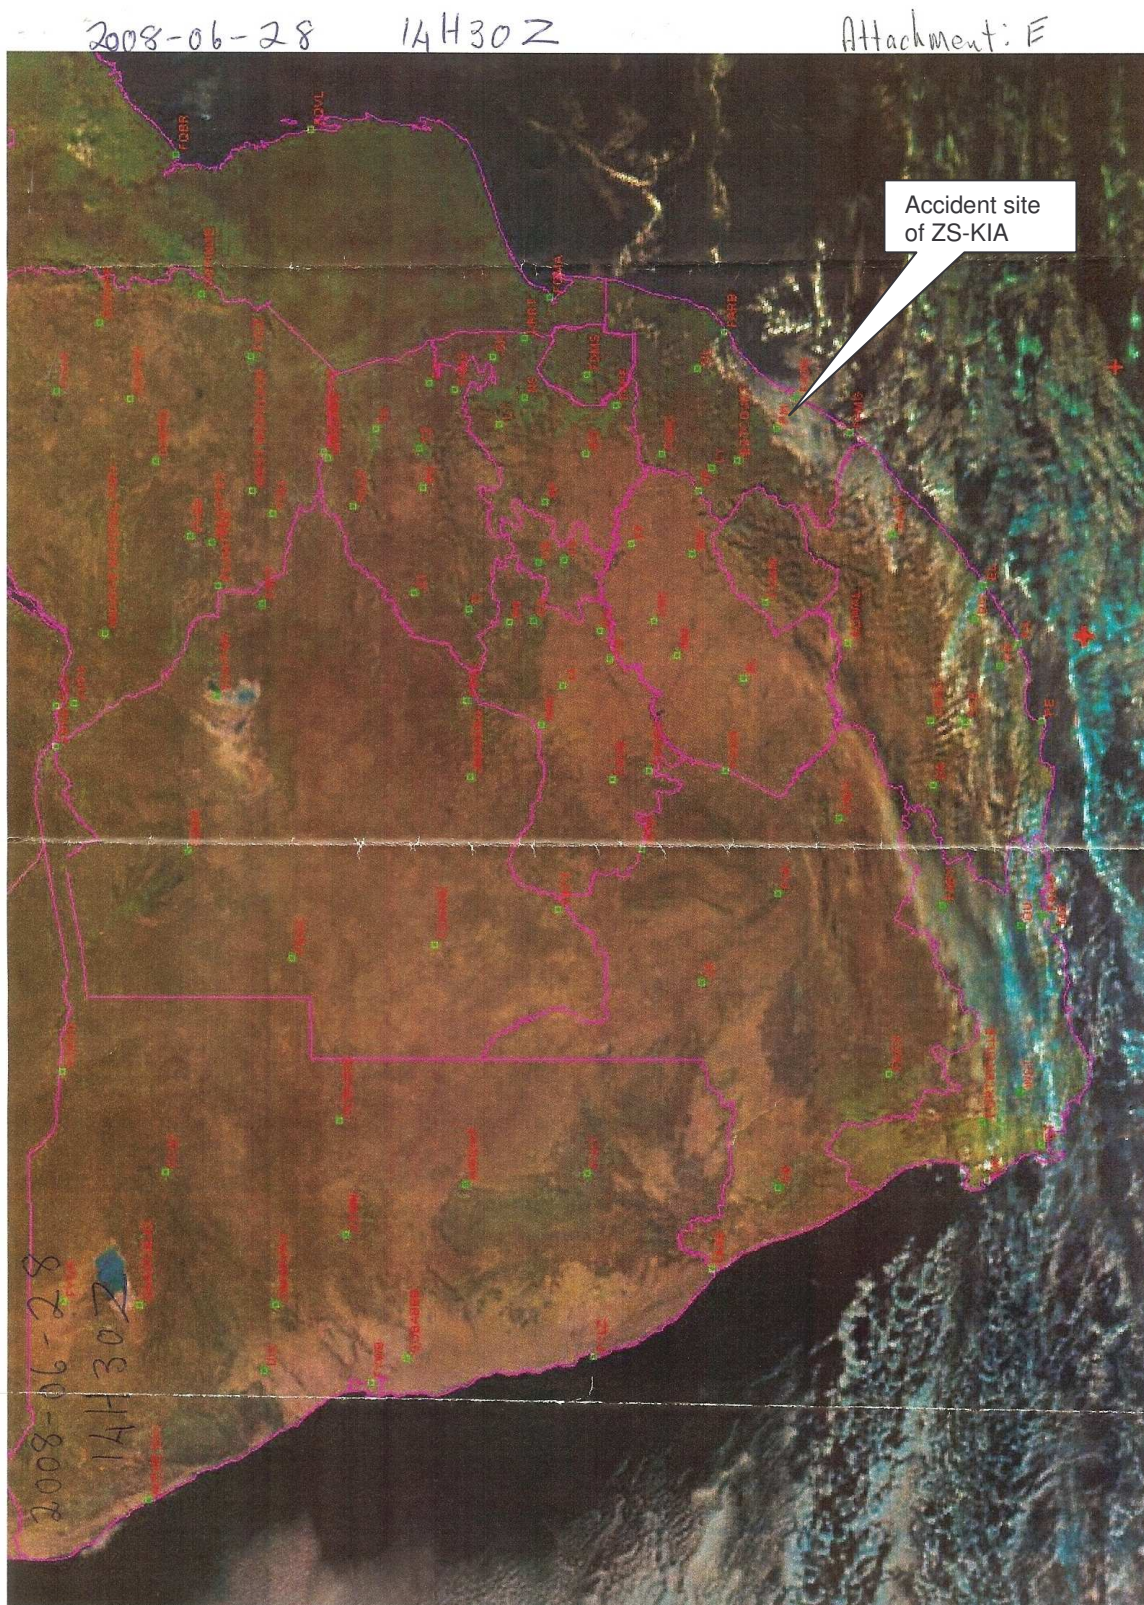
The 14h30Z satellite image shows cloudy conditions in the Hammarsdale area.

Temperature: 13 °C  
Dew Point: 10 °C  
Wind Direction: 130 °TN 12 Knots  
Cloud covers: BKN cloud at 1500ft.  
Visibility 5 to 10 km

**Photo 2:** Satellite image indicating the weather conditions at the time of the accident.

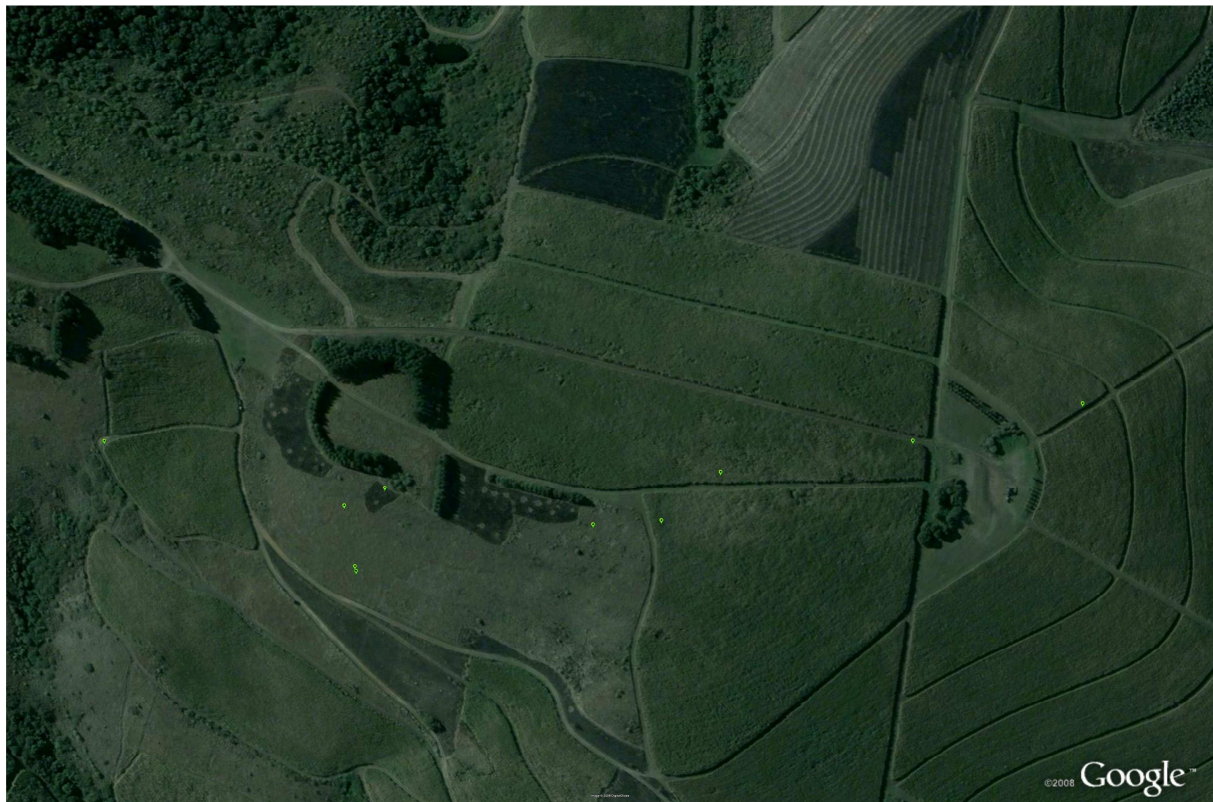
1.12.1 The main wreckage of the aircraft was found in a burnt sugar cane field, facing in the direction of 196°. The debris was scattered over an area of approximately 730 metres in length. The aircraft was found broken up into 10 major sections.

1.12.2 These sections consisted of the main wreckage, right-hand wing inner section, whole left-hand wing, a fibreglass section of the aircraft, right-hand wing outer section, 3 pieces of the elevator and a piece of the inboard left-hand wing aileron.

- 1.12.7 The engine examination revealed no pre-impact abnormalities that could have indicated a power loss.
- 1.12.8 The left-hand wing inner section was found inverted 130.4 metres from the main wreckage. The right-hand wing was found inverted 300 metres from the main wreckage. A piece of unidentifiable fibre glass was found 320.9 metres from the main wreckage. A part of the stabilator was found 377.4 metres away from the main wreckage. Another part of the stabilator was found 432.6 metres from the main wreckage. Again another part of the stabilator was found 488.3 metres from the main wreckage. The outboard section of the left-hand wing was found inverted 608.2 metres from the main wreckage. A piece of the inboard left-hand wing aileron was found approximately 730 metres from the main wreckage.

**Photo 3:** The green dots indicate the major sections of the aircraft.

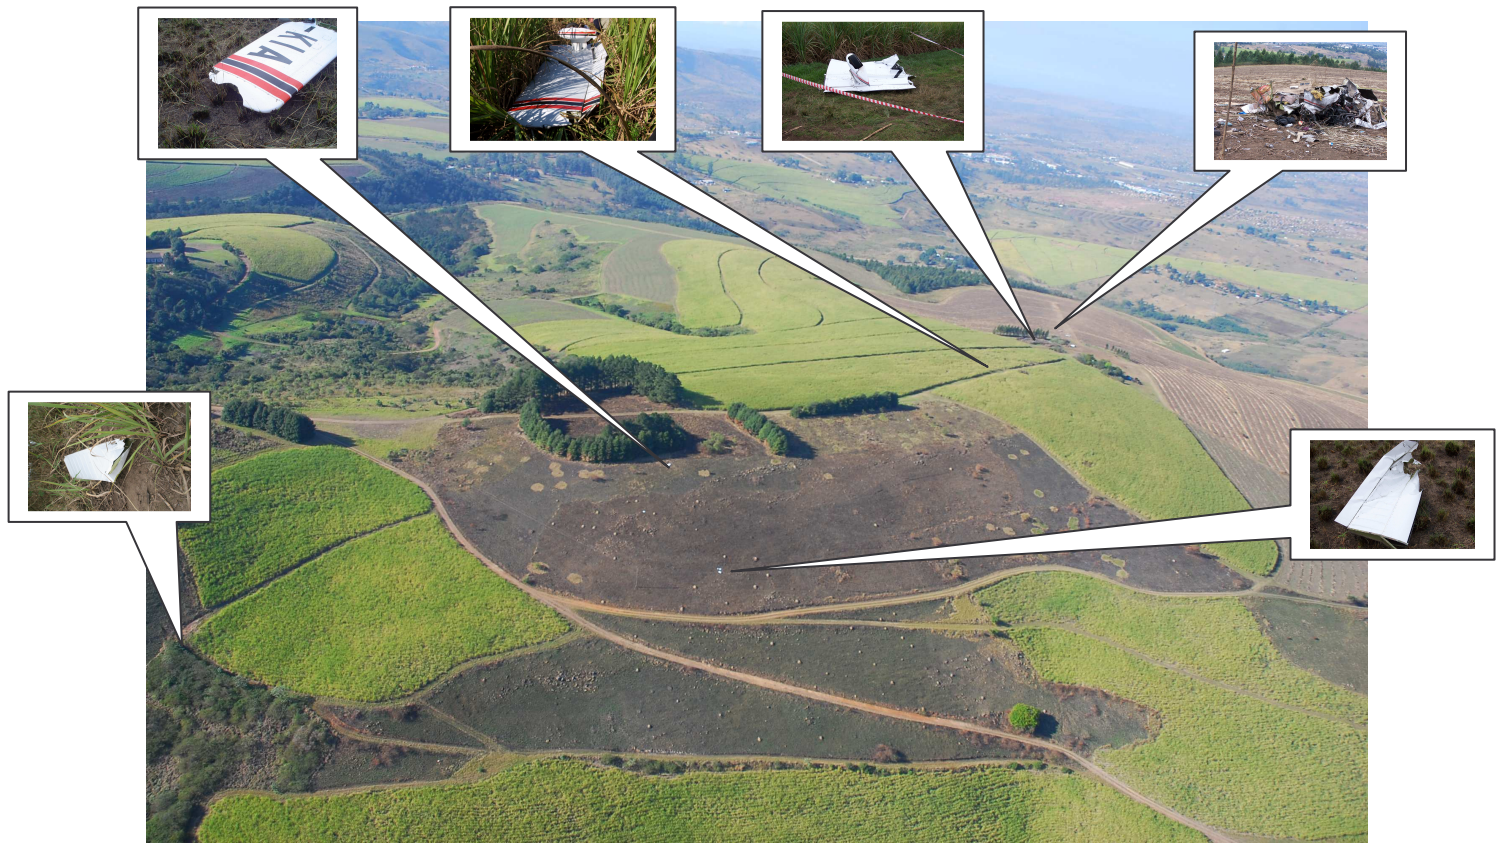
**Photo 4:** Aerial view of the accident site.
