AIRCRAFT ACCIDENT REPORT AND EXECUTIVE SUMMARY

Reference:	CA18/2/3/8522	
Aircraft Registration	ZS-PFN	Date of Accident	26 July 2008		Time of Accident	0700Z
Type of Aircraft	Beech craft Bonanza		Type of Operation		Private	
Pilot-in-command Licence Type		Private	Age	43	Licence Valid	Yes
Pilot-in-command Flying Experience		Total Flying Hours	267,22		Hours on Type	83,22
Last point of departure		Wonderboom Aerodrome (FAWB)				
Next point of intended landing		Thabazimbi Aerodrome				
Location of the accident site with reference to easily defined geographical points (GPS readings if possible)						
Limpopo Province; Thabazimbi aerodrome on Runway 25						
Meteorological Information		Surface wind: 90°/5 knots; Visibility: poor; Temperature: 10 °C and no clouds				
Number of people on board	1 + 1	No. of people injured	1	No. of people killed	0	
Synopsis						
<p>The pilot and the passenger were engaged on a private flight from Wonderboom Aerodrome to Thabazimbi Aerodrome. The pilot reported that he had departed from Wonderboom Aerodrome at approximately 0630Z under special VFR conditions.</p> <p>During touchdown, the pilot reported a loud scratching noise and the voice warning system came o

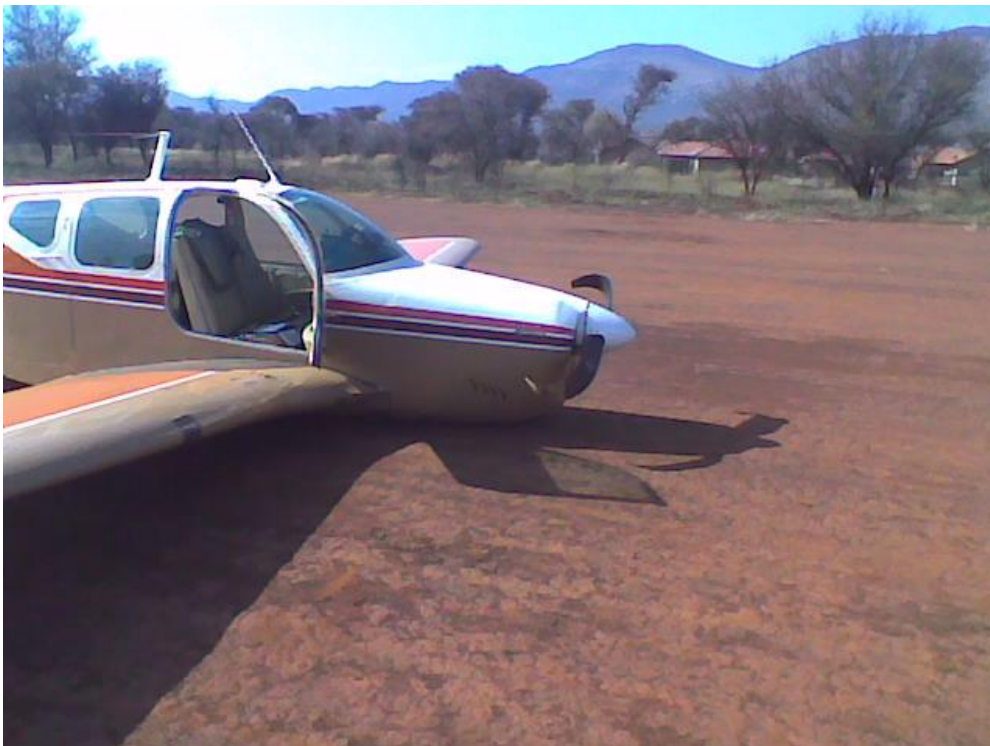
- 1.3.1 The aircraft sustained damage to the step, propeller blades, flaps and belly.

Picture 1, showing damage caused to aircraft after landing

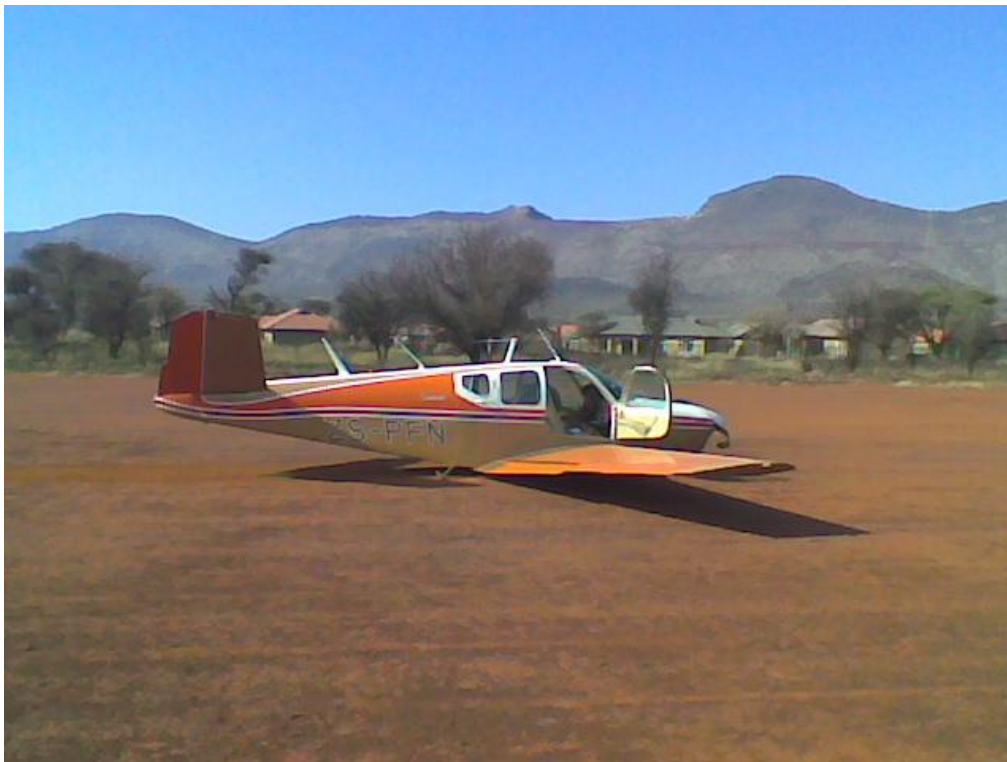
Picture 2

- 1.12.1 After the aircraft touched down, the aircraft skidded for approximately 130 metres in a straight line before coming to a standstill. There was substantial damage to the propeller and the bottom fuselage sustained minimum scraping damage.

1.12.2 The main wheel bay flaps were halfway open and the undercarriage circuit breaker had popped out.
