AIRCRAFT ACCIDENT REPORT AND EXECUTIVE SUMMARY

| | | | | Reference: | CA18/2/3/8550 | |
| Aircraft Registration | ZU-EHD | Date of Accident | 11 September 2008 | | Time of Accident | 1000Z |
| Type of Aircraft | Auto gyro MT 03 | | Type of Operation | | Private | |

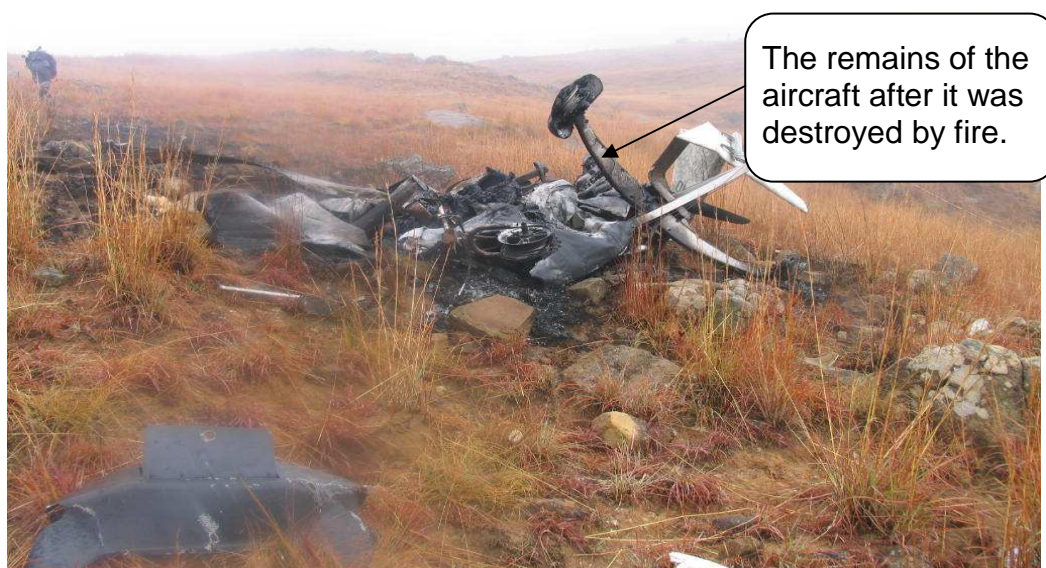
Figure 1: Damage to aircraft

- 1.3.1 The aircraft was destroyed.

1.14.1 A post-impact fire burnt out the aircraft completely.

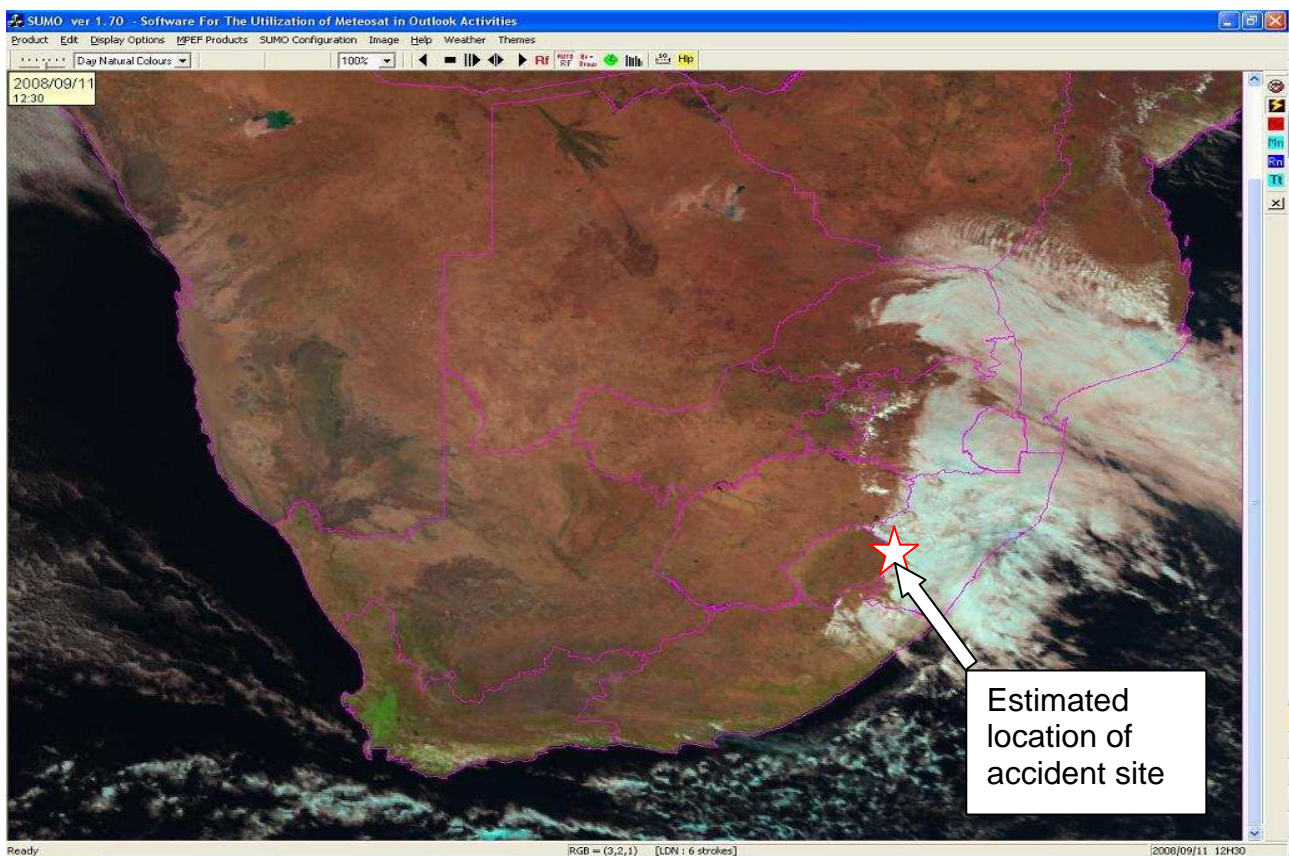
Figure 2: The weather conditions in the vicinity of the accident site at the time of the accident

Temperature: 11°C
Visibility: 8 km
Dew point: 8°C
Freezing: 1000 ft
QNH: 1027 mb

1.7.1.4 NB: No actual observations were present at the time and site of the accident. The information in 1.7.1.3 was derived using actual values from nearby areas.

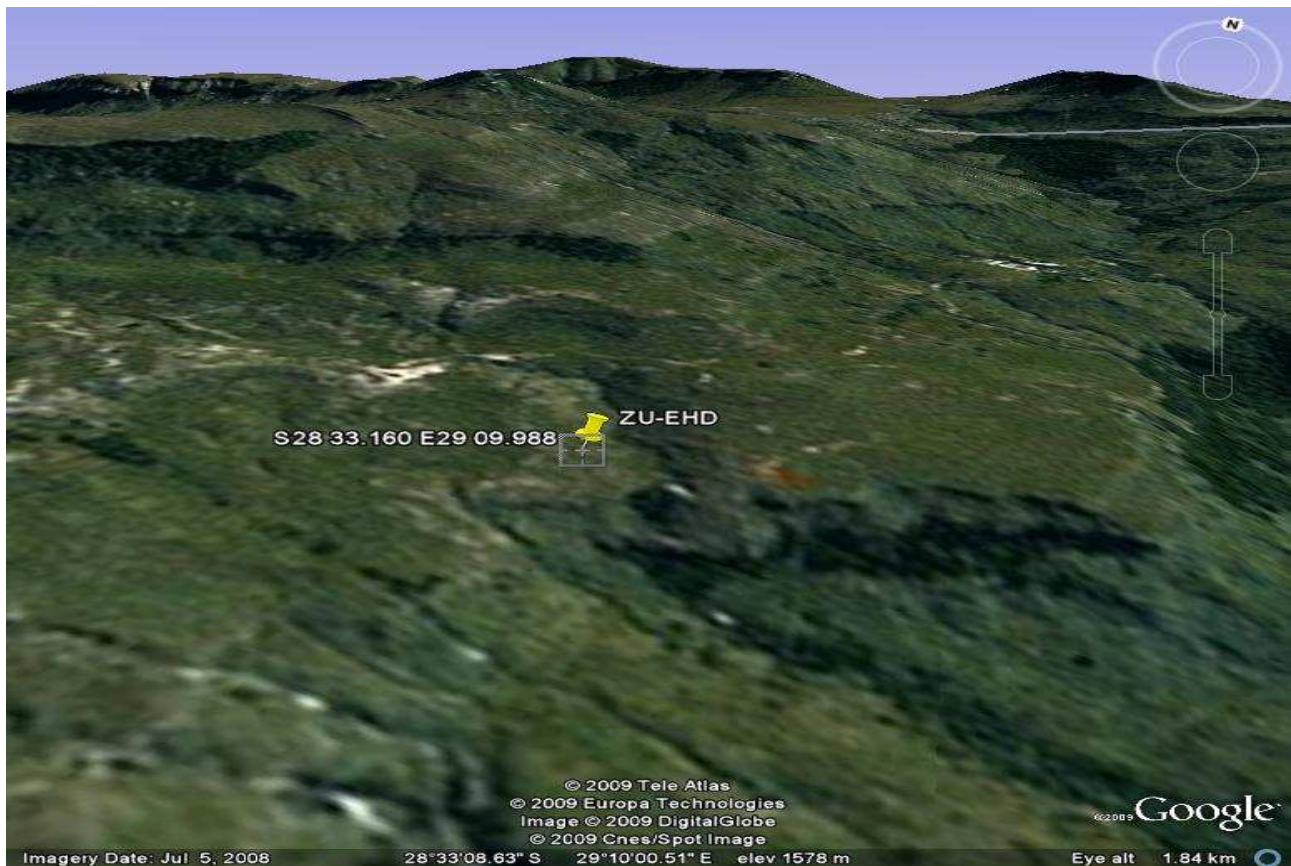
Figure 3: The terrain of the accident site

- 1.10.1 The accident did not occur at an aerodrome. It occurred on a mountainous, sloping, firm, rocky ground at a private farm (Scheepershoek) between Harrismith and Bergville. The GPS co-ordinates are S28° 33' 160" E029° 09' 988" at an elevation of 5 165 ft AMSL.

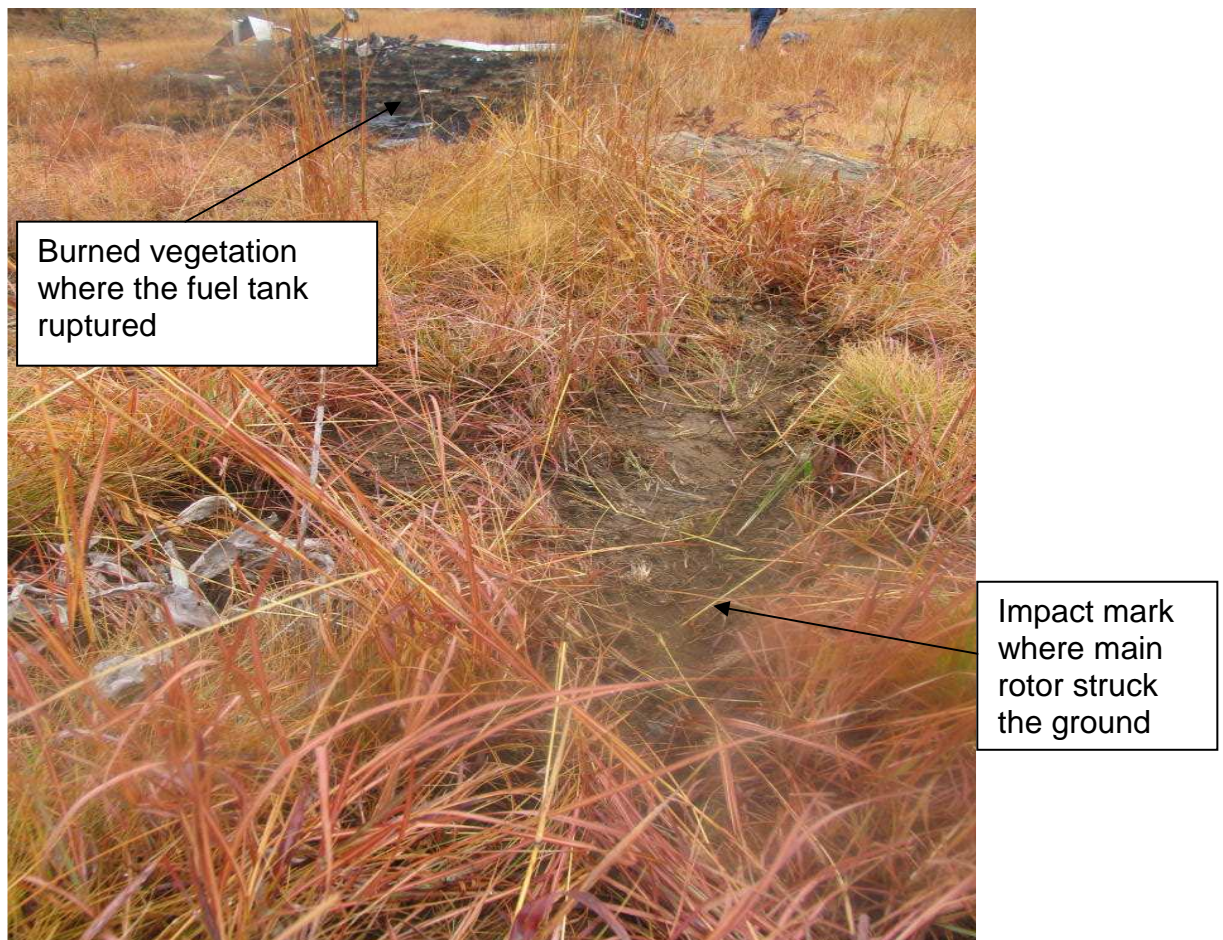
Figure 4: The accident impact marks

1.12.1 The aircraft was heading in a north-easterly direction (a heading of approximately 045°) when it impacted an outcropped rock. The aircraft then bounced for approximately 4 m, rolled towards the right and the rotor blade struck the ground. The tip of the rotor blade departed the aircraft and was flung towards the right side of the aircraft. The aircraft then impacted the ground, the fuel tank ruptured and the aircraft skidded for approximately 12 m before coming to rest in a heading of 180°.

1.12.3 The distances from the main wreckage to the points where the aircraft first impacted the rock, where the rotor blade struck the ground and where the aircraft impacted the ground and fuel tank ruptured were established to be approximately 20 m, 16 m and 12 m respectively.

1.12.4 Although the rotor blade tip was found 26 m from the main wreckage, most of the debris was found within a 15 m radius from the main wreckage.

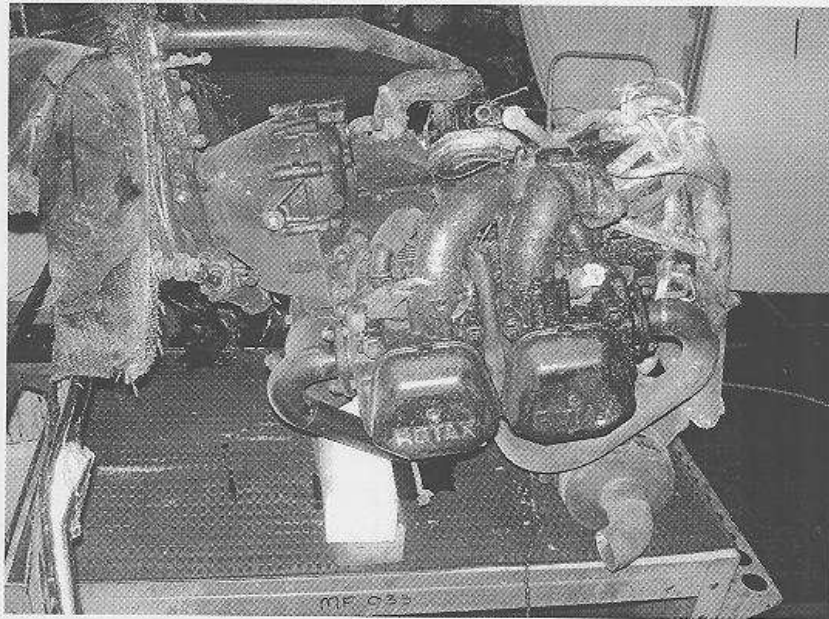
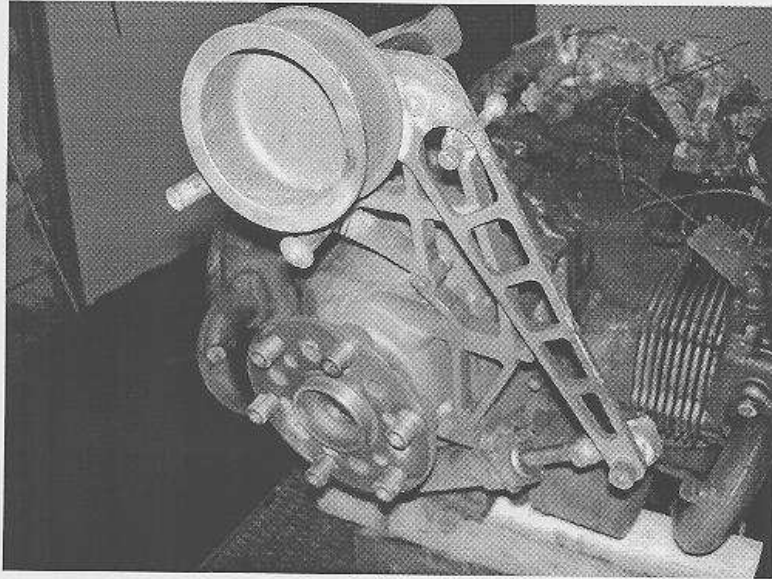
Visual external inspection on the following parts were conducted witch includes the following. See figure 1and 2

No damage to the external mechanical parts were detected which could have led to engine failure or engine stoppage.

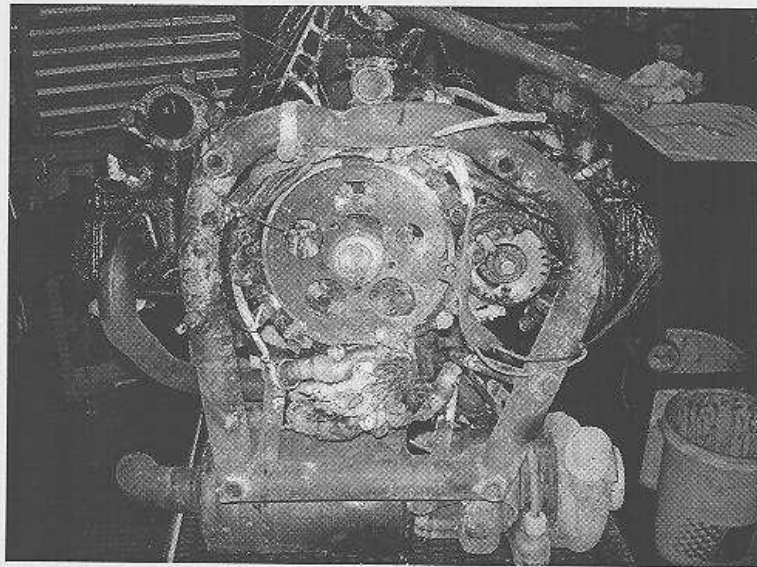
Figure 3 Ignition unite

Figure 3 – 6 are components which were totally destroyed during the fire and no comments could be stated.

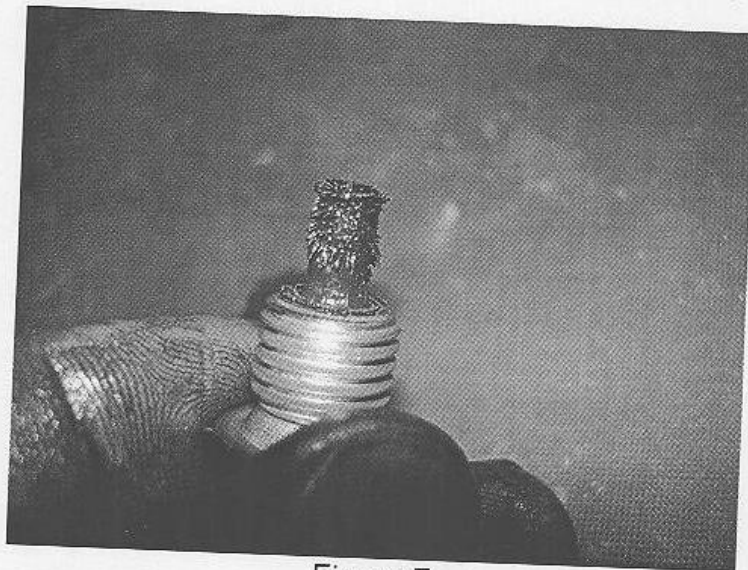
Figure 7

During the internal inspection, the magnetic plug was removed. The plug revealed no signs of excessive metal particle witch were normal due to engine wear. See Figure 7.

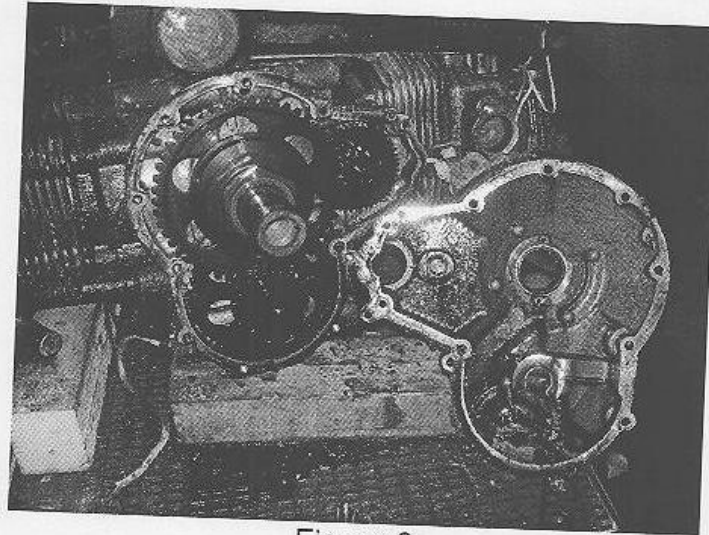
Figure 8

The ignition housing was disassembled and no mechanical failure was detected to the water pump drive gear sprag clouts and starter gear drive. See figure 8

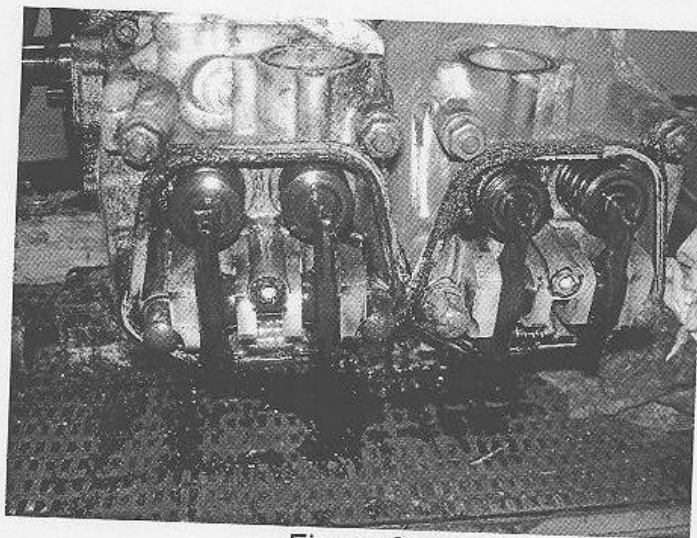
Figure 9

All valve covers was removed and no sign of mechanical failure were detected to all rocker arms, rocker arm shafts, valve push-rod assembly and valve springs. See figure 9

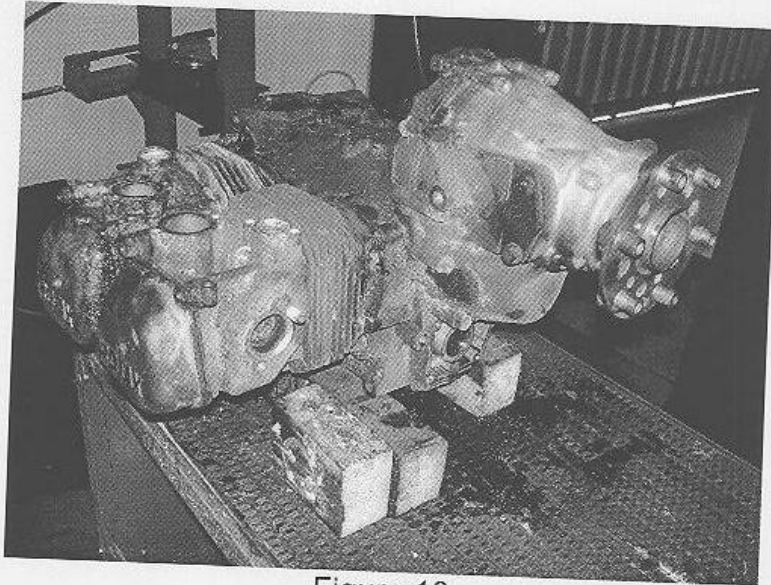
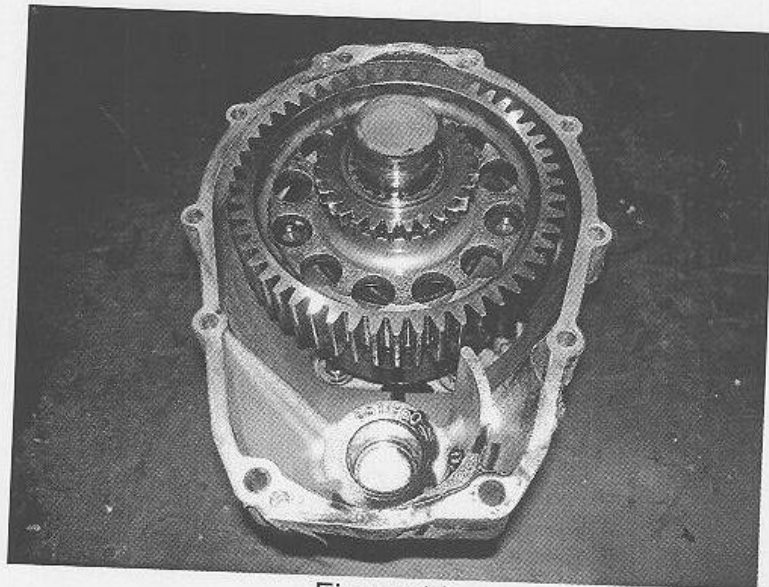
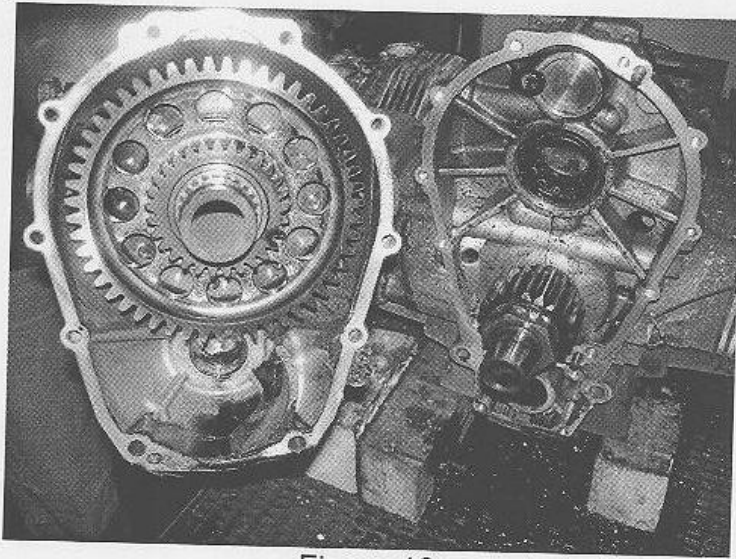
The gearbox was removed and it revealed no signs of any damage to the outer casing, gears, bearings, drive shafts and crank shaft drive gear. See figure 10 – 12

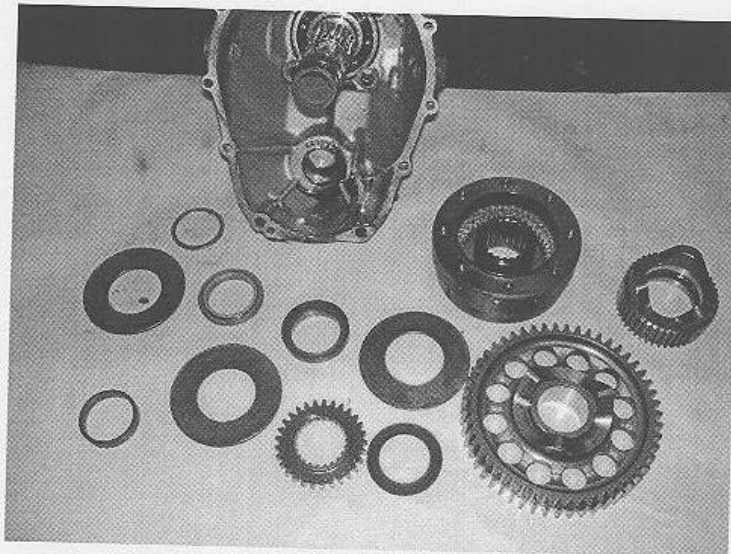
Figure 13

The gearbox was disassembled, and no damage to the gearbox components was detected. See figure 13 for the gear set assembly.

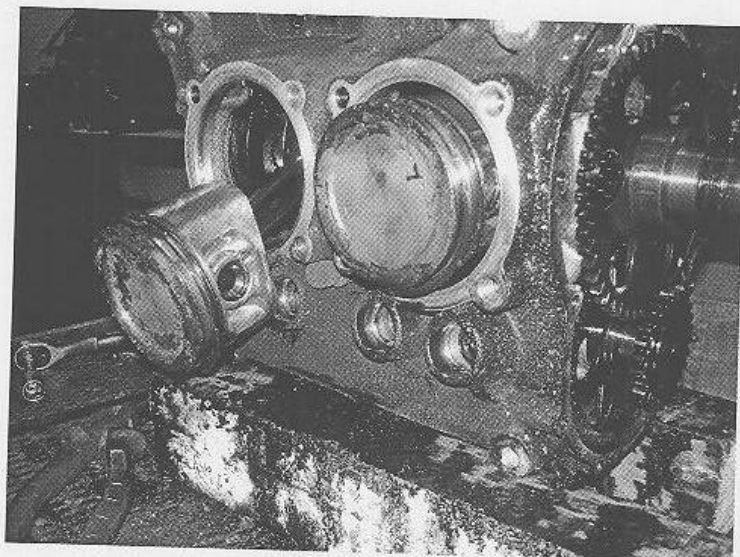
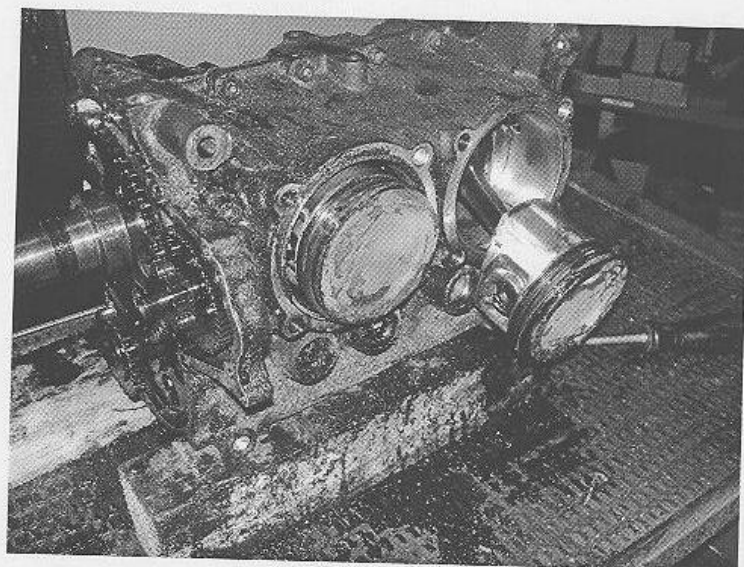
All four cylinder heads and sleeves were removed and no damage to the pistons, piston rings, and con-rods could be detected. See figure 14 – 15.

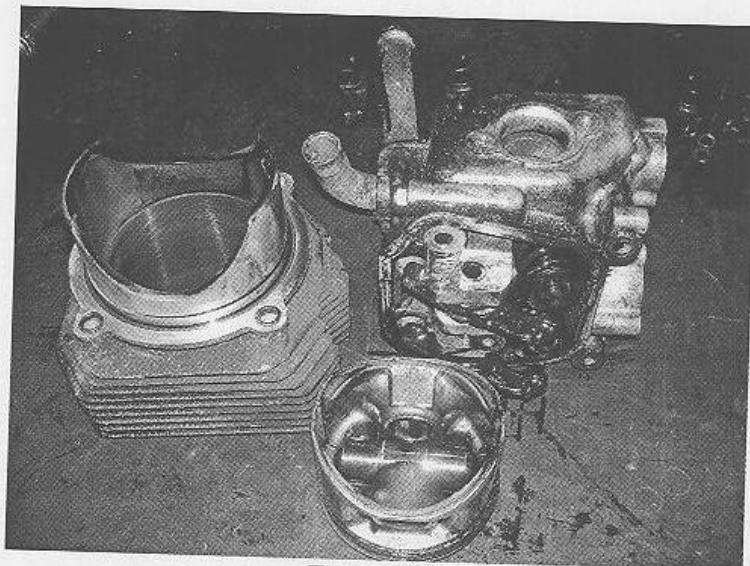
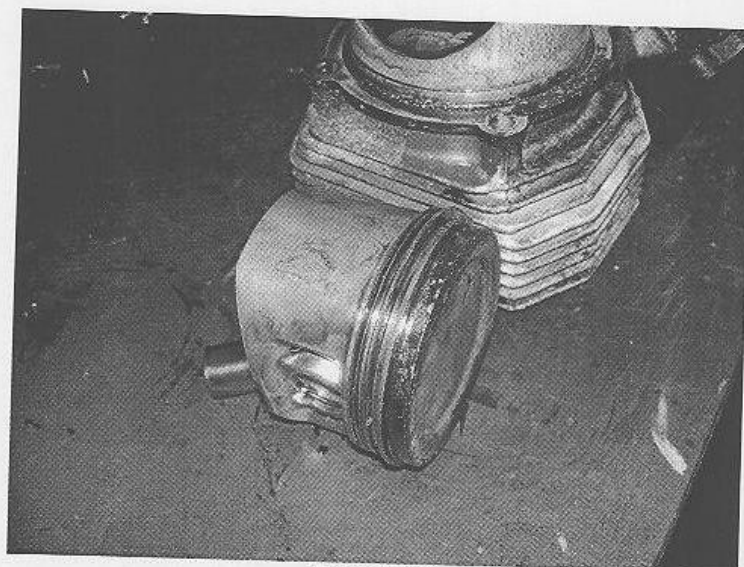
All four cylinders showed no signs of damage externally or internally. See figure 16 and 17.

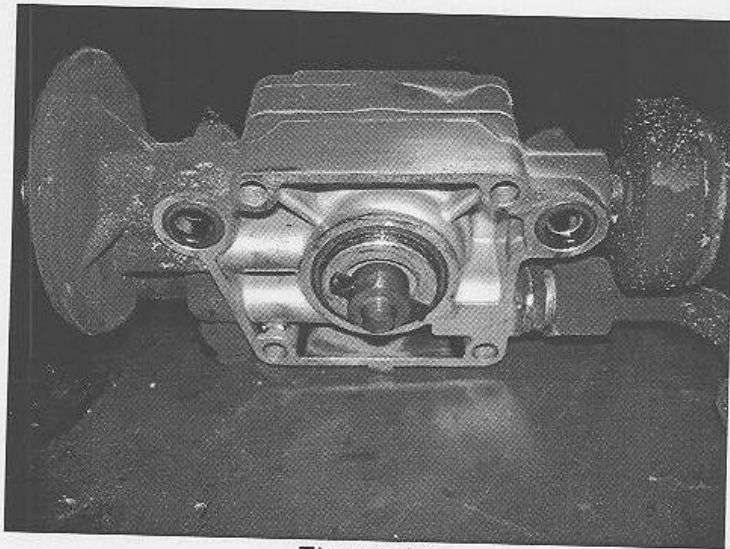
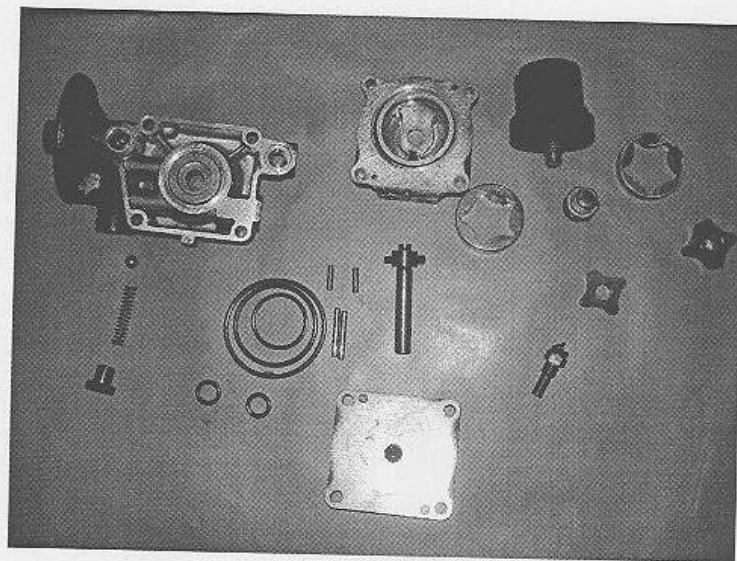
The oil pump was disassembled and all the internal mechanical parts were intact and no damage could be found. Figure 18 and 19 shows all the parts of the oil pump assembly.

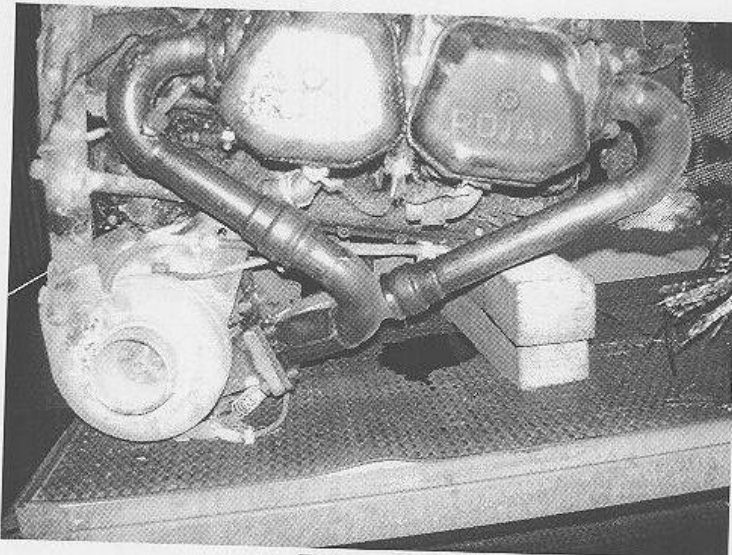
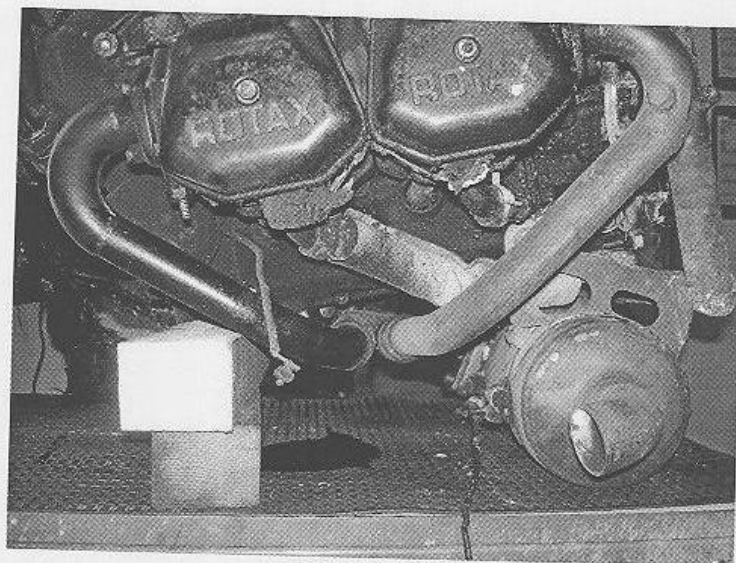
The exhaust system, turbo assembly and waist gate control was inspected and it revealed no signs of damage. See figure 20 and 21

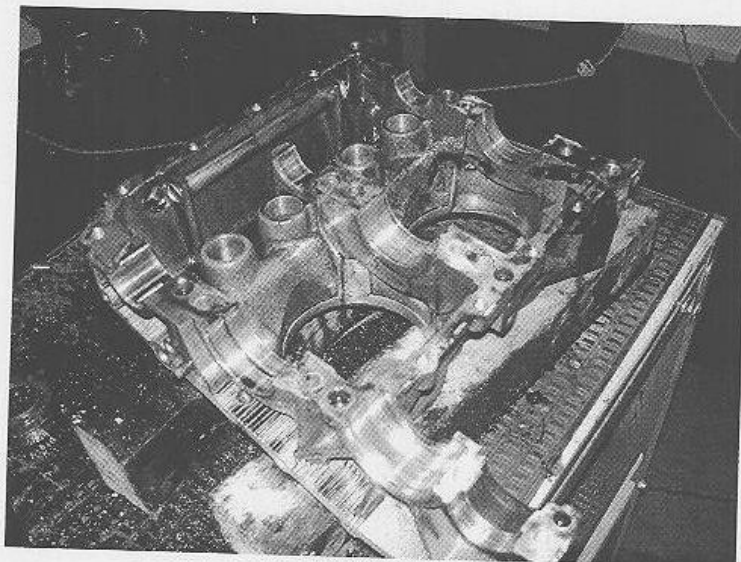
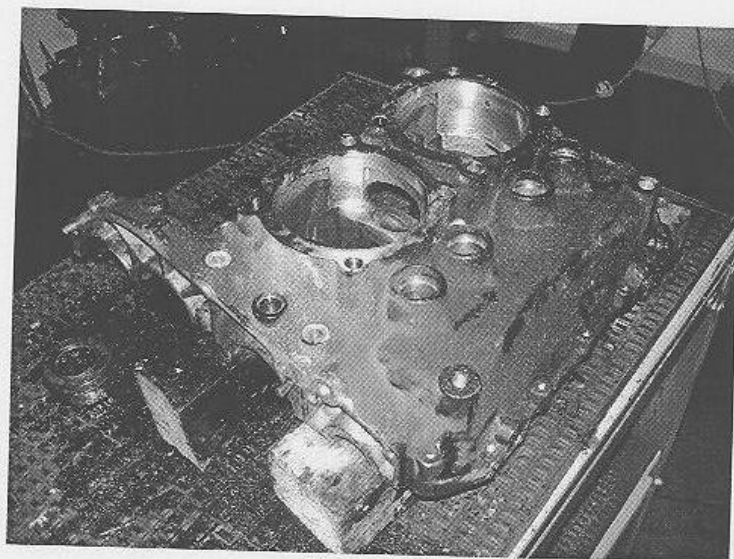
The two crank case halves showed no signs of cracks or damage internally or externally. All bearing services showed no signs of excessive wear. See figure 22 and 23

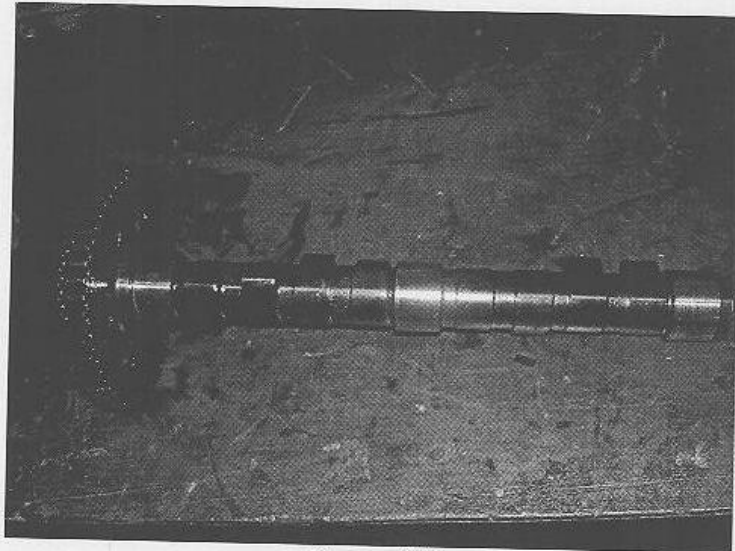
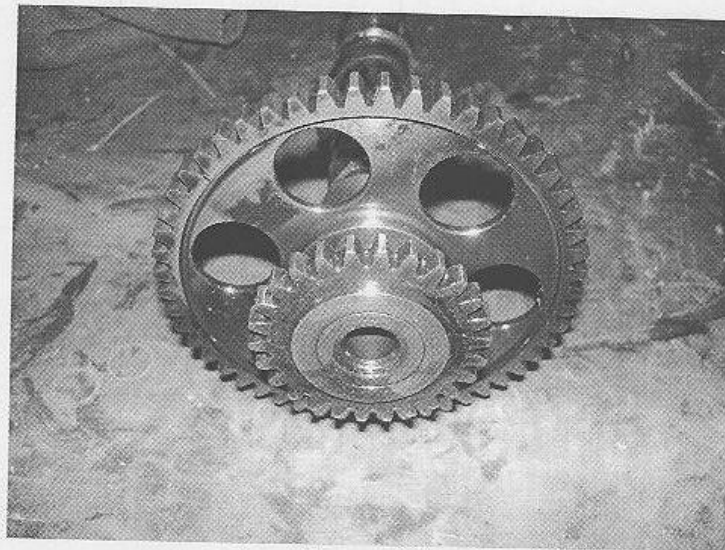
The camshaft showed no signs of wear on the bearing services or cam lifters. All drive gears was still in tacked. See figure 24 and 25

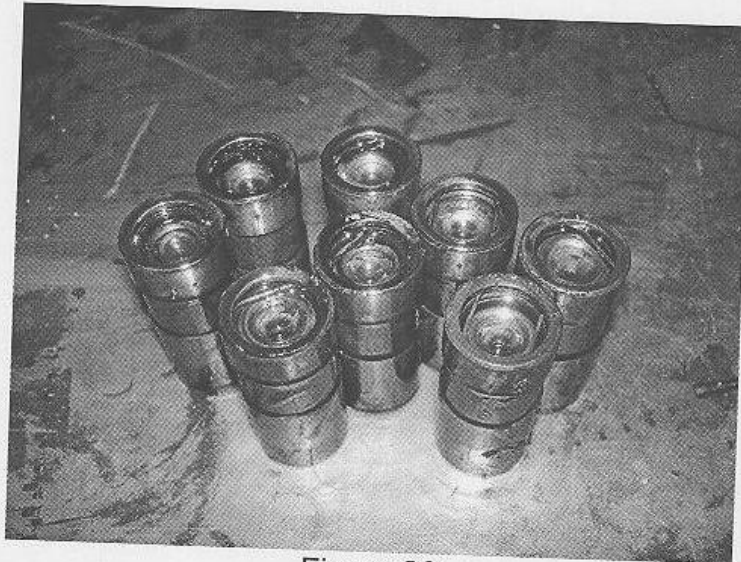
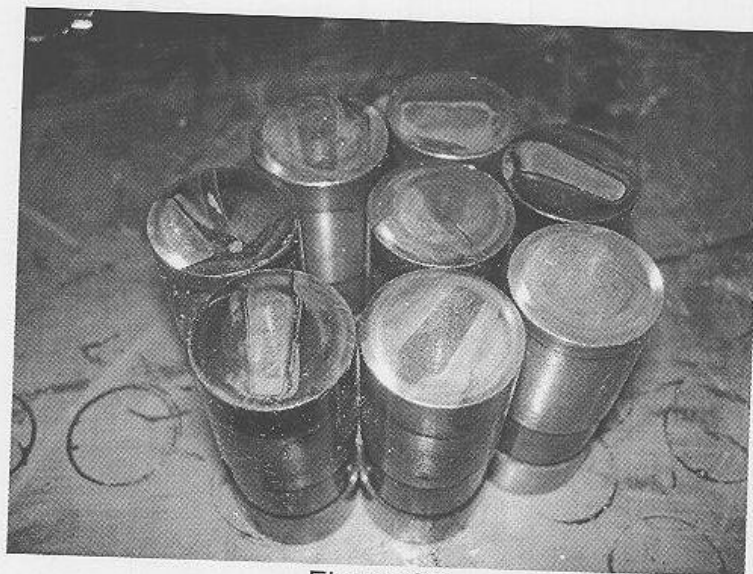
All the hydraulic lifters were in tacted and showed no signs of excessive wear on the camshaft mating services. See figure 26 and 27.

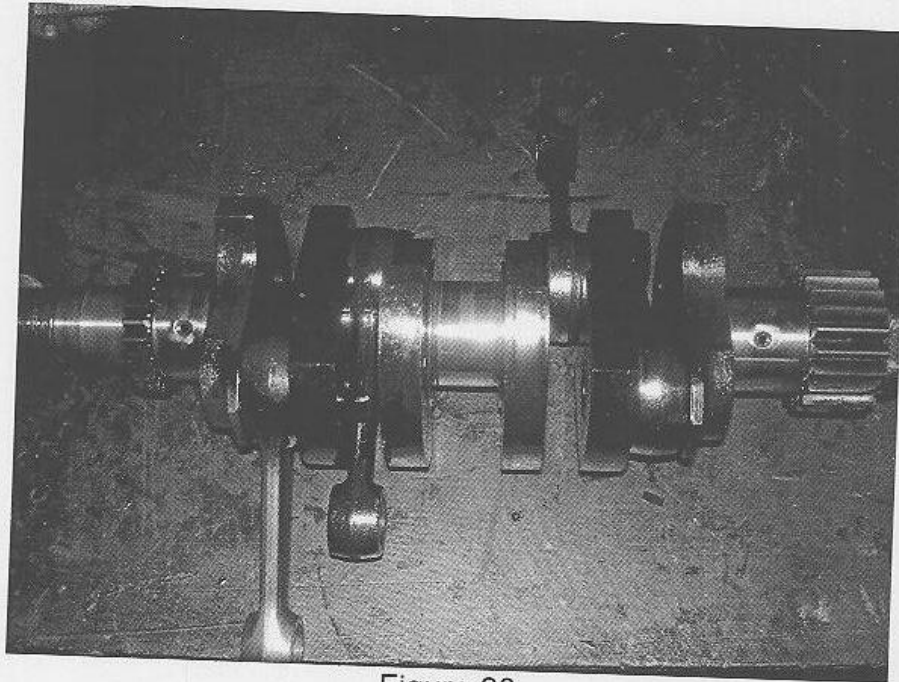
Figure 28

The crank shaft was in tacked and all bearing services showed no signs of excessive wear. The big end bearings were rotating smoothly. The con rods showed no signs of over heating or seizure at the small end bearing services. See figure 28.
