AIRCRAFT ACCIDENT REPORT AND EXECUTIVE SUMMARY

Reference:	CA18/2/3/8563	
Aircraft Registration	ZS-FVL	Date of Accident	18 October 2008		Time of Accident	1530Z
Type of Aircraft	Piper PA32-300		Type of Operation		Private	
Pilot-in-command Licence Type		Private Pilot	Age	60	Licence Valid	Yes
Pilot-in-command Flying Experience		Total Flying Hours as on 18 September 2007	548.2		Hours on Type	Unknown
Last point of departure		Private airfield, Farm Tswana Lodge, Limpopo Province				
Next point of intended landing		Private airfield, Farm Tswana Lodge, Limpopo Province				
Location of the accident site with reference to easily defined geographical points (GPS readings if possible)						
Farm Donkerhoek, Limpopo Province (GPS: S 23° 55.088' E 027° 54.177')						
Meteorological Information		Wind 360°TN at 10 kts, temperature 29°C, visibility 10 km				
Number of people on board	1 + 2	No. of people injured	1	No. of people killed	2	
Synopsis						
<p>On 18 October 2008 at approximately 1400Z, a pilot accompanied by two passengers took off from a private airfield at Tswana Lodge for an afternoon sightseeing flight.</p> <p>After the lodge was over flown twice by the pilot, it seemed to the only s

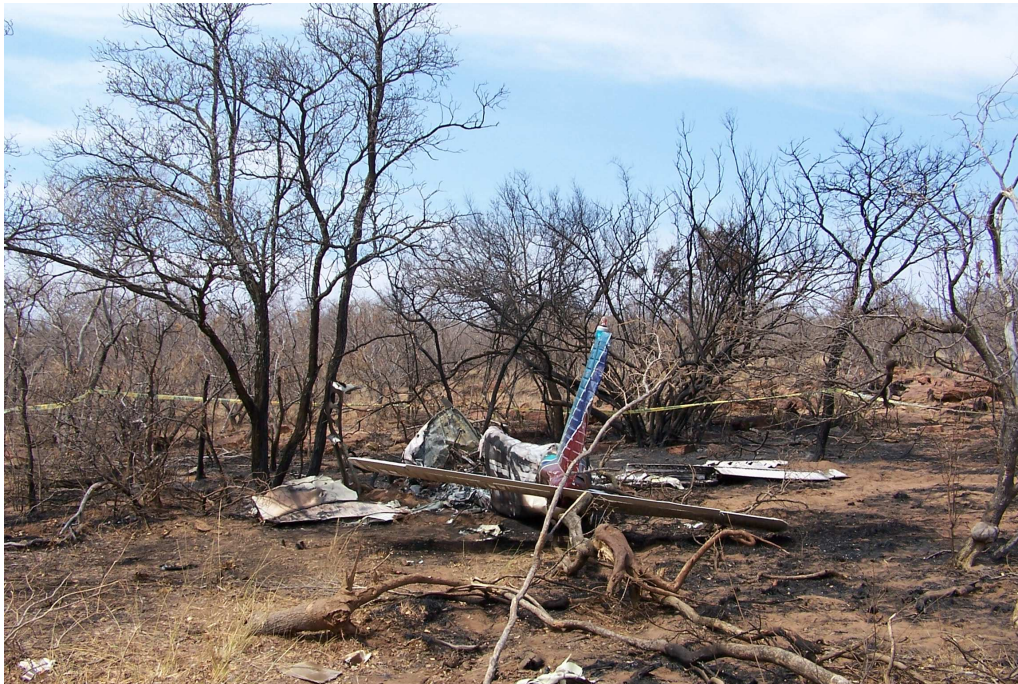
- 1.3.1 The aircraft was destroyed by a post-impact fire.

Figure 1: The aircraft was destroyed by a post-impact fire

- 1.14.1 A post-impact fire erupted when the aircraft impacted the ground. The aircraft was destroyed by the post-impact fire. The aircraft caught fire on impact with the ground most probably due to rupturing of the fuel tank as a result of impact with the ground. This could have caused fuel to leak onto the hot engine, which in turn ignited the fuel.
- 1.14.2 The aircraft accident occurred in between trees on a farm, 246.4 m from a runway at an unlicensed airfield at Tswana Lodge. The airfield has no rescue or fire services available as it is not a requirement in terms of the Civil Aviation Regulations 1997.
- 1.14.3 An attempt was made by the residents of Farm Donkerhoek to extinguish the fire by means of sand and water.

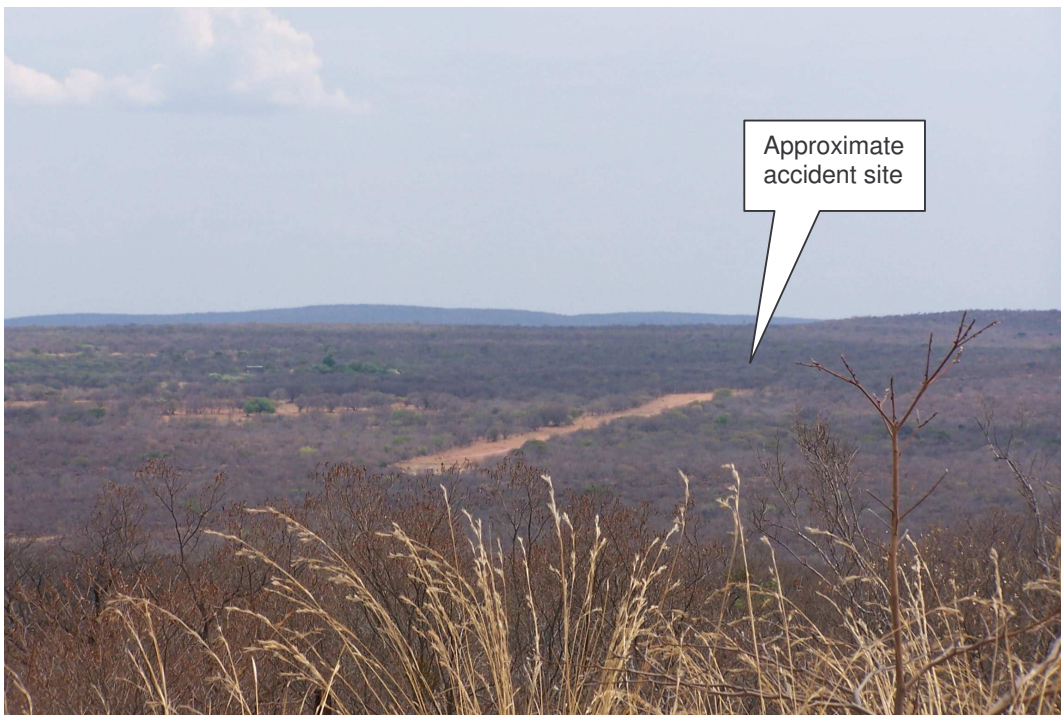
Figure 3: The runway of the unlicensed airfield at Tswana Lodge as viewed from the R33 public road

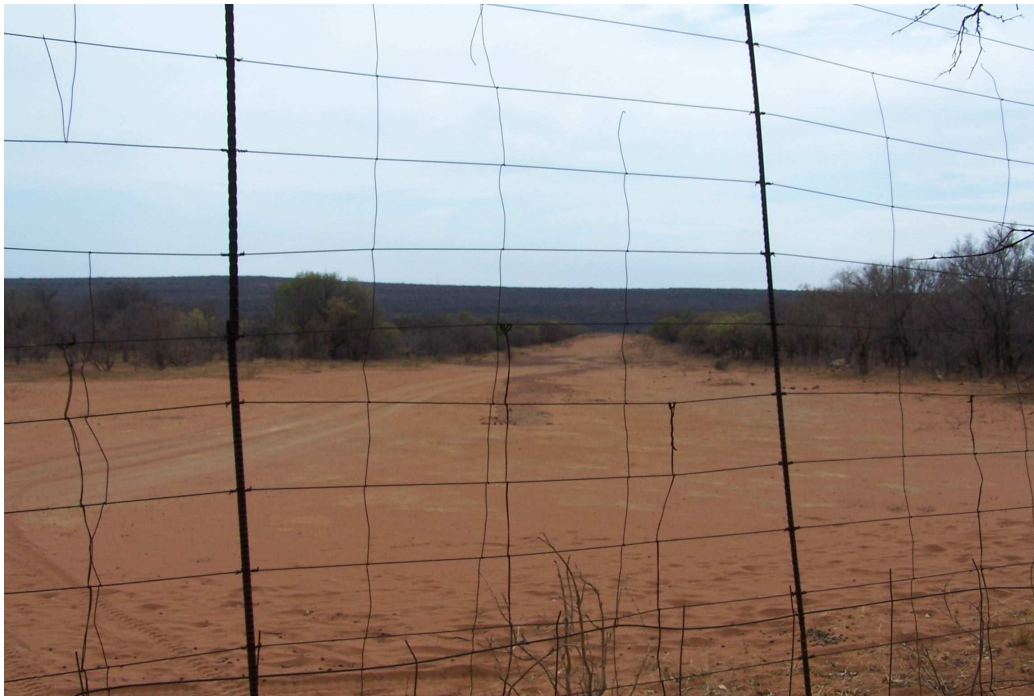
Figure 4: The end of the threshold of the runway at Tswana Lodge, bordered by the fence between Tswana Lodge and Farm Donkerhoek.

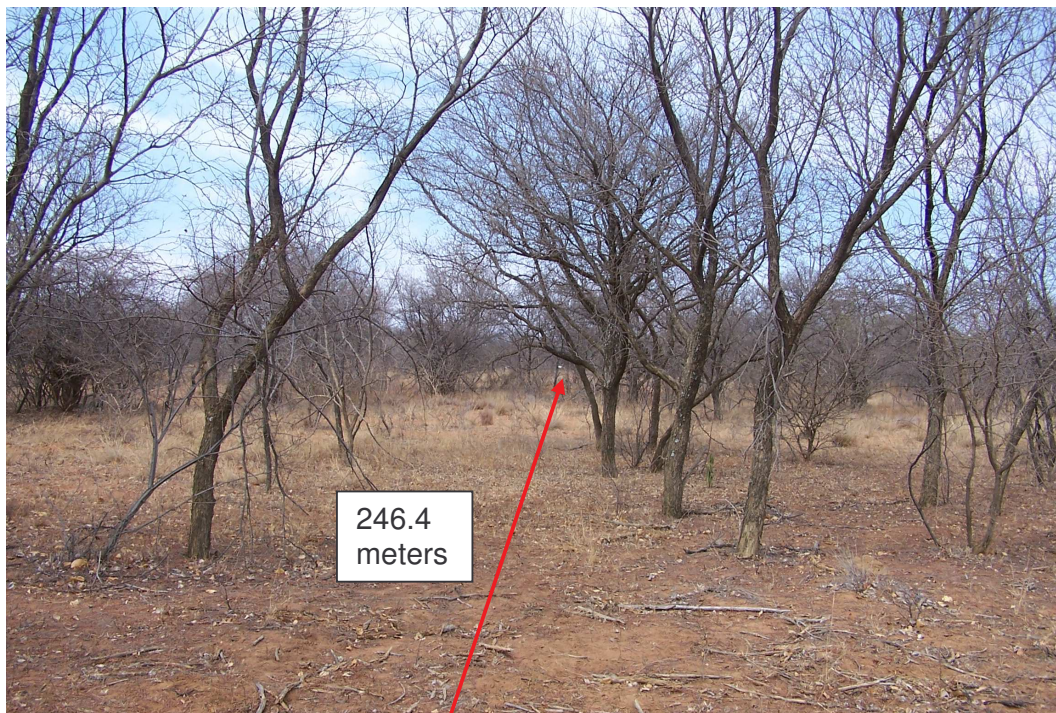
1.12.1 The aircraft was found 246.4 m from the end of the threshold of the runway of an unlicensed airfield on Tswana Lodge, on the farm Donkerhoek. The aircraft was found destroyed by a post-impact fire, facing on a heading of 175°. During the impact sequence, the aircraft impacted trees 189.4 m from the end of the threshold of the runway at an angle of approximately 45° in a nose-down attitude. The aircraft impacted the ground at the geographical position of S 23° 55.088' E 027° 54.177'.

Figure 5: Photo taken from the end of the threshold of the runway at Tswana Lodge, indicating the distance of the wreckage from the runway

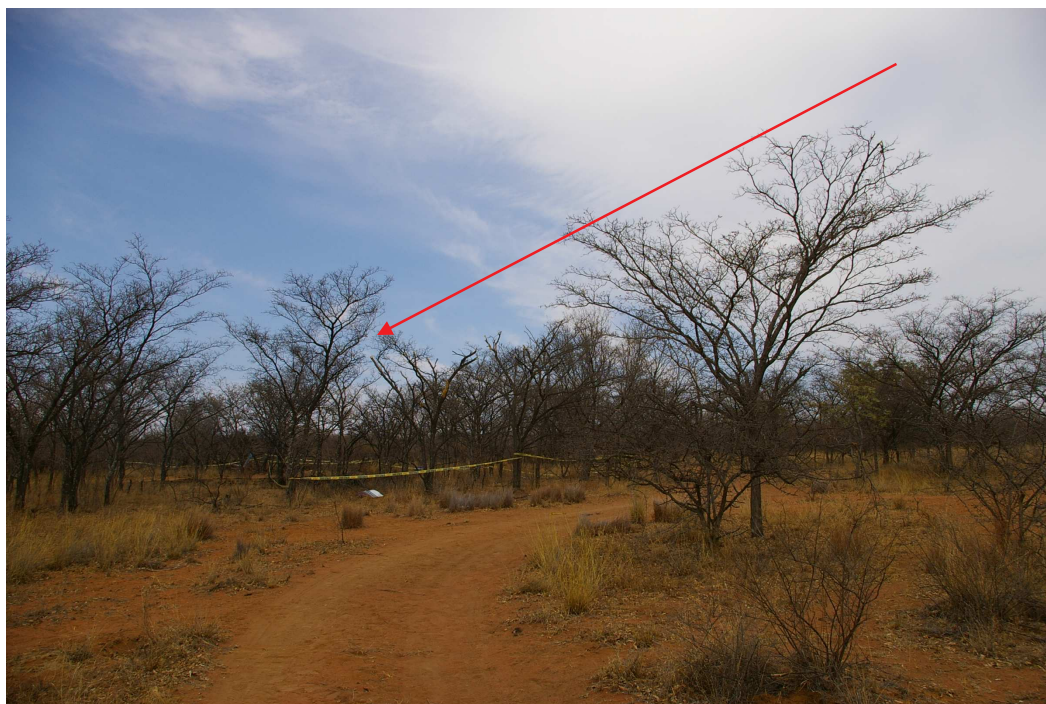
Figure 6: Indicating the trees the aircraft impacted and impact angle
