COMPILED BY	<b>CrashLAB</b>	PAGE 1 OF 15	
COMPILED FOR: Civil Aviation Authority		DOCUMENT NUMBER MET-003-11-08	
	INVESTIGATION REPORT: STRUCTURAL FAILURE, TECNAM P92 ECHO, ZU-DMT	DATE 2008-11-14	ISSUE 1

ITEM: STRUCTURE, TECNAM P92 ECHO LIGHT AIRCRAFT, ZU-DMT

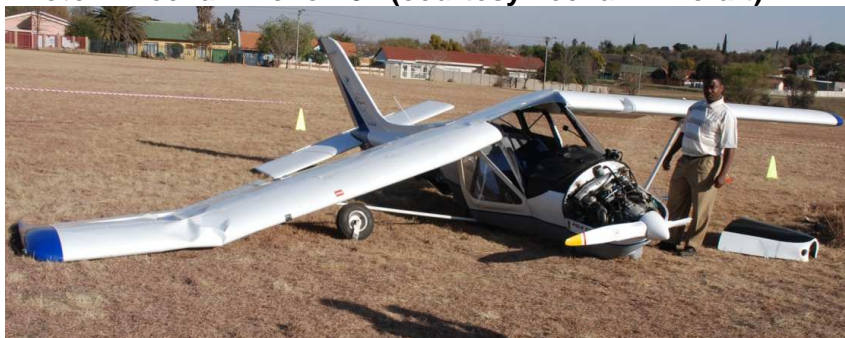
Photo 2: Condition after previous accident (courtesy SACAA)

- 7.1. The rebuilding process of the relevant aircraft proved to have no effect on this accident.
- 7.2. All primary main wing structural member material compositions and conditions compared favourably to OEM specifications.

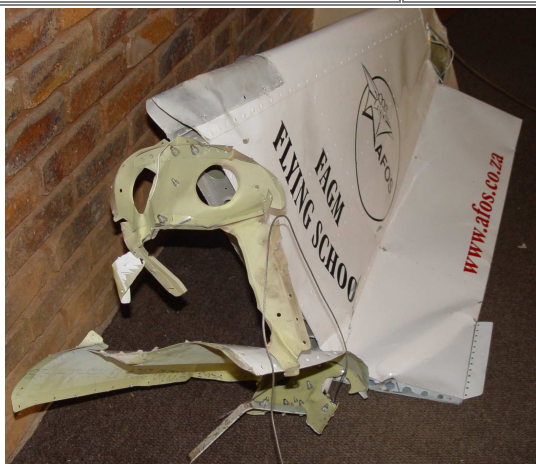
Photo 3: Rudder failure at point A (digital)

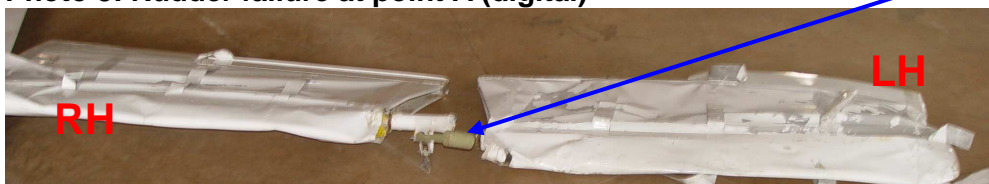
Photo 4: Horizontal stabilizer failure at point A (digital)

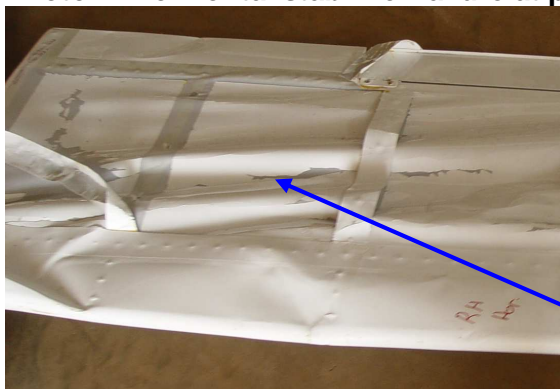
Photo 5: Horizontal stabilizer showing extensive buckling, blue arrow (digital)

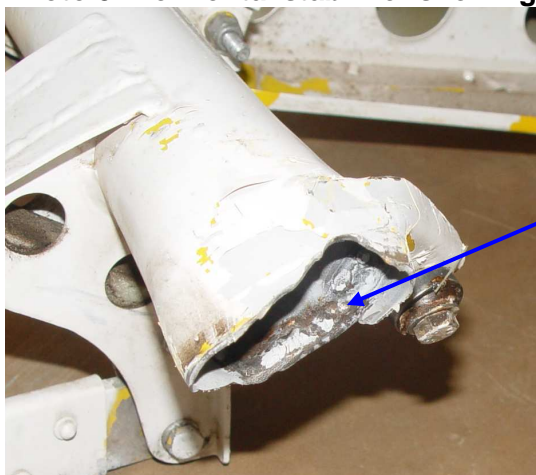
Photo 6: Horizontal stabilizer point of fracture (digital)

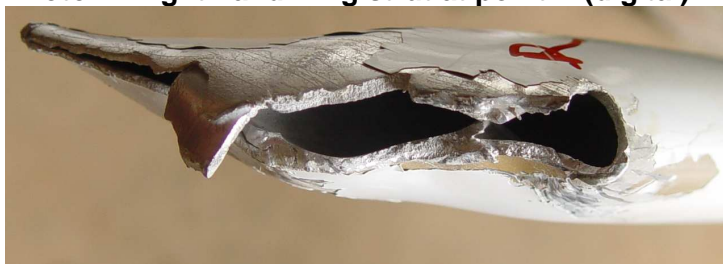
**6.1.2. Main Wing Assembly Failure at Points B, C and D.** The visual inspection revealed that the right hand (pilot view) wing strut fractured at point B. The fracture geometry corresponds with a bending type failure (Photo 8) and not an overload. No clear signs of pre-impact fracture development could be detected. The black rubber mark (Photo 7, blue arrow) was inflicted during contact with the right hand main landing wheel, most probably after wing separation and on impact as little bending damages were detected at the position of contact. The bending damage to the right-hand wing strut wing attachment point (Photo 9, blue arrow) corresponds to an upward and aft direction of separation for the right hand wing (Photo 9, red arrow).

**Photo 8: Right hand wing strut fracture surface (digital)**

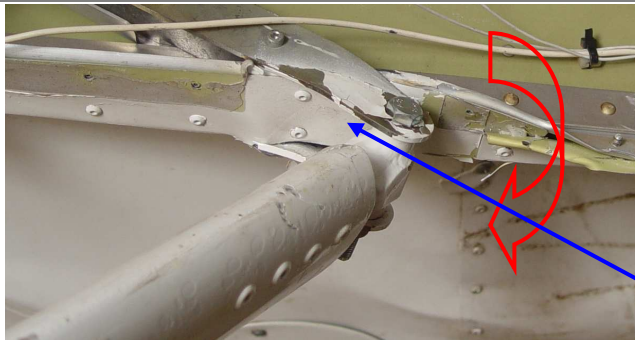
Photo 9: Right hand wing strut wing attachment point (digital)

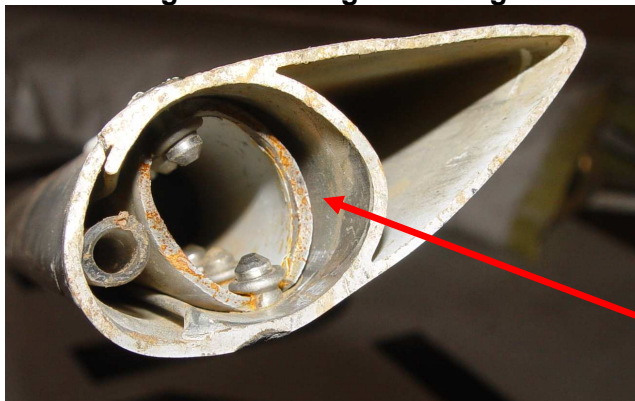
The left hand wing strut fractured at point D. The damages to the fuselage attachment at point D (Photo 11) point toward a forward direction of failure. The inner steel based tube (Photo 10, red arrow) fractured at the rivet points. The fracture surface showed no clear signs of pre-impact development and the geometry corresponded with that of a ductile material under overload conditions (Photo's 12 and 13).

Photo 10: Left hand wing strut fracture at point D (digital)

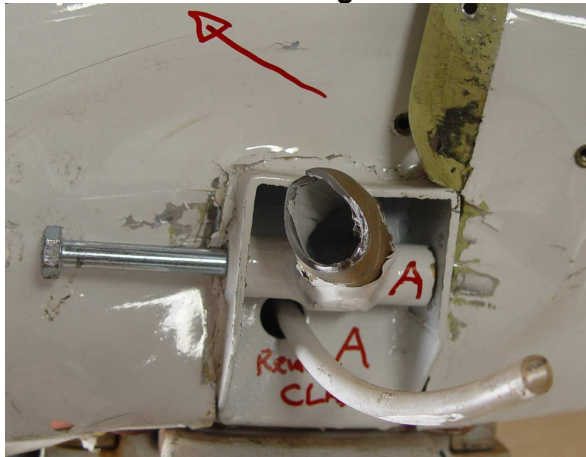
Photo 11: Left hand strut fuselage attachment at point D (digital)

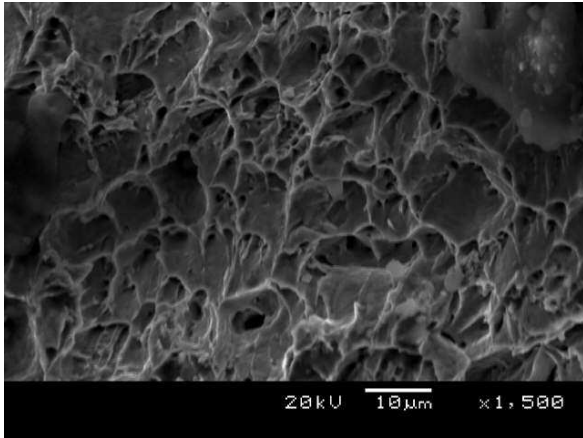
Photo 12: Fractograph, left hand strut fracture surface at point D (x1500, SEM)

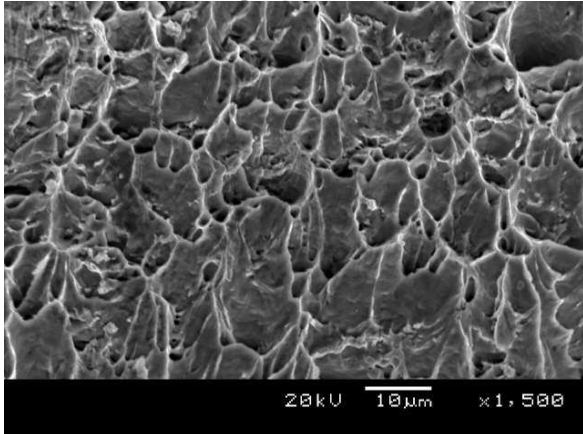
Photo 13: Fractograph, left hand strut fracture surface at point D (x1500, SEM)

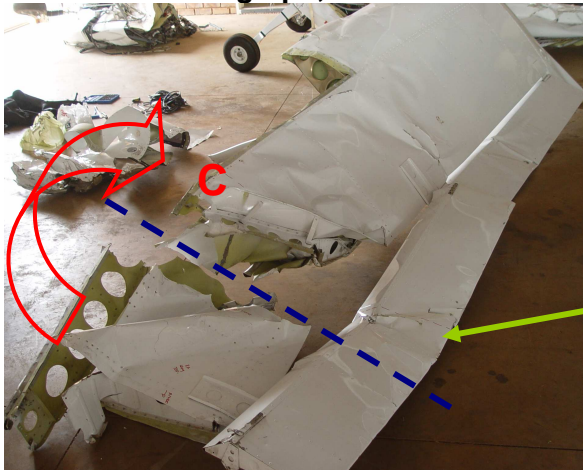
The visual investigation showed that the right hand wing (pilot view) separated from the remainder between the cabin truss attachment and the right hand strut attachment points at point C (Photo 14, blue dashed line). The direction of separation proved to upward and aft (Photo 14, red arrow). Taking into account the corresponding damages to the right hand flap (Photo 14, green arrow) it can be assumed that it was in position at the moment of wing separation. The wing structure revealed signs of buckling (Photo 15, red arrow) in the area between the strut and fuselage attachment points. The leading edge top and bottom L-shaped, aluminium based structural beams from the right hand wing (Photo 16, red arrows) were exposed to a SEM investigation. The fractographs (Photo's 17, 18 and 19) revealed a typical ductile material failing under overload conditions. No clear signs of pre-impact fracture development could be detected.

Photo 14: Right hand wing separation at point C (digital)

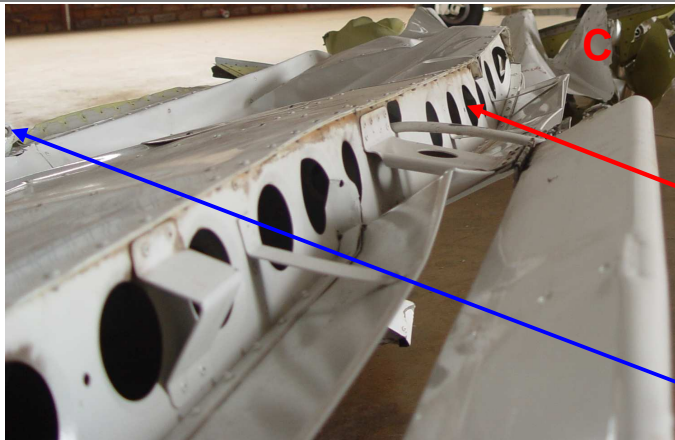
Photo 15: Right hand wing buckling damages (digital)

Evidence corresponding with the type of resultant forces induced on the separated right hand wing was clearly visible. The consequential buckling of the right hand wing would have been severely detrimental to the overall strength thereof. Taking into account that none of the fracture surfaces revealed any clear signs of pre-impact discrepancies, it can be derived that the right hand wing separated under high load conditions induced by excessive lift forces during operation.

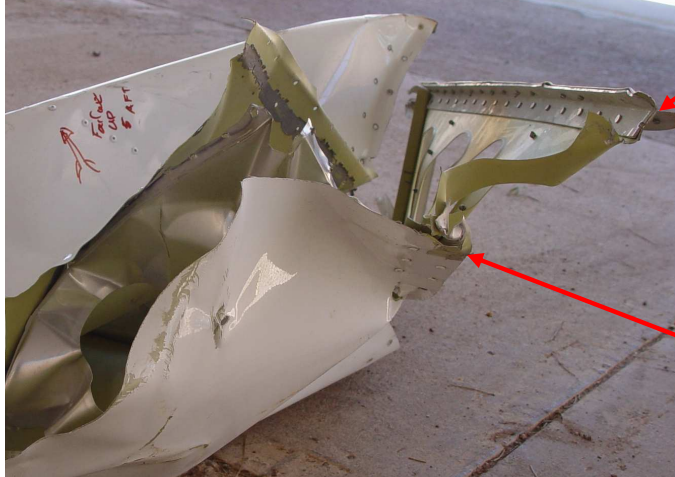
Photo 16: Right hand wing fractures at point C (digital)

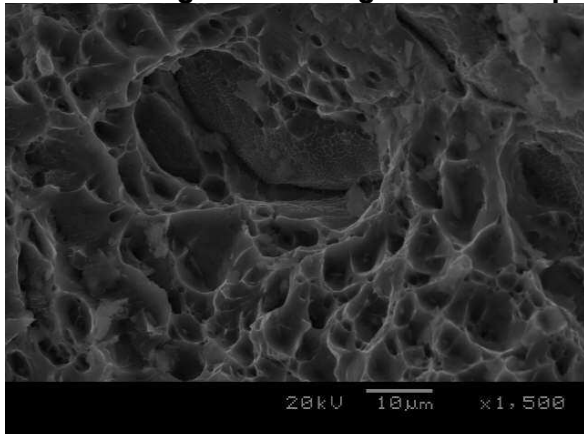
Photo 17: Fractograph, right hand wing top L-beam (x1500, SEM)

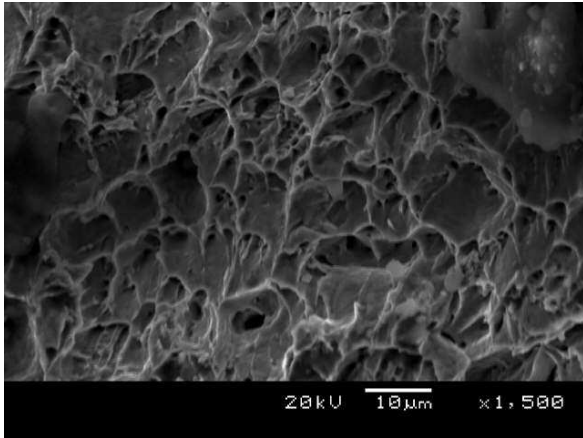
**Photo 18: Fractograph, right hand wing top L-beam (x1500, SEM)**

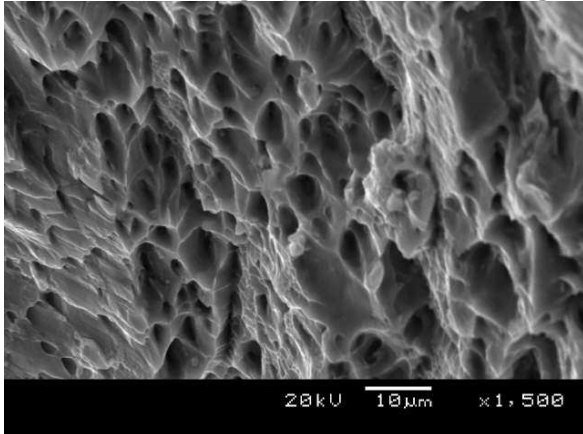
**Photo 19: Fractograph, right hand wing bottom L-beam (x1500, SEM)**

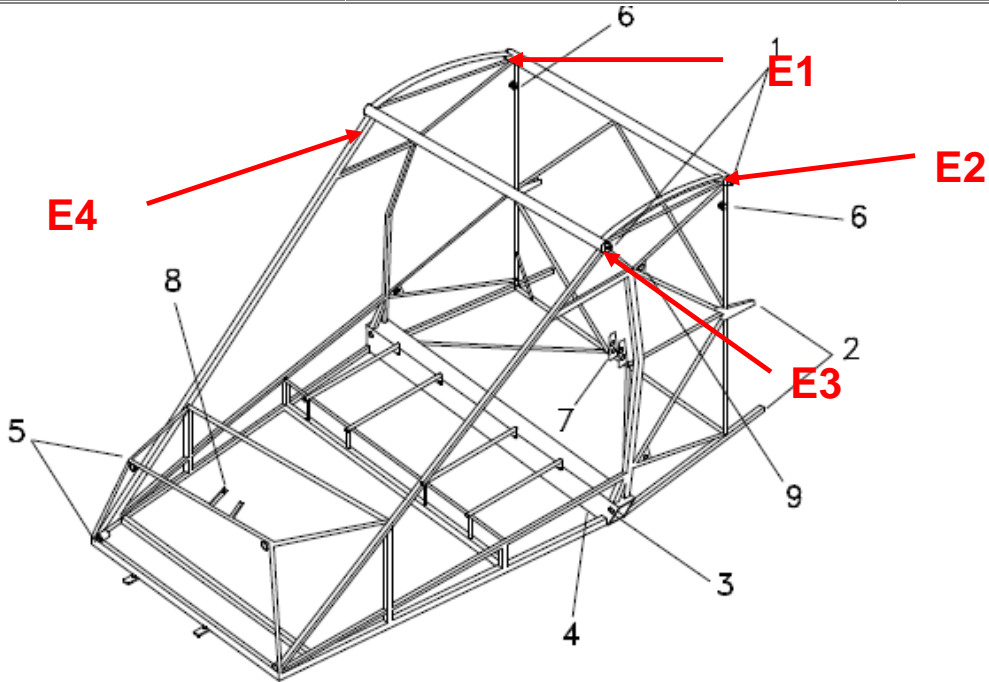
**6.1.3. Cabin Truss Failure at Point E.** The visual investigation revealed that the remainder of the left hand wing and centre section separated from the cabin truss at 4 primary points, E1 to E4 (Diagram 3 and Photo 20). The fracture surfaces at all four primary failure positions (Photo's 21, 22, 23 and 24) corresponds with an overload type of geometry and revealed no clear signs of pre-impact or wing separation development.

Diagram 3: Cabin truss layout with primary fractures designated by red arrows

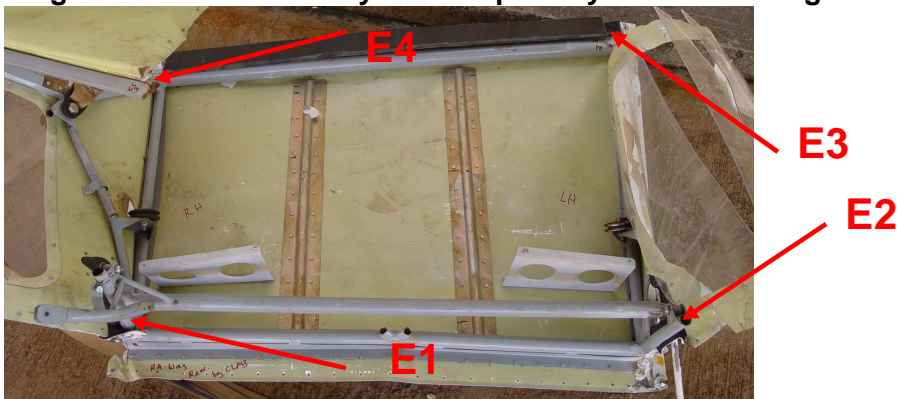
Photo 20: Primary fracture points, cabin truss (digital)

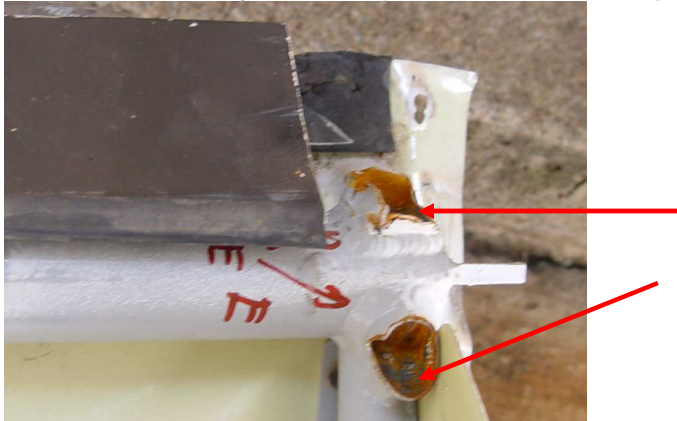
Photo 21: Fracture at point E3 (digital)

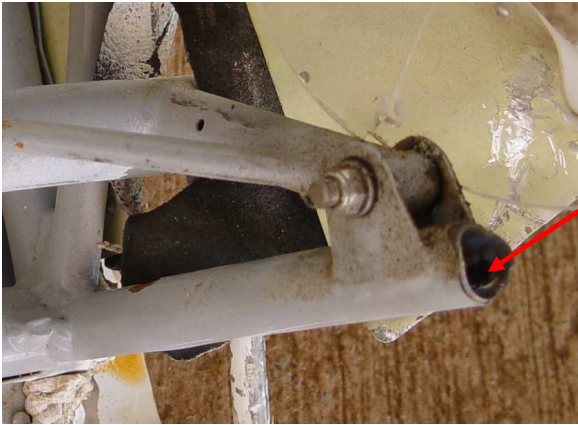
Photo 22: Fracture at point E2 (digital)

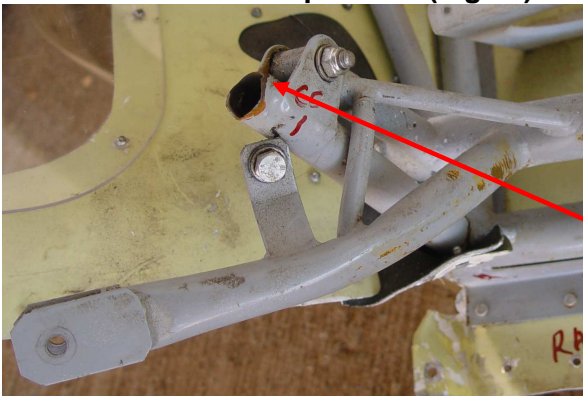
Photo 23: Fracture at point E1 (digital)

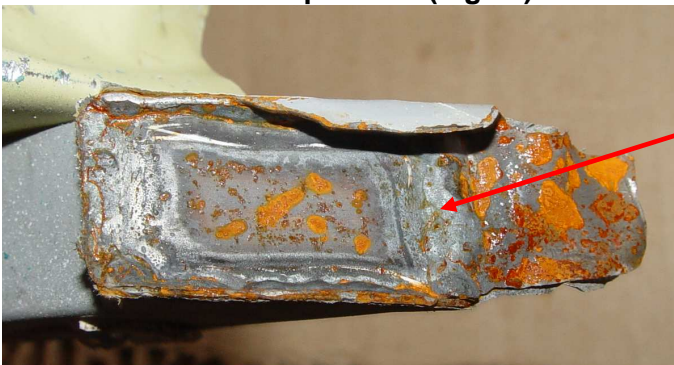
Photo 24: Fracture at point E4 (digital)

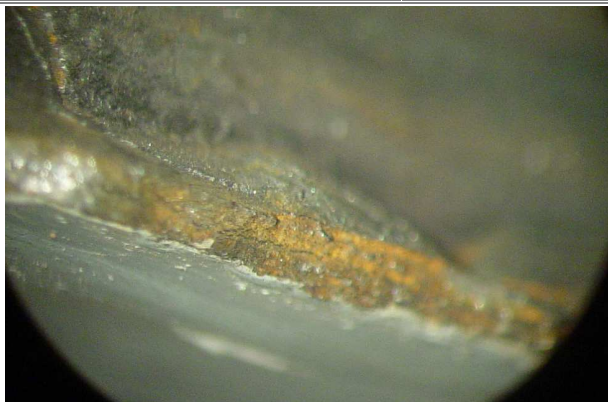
The stereomicroscope investigation confirmed some corrosion damages (Photo 25) to most of the fracture surfaces as received. These damages were most probably inflicted after impact. The non-corrosion damaged surfaces conform to overload type geometries (Photo's 26 and 27) with no clear signs of pre-impact crack formation and/or weakening of the cabin truss structure.

Photo 25: Fracture surface showing corrosion damages, cabin truss (stereo)

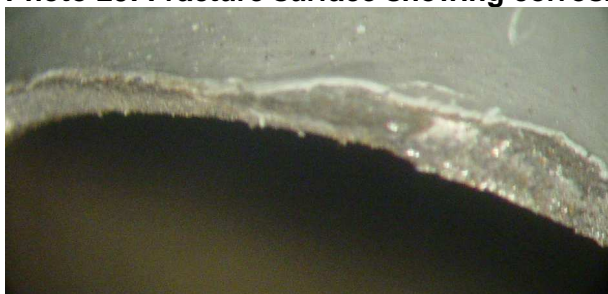
Photo 26: Fracture surface, cabin truss (stereo)

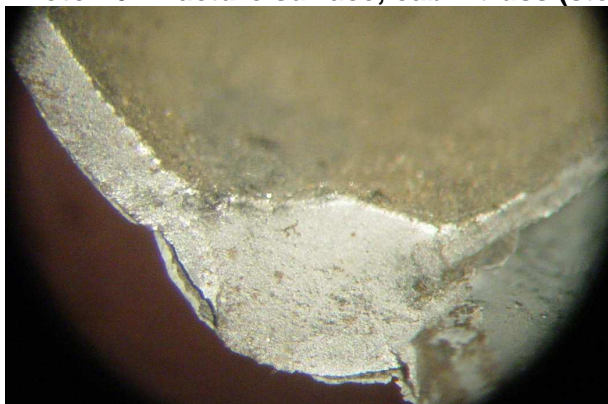
Photo 27: Fracture surface, cabin truss (stereo)

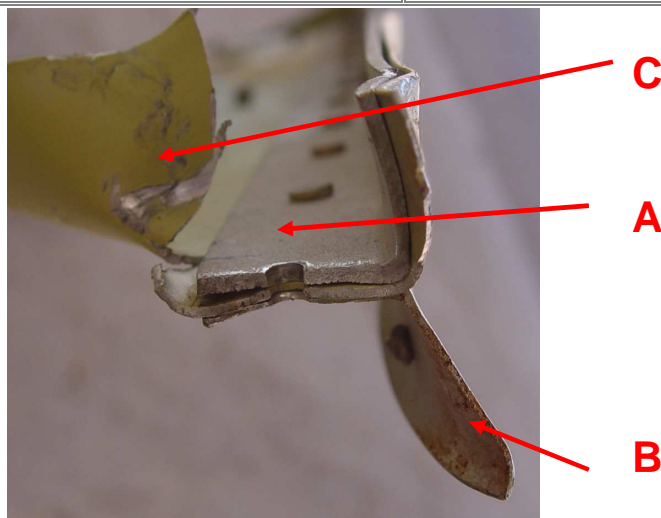
**Photo 28: primary structural components, main wings**

Hardness tests, Spectroscopy and X-ray (EDS) analysis methods (results attached) were utilized to compare the compositions and conditions of the primary wing structural ribs and cabs A, B and C (Photo 28) to the OEM specifications.

Wing Ribs A and C compared favourable to the OEM specified **6061-T6** aluminium as well as the Spar Cab B to the specified **2024-T3** Aluminium.

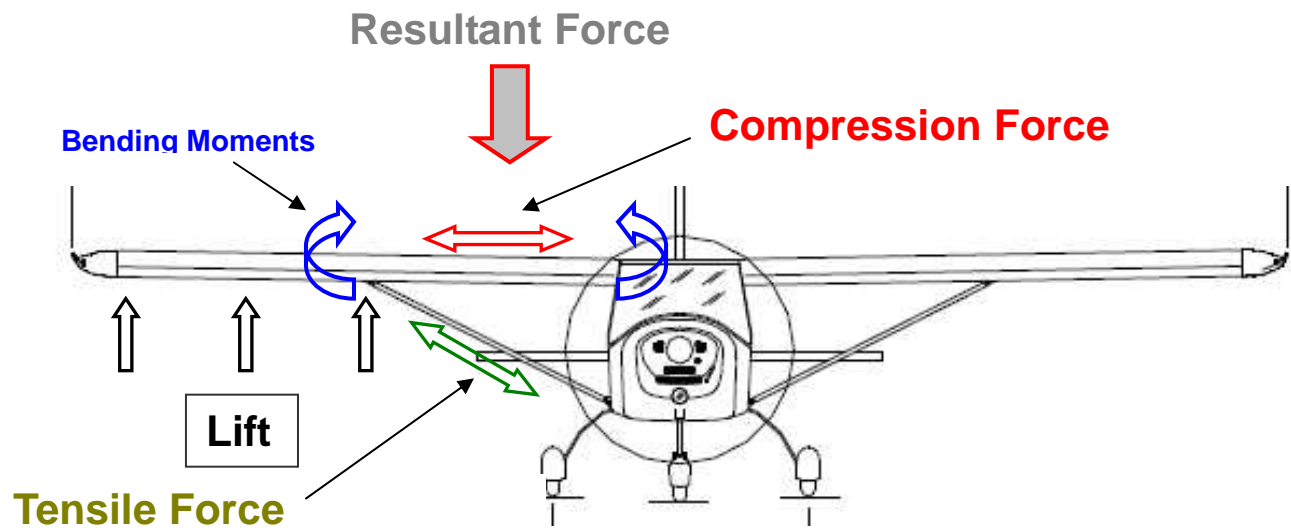
**Diagram 4: Wing forces induced under high lift conditions**

- 7.3. Under high load conditions induced by excessive **lift forces** (See diagram 4, black arrows), the wing strut will be subjected to a **tensile force** (green arrow). Two **bending moments** will be created around the strut to wing and the wing to fuselage attachment points (blue arrows). These bending moments will have a resultant **compression force** (red arrow) induced in the area between the two attachment points. This **compression force**, combined with the **bending moment** forces, will induce a **downward force** (red/grey arrow) in this section. Under excessive lift conditions, these resultant forces may induce **buckling** in the area between the strut and fuselage attachment points.

- 8.1. The operating envelope limitations set by the OEM and other authorities should be adhered to at all times.
