AIRCRAFT ACCIDENT REPORT AND EXECUTIVE SUMMARY

Reference:	CA 18/2/3/8588	
Aircraft Registration	ZU-ETR	Date of Accident	30/11/2008	Time of Accident	0749Z	
Type of Aircraft	AUTOGYRO MT 03		Type of Operation	Private		
Pilot-in-command Licence Type	Gyroplane	Age	59	Licence Valid	Yes	
Pilot-in-command Flying Experience	Total Flying Hours	52.6		Hours on Type	52.6	
Last point of departure	Vryheid Aerodrome (KZN)					
Next point of intended landing	Vryheid Aerodrome (KZN)					
Location of the accident site with reference to easily defined geographical points (GPS readings if possible)						
Between pylon 208 and pylon 209 on the Normandie/Umfulozi electrical power line at coordinates S27° 47.850 E030°57.035 on the farm Sterkstroom in the Vryheid district.						
Meteorological Information	Temperature:28°C, Visibility: >10 km, Dew point: 16°C, Surface wind 270/03KT					
Number of people on board	1+0	No. of people injured	0	No. of people killed	1	
Synopsis

Name of Owner/Operator : Albryl Trading CC
Manufacturer : Autogyro GMBH
Model : MT 03
Nationality : South African
Registration Marks : ZU-ETR
Place : Vryheid (KZN)
Date : 30/11/2008
Time : 0749Z

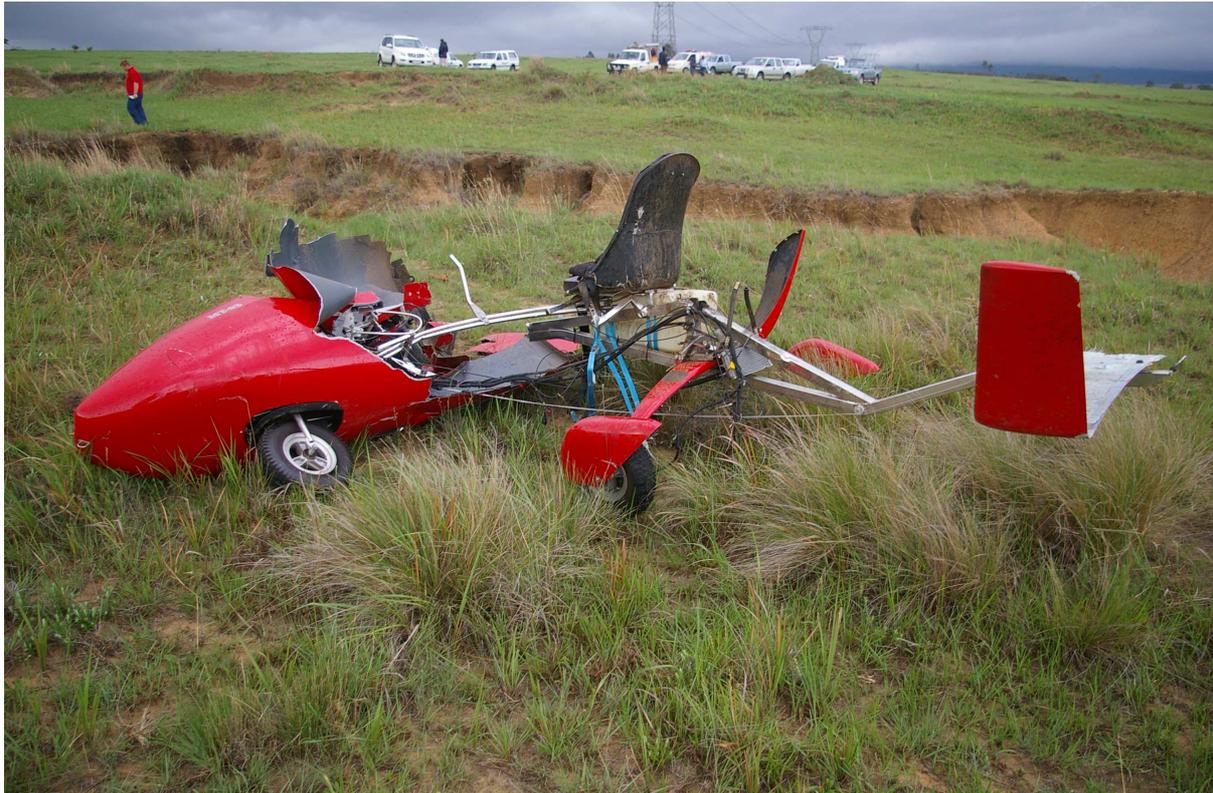
1.3.1 The aircraft was destroyed during the sequence of the accident. (See Photo 1)

Photo 1 Destroyed Autogyro.

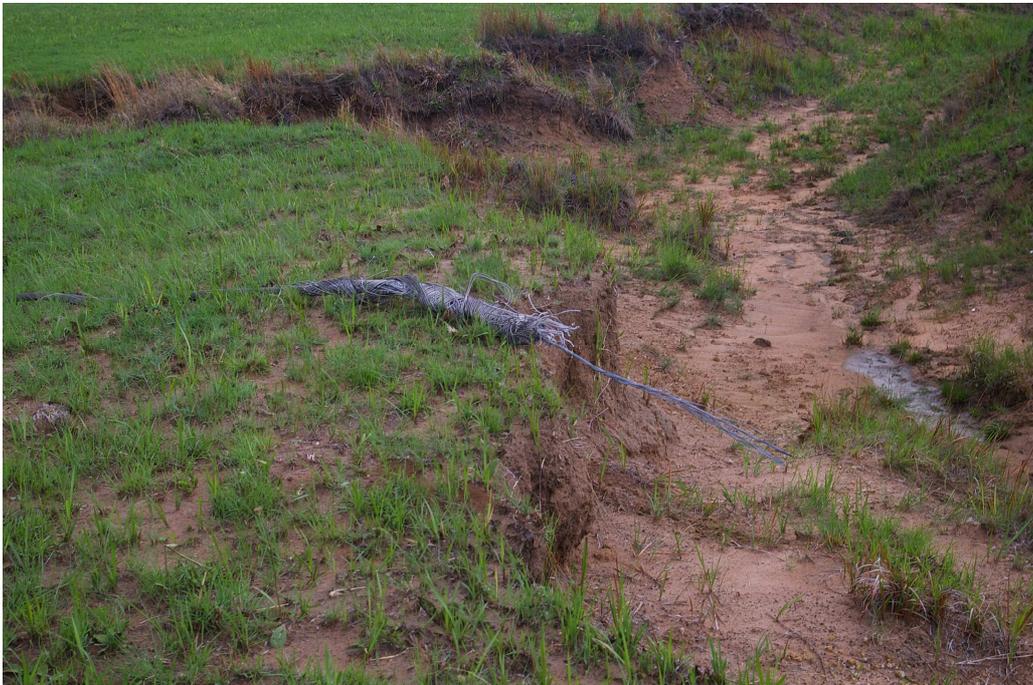
1.4.1 One of the 38 millimetre high tension power lines was severed and a second high tension wire was extensively damaged.

The aircraft was destroyed during the impact sequence. The aircraft impacted with high tension electrical wires, whereafter it impacted with the ground approximately 75 metres further on, beyond the high tension wires. The accident site was in an open field with an elevation of 3746 feet above mean sea level (AMSL). The severed high tension wire was found on the ground below the power line. **(See photo 2)**

Photo 2 One end of the broken electrical cable on the ground.

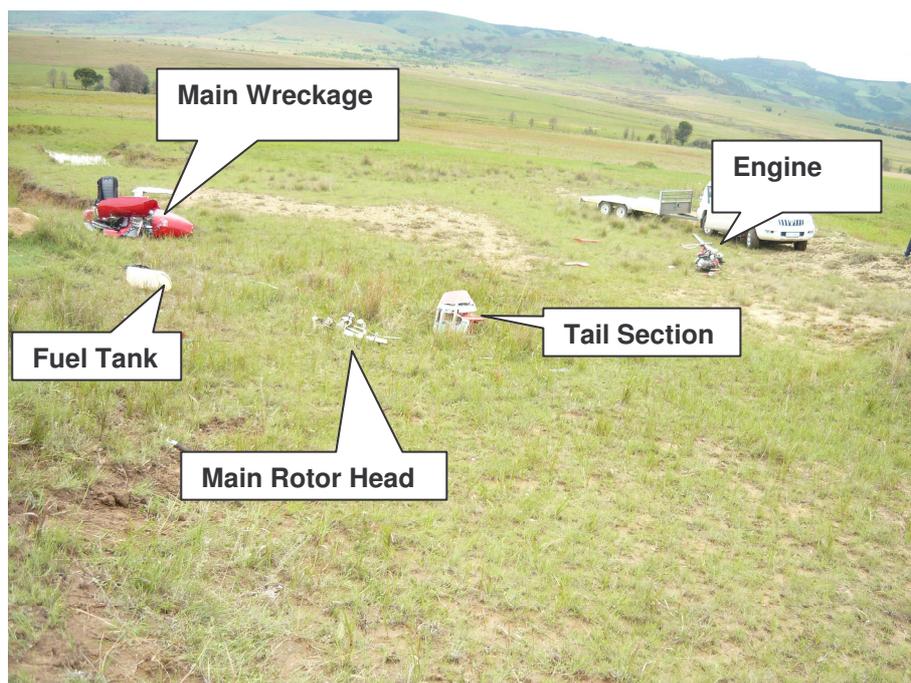
The fuselage of the Gyroplane was destroyed during the impact sequence. The engine was separated from the fuselage and was found approximately 14 metres from the main wreckage. The tail section of the Autogyro was also severed from the mountings and was found approximately 12 metres away from the main wreckage. One of the fuel tanks was separated from the main wreckage and was found approximately 3 metres from the main wreckage. The propeller was destroyed and pieces were scattered as far as 43.2 metres on either side of the aircraft's original flight path. **(See Photo 3)** An inspection of the airframe and controls indicated that all damage was caused by the sequence of the accident. No evidence was found of any pre-impact defects that might have affected the flight.

Photo 3 Wreckage distribution.

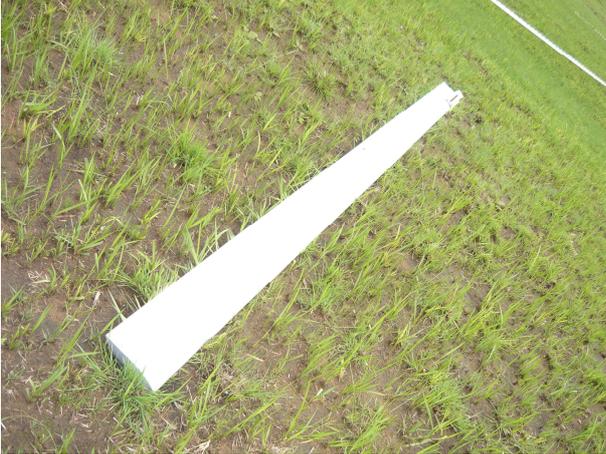
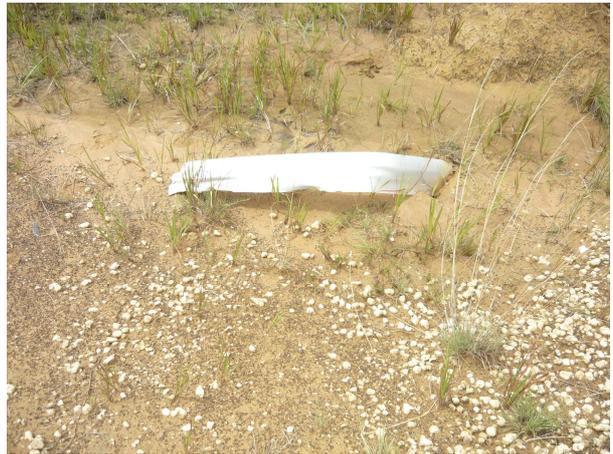
The rotor head had separated from the engine and main rotor blades. The rotor head was found approximately 11 metres from the main wreckage. One of the rotor blades was intact and found approximately 13 metres before the impact point with the high tension wire. The other rotor blade was destroyed and was found approximately 14 metres after the impact point with the high tension wire. (See **Photo 4.**)

Photo 4 Main rotor blades.

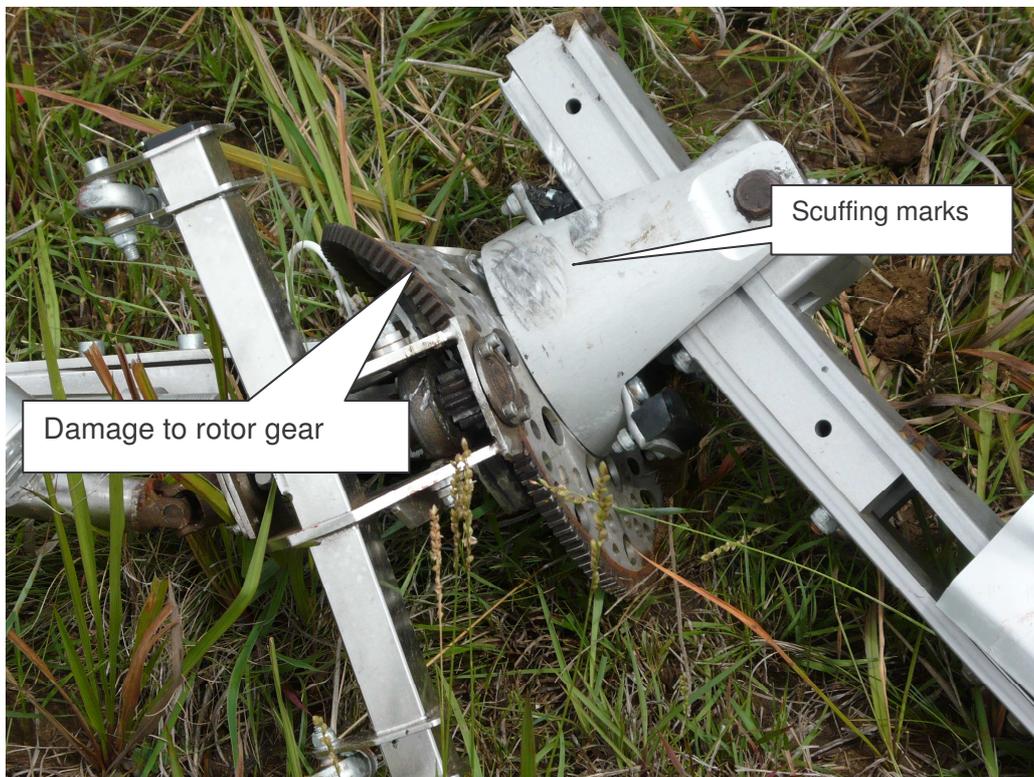
Clear evidence of damage caused by a cable scuffing against the head just below the rotor blades and above the rotor gear was visible. The rotor gear was also damaged by the cable. (See **Photo 5.**)

Photo 5 Damage to the rotor head and rotor gear.

The investigator is of the opinion that these scuffing marks were caused by the high tension electrical cable.
