AIRCRAFT ACCIDENT REPORT AND EXECUTIVE SUMMARY

Reference:	CA18/2/3/8628	
Aircraft Registration	ZS-RKA	Date of Accident	23 March 2009		Time of Accident	0700Z
Type of Aircraft	Robinson R44 Astro		Type of Operation		Private	
Pilot-in-command Licence Type		Private	Age	49	Licence Valid	Yes
Pilot-in-command Flying Experience		Total Flying Hours	350		Hours on Type	230
Last Point of Departure		Sea Rest Farm, Port Elizabeth (GPS co-ordinates: S33°45'05.44" E26°26'16.35") elevation 650 ft AMSL				
Next Point of Intended Landing		East London Aerodrome (FAEL)				
Location of the Accident Site with Reference to Easily Defined Geographical Points (GPS readings if possible)						
Woody Cape Beach near Port Elizabeth (GPS co-ordinates: S 33°0.752' E26°0.437 7') elevation 121 ft AMS L						
Meteorological Information		Temperature 22°C, surface wind 250° at 13 kts, vis ibility > 10 km				
Number of People on Board	1 + 1	No. of People Injured	0	No. of People Killed	0

Name of Owner/Operator : Super Pro Dairy (Pty) Ltd
Manufacturer : Robinson Helicopter Company
Model : Robinson R44 Astro
Nationality : South African
Registration Marks : ZS-RKA
Place : Private Helipad at Sea Rest Farm, Port Elizabeth
D

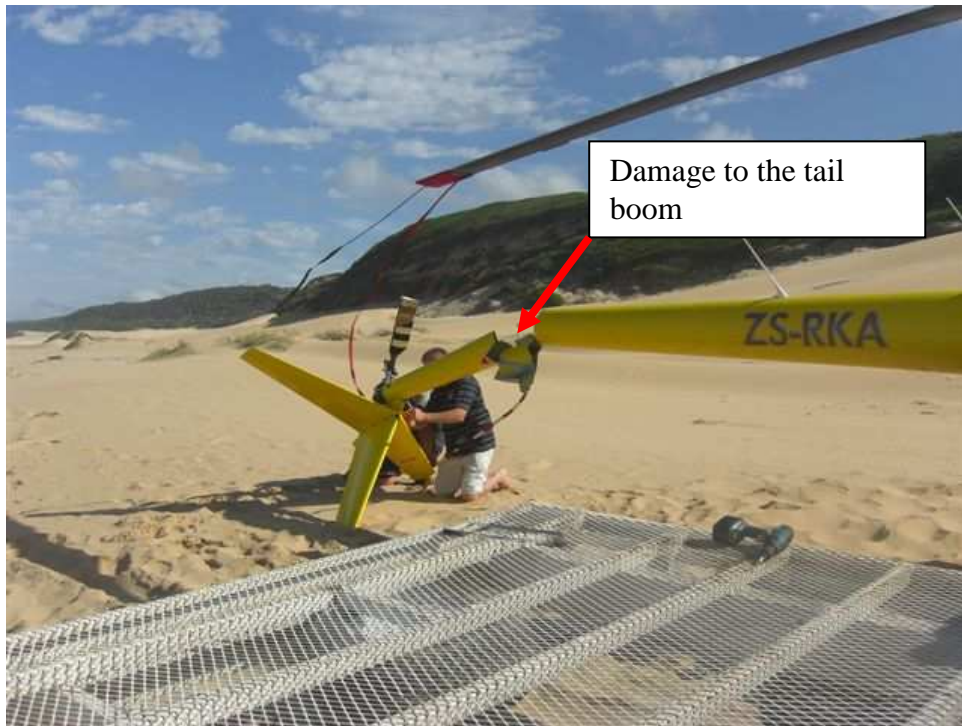
Figure 1: Damage to the tail boom

1.12.1 The helicopter's engine failed and the pilot immediately entered autorotation, intending to land the helicopter on the beach sand. In the process of recovering, the main rotor blades cut the tail boom before the tail rotor. The skids impacted the ground causing damage to the left-hand skid. The aircraft came to rest in soft sand at Woody Cape Beach.

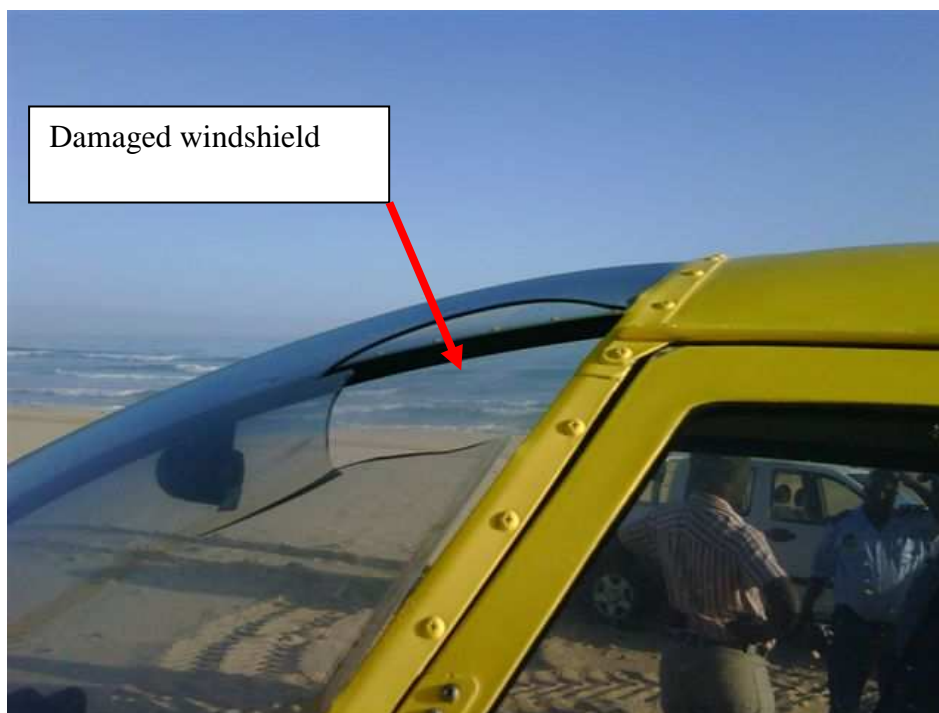
Figure 2: Damage to the left windshield

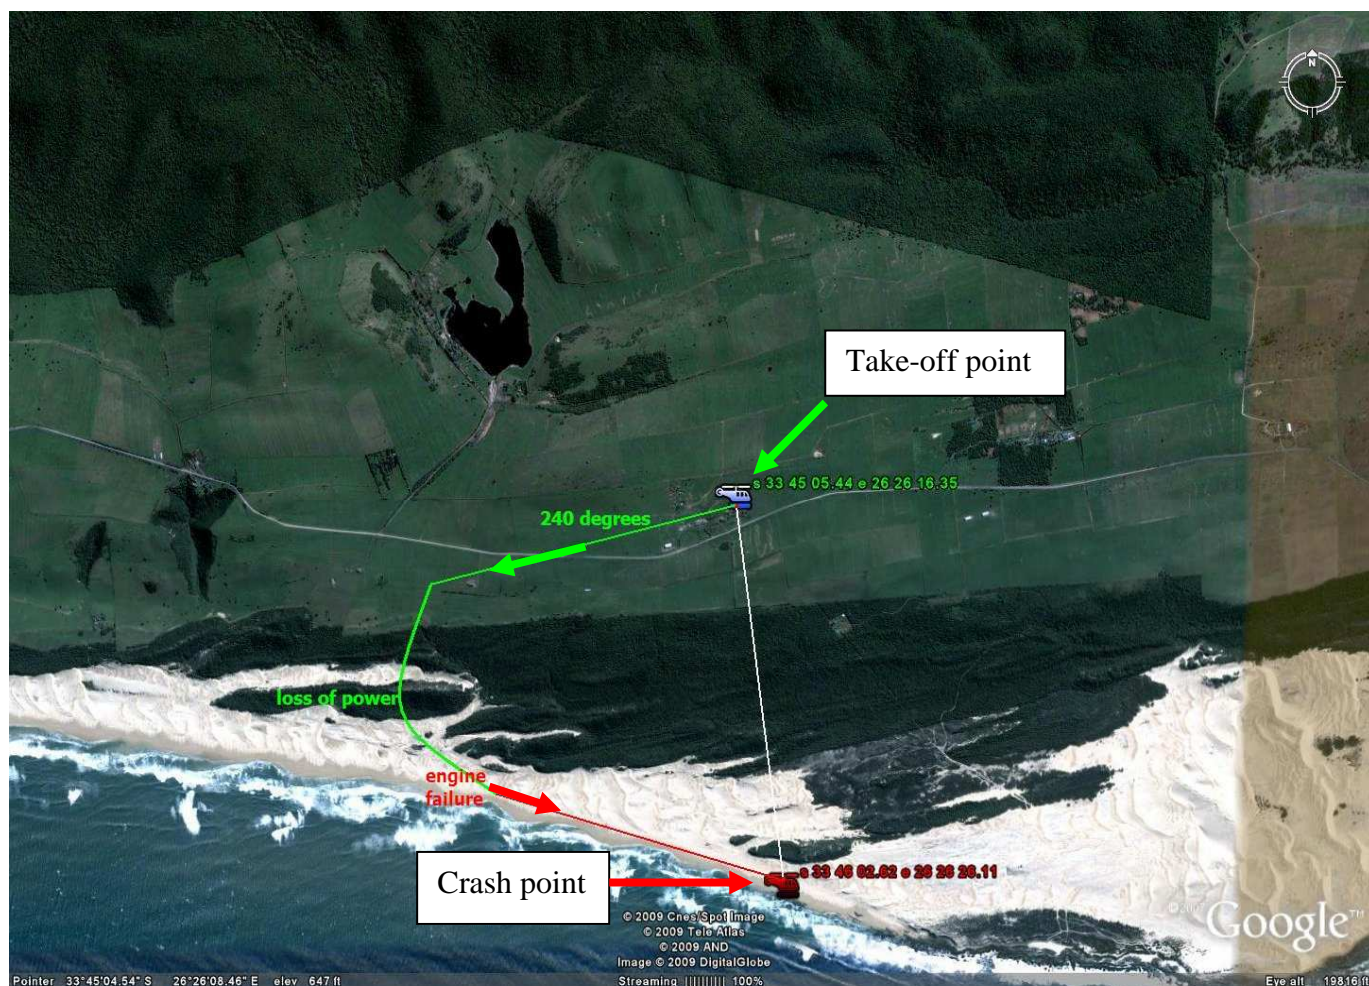
1.12.2 The aircraft impacted the ground, facing east, at the Woody Cape Beach at a geographical position of S33°0.752' E26°0.4377', elevation 121 ft.

Figure 5: The flight sequence to the crash point

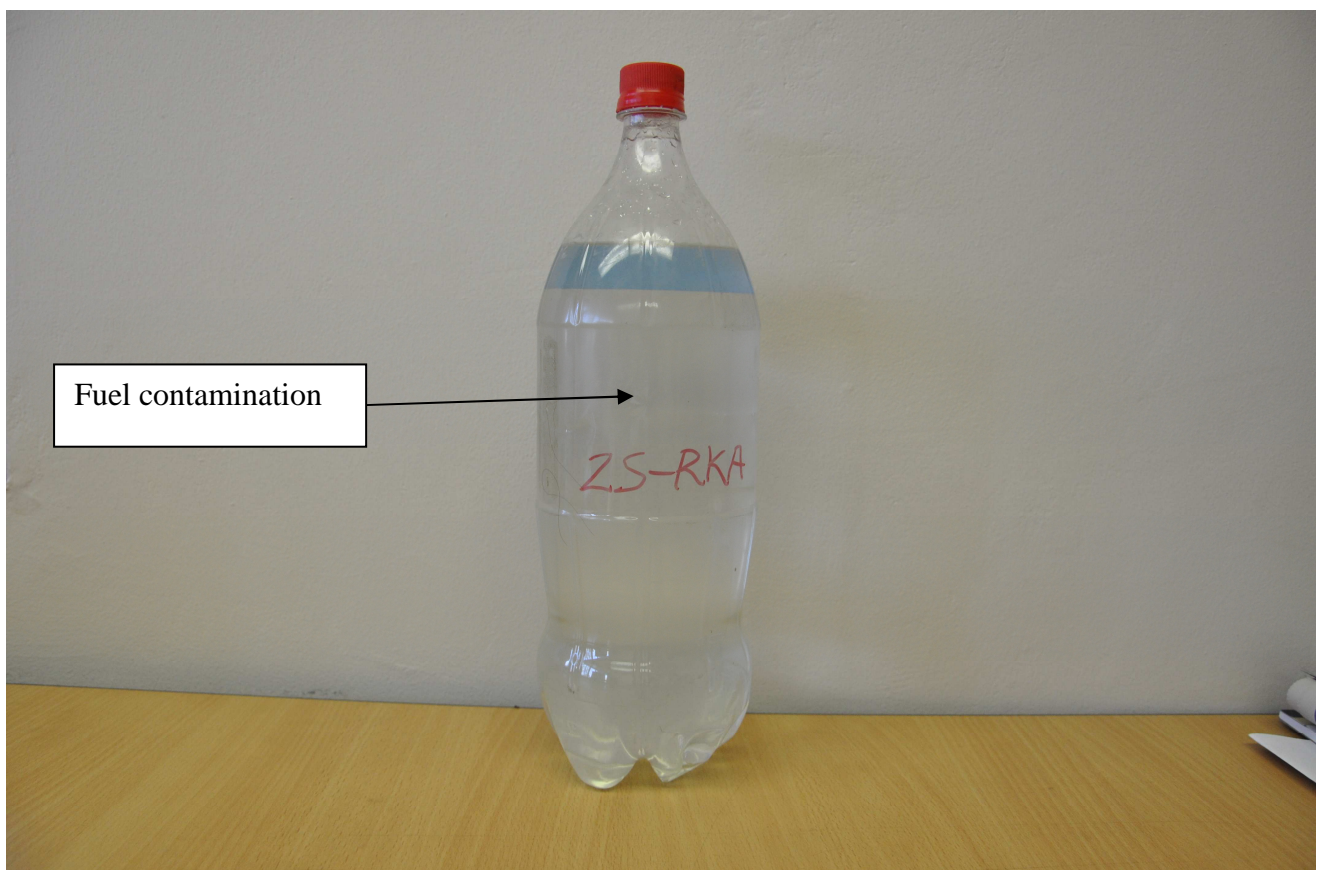
1.16.1 An onsite test investigation was conducted; the drum used to refuel the aircraft was found to have water in it.

Picture 6: Fuel contaminated by water

1.16.2 The aircraft maintenance organisation (AMO) that recovered the helicopter found three litres of water in the fuel tanks. Water was also evident in the gascolator and carburettor fuel bowls.

2.1.5 The AMO that recovered the helicopter found three litres of water in the fuel tanks and in the gascolator and carburettor fuel bowls. Referring to 1.18.3, a small quantity of fuel should be drained from the gascolator and from each tank using the quick drains prior to the first flight each day. Enough fuel should be drained to remove any water or dirt and checked for approved fuel colour. If fuel contamination is suspected, one should continue to drain fuel from gascolator and tank until all contamination is eliminated. Out of the tests and analysis, the conclusion was that fuel contamination was a contributory factor to the engine failure.

- 3.2.1 Engine failure due to fuel contamination, which resulted in the pilot executing a forced landing.
