AIRCRAFT ACCIDENT REPORT AND EXECUTIVE SUMMARY

Reference:	CA18/2/3/8658	
Aircraft Registration	ZS-MKG	Date of Accident	27 May 2009		Time of Accident	1050Z
Type of Aircraft	Cessna TU206F (Aeroplane)		Type of Operation		Commercial (Aerial Survey)	
Pilot-in-command Licence Type		Commercial	Age	22	Licence Valid	Yes
Pilot-in-command Flying Experience		Total Flying Hours	329.9		Hours on Type	130.7
Last point of departure		Wonderboom Aerodrome (FAWB)				
Next point of intended landing		Wonderboom Aerodrome (FAWB)				
Location of the accident site with reference to easily defined geographical points (GPS readings if possible)						
Goedgevonden Cole mine near Ogies (GPS position: South 26°06.659' East 029°04.290', elevation 5170 feet)						
Meteorological Information		Surface wind; 270°/7 knots, Temperature; 20 °C, Visibility; +10km				
Number of people on board	1 + 1	No. of people injured	1 + 1	No. of people killed	0	
Synopsis						
<p>The pilot, accompanied by a camera operator, departed from Wonderboom Aerodrome at approximately 0830Z on the morning of 27 May 2009 on a geographical survey flight in the Bethal and Kriel area.</p> <p>After being airborne for approximately two hours, the

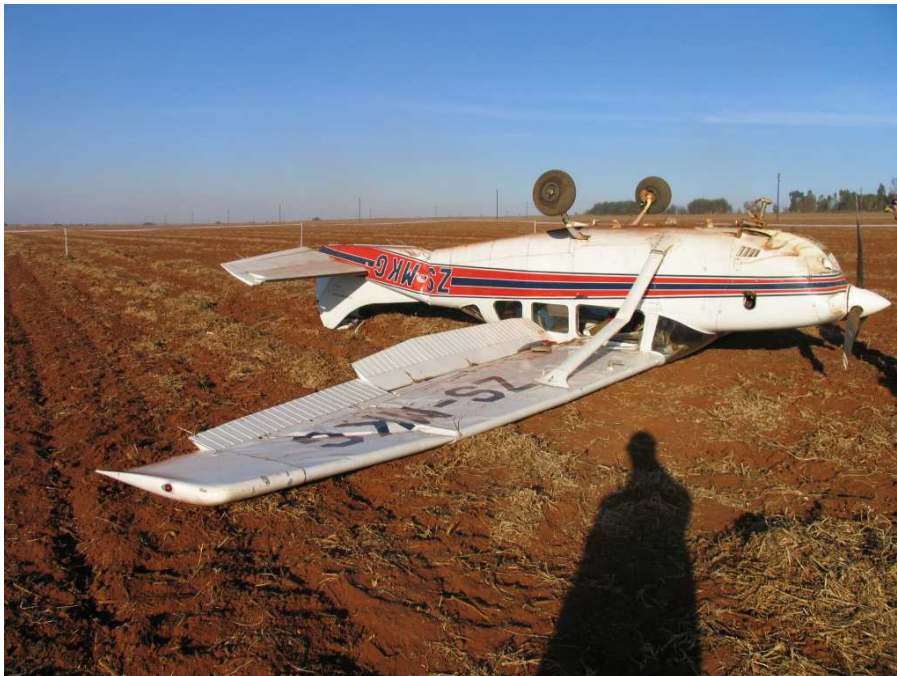
- 1.3.1 The aircraft was substantially damaged when the nose wheel broke off during the forced landing and the aeroplane nosed over.

Figure 1. A view of the aircraft as it came to rest in an inverted attitude in a ploughed field.

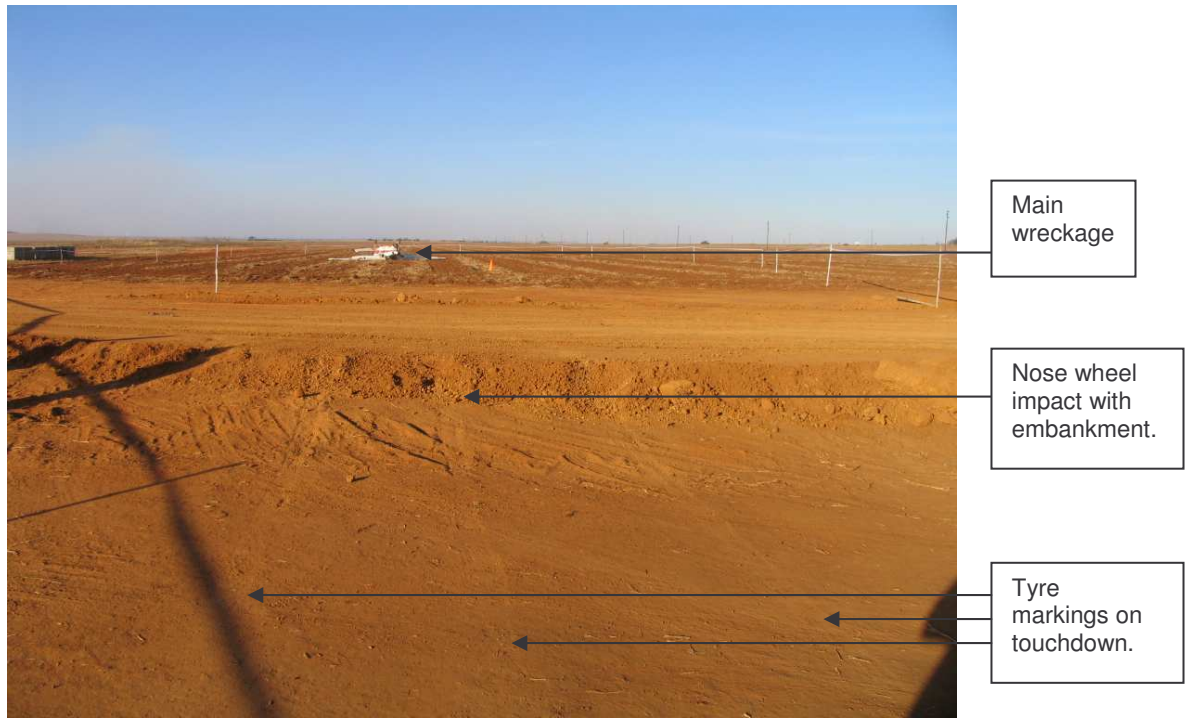
1.12.2 The first ground markings were caused by the tyres as the pilot landed on level ground. Thirteen metres after the touchdown, the nose wheel and two main wheels collided with an embankment on the edge of a mine service road running diagonally across the aeroplane's path. The road surface was elevated approximately 40 cm above the level ground surface where the aircraft touched down initially. The aircraft bounced back into the air, and simultaneously the nose wheel broke off. (The wheel was afterwards located 73 m further on along the wreckage path, and the nose gear strut and left wing impact markings were found 20m past the wheel. The strut dug into the soft soil of the ploughed field and the aircraft nose over, coming to rest in an inverted attitude some 10 m further on, 103 m past the embankment.

Figure 2. Indicate the touchdown point of the aircraft (tyre markings) as well as the embankment.

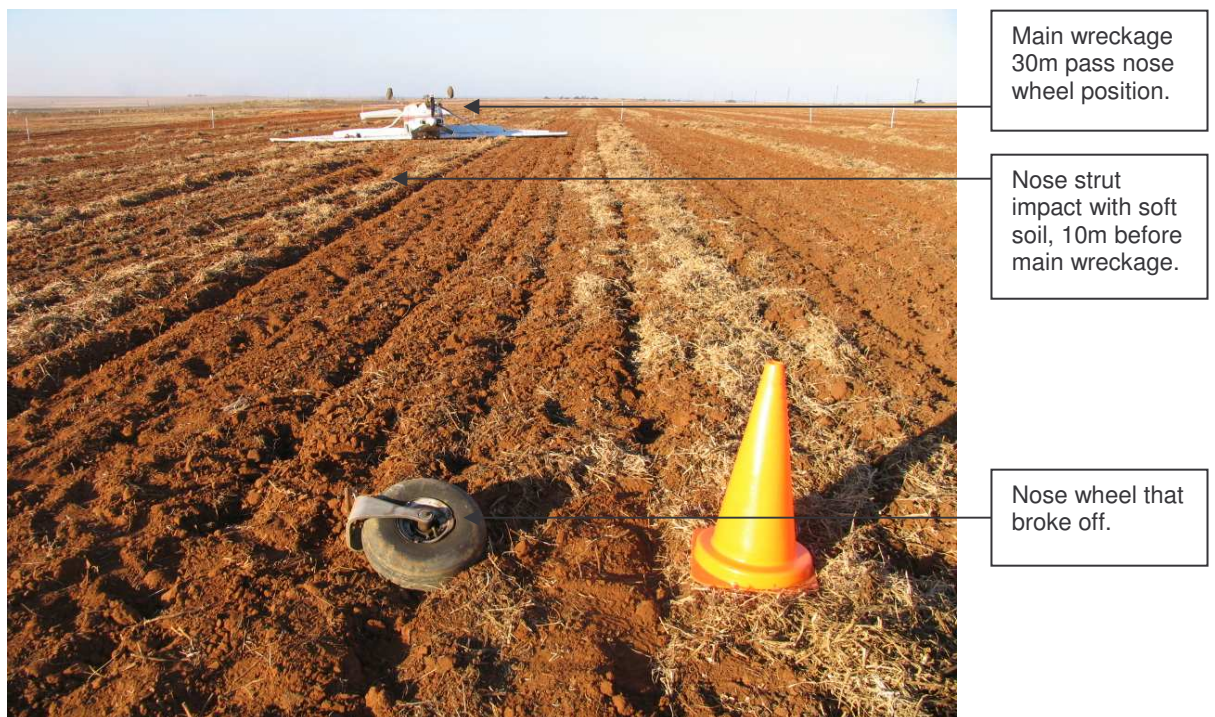
Figure 3. Indicate position of the nose wheel and main wreckage.

- 3.1.8 During the forced landing the aircraft collided with an embankment, which caused the nose wheel to break off. The aeroplane bounced, and on striking the ground again, nosed over.

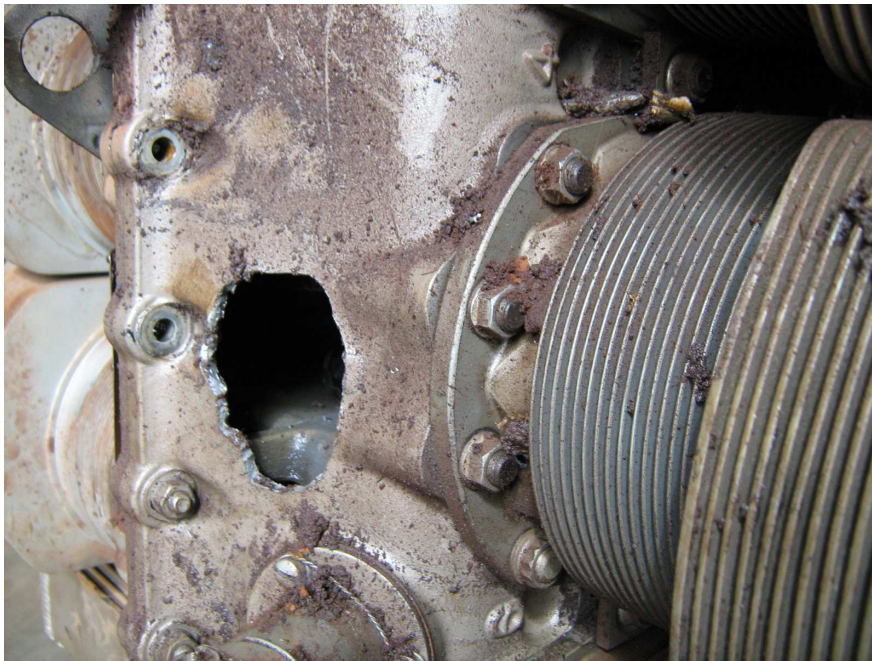
- The conrods from cylinders No's 4 and 5 failed in the area of the upper conrod cap.
- The crankshaft journals No. 4 and 5 display evidence of smearing caused during the failure sequence of the big-end bearings.
- The crankcase had a hole of approximately 100mm in diameter in the upper casing area in line with No. 4 cylinder.

Figure 4: View of the hole in the crankcase in line with the No. 4 cylinder.

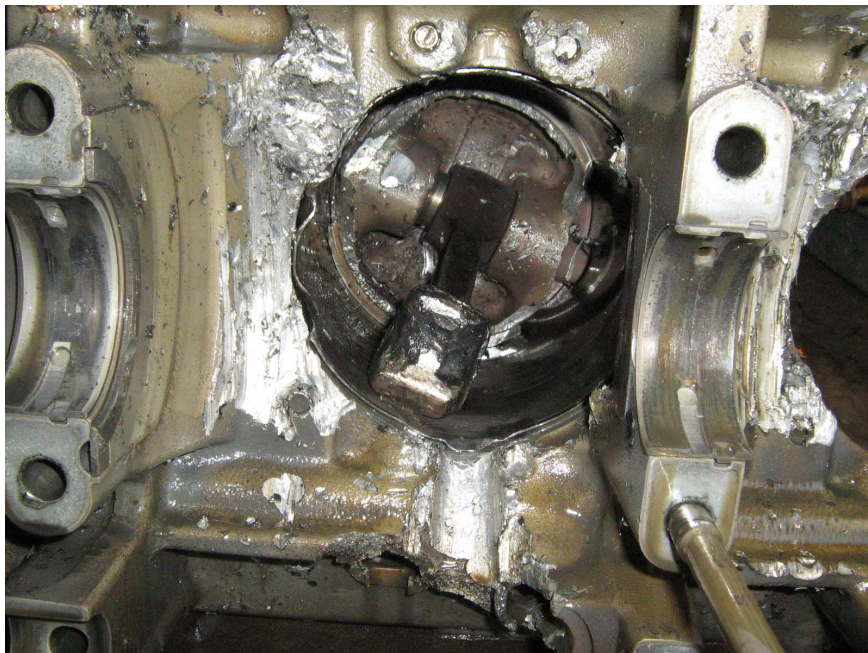
and 6 from the crankcase assembly. It was, however, impossible to remove the pistons and conrods from these cylinders due to severe damage they had sustained during the failure. It was also impossible to remove cylinder No. 5 from the crankcase due to extensive internal damage.

Figure 5: A view of the failed conrod (No. 5), with severe internal engine damage visible.

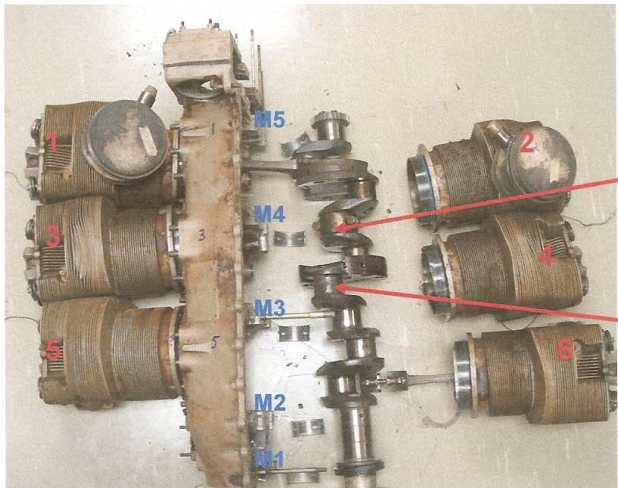
Photo 1: Supplied engine components (digital)

Failed Conrod/bearing No 4

Failed Conrod/bearing No 5

6.1. **Visual and Stereo- Microscope Investigation.** The visual inspection revealed extensive damages to the number 4 and 5 connecting rods (Photo 1), corresponding bearings and inner walls of the crankcase. The crankshaft serial number is depicted in Photo 2 and is of VAR quality (Photo 3).

The pistons showed no clear signs of pre-detonation or other damages (Photo 1).

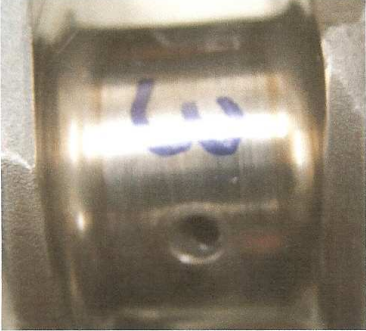
Photo 10: Remainder of crankpin surfaces (digital)

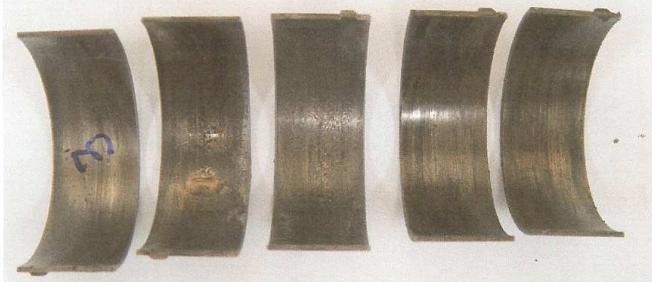
Due to extensive damages, the remains of both the number 4 and 5 sleeve bearings (Photo 7) revealed no clear indications toward the failure mechanism/s during operation. The remainder of the big end sleeve bearings revealed signs of extensive metal impregnation (Photo 12) prior to final failure of the engine. This proved to be an indication that lubricant was available and under pressure during operation.

Photo 12: Remainder of big end bearings showing metal impregnation (digital)

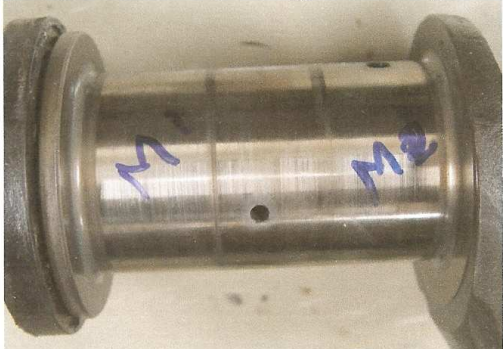
The main bearings (Photo 1, M1-5) proved to be in relative good condition (Photo's 13 and 14) except for various levels of metal impregnation on the corresponding bearing surfaces (Photo 15). The oil feed lines toward the crankpin surfaces showed no signs of blockage. Again, the metal impregnation and relative low temperature exposures to the main bearings positions are an indication of available lubricant under pressure.

Photo 13: Condition of main bearing surfaces (digital)

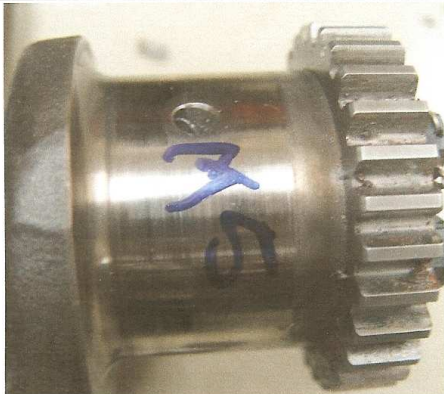
Photo 14: Condition of main bearing surfaces (digital)

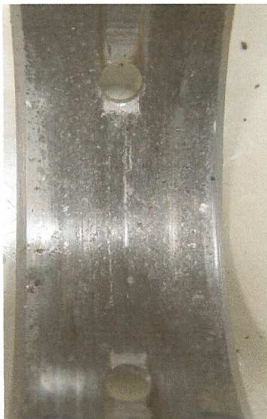
Photo 15: Main sleeve bearing surfaces showing metal impregnation (digital)
