# AIRCRAFT ACCIDENT REPORT AND EXECUTIVE SUMMARY

| | | | | Reference: | CA18/2/3/8768 | |
| <b>Aircraft Registration</b> | <b>ZS-HFG</b> | <b>Date of Accident</b> | 12 March 2010 | | <b>Time of Accident</b> | 1200Z |
| <b>Type of Aircraft</b> | Bell Jet Ranger 206B (Helicopter) | | <b>Type of Operation</b> | | Private | |

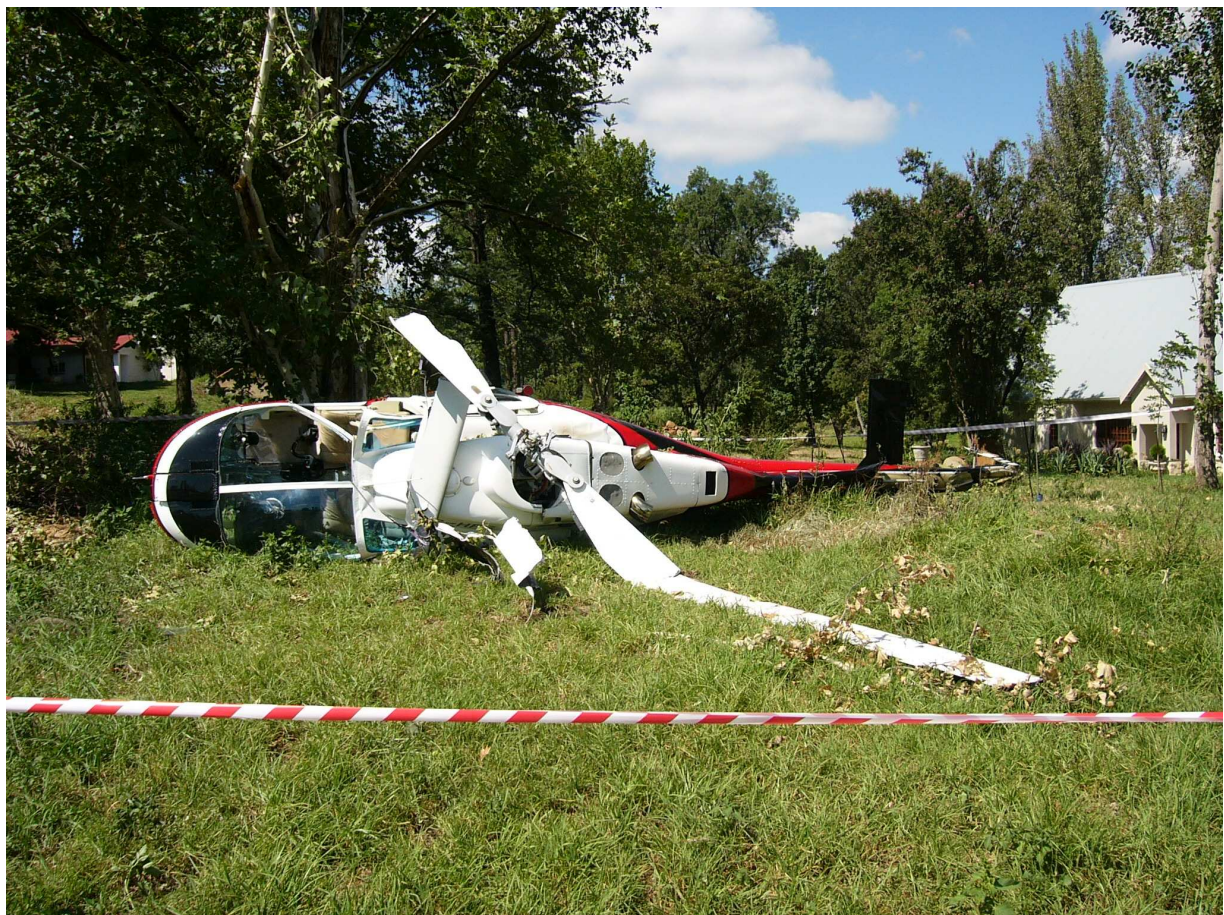
- 1.3.1 The aircraft was destroyed in the course of the accident. (See Figure 1.)

**Figure 1:** Damage caused to the helicopter because of the accident.

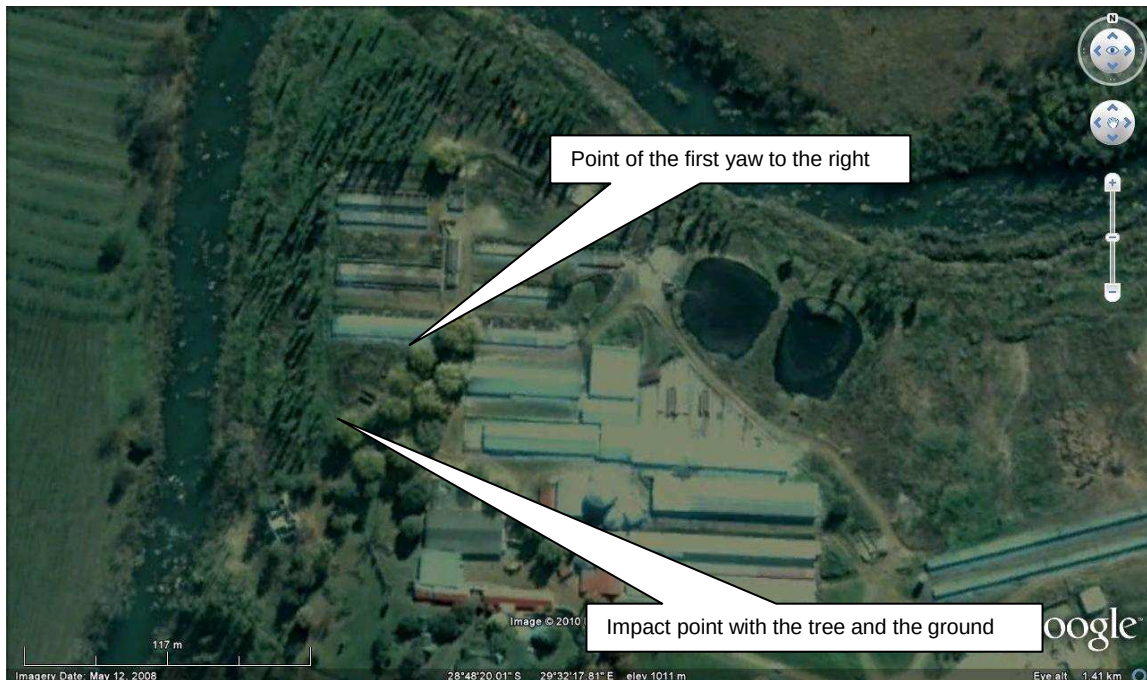
The accident site was at GPS position S 28°48'20" E 29°32'14" next to a hedgerow of tall trees (± 120-150 feet high). To the southern side of the trees were some tall

**Figure 2:** Accident site

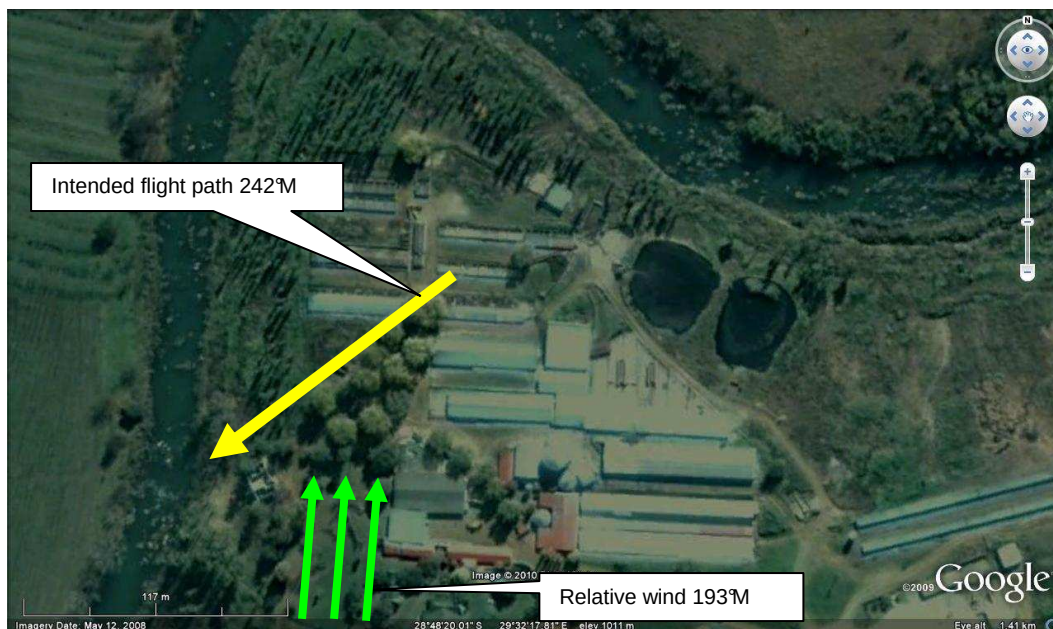
On the day of the accident, the intended flight path was at approximately 240-250°M with a relative wind of 193°M at 6 knots. (See Figure 3.)

**Figure 3:** Intended flight path and relative wind direction

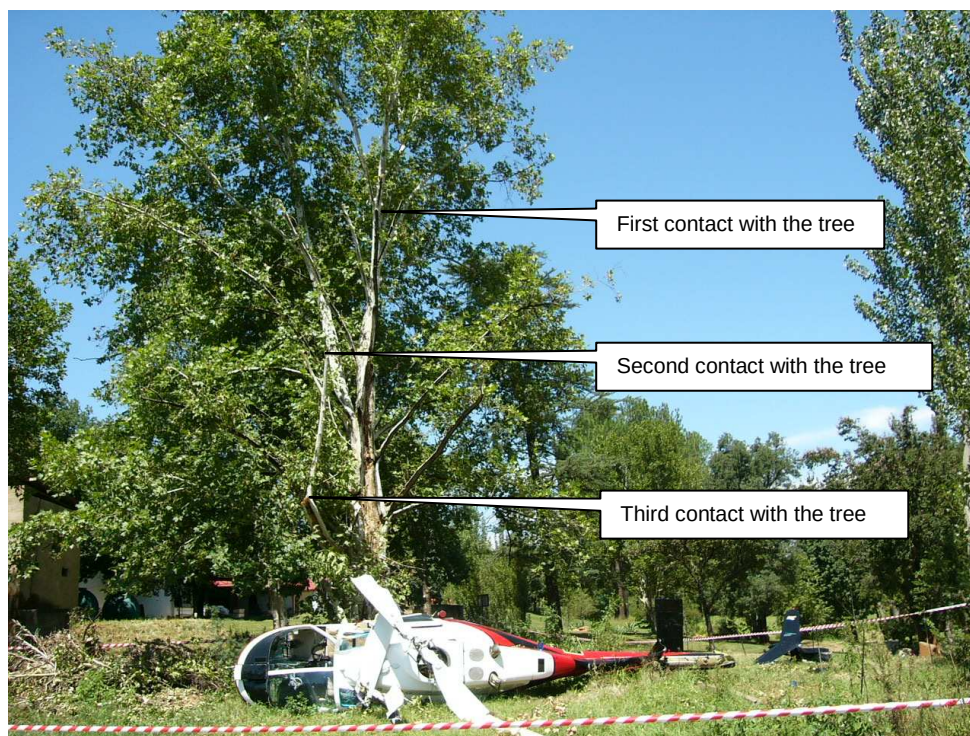
1.12.3 After the first sudden yaw to the right, the aircraft yawed to the right again in a north-westerly direction before the helicopter collided with a tree. (See Figure 3.) The main rotor blades made contact with the tree three times before the aircraft hit the ground. (See Figure 4.)

**Figure 4:** Main rotor blade contact marks with the tree before aircraft hit the ground.

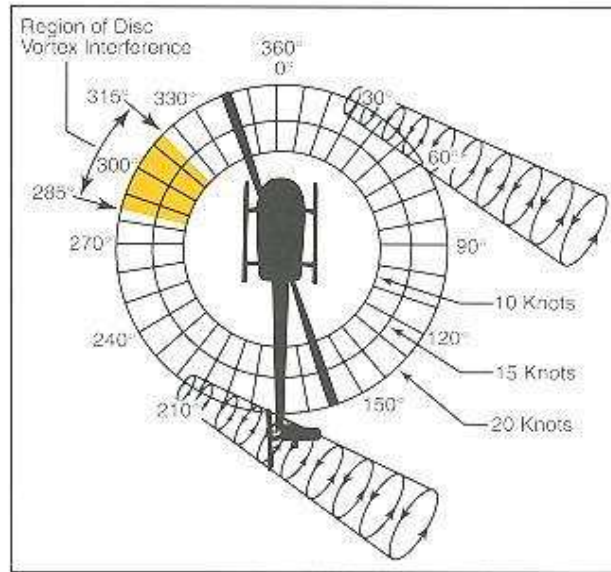
“During a right turn, the tail rotor experiences a reduction of thrust as it comes into the area of the main rotor disc vortex. The reduction in tail rotor thrust comes from the airflow changes experienced at the tail rotor as the main rotor disc vortex moves across the tail rotor disc. The effect of the main rotor disc vortex initially increases the angle of attack of the tail rotor blades, thus increasing tail rotor thrust. The increase in the angle of attack requires that right pedal pressure be added to reduce tail rotor thrust in order to maintain the same rate of turn. As the main rotor vortex passes the tail rotor, the tail rotor angle of attack is reduced. The reduction in the angle of attack causes a reduction in thrust and right yaw acceleration begins. This acceleration can be surprising, since you were previously adding right pedal to maintain the right turn rate. This thrust reduction occurs suddenly, and if uncorrected, develops into an uncontrollable rapid rotation about the mast. When operating within this region, be aware that the reduction in tail rotor thrust can

**Figure 5:** Main rotor disc vortex interference

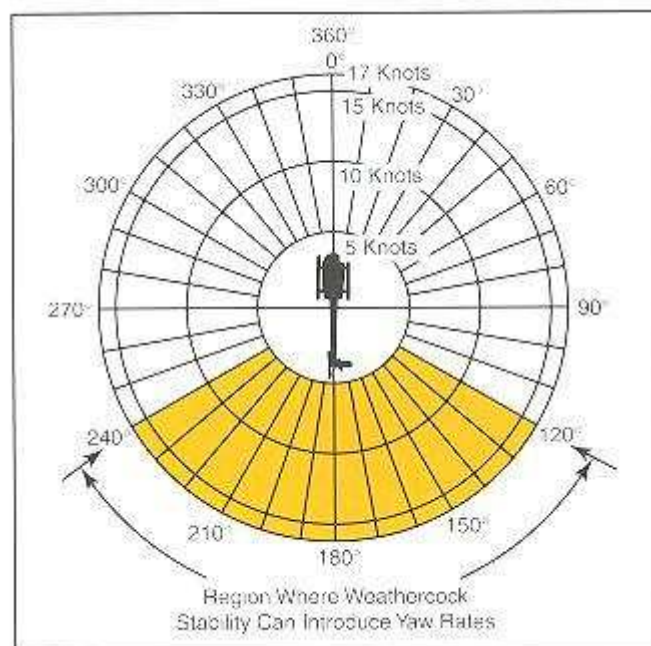
“In this region, the helicopter attempts to weathervane its nose into the relative wind. Unless a resisting pedal input is made, the helicopter starts a slow, uncommanded turn either to the right or left depending upon the wind direction. If the pilot allows a right yaw rate to develop and the tail of the helicopter moves into this region, the yaw rate can accelerate rapidly. In order to avoid the onset of LTE in this downwind condition, it is imperative to maintain positive control of the yaw rate and devote full attention to flying the helicopter.” (See Figure 6.)

**Figure 6:** Weathercock stability

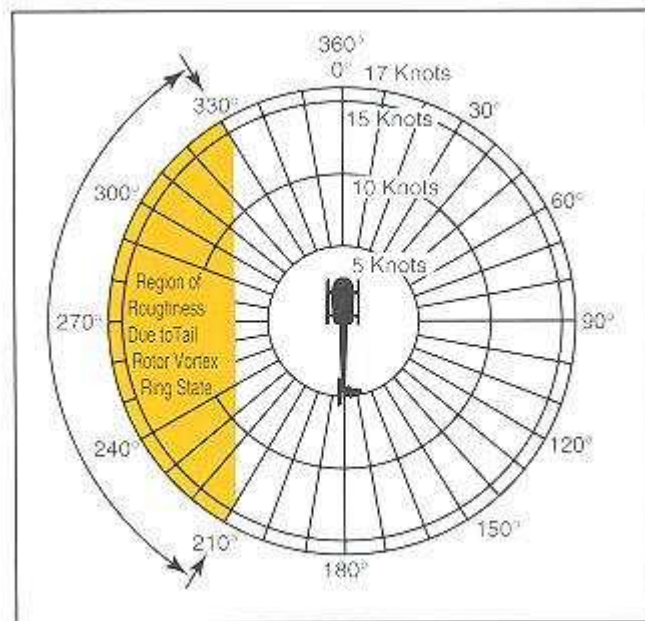
“Winds within this region cause a tail rotor vortex ring state to develop. The result is a non-uniform, unsteady flow into the tail rotor. The vortex ring state causes tail rotor thrust variations, which result in yaw deviations. The net effect of the unsteady flow is an oscillation of tail rotor thrust. Rapid and continuous pedal movements are necessary to compensate for the rapid changes in tail rotor thrust when hovering in a left crosswind. Maintaining a precise heading in this region is difficult, but this characteristic presents no significant problem unless corrective action is delayed. However, high pedal workload, lack of concentration and over controlling can all lead to LTE.

“When the tail rotor thrust being generated is less than the thrust required, the helicopter yaws to the right. When hovering in left crosswinds, you must concentrated on smooth pedal coordination and not allow an uncontrolled right yaw to develop. If a right yaw rate is allowed to build, the helicopter can rotate into the wind azimuth region where weathercock stability then accelerates the right turn rate. Pilot workload during a tail rotor vortex ring state is high. Do not allow a right yaw rate to increase.” **(See Figure 7.)**

**Figure 7:** Tail rotor vortex ring state

“If a sudden unanticipated right yaw occurs, the following recovery technique should be performed. Apply full left pedal while simultaneously moving cyclic control forward to increase speed. If altitude permits, reduce power. As recovery is affected, adjust controls for normal forward flight. Collective pitch reduction aids in arresting the yaw rate but may cause an excessive rate of descent. Any large, rapid increase in collective to prevent ground or obstacle contact may further increase the yaw rate and decrease rotor rpm. The decision to reduce collective must be based on your assessment of the altitude available for recovery. If the rotation cannot be stopped and ground contact is imminent, an autorotation may be the best course of
