AIRCRAFT ACCIDENT REPORT AND EXECUTIVE SUMMARY

Reference:	CA18/2/3/8789	
Aircraft Registration	ZU-VDW	Date of Accident	29/05/2010		Time of Accident	1030Z
Type of Aircraft	Aveko S.R.O. VL3A1 Flamingo		Type of Operation		Private (Air race)	
Pilot-in-command Licence Type		Commercial	Age	39	Licence Valid	Yes
Pilot-in-command Flying Experience		Total Flying Hours	1706,4		Hours on Type	16,2
Last point of departure		FARG (Rustenburg)				
Next point of intended landing		FARG (Rustenburg)				
Location of the accident site with reference to easily defined geographical points (GPS readings if possible)						
Near Bela-Bela at GPS position S 24° 54' 27.00" & E028° 14' 54.00" at an elevation of 3674 ft / 1120 m AMSL						
Meteorological Information		Fine weather conditions prevailed at the time of the accident with a light south-westerly wind, mild temperature and no cloud.				
Number of people on board	1+1	No. of people injured	0	No. of people killed	1+1

Synopsis		<p>On 29 May 2010, the aircraft (ZU-VDW) took part in the President's Trophy race.</p> <p>During descent the left wing failed as a result of flutter. The aircraft crashed at approximately 1030Z in clear daytime conditions near Bela

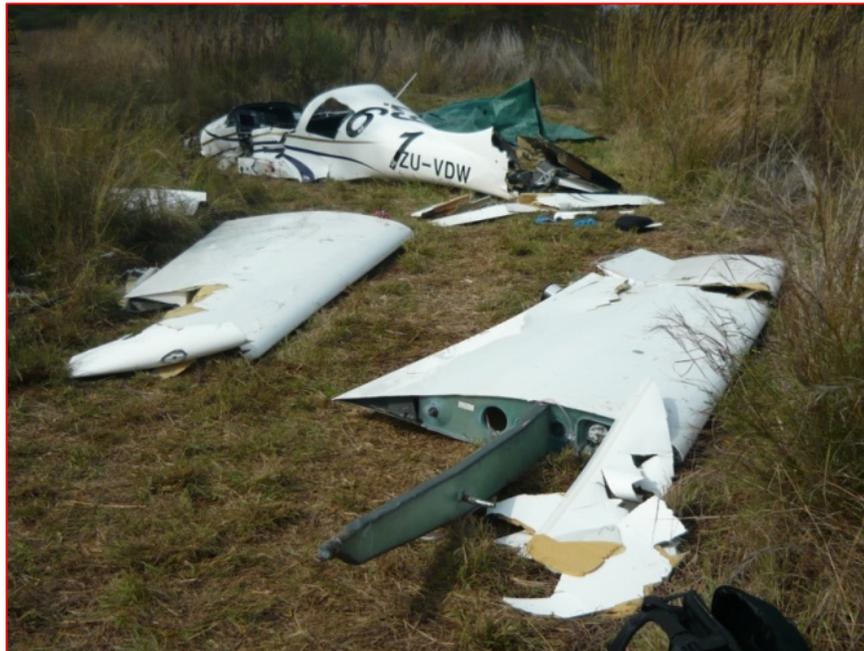
1.3.1 The aircraft was destroyed during the accident sequence.

Fig 2: View of the aircraft wreckage after the wings were recovered

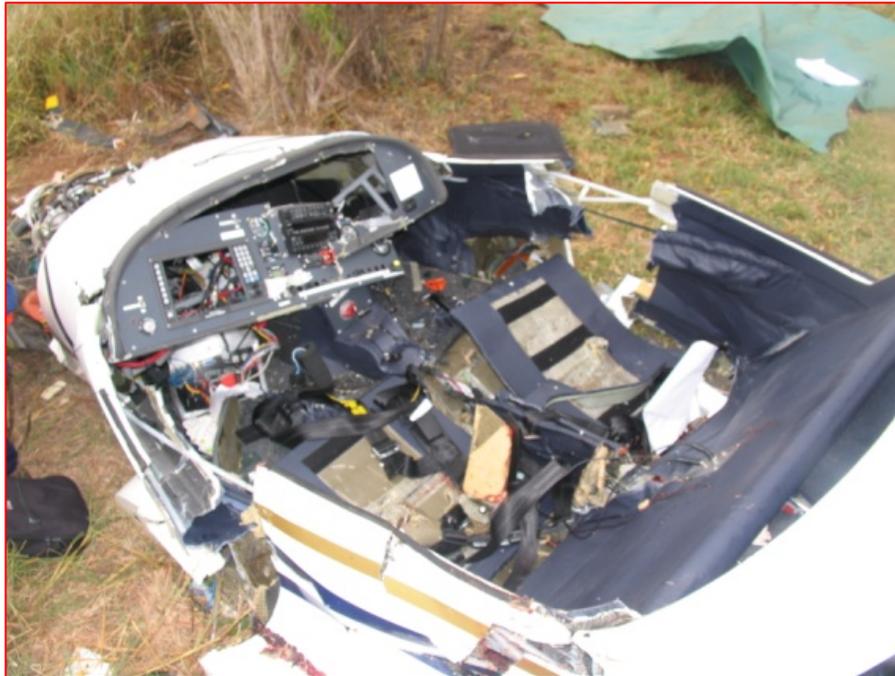
Figure 3: View of the cockpit area

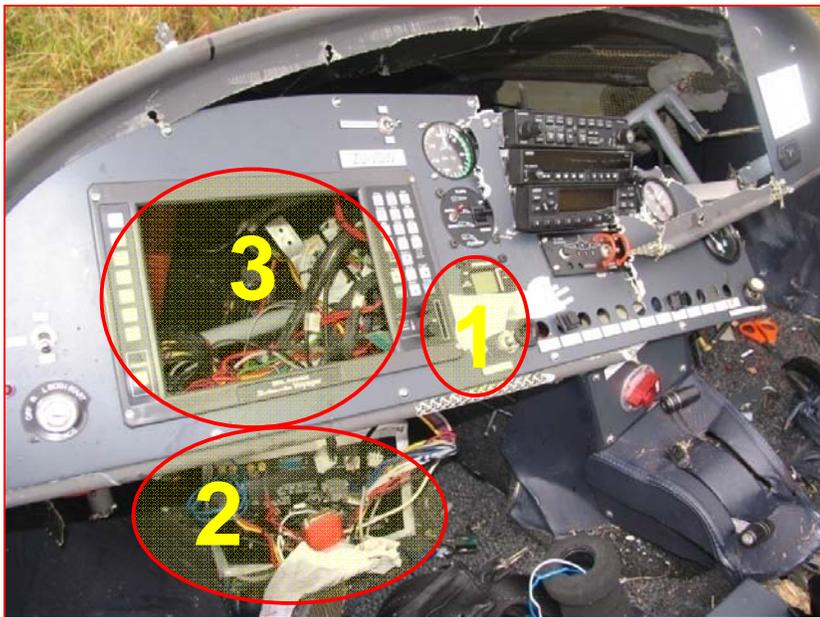
- 1.8.2 The aircraft was also equipped with an MGL EFIS (Electronic Flight Instrument Systems) VOYAGER (see Fig 5). After removal this device was sent to the agents in Cape Town to be downloaded. The report-back received from the agents was that no information could be retrieved as the memory card used in this device was not present in the device. The aircraft owner advised telephonically that to the best of his knowledge no memory card had ever been installed in this device; therefore no navigational data could be extracted from the unit.

Figure 5: Circle 1 indicates the slot for the memory card. Circle 2 indicates the position of the EFIS after the accident and circle 3 the normal position of fitment for the EFIS.

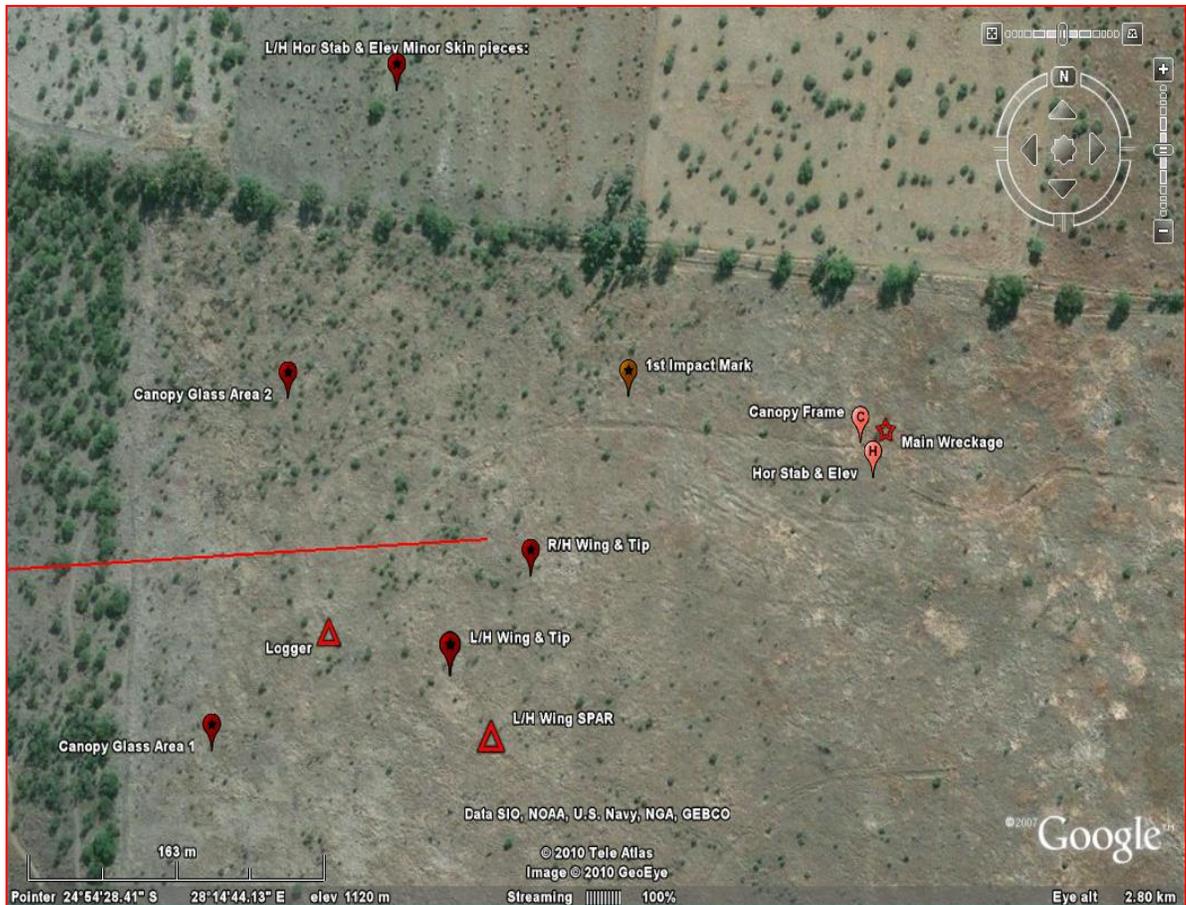
1.12.1 All the major components were located at positions as indicated on the diagram (see fig 7).

easterly direction and finally stopped facing the direction 87°M. The position of the initial impact point was recorded as S24°54'27.48" & E28°14'44.75" at an elevation of 3674 ft / 1120 m AMSL (see Fig 7).

Figure 7: Wreckage distribution on accident site
reference: Google Earth

1.12.5.1 The R/H wing was located approximately 203 m SW of the main wreckage at a GPS position recorded as S24°54'30.27" & E28°14'42.84".

1.12.5.2 The L/H wing was located approximately 259 m SW of the main wreckage at a GPS position recorded as S24°54'31.83" & E28°14'41.25".

1.12.5.3 The L/H wing spar was located approximately 265 m SW of the main wreckage at a GPS position recorded as S24°54'32.78" & E28°14'42.07".

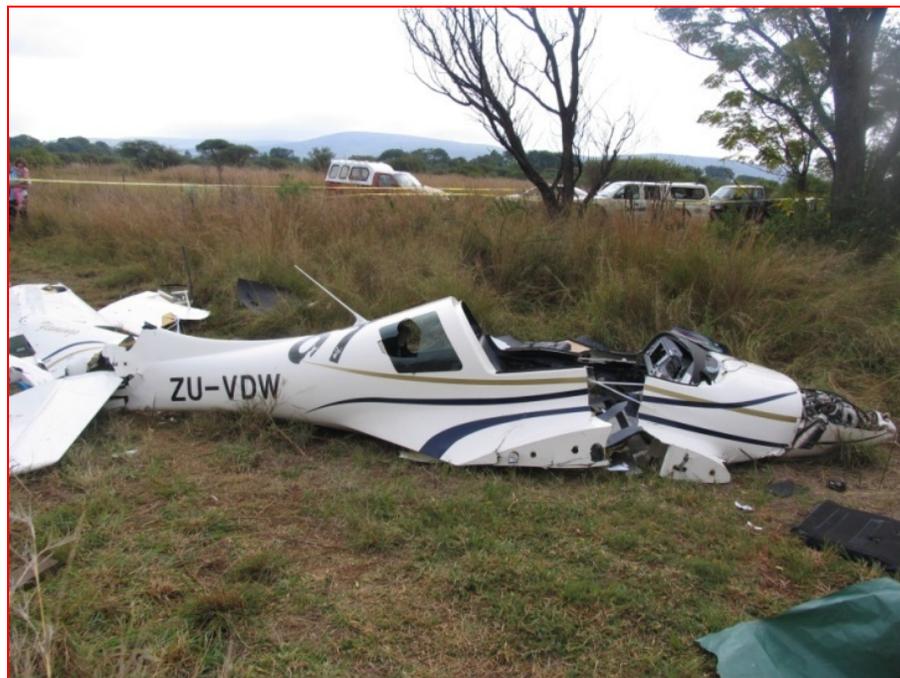
Figure 8: Aircraft main wreckage

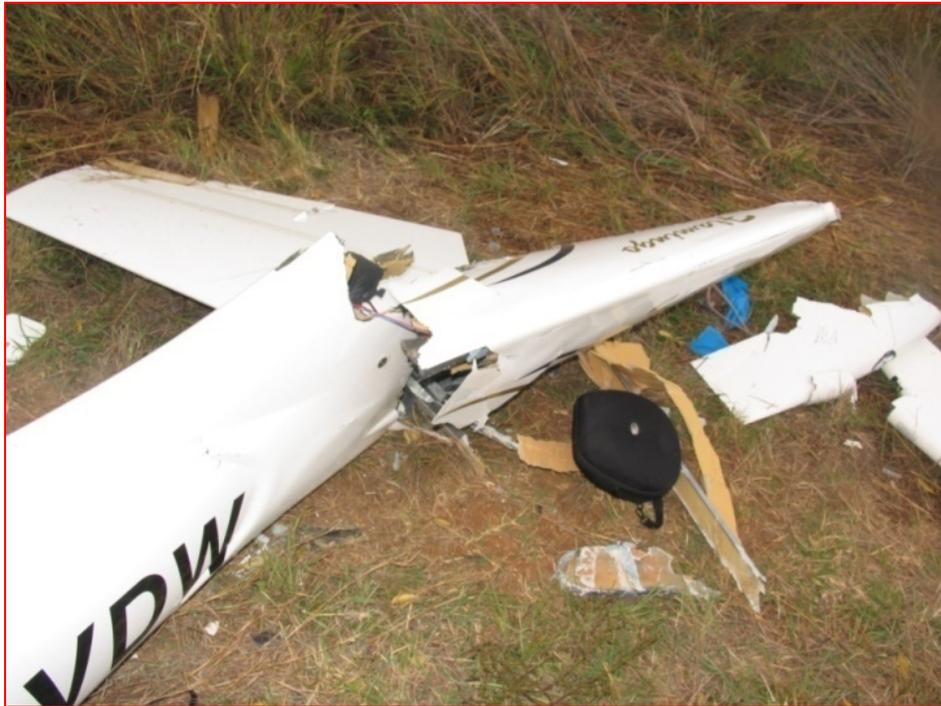
1.12.7 Horizontal Stabiliser & Elevator (see Fig 9)

- 1.12.7.1 The main spar of the horizontal stabiliser was still attached to the main wreckage. However, the skin of both the L/H horizontal stabiliser and the L/H elevator were stripped partially from the spar. Pieces of the skin were located in close proximity to the main wreckage and also 318 m NW of the main wreckage at a GPS position recorded as S24°54'22.80" & E28°14'40.20".

Figure 9: Aircraft empennage area

- 1.18.6.3 The pilot commenced his descent at 23,47158 km from where the wreckage was located.
- 1.18.6.4 The manufacturer advised that some modifications have been made to the aircraft since this accident. These modifications are intended to reduce the vibrations reported and include covering the gap between the elevator and the horizontal stabilizer with Teflon tape. In addition some reinforcements have been added to the mounting bracket for the elevator control arms.

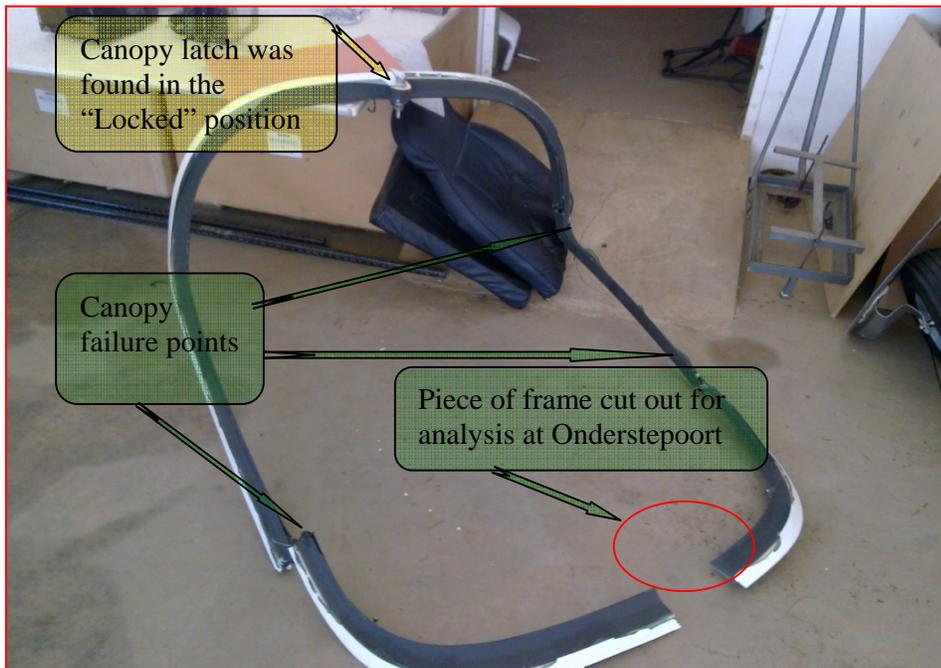
1.12.6 Canopy (see Fig 10)

- 1.12.6.1 The canopy frame was located at the main wreckage, but the canopy glass had disintegrated in flight and was located in two different areas as shown in fig 7.
- 1.12.6.2 Although witnesses stated that there were various birds in the direct vicinity of the aircraft at about the same time that the aircraft's wings separated from the airframe, no conclusive evidence of bird strike could be found.
- 1.12.6.3 Pieces of canopy glass, soiled with a fatty deposit, were recovered from the accident site and were submitted to the Onderstepoort Veterinary Centre / Clinic (Pathology) for investigation. The purpose was to determine whether these deposits were of an animal nature. The results proved negative.

Figure 10: Canopy frame

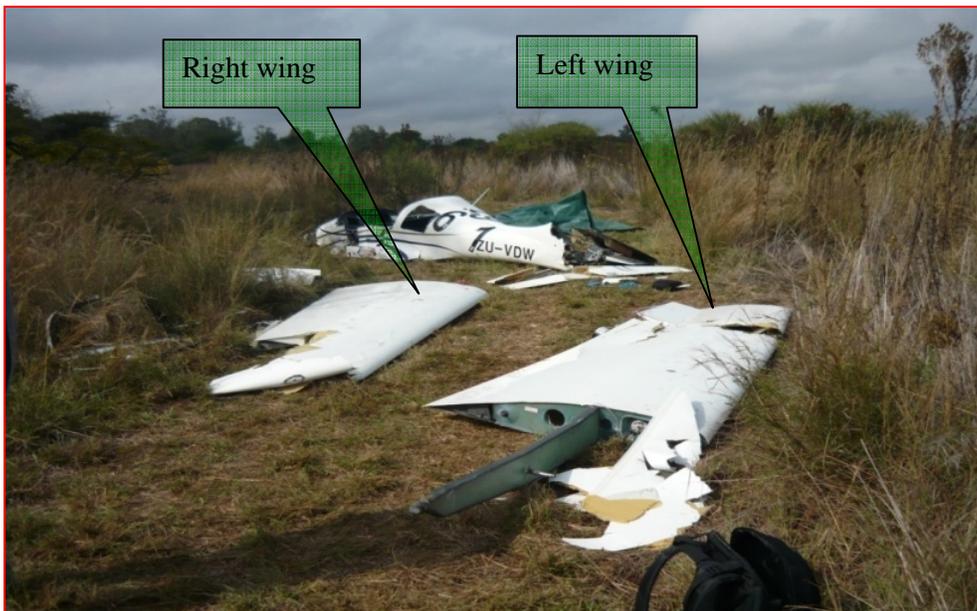
Figure 11: LH & R/H wing after recovery

- 2.7 Of all the possible causes of wing failure considered, the most likely cause was flutter.
- 2.8 Neither of the occupants was wearing their shoulder harnesses, as these were still tied up with cable wraps.

- 3.2.1 Wing flutter was considered to be the main cause of the wing failure.

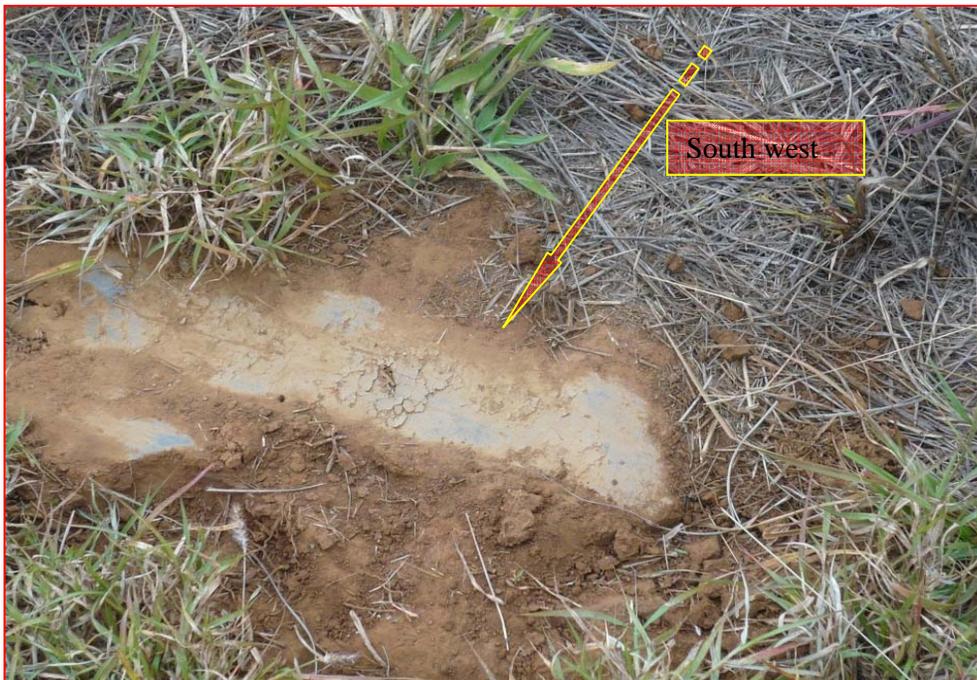
Figure 12: Initial impact point of the fuselage with the arrow indicating the direction of movement

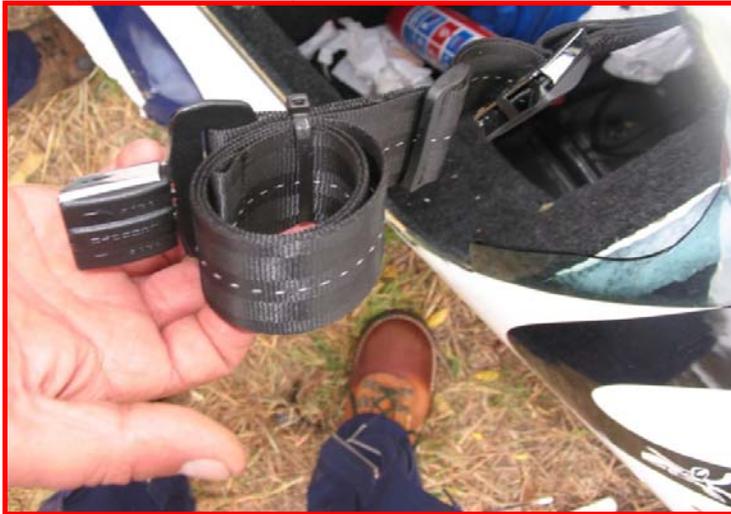
1.15.3 Neither of the occupants made use of the shoulder harnesses, as these were still tied up with cable wraps at the time of the accident.

Figure 13: Both shoulder harnesses were tied up with cable ties, i.e. not worn

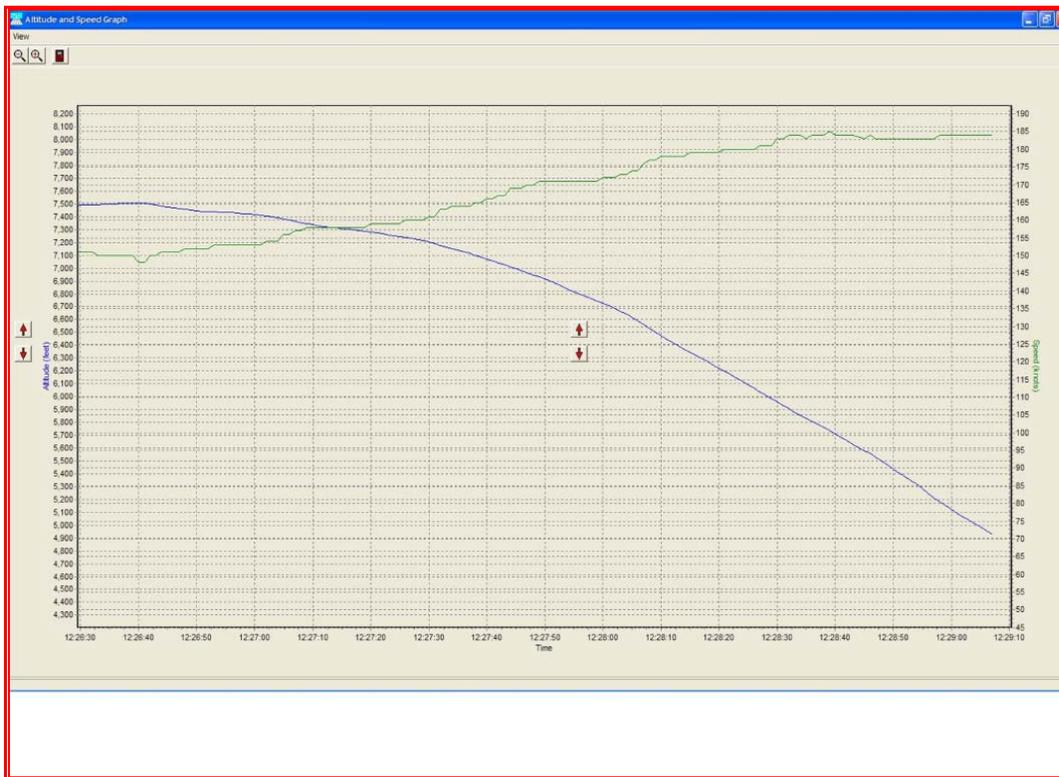
From the logger it was determined that he descended at 445 ft / min during the 1st minute after commencing the descent. During the 2nd minute after commencing the descent he descended at 1360 ft / min and at 774 ft / min during the last 27 seconds recorded.

Figure 15: Last 3 minutes of the logger recording

- 1.16.12 The diagram (Figure 15) showed that during the accident flight the aircraft was logged doing a straight and level ground speed of 152 kts. Bearing in mind that the aircraft was tested at 142 kts (TAS) maximum speed, it can be deduced that there was a 10 kt tailwind.

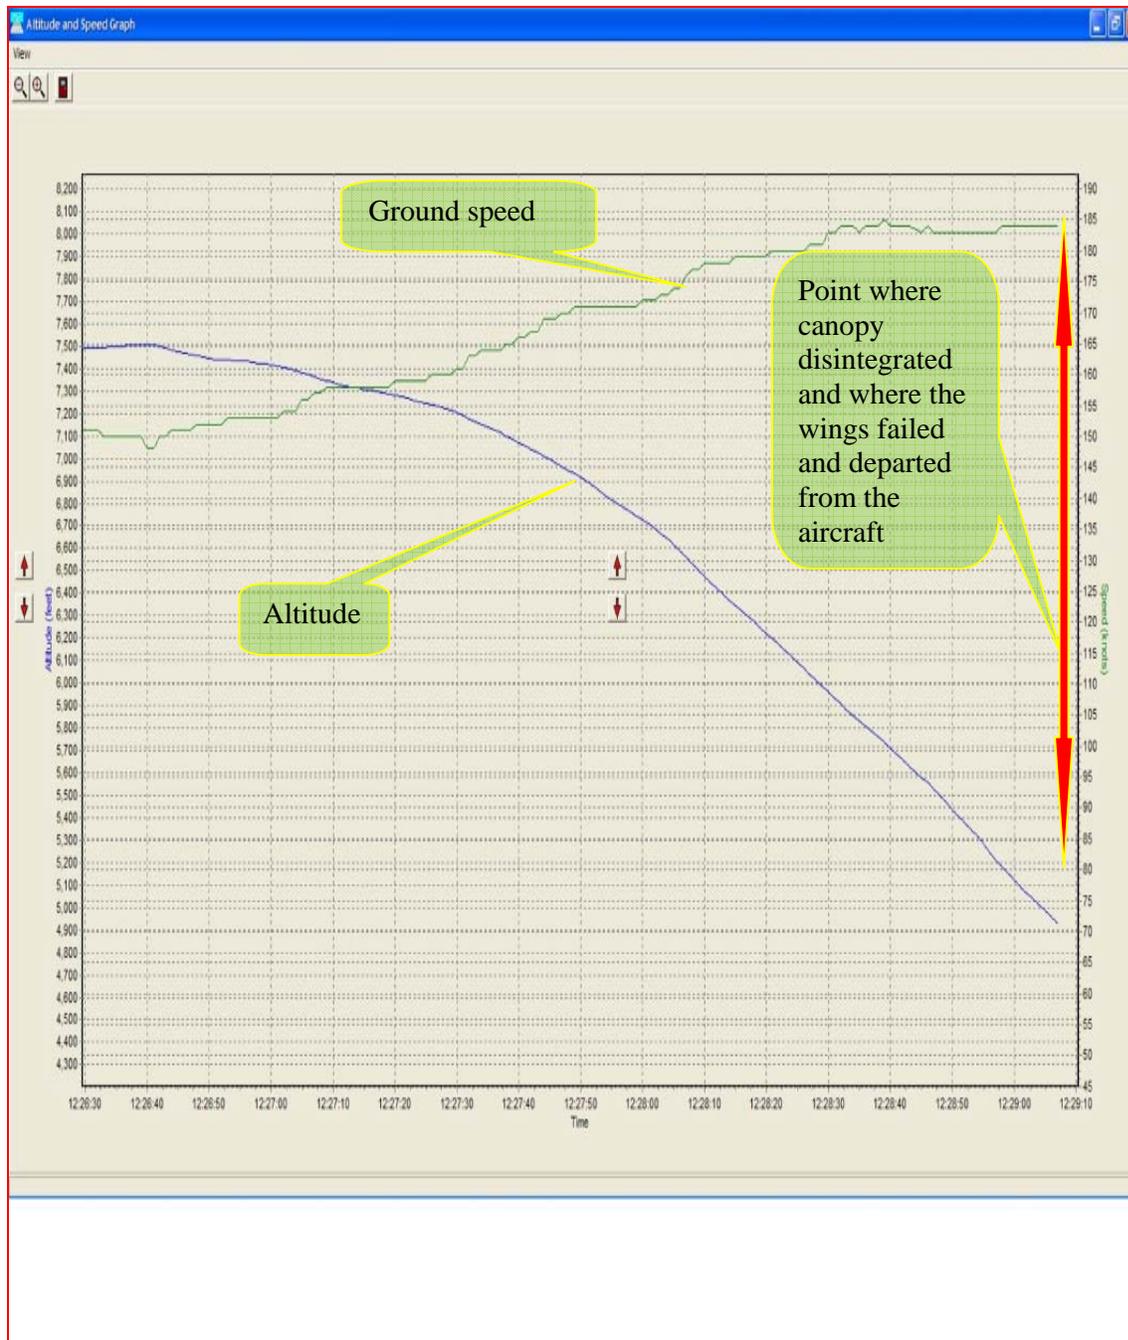
1.18.5 The logger stopped functioning at 12h29:07B, at a GPS position of S24° 54,495" & E028° 14,700", an altitude of 4926 ft AMSL and at a GS (ground speed) of 184 kts. It can be concluded from this information that this was the point where the canopy glass disintegrated and where the wings failed and departed from the aircraft.

Figure 16: Logger details of the last 3 minutes of recording

It is therefore recommended that during air races, such as the President's Trophy, the organisers ensure that the logger devices are downloaded at the end of each race day and that pilots who exceeded the flight envelope of the aircraft in any respect should be disqualified from the race with immediate effect and reported to the authorities (SACAA) for further possible action.
