AIRCRAFT ACCIDENT REPORT AND EXECUTIVE SUMMARY

Reference:	CA18/2/3/8812	
Aircraft Registration	ZU-ASL	Date of Accident	22 July 2010		Time of Accident	1445Z
Type of Aircraft	Bushbaby 450		Type of Operation		Private	
Pilot-in-command Licence Type		MPL (Microlight)	Age	42	Licence Valid	Yes
Pilot-in-command Flying Experience		Total Flying Hours	136,45		Hours on Type	61,05
Last point of departure		New Tempe Bloemfontein (FATP)				
Next point of intended landing		New Tempe Bloemfontein (FATP)				
Location of the accident site with reference to easily defined geographical points (GPS readings if possible)						
Private farm 15 miles south of New Tempe Aerodrome						
Meteorological Information		Surface wind: Easterly, 3 knots; temperature: 14°C; V isibility: CAVOK				
Number of people on board	1+1	No. of people injured	0	No. of people killed	0	
Synopsis						
<p>On 22 July 2010, at approximately 1400Z, the pilot accompanied by a passenger took off from New Tempe Aerodrome on a local pleasure flight with the intention of returning to New Tempe after the flight. The pilot stated that the aircraft developed a severe vibration coming from the engine, approximately 45 minutes into the flight.

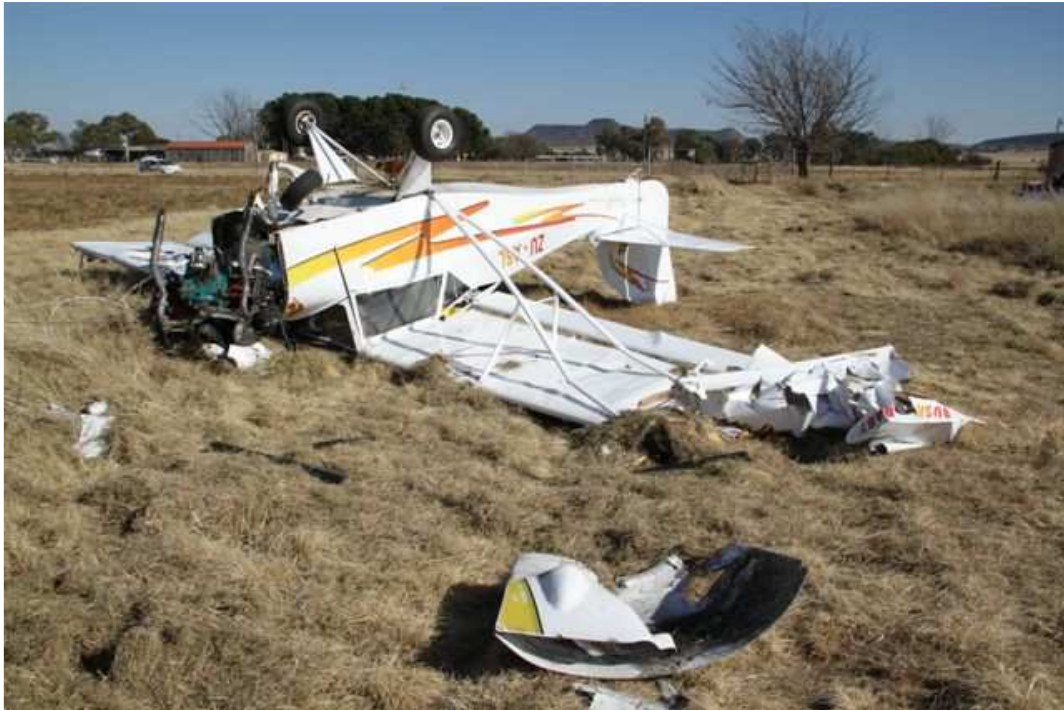
1.3.1 The aircraft sustained substantial damage to the nose gear, the wings, and the tail.

FIGURE 1: Damage to the aircraft

1.12.1 The accident site was flat, grassy terrain on a private farm about 20 km outside Bloemfontein. During the landing sequence, the aircraft hit a mound of soil and nosed over, coming to rest in an inverted position.

1.12.2 The aircraft sustained substantial damage. The integrity of the flight control system was established and all parts of the aircraft were accounted for at the accident site.
