AIRCRAFT ACCIDENT REPORT AND EXECUTIVE SUMMARY

Reference:	CA18/2/3/8893	
Aircraft Registration	ZU-RDS	Date of Accident	5 February 2011		Time of Accident	1030Z
Type of Aircraft	Magni Gyro M16		Type of Operation		Private	
Pilot-in-command Licence Type		Gyroplane	Age	55	Licence Valid	Yes
Pilot-in-command Flying Experience		Total Flying Hours	233.0		Hours on Type	233.0
Last point of departure		Bucks Private Aerodrome (10 km south of the town of Douglas) (Northern Cape province)				
Next point of intended landing		Bucks Private Aerodrome (10 km south of the town of Douglas) (Northern Cape province)				
Location of the accident site with reference to easily defined geographical points (GPS readings if possible)						
On a private aerodrome (Bucks Aerodrome) at the GPS position S 29°5'16" E 23°43'49"						
Meteorological Information		Wind: 340°TN/06 knots; Temperature: 25°C; Dew Point : 15°C; Visibility: >10 km; Clouds: 3-4 eights at 3500 ft.

Name of Owner/Operator : A.J. Greedy
Manufacturer : Magni Gyro
Model : Magni M16
Nationality : South African
Registration Marks : ZU-RDS
Place : Bucks Aerodrome near Douglas (Northern Cape province)
Date : 5 February 2011
Time : 1030Z

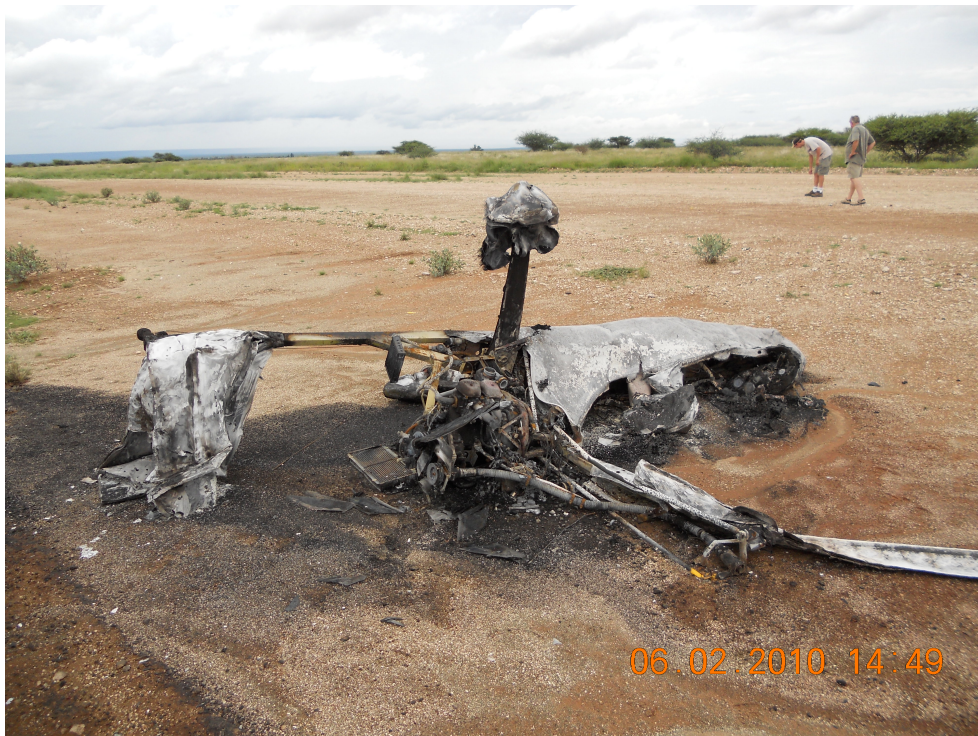
1.3.1 The gyrocopter was consumed by the post-impact fire after coming to rest on its right side. (See Fig. 1)

Figure 1 A view of the wreckage.

- 1.14.1 The gyrocopter was consumed by the post-impact fire which was caused by a ruptured fuel tank which caused a fuel spillage onto the hot engine and exhaust manifold. The fire was extinguished by the eye-witness who rushed to the scene of the accident and made use of a fire extinguisher.

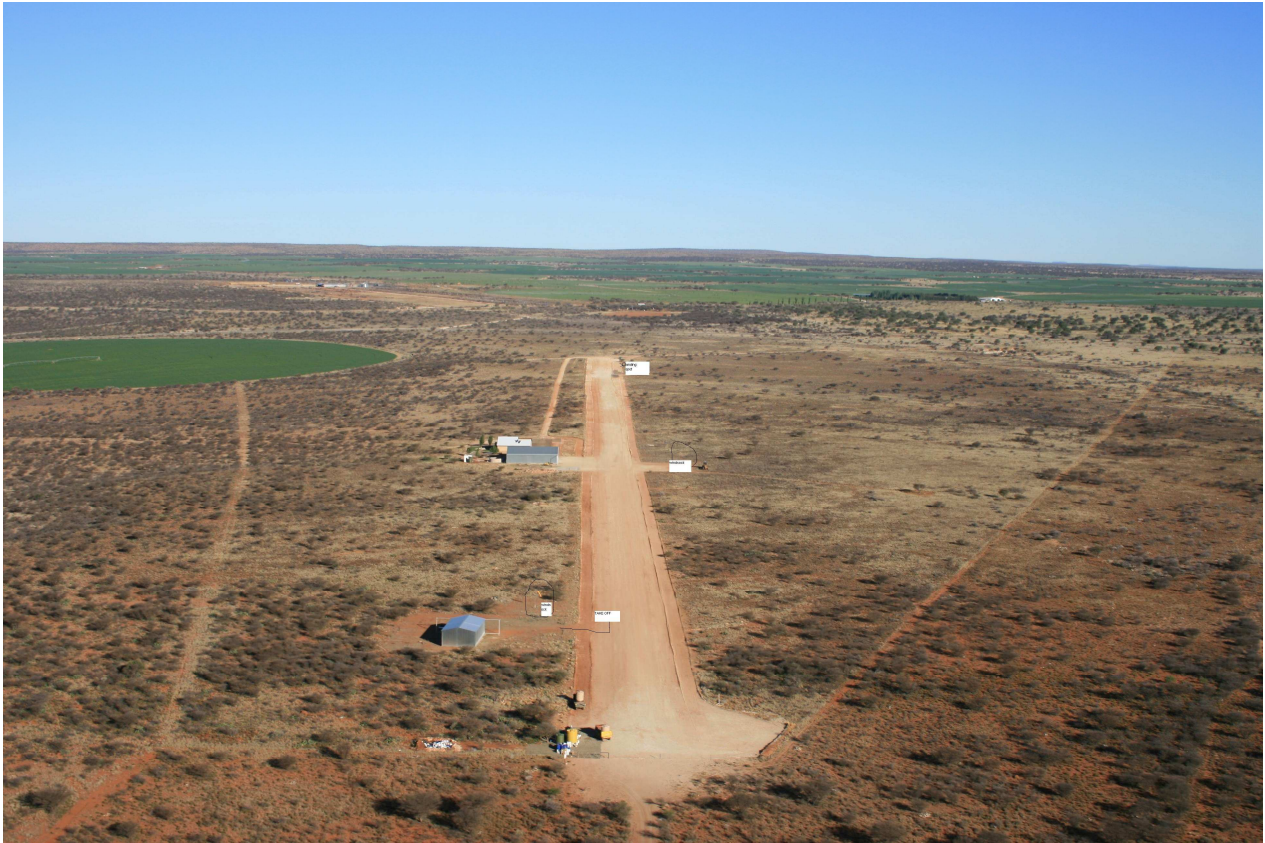
The accident did not occur at or near an aerodrome. The accident occurred at an (unlicensed) aerodrome, which was located 10 kilometres south of the town of Douglas (Northern Cape province) at the GPS position S 29°5'16" E 23°43'49". The length of the runway was 1200 m with a runway orientation of 16/34. **(See Fig 2.)**

Figure 2 A view of the runway with the accident site at the end of the runway.

The final position of the wreckage was found to the right side towards the end of Runway 16 with the nose of the gyrocopter facing in a north-easterly direction, lying on its right side.
