AIRCRAFT ACCIDENT REPORT AND EXECUTIVE SUMMARY

Reference:		CA18/2/3/8995	
Aircraft Registration	ZU-AKW	Date of Accident	14 December 2011		Time of Accident	1625Z	
Type of Aircraft	Koala Super Special		Type of Operation		Private		
Pilot-in-command Licence Type		Commercial	Age	27	Licence Valid	Yes	
Pilot-in-command Flying Experience		Total Flying Hours	+289,4		Hours on Type	5,4	
Last point of departure		Swartkops Aerodrome (FASK) (Gauteng)					
Next point of intended landing		Swartkops Aerodrome (FASK) (Gauteng)					
Location of the accident site with reference to easily defined geographical points (GPS readings if possible)							
On the R55 tar road near Laudium, 5 nm south-west of Pretoria							
Wind: Visibility: Temperature: Dew point: Cloud cover: Cloud base:		Weather was fine; Surface Wind: light/03 kt, Visibility: 10 000 m,					
Number of people on board	1+1	No. of people injured	0	No. of people killed	1 + 1		
Synopsis							
<p>The pilot and a passenger who was the future owner of the aircraft, departed from Swartkops Aerodrome (FASK) on a local private flight to the General Flying Area. A witness observed the aircraft flying overhead his house in a slightly south-westerly d

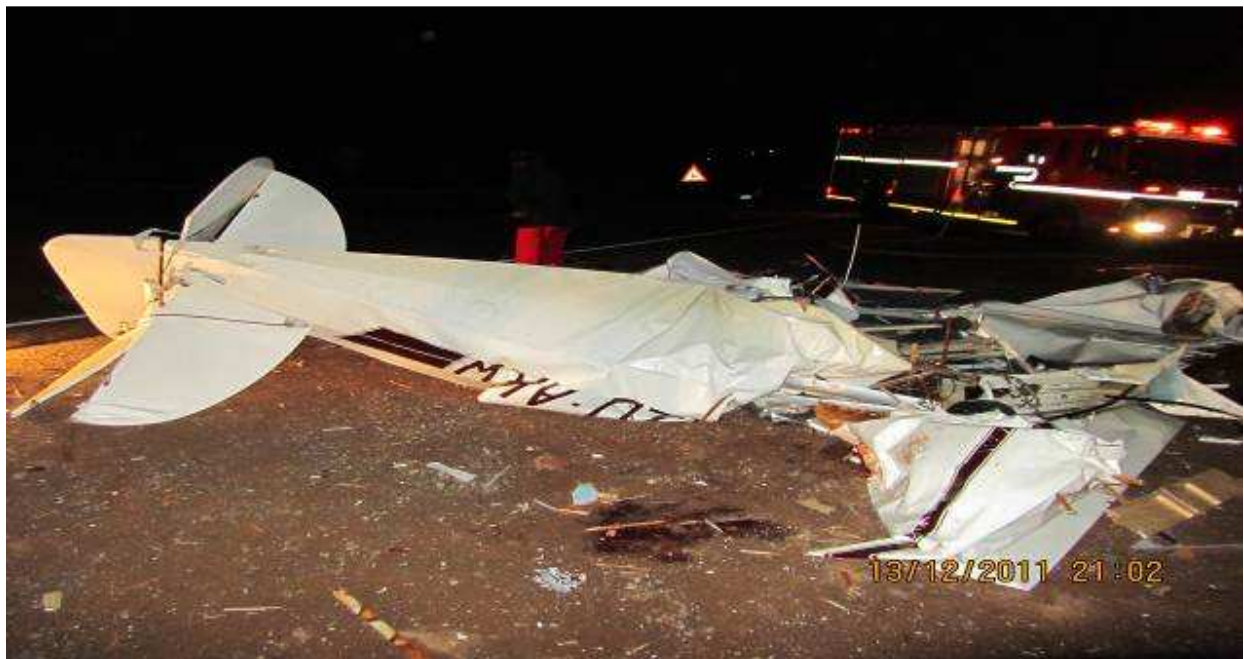
1.3.1 The aircraft was partly destroyed during the impact sequence.

Figure 1: Extensive damage to aircraft

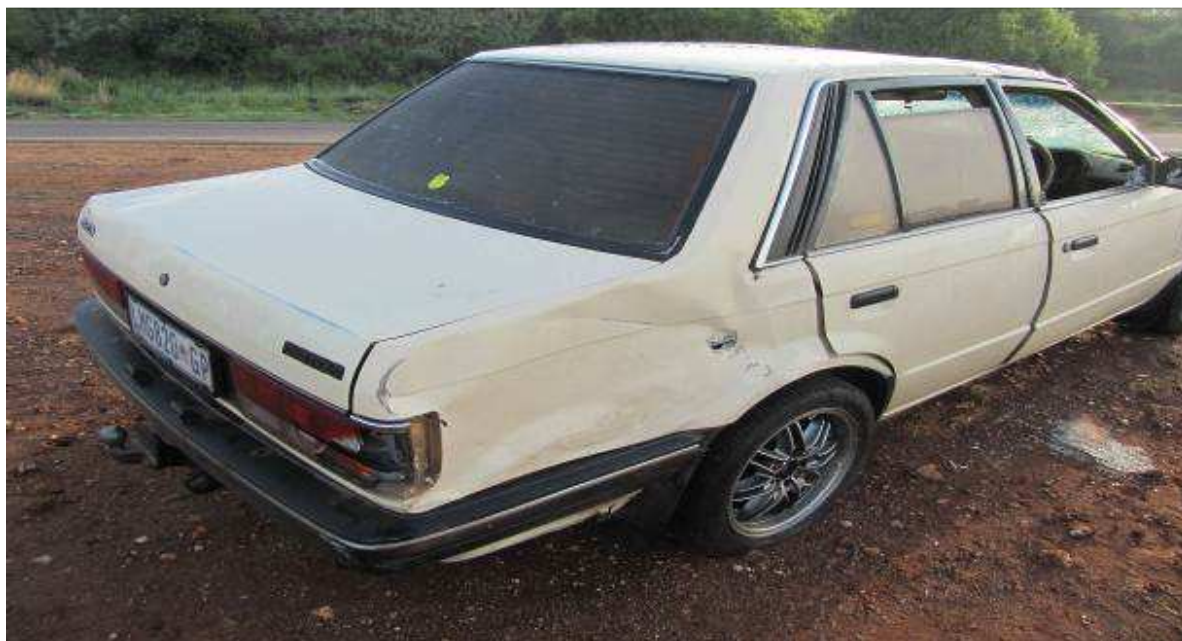
1.4.1 The aircraft collided with a vehicle, causing substantial damage to the vehicle.

Figure 2: Damage to vehicle

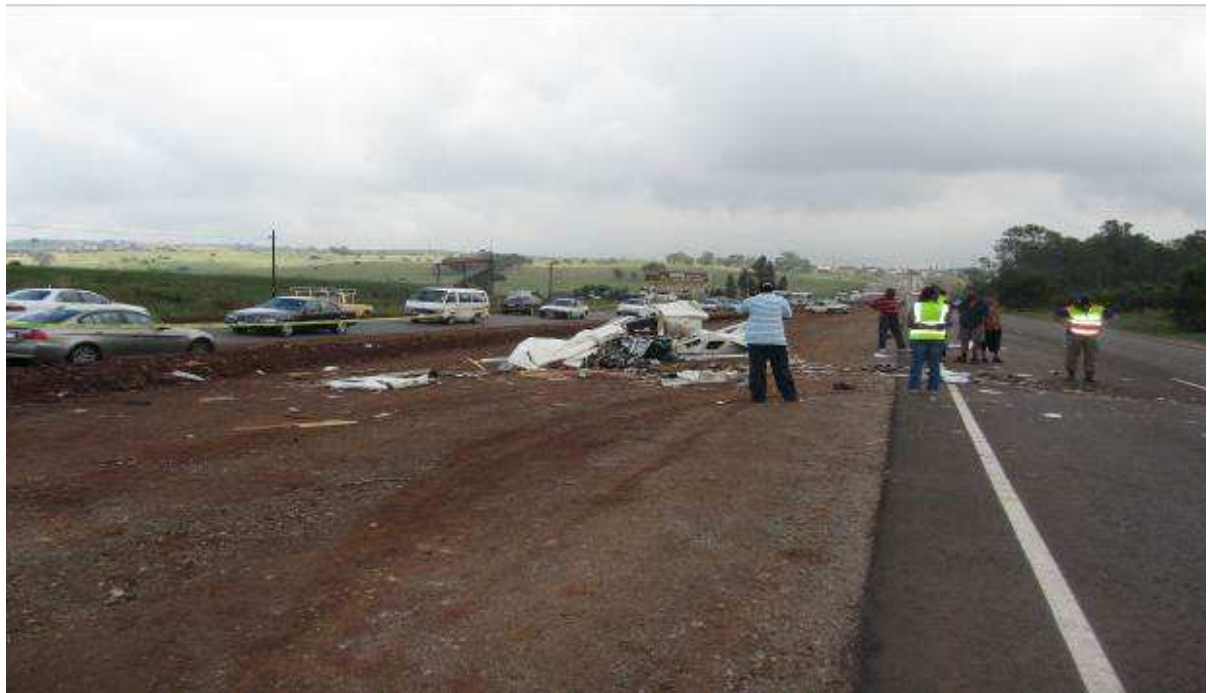
1.12.1 The aircraft descended during flight in a southerly direction and hit the roof of a vehicle travelling in a northerly direction on the R55 road near Laudium, south-west of Pretoria. The aircraft wreckage came to rest on the verge of the road. Although the aircraft was destroyed during the impact sequence with the vehicle and the road, the wreckage remained virtually intact, with some debris scattered close to the main wreckage. Damage sustained to the propeller indicated that the propeller was turning at a slow speed during the impact sequence.

Figure 3: The aircraft impacted a vehicle on the tar road and came to rest on the verge of the road

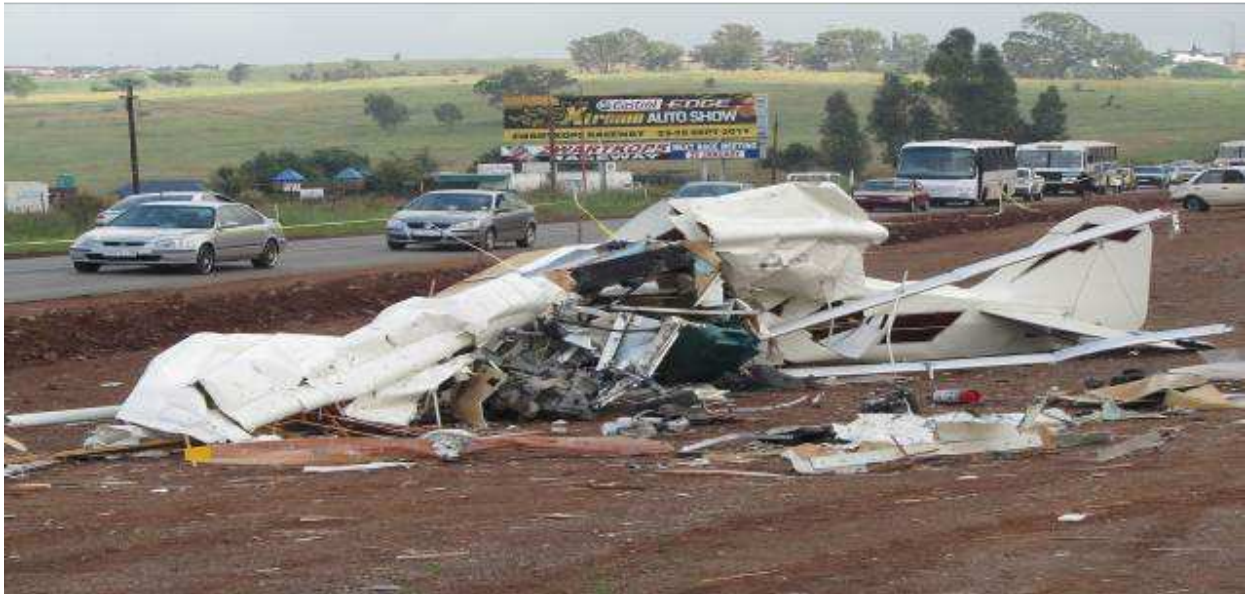
Figure 4: The main wreckage of the aircraft. The propeller blades indicated low rpm during the impact sequence

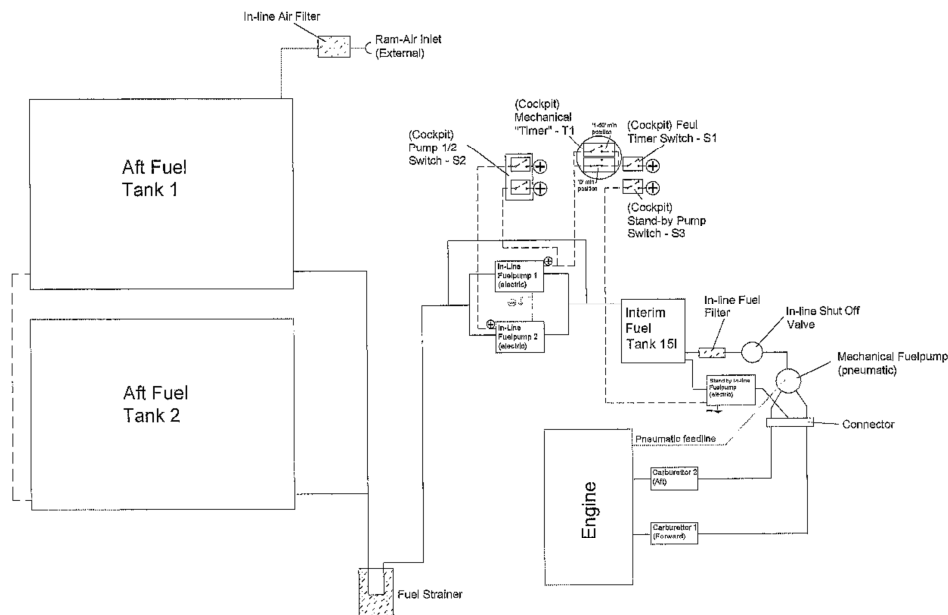
Diagram 2: ZU-AKW Fuel and Electrical Systems (approximate and applicable only)

6.2.1. Fuel Lines. The majority of the fuel line system was retrieved. No clear indications of leakage, blockage or in flight fire was noted and therefore assumed serviceable on impact. The recovery team cut some of the major fuel lines. Taking into account the uniqueness of the accident aircraft's fuel system layout, the retrieved parts, combined with information received from previous owners, were utilized to compose the most probably fuel system layout diagram as depicted in **Diagram 2**.

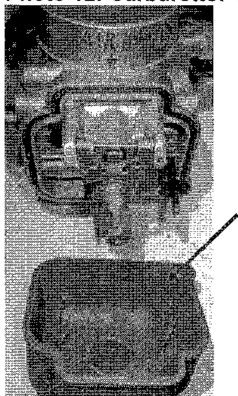
The float chamber (25) was severed on impact leaving the gasket (24) slightly damaged but in position (Photo 18, green arrow).

Photo 13: Carburettor 1 float chamber (digital)

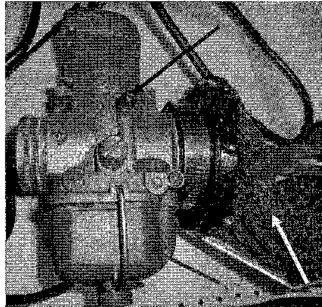
6.2.12. Carburettor No 2 (Aft). The visual outer inspection of the aft Bing 54 type no 2 carburettor (Photo 19, Diagram 3) revealed an impact fractured vent line (31; Photo 19, blue arrow) but with fuel feed line and float chamber (25; Photo 19, red arrow) still in position. The still attached air filter (Photo 19, yellow arrow) revealed some impact damages and post-impact contamination with no clear indications of pre-impact clogging or other. The throttle cable was still attached as in the as found condition but without a rubber grommet (13) in position.

Photo 19: Carburettor 2 (digital)

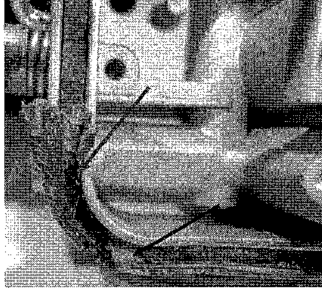
The float chamber (25) was removed from position with both floaters (21) in position and in good condition (Photo 21, red arrow). A test performed revealed no leakage into the floats. The float chamber gasket (24) was found in position but, due to a foreign object jammed between the chamber and casing interfaces during fitment (Photo 22, red arrow), the gasket was extensively damaged (Photo 22, blue arrow).

Photo 22: Carburettor 2 float chamber gasket (digital)

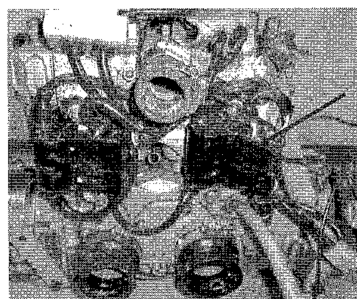
Both the CDI's was still in position with the aft unit extensively damaged on impact (Photo 30, red arrow). Inspection of the dual sparkplugs (numbered 1 to 4 starting forward; Photo 32) showed numbers 2 and 3 to be in position and intact while numbers 1 and 4 was fractured on impact. The sparkplug wires was still intact and connected to the respective CDI's. On removal all sparkplugs revealed no clear indications of severe carbon build-up, oil deposits or other discrepancies (Photo 32).

Photo 30: Dual Ducati CDI's (digital)

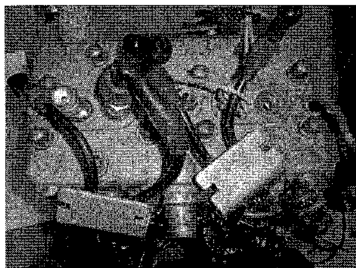
Photo 31: Sparkplugs (digital)

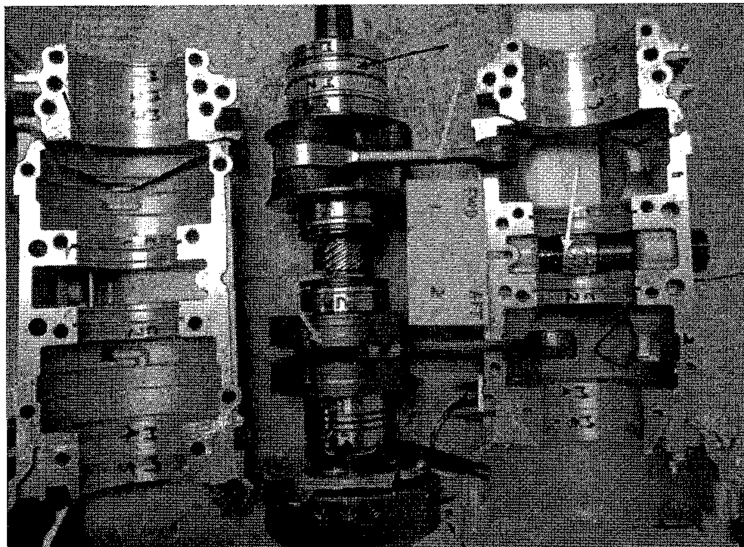
The crankcase revealed several impact fractures (Photo 38, red arrow). The set of crankshaft bearings numbered M1 to M5 (Photo 38, blue arrow) showed no signs of wear, seizure or exposure to high temperatures. The matching crankcase bearing contact surfaces revealed no signs of rotational damages or other. The crankshaft (Photo 38, orange arrow) was found in good condition. The connecting rods (Photo 38, green arrow) showed no signs of bending or temperature induced discolouring with both the big-end and piston needle bearings in good condition. The rotary valve drive gear system was found in excellent condition (Photo 38, yellow arrow).

Photo 38: Crankshaft assembly (digital)

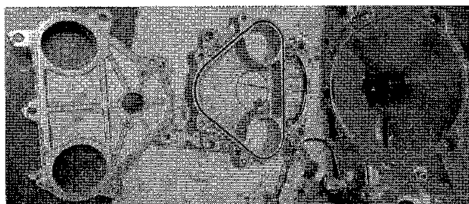
Although the oil feed line and reservoir was found separated from the engine, the rotary valve assembly (Photo 39) revealed no clear indications of wear with the O-ring intact and in place.

Photo 39: Rotary valve assembly (digital)

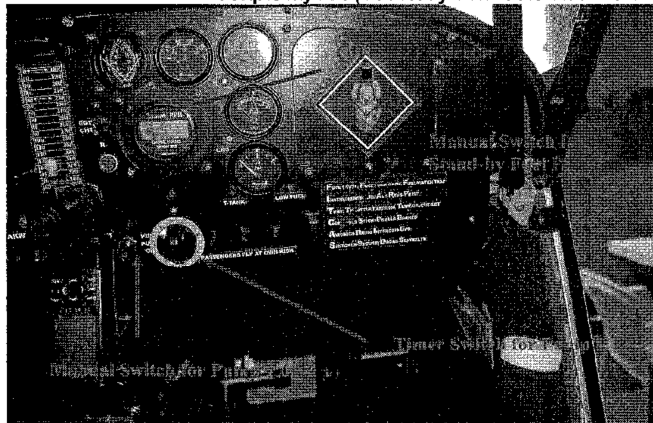
Photo 43: ZU-AKW cockpit layout (courtesy Francois Haarhoff Trust)

6.4.3. Other Selectors. The CHT selector was found at the "R" (rear (aft) cylinder head, sparkplug no 3) position (Photo 43). The Stand-by Fuel Pump switch (Photo 43) was not recovered. The Throttle was found at the "IDLE" position (Photo 43).

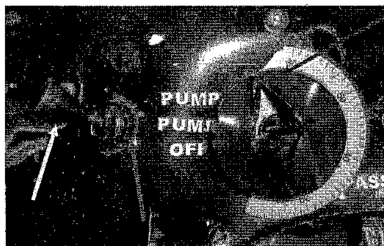
The Fuel Timer switch (Photo 42) was not recovered. The Timer switch was found at the "0 minutes" position (Photo 44 red arrow). All indications are that the Timer switch was fitted at later time as it partially obscures the Manual Pump switch insignia. The Manual Pump Switch was found jammed behind the GPS bracket (yellow arrow) and at the "Pump 1" position (blue arrow).

Photo 44: Timer switch (digital)
