AIRCRAFT ACCIDENT REPORT AND EXECUTIVE SUMMARY

Reference: CA18/2/3/9017	
Aircraft Registration	ZU-DBD	Date of Accident	25 February 2012		Time of Accident 0500Z
Type of Aircraft	Raptor 582		Type of Operation		Training
Pilot-in-command Licence Type		PPL	Age	59	Licence Valid Yes
Pilot-in-command Flying Experience		Total Flying Hours	650		Hours on Type 190.6
Last point of departure		South Africa, Panorama Aerodrome, Gauteng Province (not coded)			
Next point of intended landing		South Africa, Panorama Aerodrome, Gauteng Province (not coded)			
Location of the accident site with reference to easily defined geographical points (GPS readings if possible)					
Approximately 50m to the right of Runway 30 at Panorama					
Meteorological Information		CAVOK, 8 knots, North easterly wind			
Number of people on board	1+1	No. of people injured	2	No. of people killed	0
Synopsis		<p>On 25 February 2012 at 0500Z, a pilot and a student pilot were busy with a training flight. During the take-off on Runway 30 at Panorama airfield, the student pulled back and to the left on the control bar. This led to an immediate right hand descending turn. The aircraft veered off the runway to the right and the nose

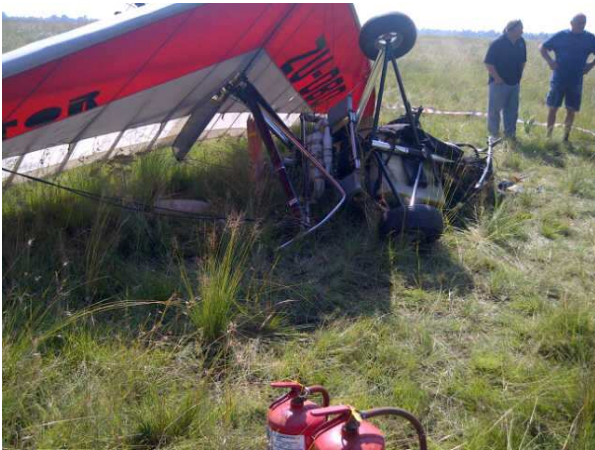
Fig 1

1.3.2 The nose gear was ripped off; the propeller and pylon sheered and the wing bent.

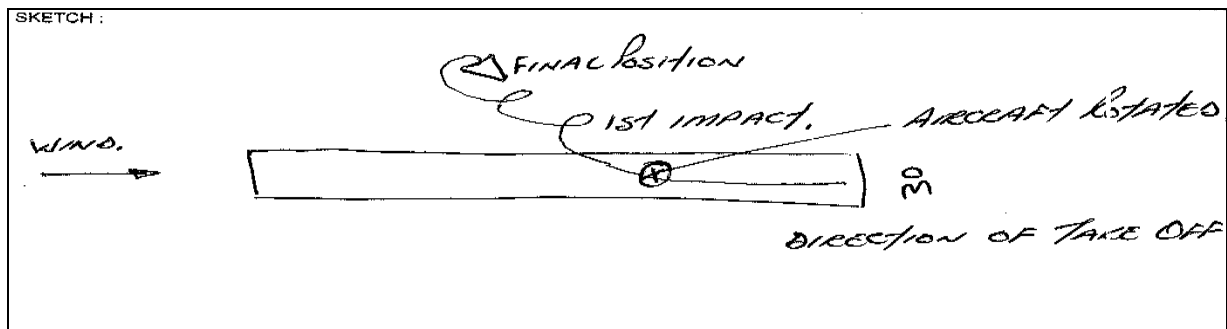
Fig 4: Sketch by the Pilot

2.2 As the aircraft rotated and took-off the student pulled the bar back and to the side causing the aircraft to go into an immediate right-hand descending turn. The instructor was unable to correct despite attempting to do so.

2.3 The aircraft impacted the ground and cartwheeled.
