POWERED GLIDER ACCIDENT REPORT AND EXECUTIVE SUMMARY

Reference:	CA18/2/3/9068	
Powered glider Registration	ZU-GAN	Date of Accident	10 August 2012		Time of Accident	11:06Z
Type of Powered glider	Pipistrel Taurus		Type of Operation		Private	
Pilot-in-command Licence Type		Glider / PPL	Age	55	Licence Valid	Yes
Pilot-in-command Flying Experience		Total Flying Hours	80.2		Hours on Type	80.2
Last point of departure		El Mirador (FALQ)				
Next point of intended landing		El Mirador (FALQ)				
Location of the accident site with reference to easily defined geographical points (GPS readings if possible)						
Game reserve in Winterton at the GPS: S28° 59'.36" E029° 28'.47"						
Meteorological Information						
Number of people on board	1 + 0	No. of people injured	0	No. of people killed	1	
Synopsis						
<p>The aircraft took off from FALQ for a local private flight. The witness saw the wings of the Taurus/powerd glider flexing and oscillating up and down along the entire span and it was also longitudinally unstable. He also noticed the wheel bay doors opening and closing in time with the pitching oscillations. The GPS shows that the Fifth and last thermal attempt was at 13:22 over the ridge

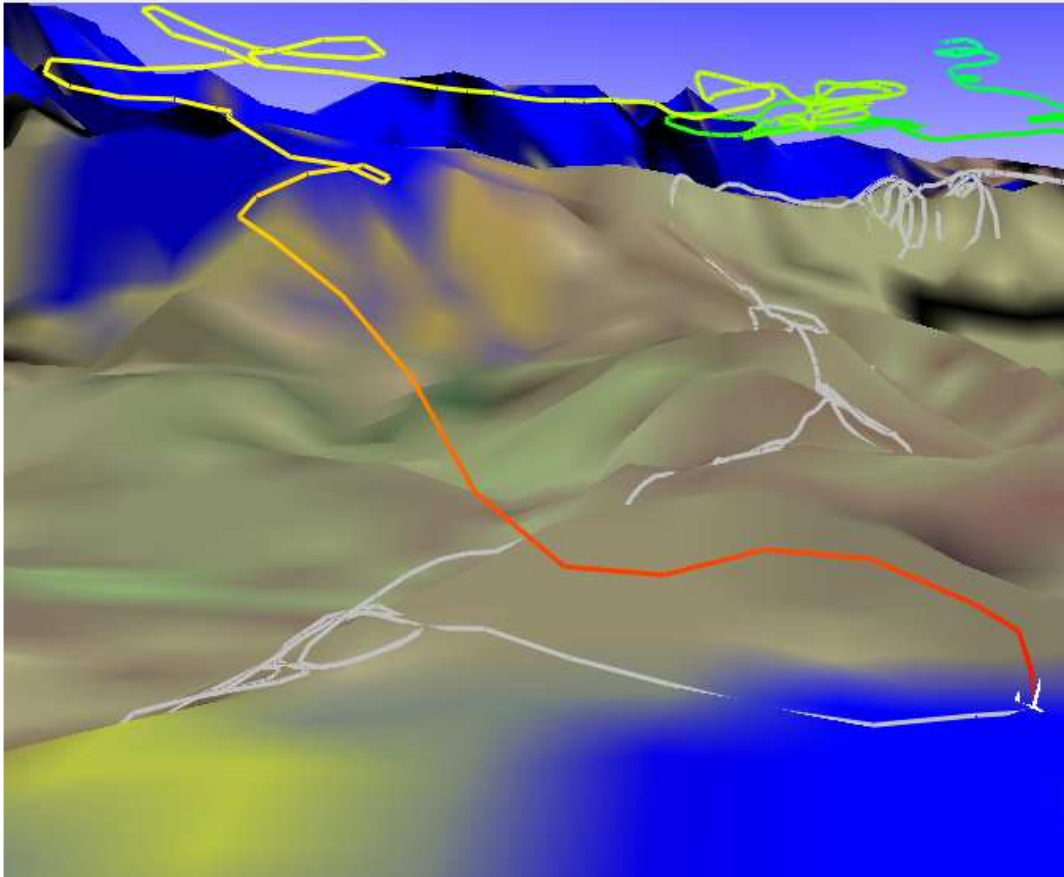
Figure 1: Flight path as downloaded from the GPS

Fifth and last thermal attempt was at 13:22 over the ridge immediately West of the airfield. Pulled up to left - found sink. Made 1 attempt to centre still turning Left. Reversed direction to Right at 12:24. Made a rapid 180 degree while descent rate increased steadily. Flew directly towards the airfield with airspeed increasing rapidly

from 150km/h to over 230km/h in 6-9 seconds. Pulled up slowing to 180km/h. Made a parabolic descent to impact close to vertical. Wind was still, rising to 11-16km/h from the East (around 20deg) for the latter part of the flight.

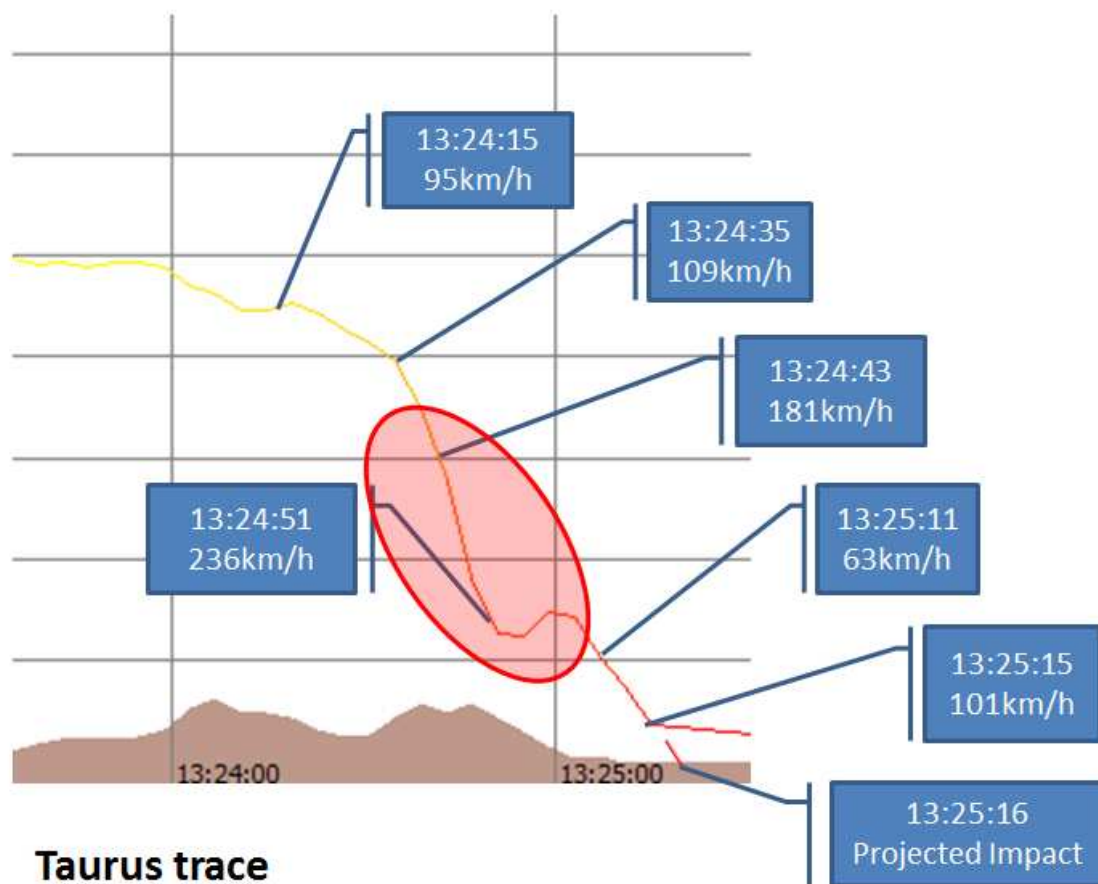
Figure 2: Speed as downloaded from the GPS

Red ellipse shows approximately where the Flap-5 Vne of 130km/h was exceeded.

exceeded, land as soon as possible and have the aircraft verified for airworthiness by authorised service personnel. The pilot flew directly towards the airfield the speed increasing rapidly from 150km/h to over 230km/h in 6-9 seconds.

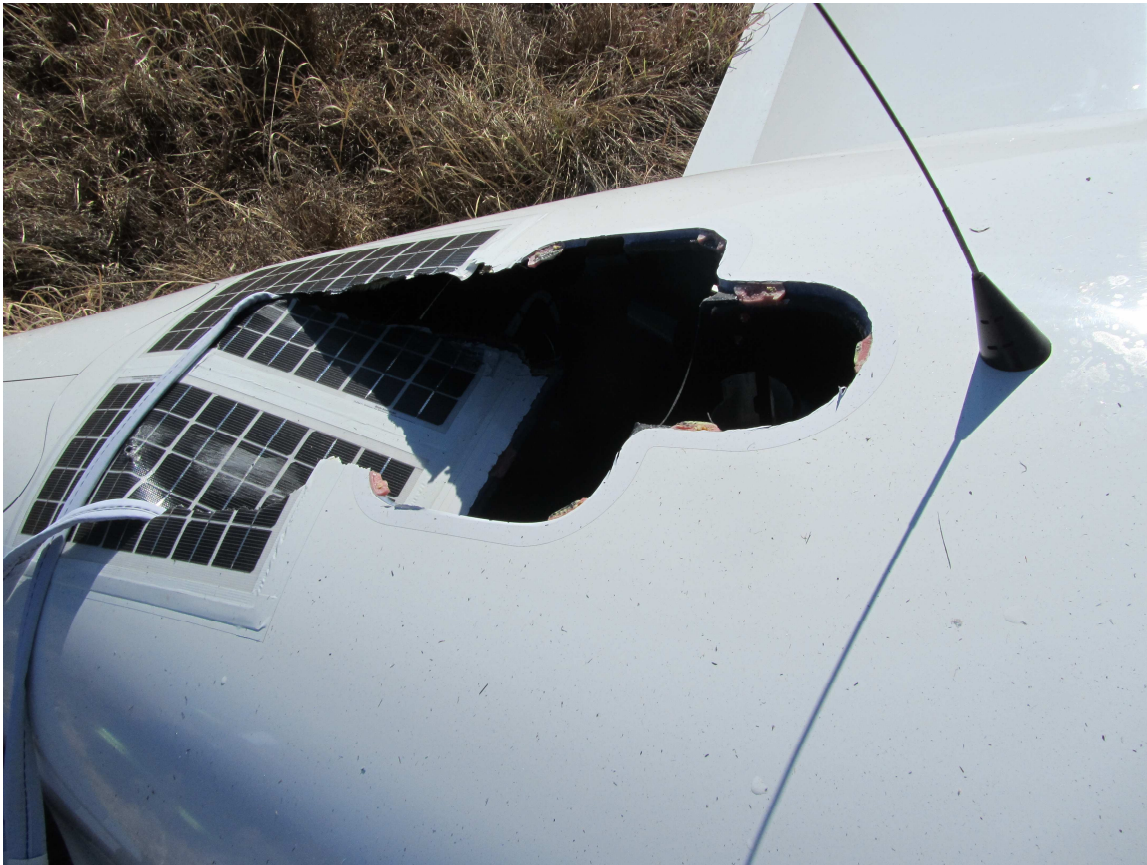
Figure 3: indicate the canopy compartment

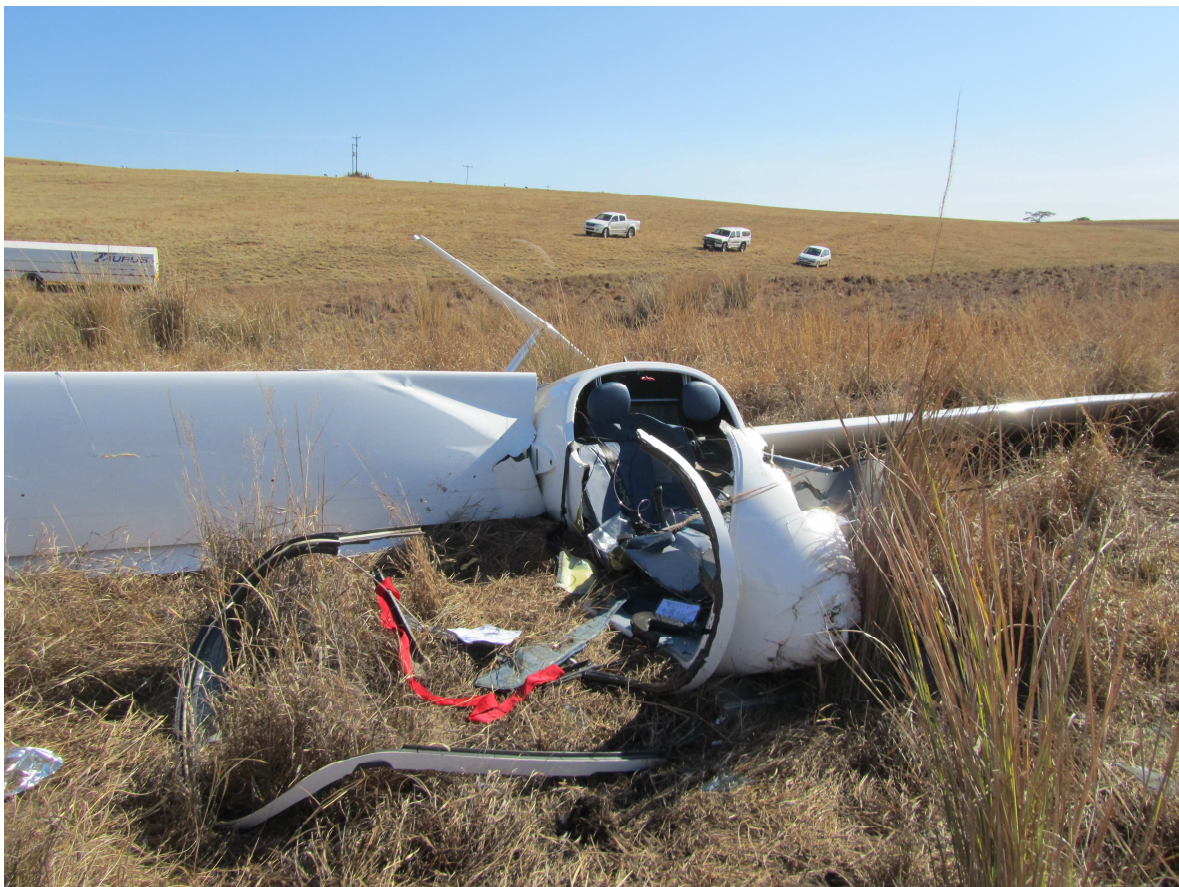
1.3.1 The glider was destroyed in the accident.

Figure 4: indicate the wreckage of the powered glider

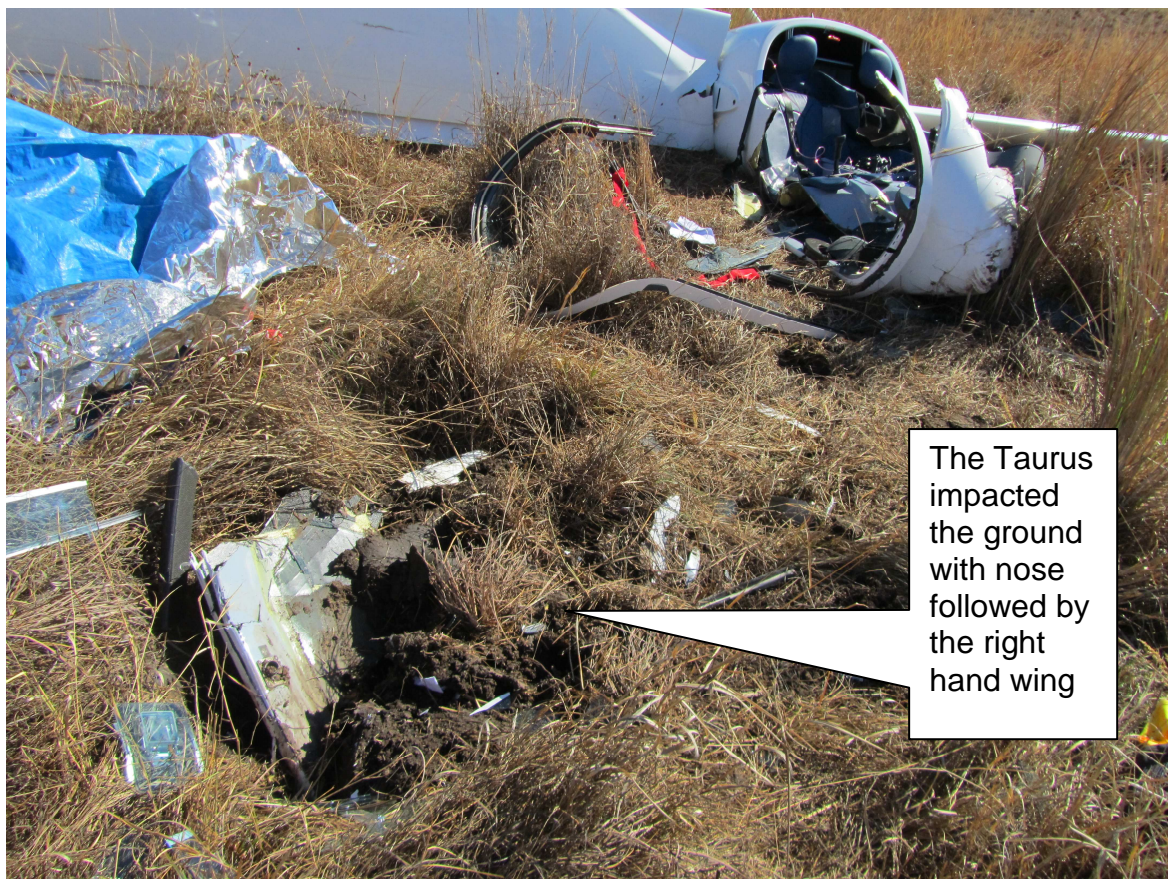
- 1.12.1 The witness saw the powered glider at approximately 500 feet. The powered glider impacted the ground in a nose down attitude followed by the right hand side. The right hand wing was ruptured as a result of impact and the left hand wing was still intact and had approximately quarter fuel. The powered glider was destroyed during impact.

Figure 6: Indicate the first point of impact

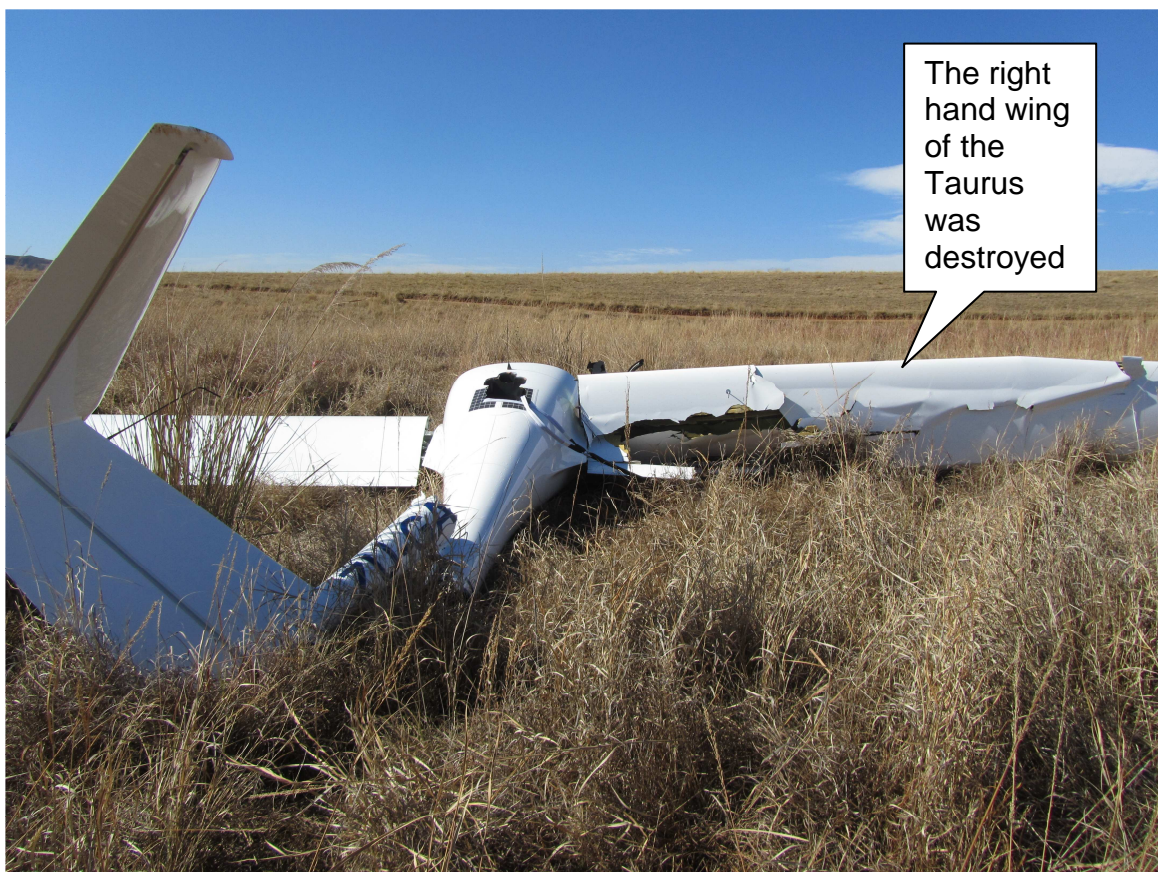
Figure 7: Indicate the wreckage of the powered glider

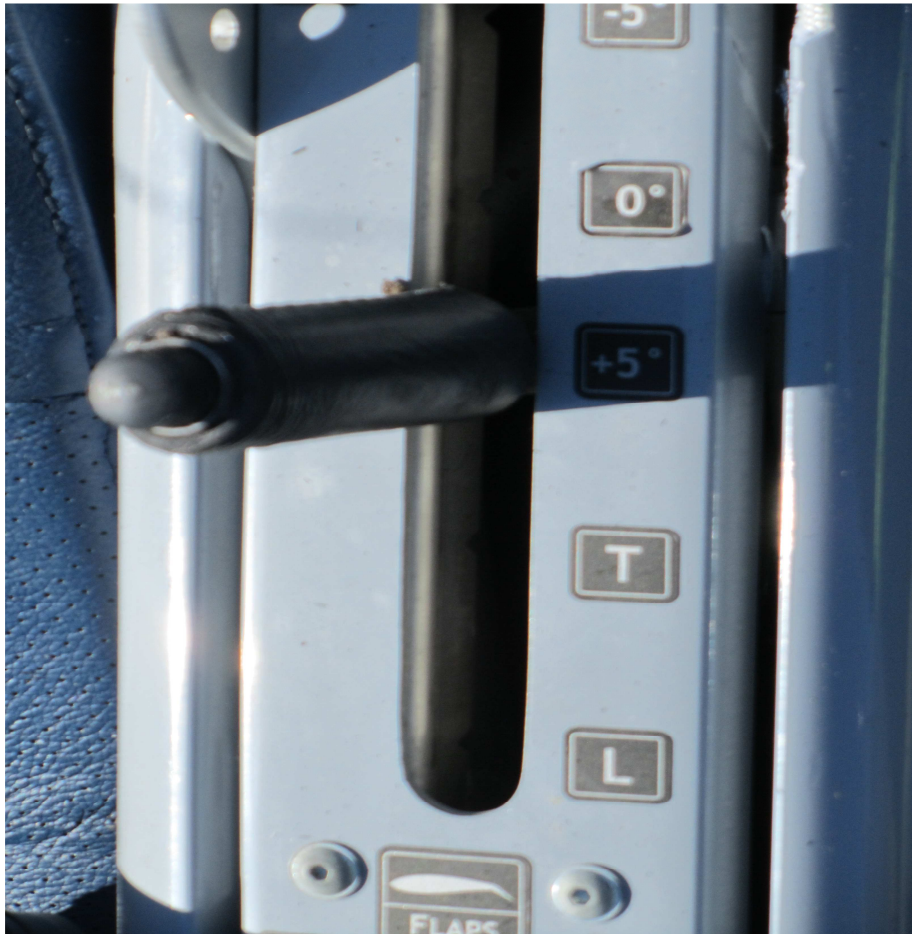
1.18.2 The flaps setting was at 5°, as per the checklist before turning base the flaps should be at "T"

Figure: 8 indicate the flap setting of +5°

- 2.2 The flaps setting were at +5°, the recommended speed is 68km/h. Prior to the accident the powered glider's speed was at approximately 211km/h which is above the limitation. The pilot deployed the ballistic parachute at approximately 500 feet above ground level which is within the manufacture's limitation. The parachute can be used in the situation such as loss of control over the powered glider, pilot incapacitation and other factors. The pilot exceeded the speed limitation which caused him to lose control of the powered glider during the flight which resulted in a stall before, the powered glider impacted with the ground.
