## AIRCRAFT ACCIDENT REPORT AND EXECUTIVE SUMMARY

Reference:	CA18/2/3/9120	
<b>Aircraft Registration</b>	ZU-EFY	<b>Date of Accident</b>	06 January 2013		<b>Time of Accident</b>	1035Z
<b>Type of Aircraft</b>	Bantam B22J		<b>Type of Operation</b>		Private	
<b>Pilot-in-command Licence Type</b>		National Pilot License	<b>Age</b>	53	<b>Licence Valid</b>	Yes
<b>Pilot-in-command Flying Experience</b>		Total Flying Hours	50.7		Hours on Type	50.7
<b>Last point of departure</b>		Hazyview Airfield, (Mpumalanga Province)				
<b>Next point of intended landing</b>		Hazyview Airfield, (Mpumalanga Province)				
<b>Location of the accidentsite with reference to easily defined geographical points (GPS readings if possible)</b>						
GPS co-ordinates S25 05.539' E030 42.415' (Sabie area, Mpumalanga Province)						
<b>Meteorological Information</b>		Temperature: 24 °C Dewpoint: 17 °C Visibility: >10k m Cloud: Sky Clear Surface wind 100/11kts				
<b>Number of people on board</b>	1+1	<b>No. of people injured</b>	1+1	<b>No. of people killed</b>	0

## AIRCRAFT ACCIDENT REPORT

**Name of Owner/Operator** : P G Eksteen  
**Manufacturer** : MicroAviation New Zealand LTD  
**Model** : Bantam B22J  
**Nationa

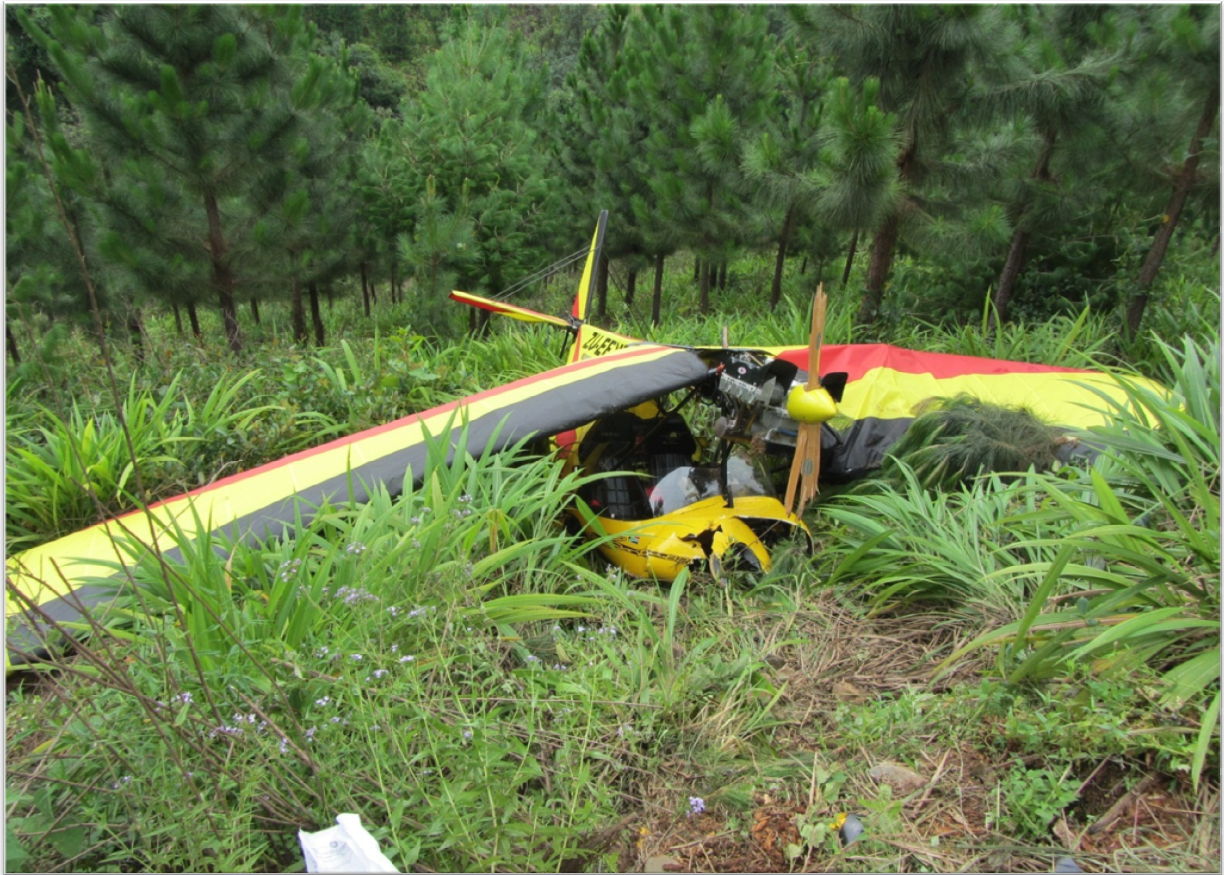
1.3.1 The aircraft sustained substantial damage to the cabin area, wings, undercarriage, nose and propeller.

*Figure 2: A view of the aircraft as it came to rest*

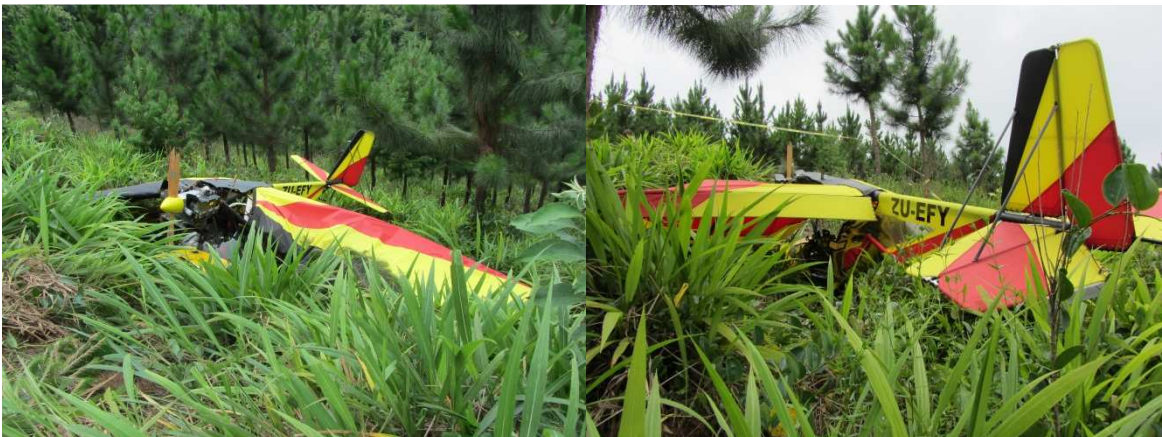
1.12.1 The aircraft's left wing struck several tree tops before the propeller struck a tree, slid down an embankment and came to rest.

1.12.2 The aircraft was found in an upright position nestled between the vegetation facing in a northerly direction.

1.12.3 Witness marks on the propeller indicated that the engine was producing power during the impact sequence.

*Figure 3 and 4: ZU-EFY's wreckage between the vegetation*
