COMPILED BY:  	Crash <small>Aviation Accident Investigation & Medalsburg</small> LAB	PAGE 1 OF 12	
COMPILED FOR: A.A.S.	INVESTIGATION REPORT: PROPELLER FAILURE, BANTAM LIGHT SPORT A/C No ZU-CZU	DOCUMENT NUMBER MET-008-07-13	
		DATE 2013-08-30	ISSUE 2

ITEM: **PROPELLER ASSY., BANTAM LIGHT SPORT AIRCRAFT,
NUMBER ZU-CZU**

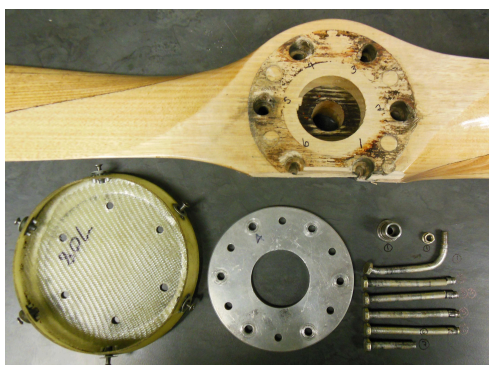
1.1. The failed propeller assembly (Photo 1) originating from a Bantam Light Sport Aircraft, number ZU-CZU, was submitted to determine the possible reasons/s for failure (Photo 2) during operation.

Photo 1: Supplied parts (digital)

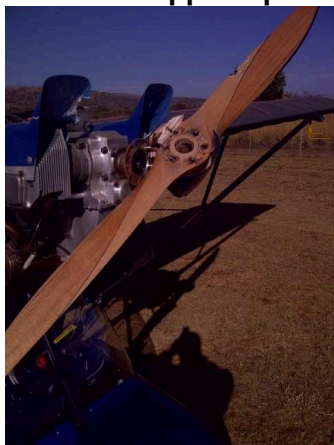
Photo 2: Propeller failure incident (courtesy Aviation Assessing Services)

The visual investigation revealed five of the total of six bolts failed during operation (Photo 2) leaving the propeller attached to the propeller flange by a single remaining bolt.

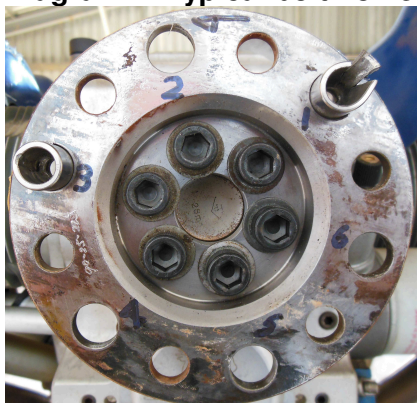
Photo 3: Propeller flange (digital)

The guide/bush related to the remaining bolt was still found attached to the propeller flange. A second guide/bush was recovered (Photo 3) for this investigation.

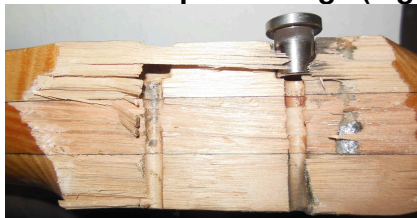
Photo 4: Propeller with guide fitted (digital)

The wood-based propeller failed during operation (Photo 4). The position of the guide/bush when fitted is shown.

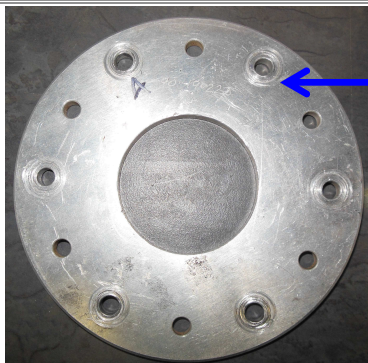
Photo 5: Spinner flange (digital)

Inspection of the forward spinner flange revealed a slight bend corresponding with the position of the remaining bolt (Photo 5) after failure. Severe rotational mechanically induced marks were noted (Photo's 6 and 7, red arrows) corresponding with the load bearing surface width of the bolt heads (Diagram 1, green arrow). This is an indication that no washers were employed during fitment (refer to Jabiru Aircraft Propeller Instruction Manual). As the spinner flange may have been refitted an undeterminable number of times, these damages could not conclusively attributed to the most recent fitment.

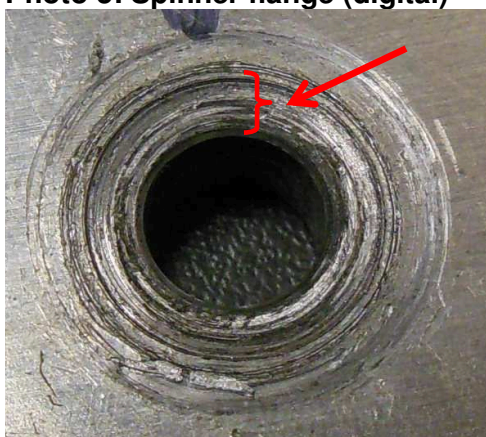
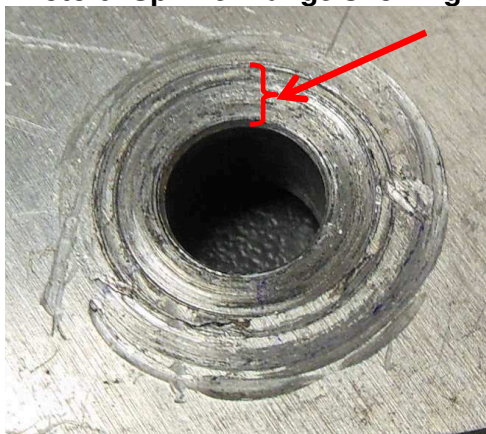
Photo 6: Spinner flange showing rotational marks (digital)

Photo 7: Spinner flange showing rotational marks (digital)

It is considered good practice for the torque to be applied to the nut end rather than the bolt head end (as per SKF Bolt Tightening Handbook). The damages inflicted to the softer aluminium spinner flange by the bolt heads clearly indicate that the torque wrench was most probably applied to the forward facing bolt heads rather than the aft facing nuts. The final tightening load (torque) are dependent on the corresponding friction coefficients related to the bolt and nut threads as well as the contact surfaces between the nut/bolt head and the flange. In this case the 'binding' effect between the harder steel bolt head and the much softer aluminium based flange surface will render a torque wrench reading that may correspond with the prescribed value whilst a lower than desired axial tension stress on the bolt are in fact present, leaving it under-torque and subsequently prone to loosening, and failure, within the 10.6 operational hours.

9.2. The investigation revealed incorrect torque application to the propeller bolts and nuts. Although no clear indications towards over-torque damages were noted, the assembly method followed may leave the propeller bolts under conditions of under-torque. Taking into account the decisive function of the relevant assembly towards Aviation Safety, it is strongly recommended that the applicable Standard Practices regarding the application of torque be adhered to at all times (refer to Excerpt 1).

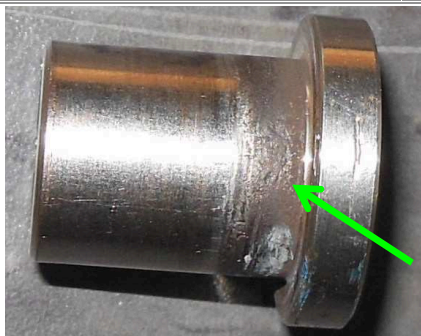
The single guide recovered for this investigation revealed some indications of rotational and axial scuffing/fretting relating to possible movement inside the propeller flange area during operation (Photo 9, green arrow). The outside diameter of the insert end of the guide measured 13.92 mm and proved to be in accordance with the propeller flange fitted to the 2200 series Jabiru engines. The relevant propeller flange was not removed from the engine or made available for this investigation. Damages to the (~1-1.5mm thickness) protective paint layer on the propeller flange (Photo's 17 and 18) confirmed the fitted positions after removal by the relevant AMO.

Photo 9: Guide showing mechanical damages (digital)

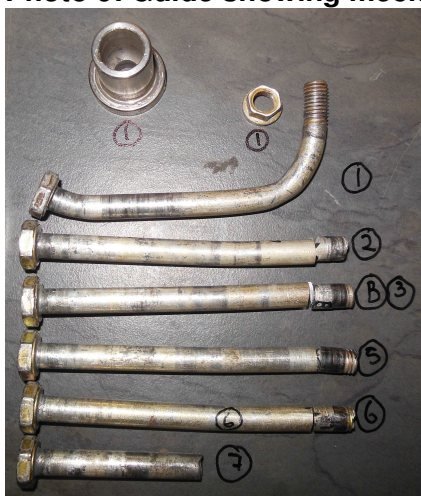
Photo 10: Supplied bolts, nut and guide (digital)

The remaining bolt (Photo 10, no 1) revealed extensive bending damages inflicted after the in-flight failure of the other five bolts. This bolt also revealed extensive stretching damages. Although measurement results revealed that the no 1 bolt is an approximate 5mm longer than the other five (5) bolts retrieved, this elongation may be attributed to the low-carbon steel, hex cap bolt type (Grade 2, rolled thread) under tensile conditions. While the variation in dimension can be attributed to the exposed tensile and/or bending loads it is possible that a longer bolt was fitted to accommodate balancing weights (washers). This investigation was not involved with the initial teardown after the incident and no photographic evidence were submitted towards confirmation from either the SACAA or the AMO involved.

Damages noticed on the relevant bolt heads, radiuses and shank areas (Photo's 10 and 11) indicates that the set of bolts were refitted on more than one occasion.

The remaining five bolts revealed comparable fractures within the threaded areas (Photo's 10 and 12). Bolt no 5 (Photo 12, yellow arrow), and to some degree No 6, revealed extensive 'polishing' of

9.3. The investigation noticed that the bolts (and single nut) were refitted for an undeterminable number of times. Taking into account the applied torque, the relatively low cost as well as the importance of the related parts to flight safety, it is strongly recommended that theses bolts/nuts are not refitted after use.

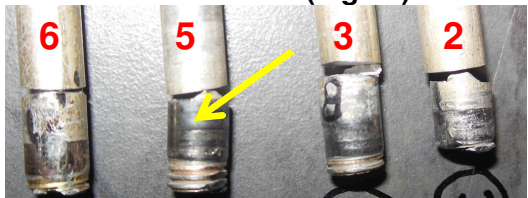
Photo 12: Fracture positions (digital)

the shank/grip area adjacent to the thread roll-out that may be attributed to these bolts being loose resulting in in-service movement inside the bush inserts. At higher magnification the corresponding fracture surface from bolt no 5 revealed clear signs of fatigue induced beach-marks (Photo's 13 and 14) as well as striations (Photo 15). The remainder of the fracture surfaces revealed ductile geometries (Photo 16). It is clear from the results that bolt no 5 most probably failed first.

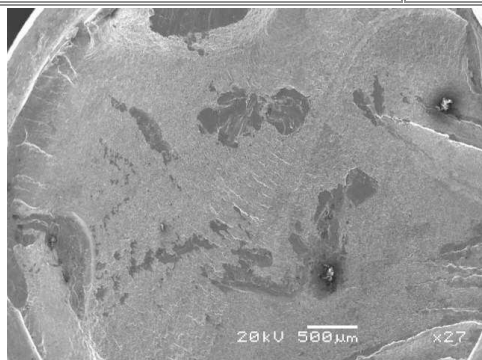
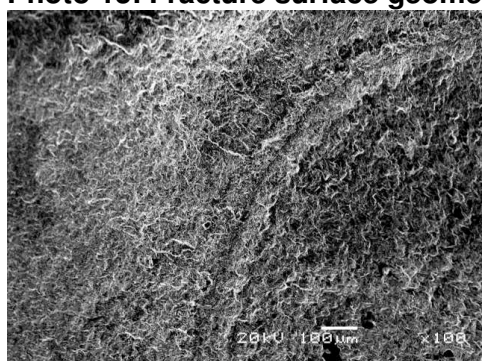
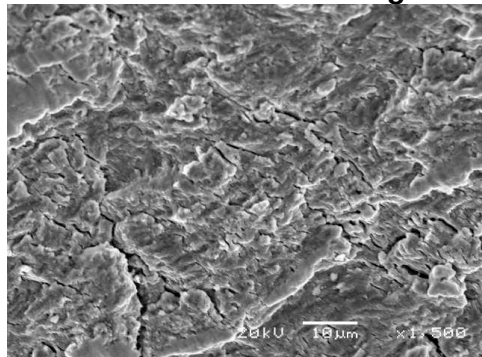
Photo 13: Fracture surface geometry; bolt no 5 (x27, SEM)

Photo 14: Fracture surface geometry showing beach-marks; bolt no 5 (x100, SEM)

Photo 15: Fracture surface geometry showing fatigue striations; bolt no 5 (x1500, SEM)

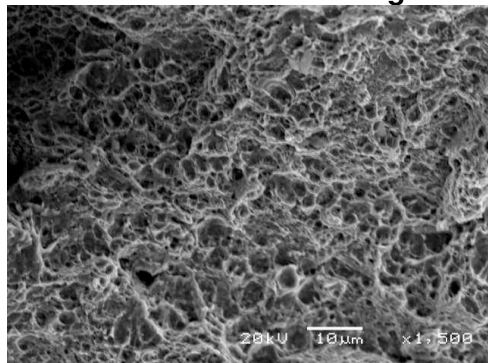
Photo 16: Fracture surface geometry showing typical ductile features; remaining bolts (x1500, SEM)

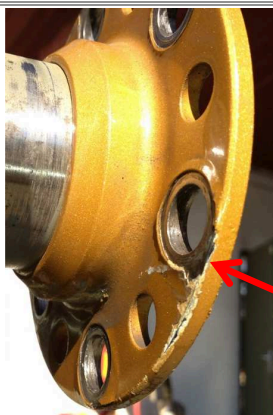
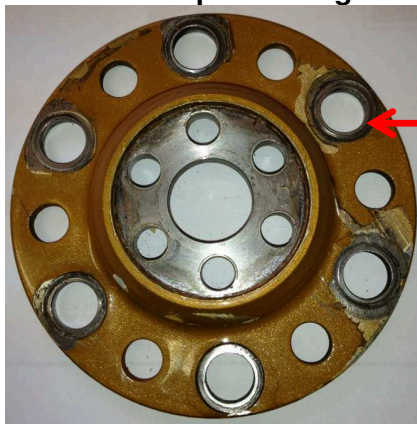
Photo 17: Propeller flange showing paint layer (courtesy Micro Aviation)

Photo 18: Propeller flange showing paint layer (courtesy Micro Aviation)

8.1.2. Break-down of Painted Layer. The relative thick (1mm+) layer of protective paint applied to the propeller flange (aft side) revealed severe break-down damages at the guide bush insert positions. The break-down of this layer of paint during service will cause the bolts to be relieved of the prescribed torque and may have resulted in the failure thereof within the 10.6 operational hours. No vibration checks could be made for this investigation to exclude possible propeller vibration forces induced on the assembly and the (softer) paint layer.

9.3. The OEM (Jabiru SA) revealed to the investigation that the primary reason for the paint application to the propeller flange is corrosion control and also under the instruction from the SACAA. *No formal documentation stipulating the paint application method were presented following a request to both parties, leaving this investigation with no option but to assume that such documentation does not exist.* Although the motive for the paint application is sound, the inclusion of a weaker component in an assembly to be exposed to torque as well as vibration and other loads during service, should be based on sound engineering principles as well as a rigorous testing phase. It is strongly recommended that the OEM revisit this paint application process in coalition with the Regulating Authority (SACAA).

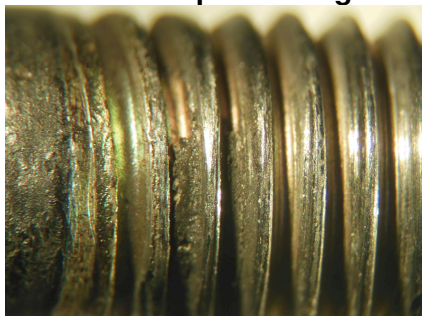
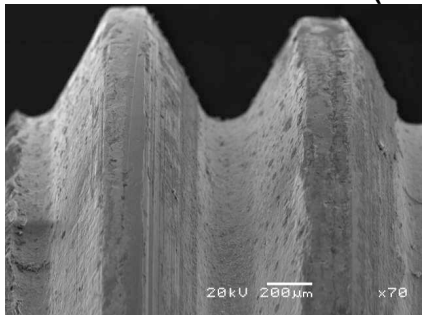
Inspection of the threaded areas revealed conforming thread control and no clear indications of over-torque damages (Photo's 19 and 20).

Photo 19: Threaded areas (stereo)

Photo 20: Threaded areas (x70, SEM)
