AIRCRAFT ACCIDENT REPORT AND EXECUTIVE SUMMARY

Reference:	CA18/2/3/9211	
Aircraft Registration	ZU-CVH	Date of Accident	19 August 2013		Time of Accident	12:15Z
Type of Aircraft	Magni M16 Gyro		Type of Operation		Hire & Fly (Private)	
Pilot-in-command Licence Type		Recreational Pilots Licence	Age	45	Licence Valid	Yes
Pilot-in-command Flying Experience		Total Flying Hours	70.5		Hours on Type	70.5
Last point of departure		Fisantekraal Airfield (FAFK, Western Cape Province)				
Next point of intended landing		Fisantekraal Airfield (FAFK, Western Cape Province)				
Location of the accident site with reference to easily defined geographical points (GPS readings if possible)						
At the intersection of runway 05 and 32 at GPS coordinates S33°46'299 E018°44'408" at an elevation of 410 ft.						
Meteorological Information		Temperature: 19 °C, Visibility: CAVOK, Wind direction: 230°, Wind speed: ± 5 kts				
Number of people on board	1 + 1	No. of people injured	1	No. of people killed	0

Name of Owner : L van Wyk
Name of Operator : Aerosport
Manufacturer : Magni Gyro
Model : Magni M16 Gyro
Nationality : South African
Registration Marks : ZU-CVH
Place : Fisantekraal Airfield
Date : 19 August 2

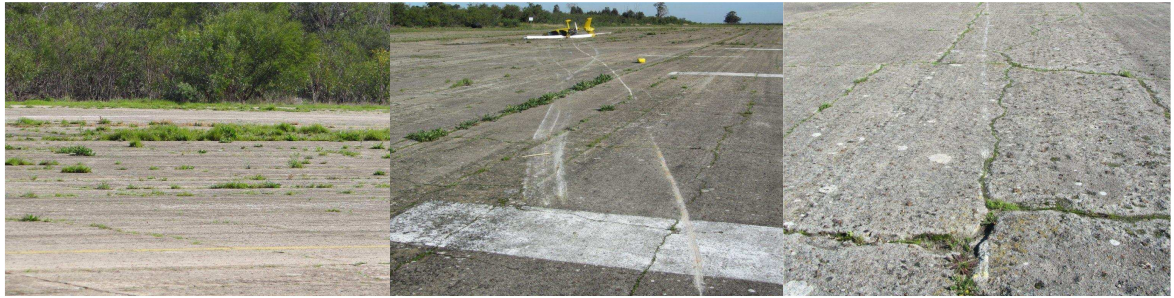
1.10.2 The runway was poorly maintained and had poor infrastructure in place. There are no boundary fences, people were seen walking across the runway to get to neighbouring settlement areas and a dog was also seen on the runway.

Figure 1: Condition of the runway and area surrounding the runway.

- 4.1 It is recommended to the Director of Civil Aviation that a full audit be carried out on the Fisantekraal Aerodrome to ensure compliance with the Civil Aviation Regulations.

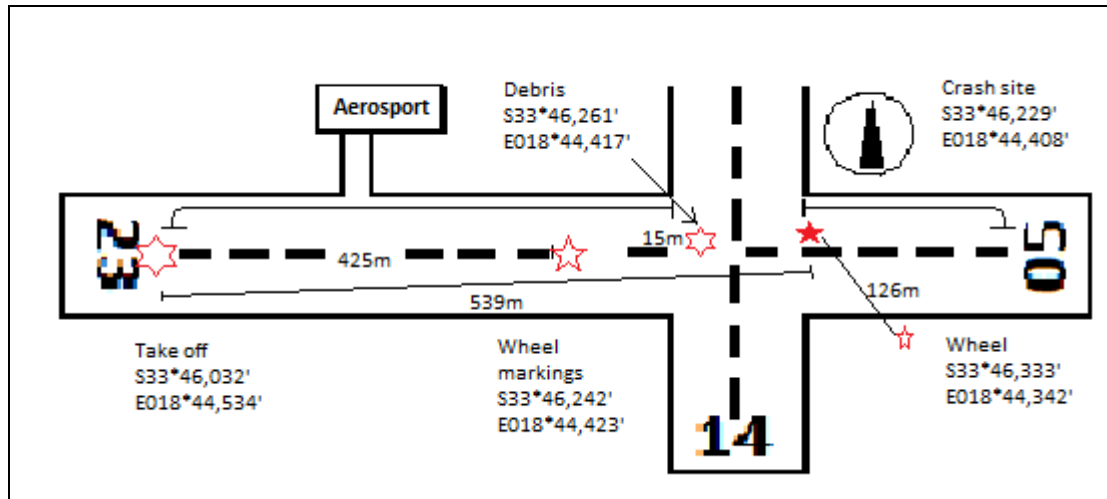
- Distance from take-off to first markings was 425 m
- Distance between the wheel marks and debris was 15 m
- Distance from the take-off to where the aircraft came to rest was 539 m.
- The wheel was found a further 126 m away at GPS co-ordinates S33°46'333" E018°44'342".

Figure 3: Wreckage diagram.

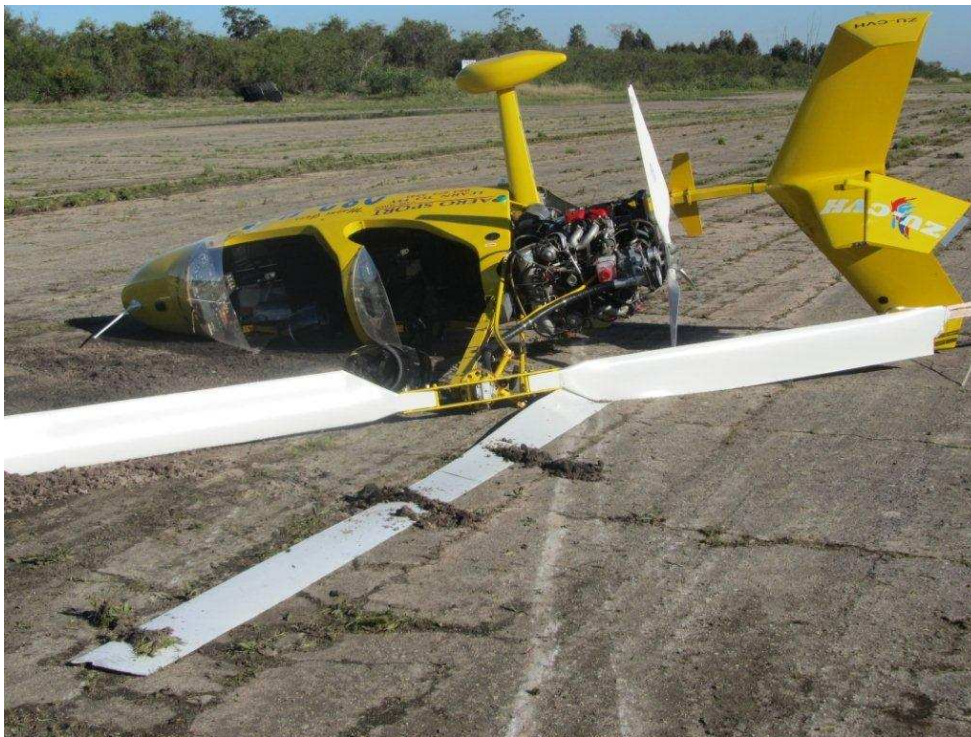
1.12.3 The aircraft slid approximately 120 m down the runway, where it came to rest at the intersection of runways 05 and 32 at GPS coordinates S33°46'299 E018°44'408" at an elevation of 410 ft.

Figure 4: Aircraft in the position it came to rest.

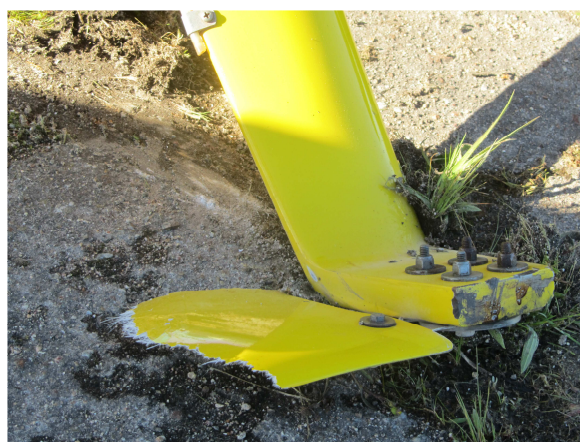
Figure 5: Missing left wheel.

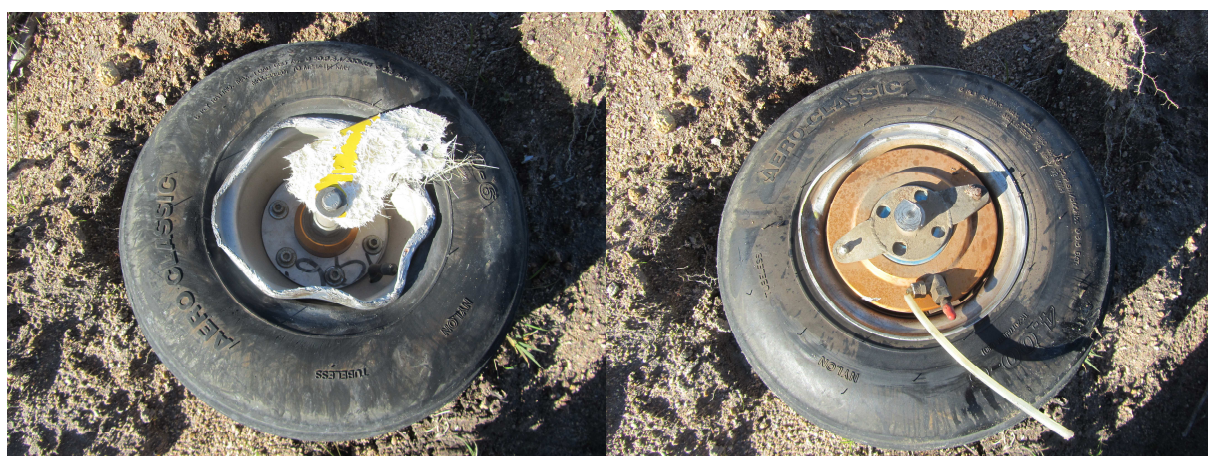
Figure 6: Both sides of the left wheel.

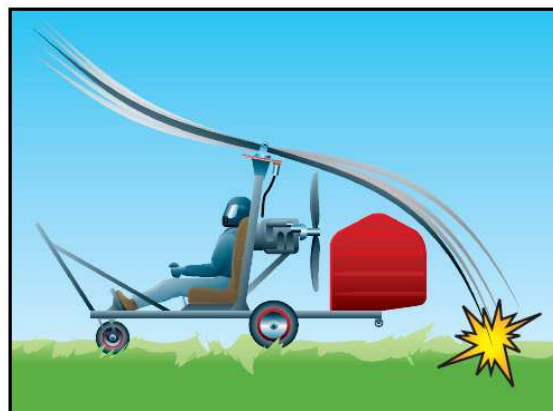
1.16.4 Blade Flap – On a gyroplane with a semi-rigid, teeter-head rotor system, blade flap may develop if too much airflow passes through the rotor system while it is operating at low r.p.m. This is most often the result of taxiing too fast for a given rotor speed. Unequal lift acting on the advancing and retreating blades can cause the blades to teeter to the maximum allowed by the rotor head design. The blades then hit the teeter stops, creating a vibration that may be felt in the cyclic control. The frequency of the vibration corresponds to the speed of the rotor, with the blades hitting the stops twice during each revolution. If the flapping is not controlled, the situation can grow worse as the blades begin to flex and bend. Because the system is operating at low r.p.m., there is not enough centrifugal force acting on the blades to keep them rigid. The chock of hitting the teeter stops combined with uneven lift along the length of the blade causes an undulation to begin, which can increase in severity if allowed to progress. In extreme cases, a rotor blade may strike the ground or propeller. Refer to figure 7.

Figure 8: Taxiing too fast or gusting winds can cause blade flap in a slow-turning rotor. If not controlled, a rotor blade may strike the ground.

To avoid the onset of blade flap, always taxi the gyroplane at slow speeds when the rotor system is at low r.p.m. Consideration must also be given to wind and direction. If taxiing into a 10-knot headwind, for example, the airflow through the rotor will be 10 knots faster than the forward speed of the gyroplane, so the taxi speed should be adjusted accordingly. When pre-rotating the rotor to accelerate slowly and smoothly, in the event blade flap is encountered, apply forward cyclic to reduce the rotor disc angle and slow the gyroplane by reducing throttle and applying the brakes, if needed. Refer to figure 8.

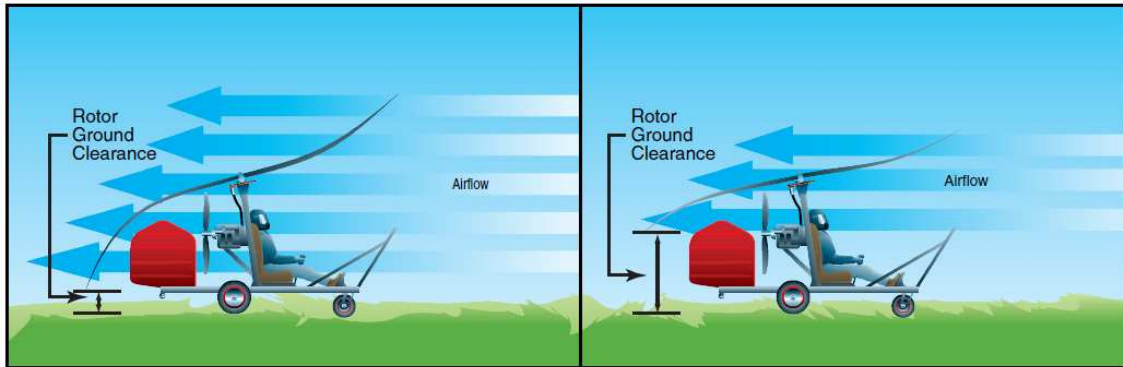
Figure 9: Decreasing the rotor disc angle of attack with forward cyclic can reduce the excessive amount of airflow causing the blade flap. This also allows clearance between the rotor blades and the surface behind the gyroplanes, minimizing the chances of a blade striking the ground.
