**AIRCRAFT ACCIDENT REPORT AND EXECUTIVE SUMMARY**

| | | | | Reference: | CA18/2/3/9234 | |
| <b>Aircraft registration</b> | ZU-EUI | <b>Date of accident</b> | 17 October 2013 | | <b>Time of accident</b> | 1030Z |
| <b>Type of aircraft</b> | Sycamore MK1 (Gyrocopter) | | <b>Type of operation</b> | Private | | |

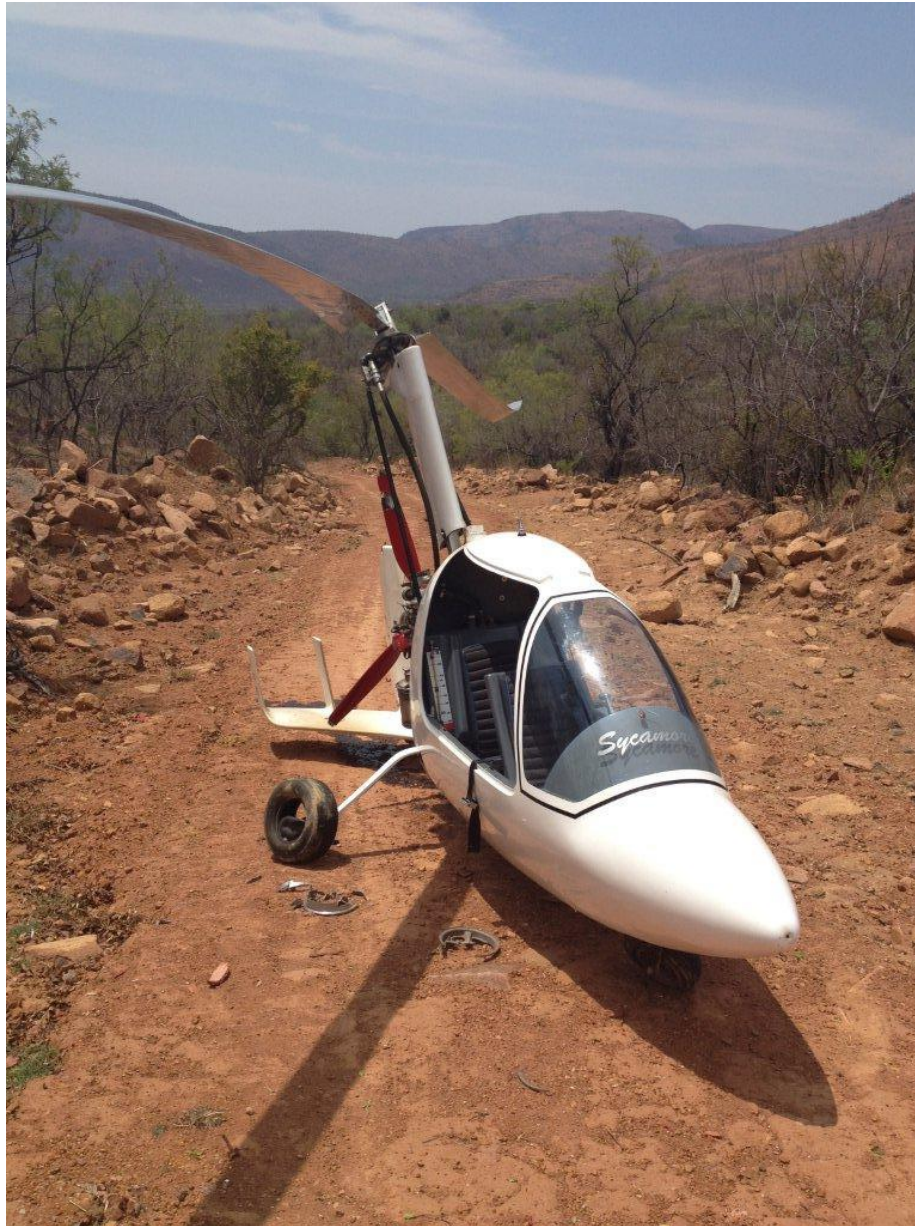
1.12.1 The pilot had limited control of the gyro-copter following the in-flight upset as the nose pitched down by approximately 30°. The pilot managed to execute a hard landing on a narrow dirt road in mountainous terrain, which resulted in damage to the nose and right main wheel assemblies. Due to inadequate vegetation clearance

the main rotor blades collided with some trees on the right-hand side of the gyrocopter as it came to rest in an upright position.

1.12.2 It was observed that the main mast had bent backwards and slightly to the right. This caused the engine cradle as well as the propeller to also move backwards and down a few degrees as the engine cradle was attached to the main mast, and as a result the propeller blades struck the oil cooler on the left side as can be seen in Figure 3 on the next page. All three the propeller blade tips were substantially damaged as a result of the impact.

**Figure 2.** The gyrocopter as it came to rest

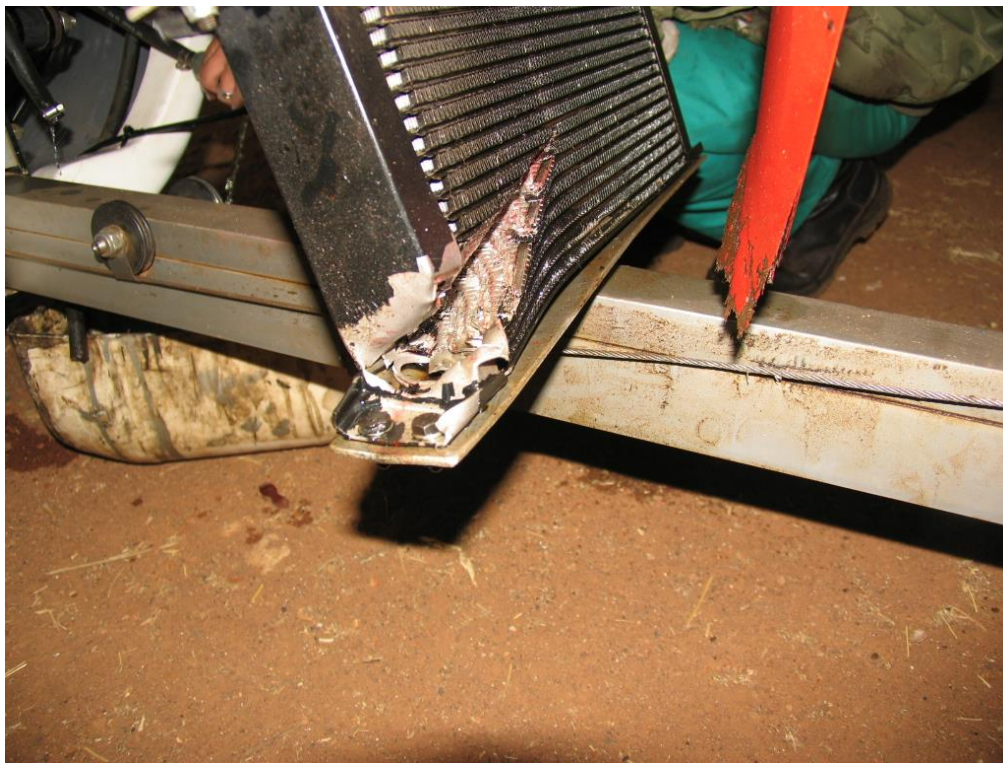
**Figure 3.** Propeller impact markings on the engine oil cooler

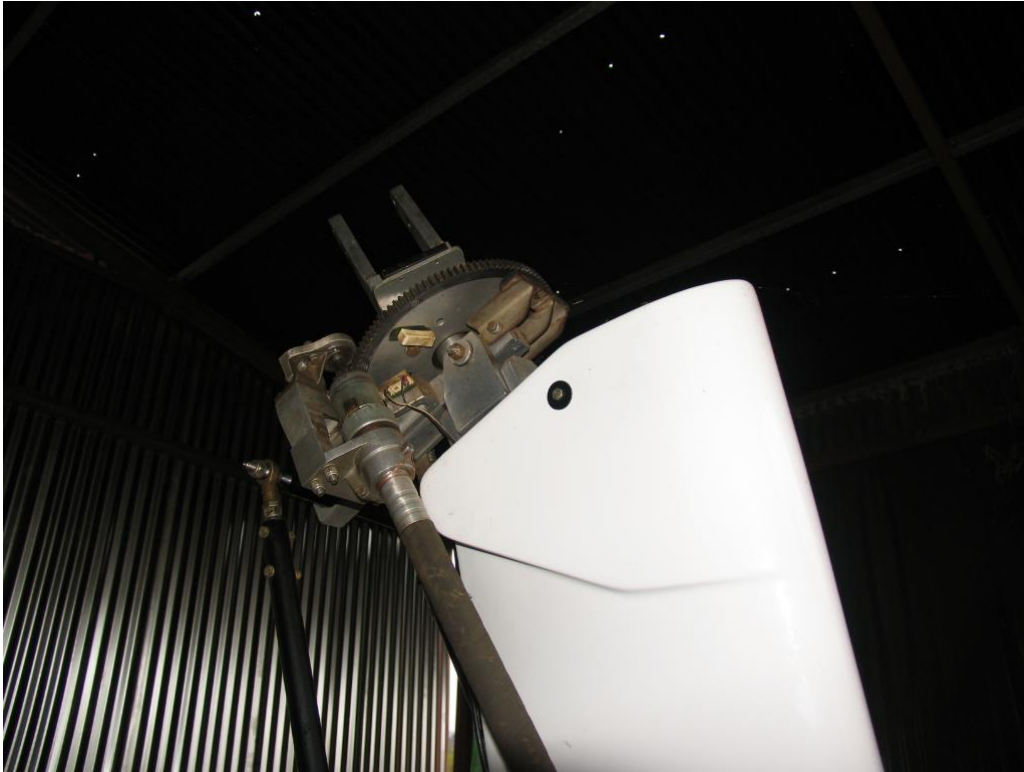
1.16.1 A post-impact inspection of the gyro-copter revealed that the main mast had bent backwards several degrees during flight. After the main rotor mast fairing had been removed, it was noted that the main rotor head attachment brackets, which were positioned on both sides of the mast, displayed signs of deformation. The main mast as well as the two attachment brackets were removed and were submitted for metallurgical examination.

**Figure 4.** Main mast and rotor head assembly prior to removal of the mast fairing

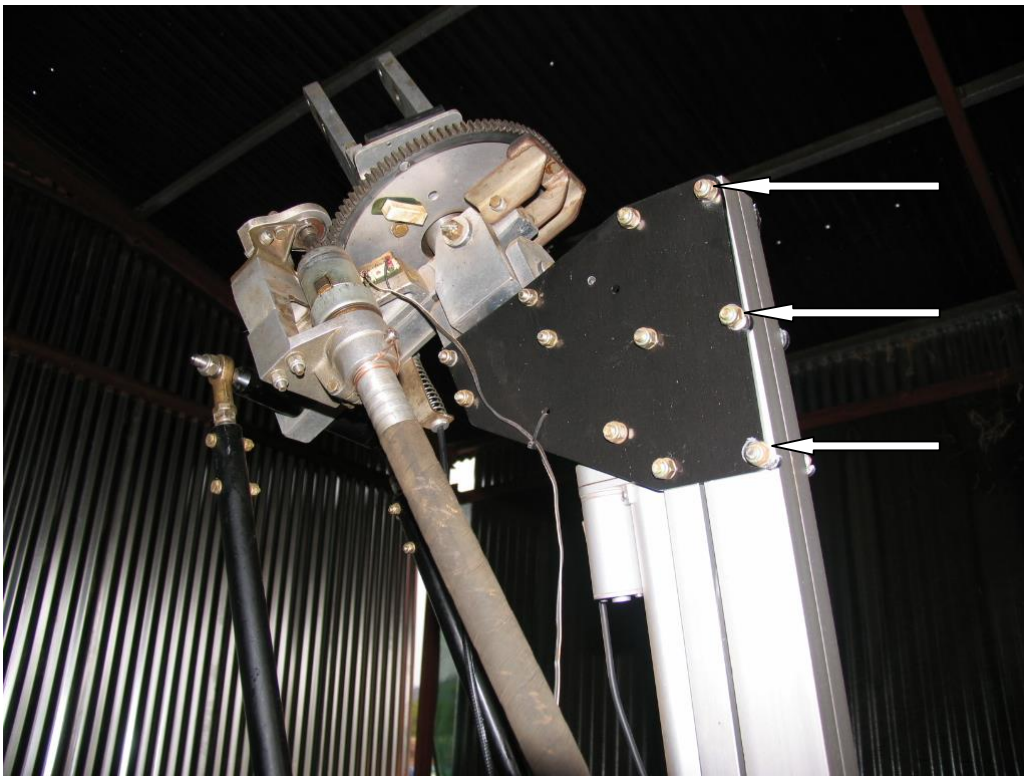
**Figure 5.** The main mast attachment bracket displaying evidence of deformation as indicated by the arrows

Both the main mast to rotor head attachment brackets displayed evidence of deformation after the mast fairing was removed. The fact that these attachment brackets were concealed behind the main mast fairing prevented the pilot from inspecting these attachment brackets prior to or after flight. The presence of a mast fairing was found not to be common practice on gyrocopters, and it was most probably fitted to this gyrocopter for cosmetic reasons. The installation of the mast fairing became a hazard as it obstructed critical components, which included flight control rods, a section of the main mast as well as the main mast attachment brackets. It was not possible for the pilot to conduct a detailed pre-flight/visual inspection on these critical components, which jeopardised the safe operation of the gyrocopter.

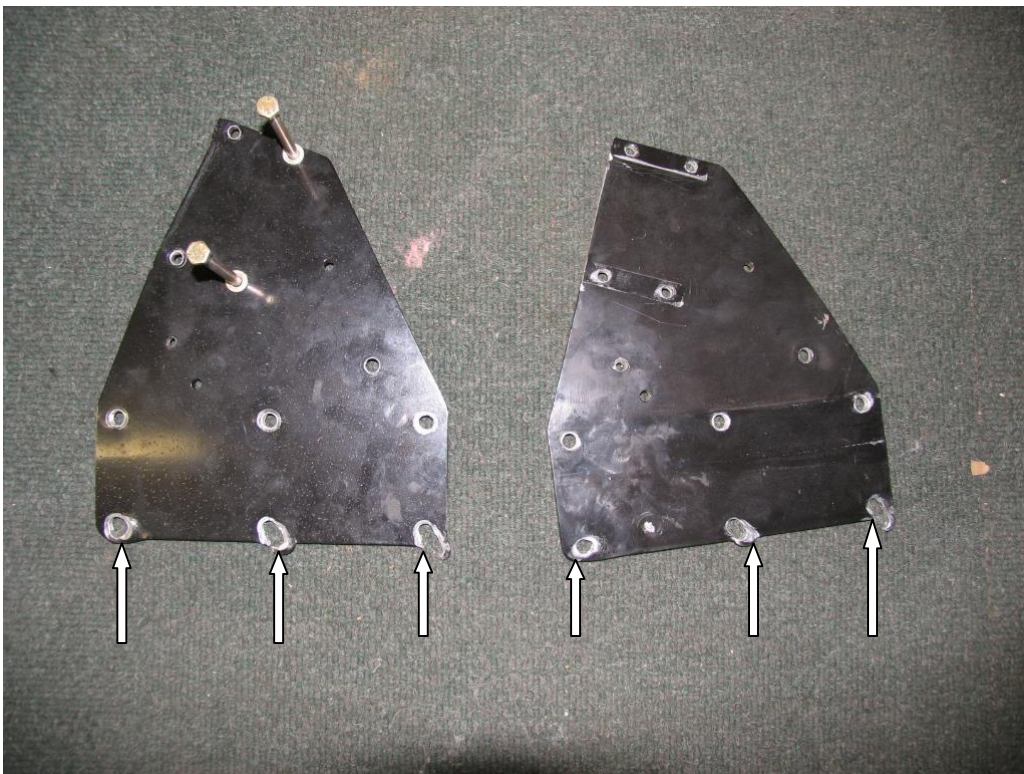
**Figure 6.** Deformation of the two attachment brackets after removal from the mast

It was found that the brackets were made of an inferior quality material, which had deformed over an undetermined period of time. Further to that, the main mast attachment brackets had no traceable history as they had no part numbers or serial

3.3.1 The deformation of the main rotor head attachment brackets, which occurred most probably over an undetermined period of time, was attributed to an inferior quality of material used for the application.

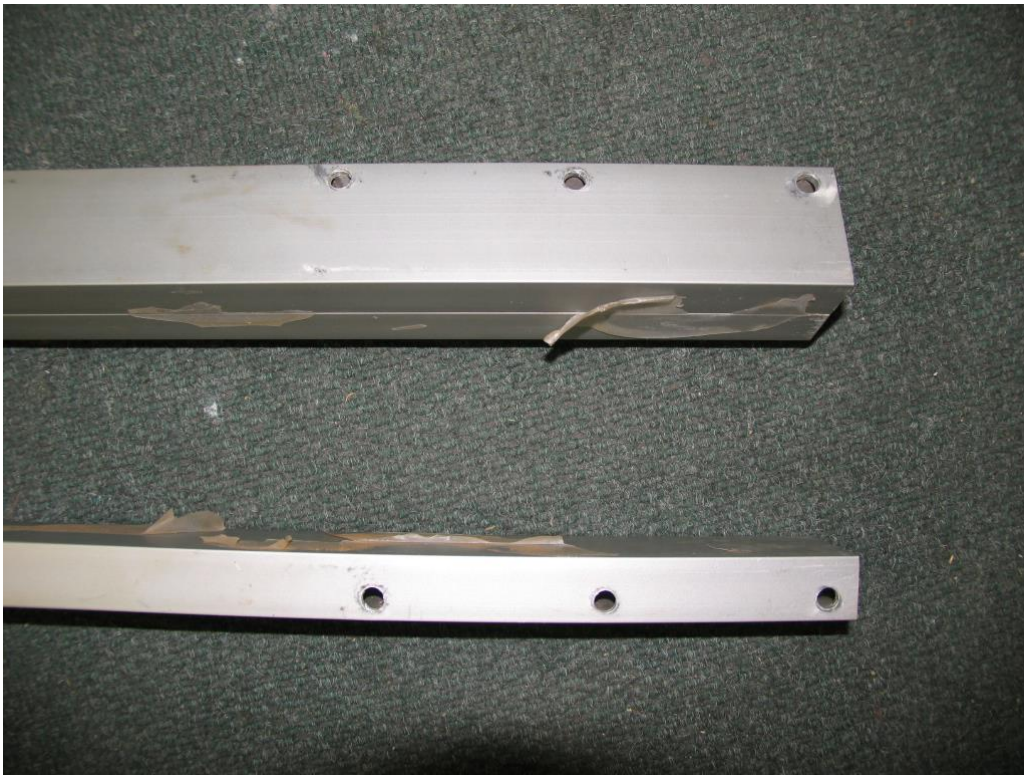
**Figure 7.** The mast attachment bracket holes which present evidence of elongation

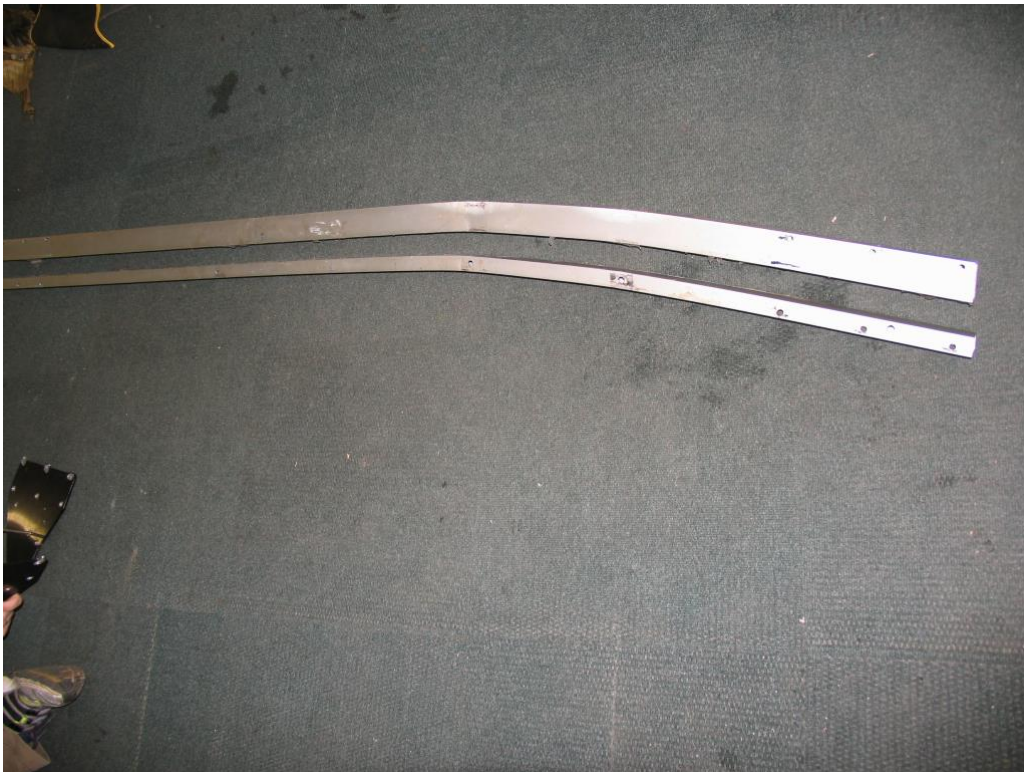
**Figure 8.** An indication of the bending the main mast suffered

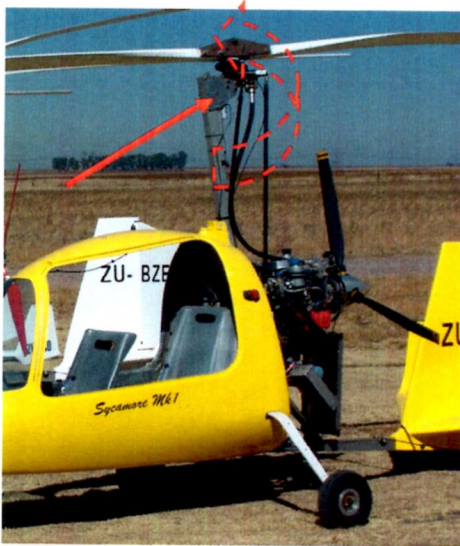
Considering the orientation of the relevant assembly (Photo 2), the applied operational loads onto the attachment brackets (Photo 2, red arrow) can be projected as shown (Photo's 2 and 3, red dashed arrows). The resultant loads on the three forward positioned bolts can therefore be anticipated as per Photo 3, yellow arrows, explaining the variation in the direction, and degree, of the elongation damages (Photo's 3 and 9).

Photo 2: Similar aircraft type showing orientation of main rotor assembly (courtesy SACAA)

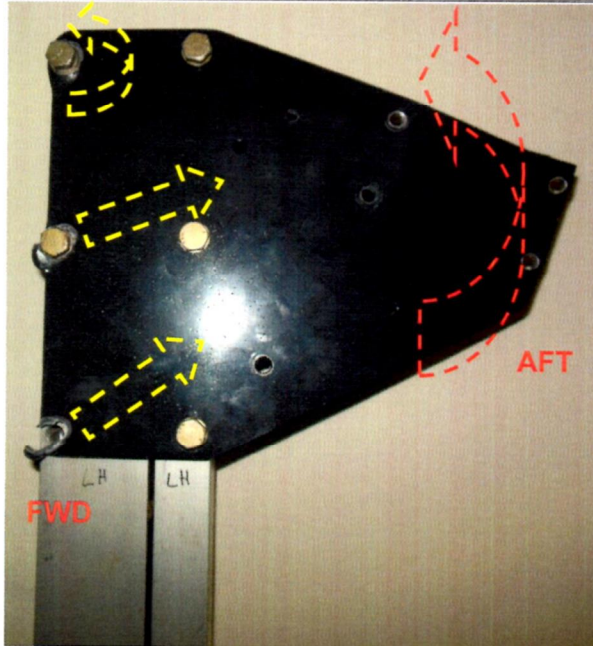
The direction of elongation damages point towards operational- and not impact load/s (Photo 3, yellow arrows). Furthermore, the extensive damages to the bolt holes and surrounding areas indicate that the brackets failed over a period of operational time.

Photo 3: Supplied parts and applied operational loads (digital)

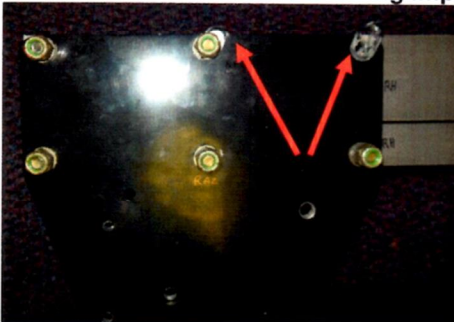
6.1. **Visual Investigation.** The visual inspection revealed impact induced bending damages to the main rotor mast (Photo 4) and severe elongation of the attachment bracket bolt holes (Photo's 5, 7, 8 and 9, red arrows).

Photo 5: Main rotor head attachment bracket assembled (digital)

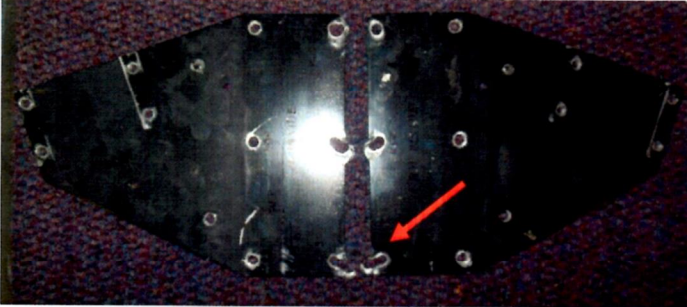
The similarity in damages (Photo's 7, 8 and 9) suggests that both brackets have been exposed to similar (in flight operational) loads.

Photo 7: Main rotor head attachment brackets, inner surfaces (digital)

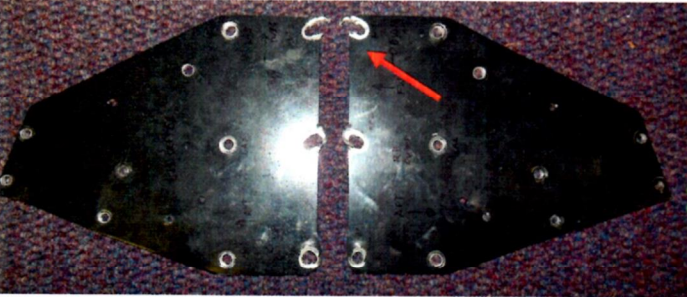
Photo 8: Main rotor head attachment brackets, outer surfaces (digital)

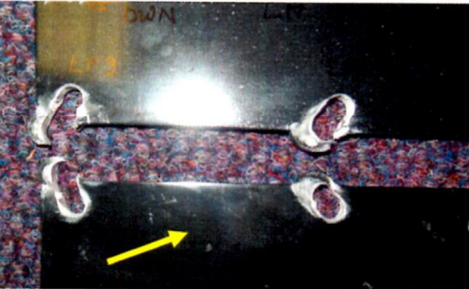
The amount of plastic deformation before final failure was notable (Photo 9) pointing towards the low anticipated strength of the brackets fitted on the accident aircraft.

The visual inspection revealed extensive surface porosity (Photo 9, yellow arrow) on the brackets from ZU-EUI when compared to the supplied reference unit. At higher magnifications, the extent of porosity became even more apparent (Photo's 12 and 13, yellow arrows). The exact cause of the noted porosity could not be determined but may be attributable to the quality of the base material as well as the manufacturing process followed.

Photo 9: Main rotor head attachment brackets showing comparable damages surfaces and surface porosity (digital)

8.2. Taking into account the application of the failed components as well as the possible negative effect on Flight Safety, it is recommended that the relevant certification section/s within the SACAA suggest a redesign of this component/s on the relevant aircraft to the OEM. In the absence of a certified OEM, it is then recommended that the relevant sections within the SACAA engage in a detailed qualification and certification process regarding the utilization of these components on standard (30ft rotors) as well as the upgraded (33ft rotors) versions.

- (a) Removal of the mast covers, if fitted.
- (b) Visual inspection around the bolt holes for cracks or any indications of plastic deformation, in particular along the forward facing edges of the attachment brackets. Any of the above must render the brackets unserviceable with immediate effect.
- (c) Indications of surface pitting/porosity pointing towards a low quality base material.
- (d) Surface Hardness test.
- (e) Non destructive test

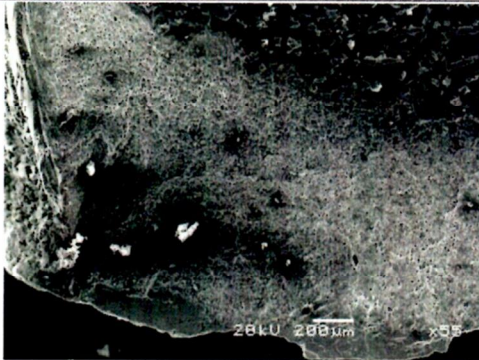
At higher magnification the fractographs from the failed bottom holes (Photo's 10 and 11) reveal a clear ductile geometry with a definite directional orientation.

Photo 10: Fractograph, LF3 bolt hole (x55, SEM)

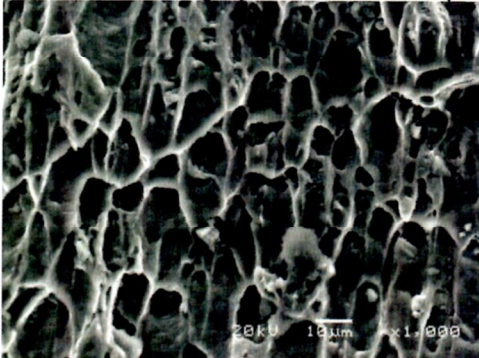
Photo 11: Fractograph, LF3 bolt hole (x1000, SEM)

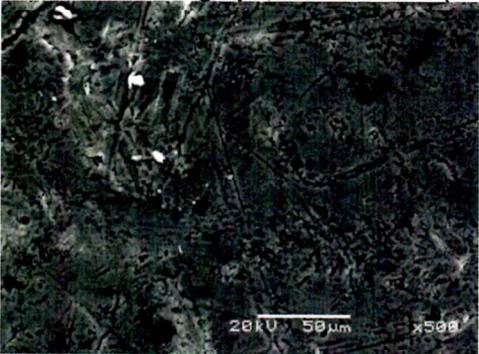
Photo 12: Reference bracket surface, etched (x500, SEM)

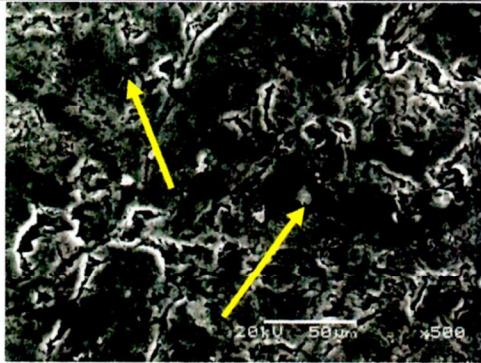
Photo 13: ZU-EUI bracket surface, etched (x500, SEM)
