# AIRCRAFT ACCIDENT REPORT AND EXECUTIVE SUMMARY

Reference:	CA18/2/3/9290	
<b>Aircraft Registration</b>	<b>ZS-PXP</b>	<b>Date of Accident</b>	12 February 2014		<b>Time of Accident</b>	0645Z
<b>Type of Aircraft</b>	Robinson R44 Raven II (Helicopter)		<b>Type of Operation</b>		Game Culling	
<b>Pilot-in-command Licence Type</b>		Commercial	<b>Age</b>	46	<b>Licence Valid</b>	Yes
<b>Pilot-in-command Flying Experience</b>		Total Flying Hours	698		Hours on Type	64
<b>Last point of departure</b>		Setlakgole aerodrome, North West province.				
<b>Next point of intended landing</b>		Setlakgole aerodrome, North West province.				
<b>Location of the accident site with reference to easily defined geographical points (GPS readings if possible)</b>						
Farm Stella in Mafikeng area at GPS position determined to be South 26°12.049' East 024°43.960', at an elevation of 4 115 feet above mean sea level (AMSL)'.  						
<b>Meteorological Information</b>		Temperature: 28 °C; Cloud cover: None; Wind speed: Very light breeze.

**Name of Owner/Operator** : Maf Toy Auto CC  
**Manufacturer** : Robinson Helicopter Company  
**Model** : R44 II  
**Nationality** : South African  
**Registration Marks** : ZS

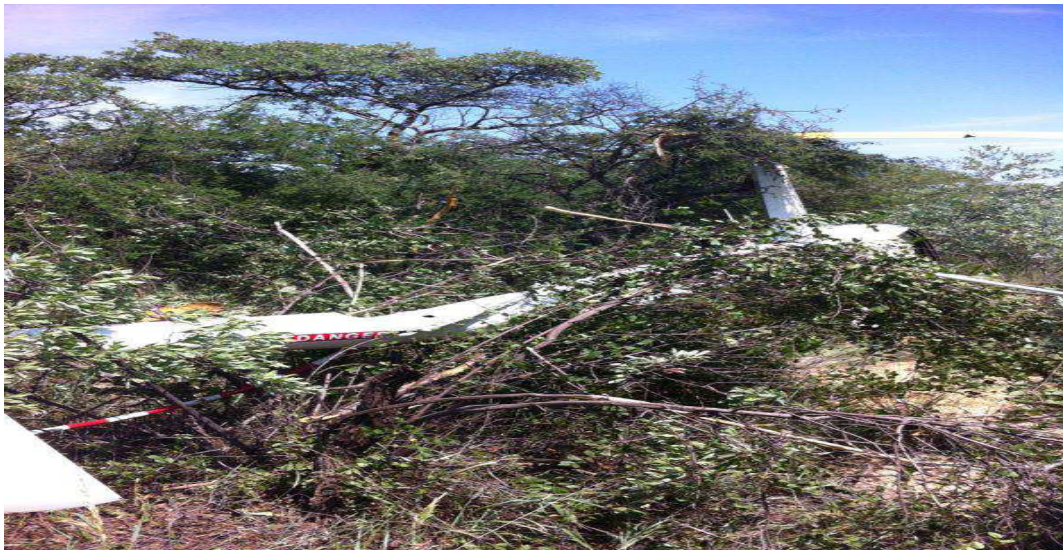
Figure 2: Wreckage as found at accident site.

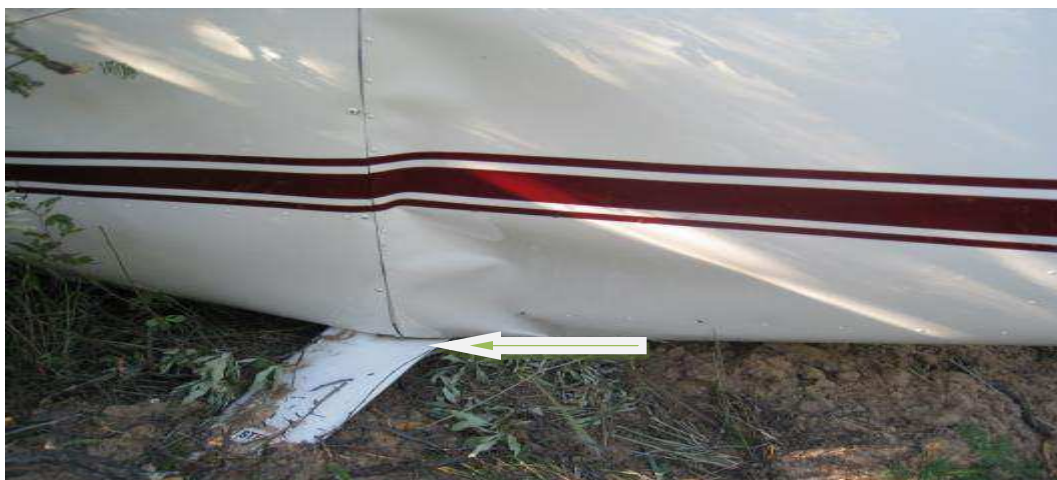
Figure 3: Evidence of damage to skids and airframe.

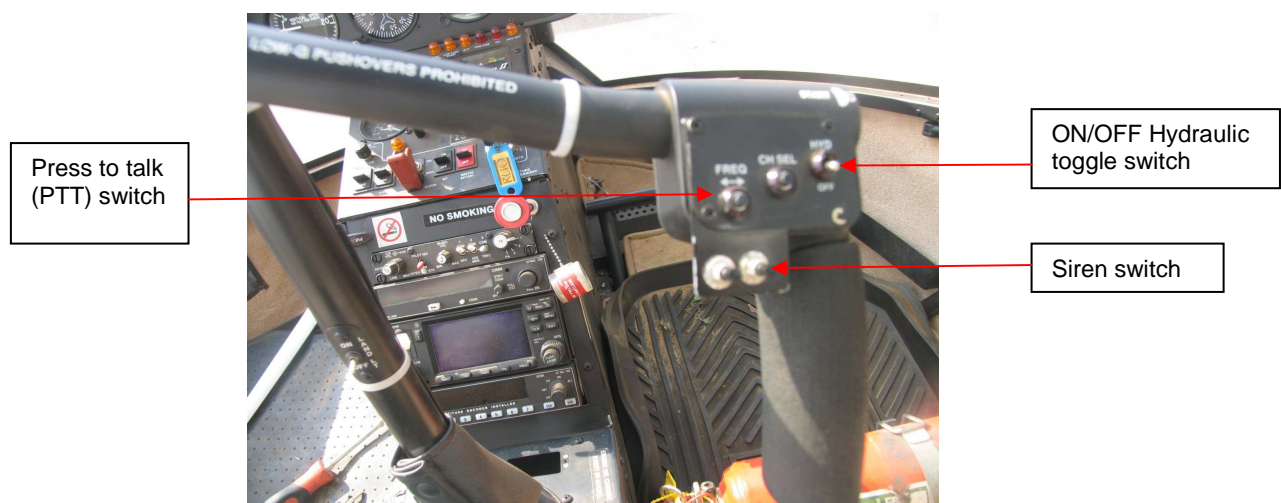
- 1.6.5 The 28-volt DC electrical system powers a single bus bar and includes an alternator, voltage controller, battery relay and 24-volt battery. Standard lighting on the R44 helicopter includes strobe, navigation, panel and map lights. The warning lights are extensive, and the low rotor warning also includes a horn activated at 97 per cent rpm. Another standard feature is the four-place voice activated intercom system. The helicopter has a press-to-talk (PTT) switch in the pistol grip on the cyclic control, which is activated by the index or key finger. The hydraulic switch is located on the front of the cyclic stick.

Figure 4: Cyclic control.

- 4.1 It is recommended to the Director for Civil Aviation that the regulating authority through the Federal Aviation Administration (FAA) advise Robinson Helicopter Company to install a safety guard on all Robinson R44 hydraulics toggle switches, to prevent pilots from inadvertently switching them OFF in-flight. (Such a recommendation was proposed and submitted to the FAA via the NTSB in May 2008, accident reference number CA18/2/3/8485. The FAA declined the recommendation at the time. However, AIID still holds the opinion that this design shortcoming with the switch on the cyclic control stick remains unsafe).

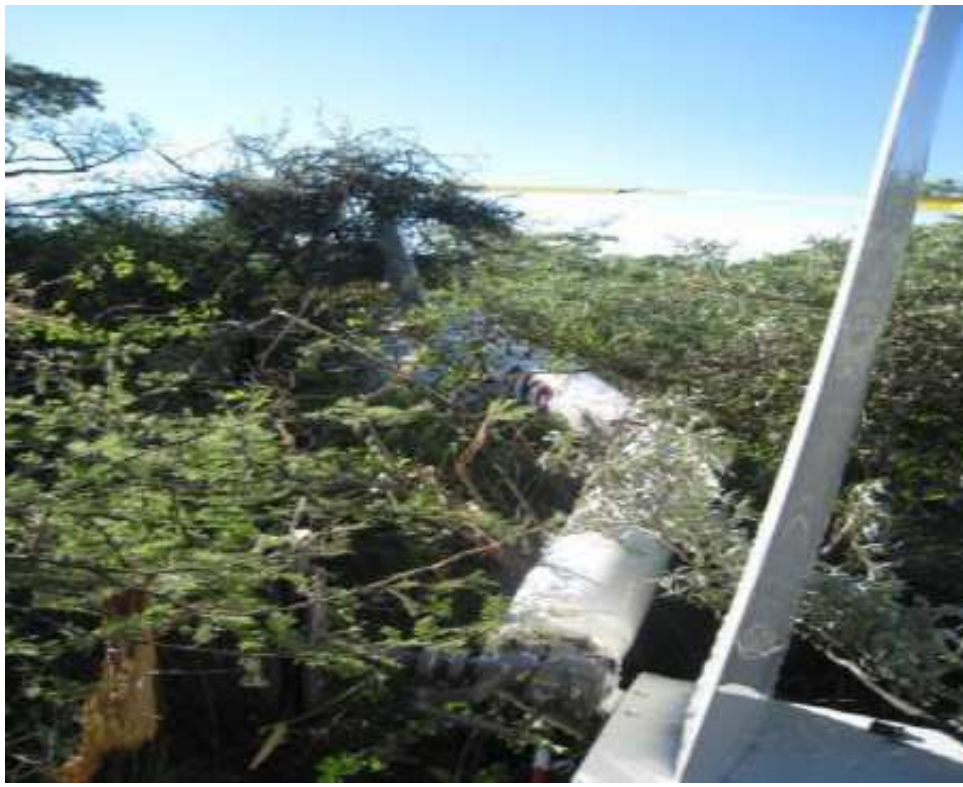
- 1.12.1 The helicopter collided with a number of small trees before landing hard on the skids. The main rotor blade severed the tail boom during the impact sequence and there was substantial damage. The tail rotor was also severed during the impact sequence with the trees. The helicopter cockpit area was intact and all the instruments were still intact and secured to their mounting points. The helicopter seats were secured to their anchors with the safety harnesses intact. Figure 6 shows the final position of the helicopter as found at the accident site and Figure 7 and 8 the damaged rotor and tail section (tail boom and tail rotor blades).

**Figure 6: Rear view of wreckage.**

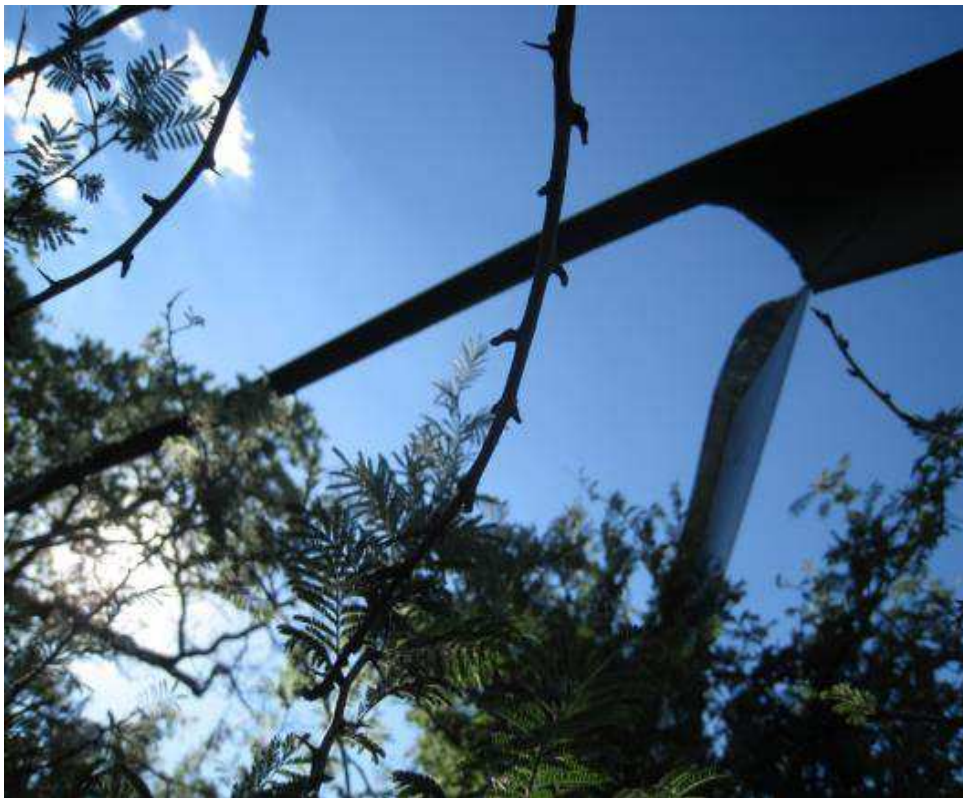
**Figure 7: Destroyed main rotor.**

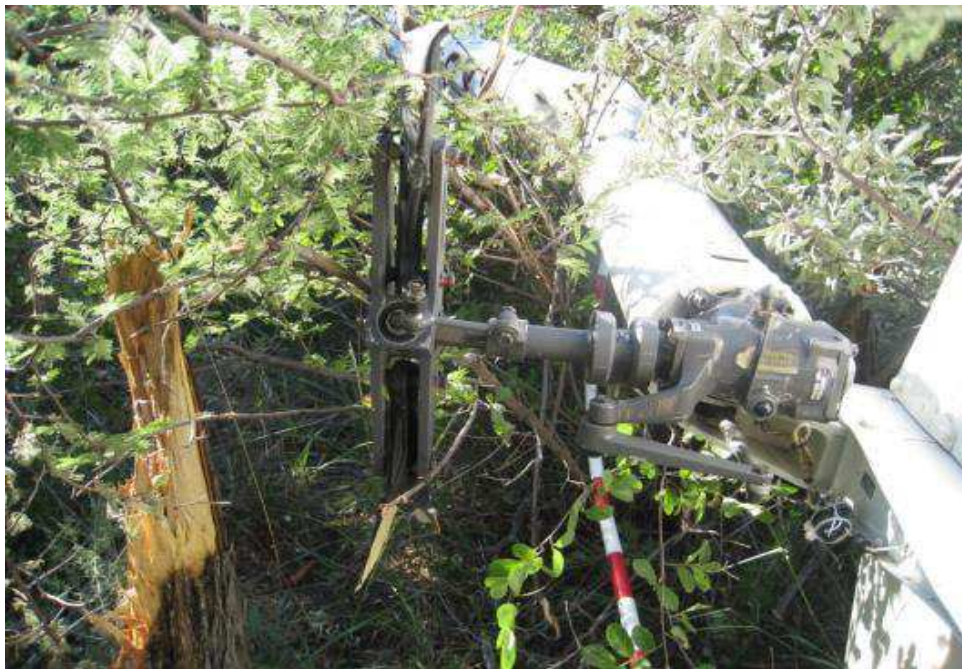
**Figure 8: Severed tail boom.**

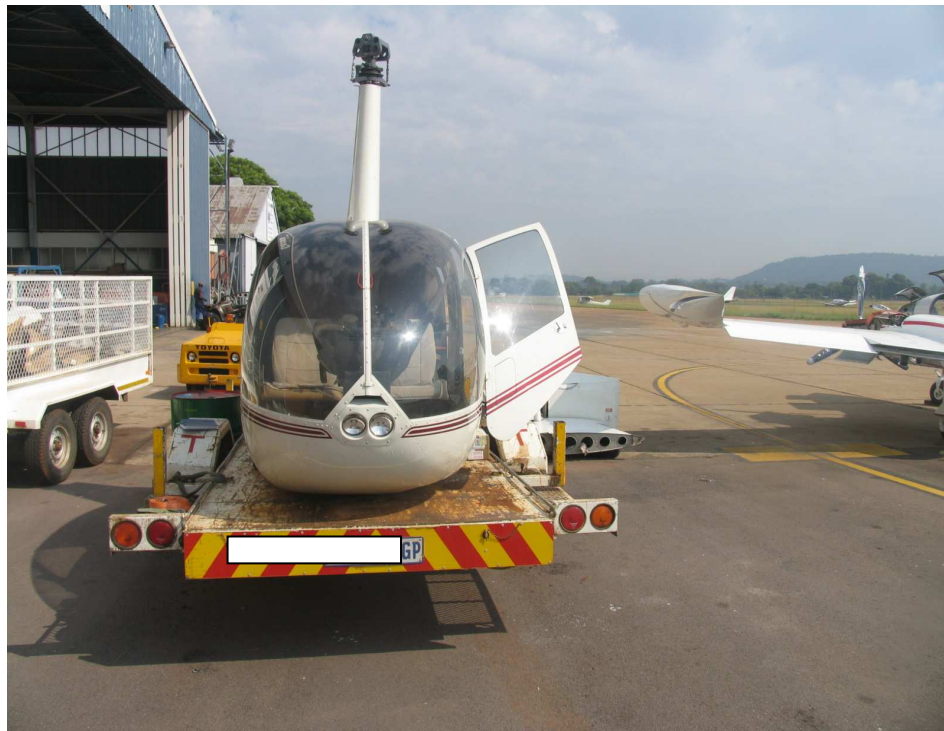
1.16.1 The helicopter crashed in bushy terrain and the investigation was off-site. All the switches inside the cockpit were found to be in an OFF position and the investigating team could not confirm their position after the accident. The tail boom and the main rotor were removed from the airframe and the helicopter, serial number 11851 with the engine still secured to it was recovered on a trailer by a SA CAA-approved AMO to Wonderboom (FAWB) aerodrome located north of Pretoria, Gauteng, for further engine testing and examination (see Figure 9).

**Figure 9: Helicopter secured on a trailer at FAWB Aerodrome.**

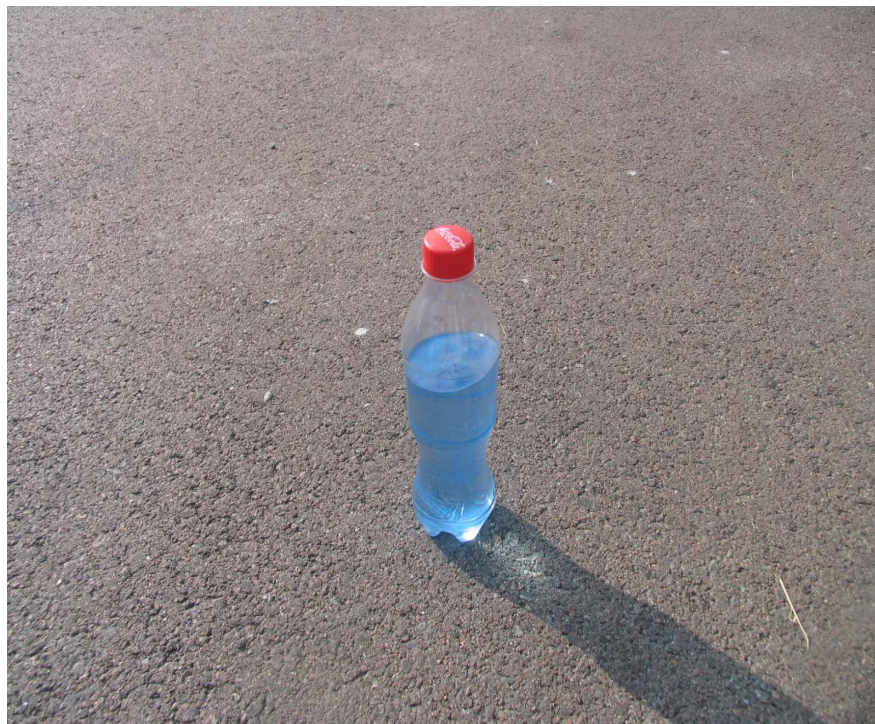
1.16.2 The engine and its components were air-blown to remove sand and dust and then subjected to a thorough inspection. All components were found to be secured to their respective mounting points and still in good condition. No fuel leak was found. The fuel filter was removed and analysed and was free from contaminants. A fuel sample was taken and was found to be clean, free from contaminants (Figure 10).

**Figure 10: Fuel sample from helicopter.**

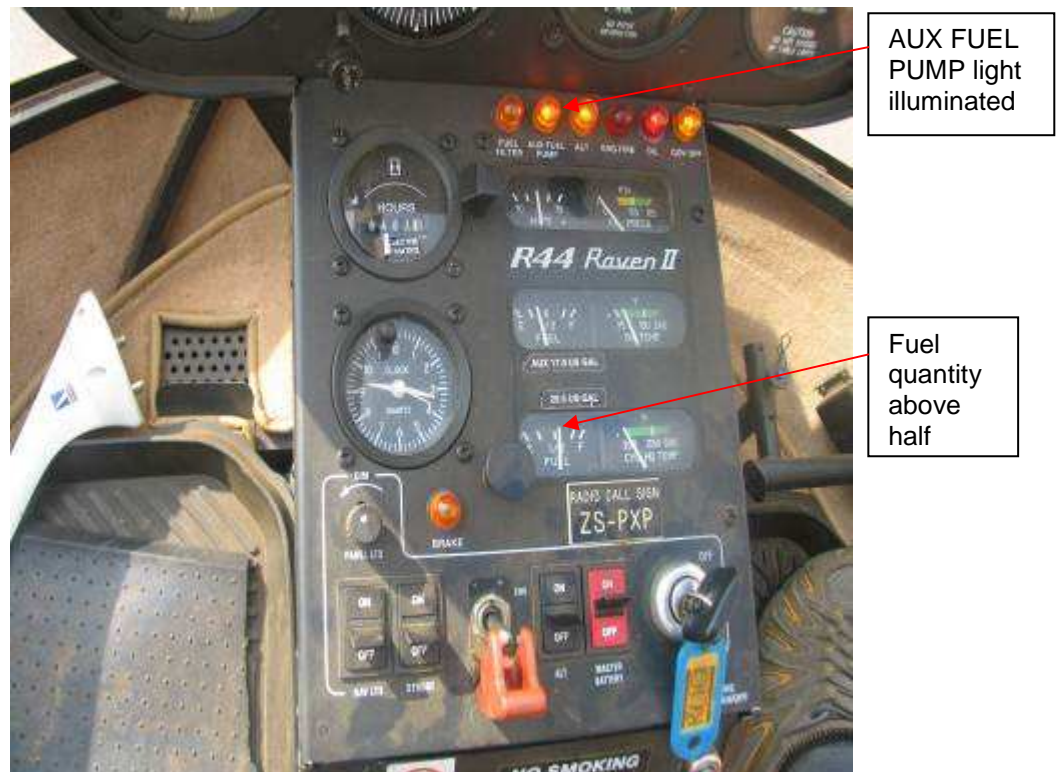
1.16.3 One of the investigators got inside the cockpit and switched ON the electrics with intention to determine whether the engine auxiliary fuel pump, the mechanical fuel pump and the clutch were functioning or operative and all were found to be serviceable, and the auxiliary fuel pump light illuminated. An aircraft maintenance engineer rated on helicopter type, (R44 Raven II) subsequently inspected and tested the helicopter's hydraulic system. This included a visual inspection of the system, an operational check using a slave hydraulic pump driven by an electric motor, and an operational check of the hydraulic pump. He concluded that the hydraulic system had functioned normally (Figure 11).

Figure 11: The helicopter instrument panel.
