## AIRCRAFT ACCIDENT REPORT AND EXECUTIVE SUMMARY

Reference: CA18/2/3/9352	
<b>Aircraft Registration</b>	<b>ZU-FVW</b>	<b>Date of Accident</b>	12 August 2014		<b>Time of Accident</b> 0955Z
<b>Type of Aircraft</b>	Sling 2 (Aeroplane)		<b>Type of Operation</b>	Private	
<b>Pilot-in-command Licence Type</b>	Private pilot licence		<b>Age</b>	28	<b>Licence Valid</b> Yes
<b>Pilot-in-command Flying Experience</b>	Total Flying Hours		168.3		<b>Hours on Type</b> 124.3
<b>Last point of departure</b>		Port Elizabeth (FAPE) international aerodrome: Eastern Cape.			
<b>Next point of intended landing</b>		Tedderfield private aerodrome (FATA): Gauteng.			
<b>Location of the accident site with reference to easily defined geographical points (GPS readings if possible)</b>					
On a privately owned farm at GPS coordinates determined to be (S 32° 50.45.0' E 025° 48 .25.0') at an elevation of approximately 1 782 feet above mean sea level (AMSL).					
<b>Meteorological Information</b>		CAVOK weather conditions were reported.

**Name of Owner/Operator** : Madiba Bay School of Flight.  
**Manufacturer** : The Airplane Factory  
**Model** : Sling 2  
**Nationality** : South African  
**Registration Marks*

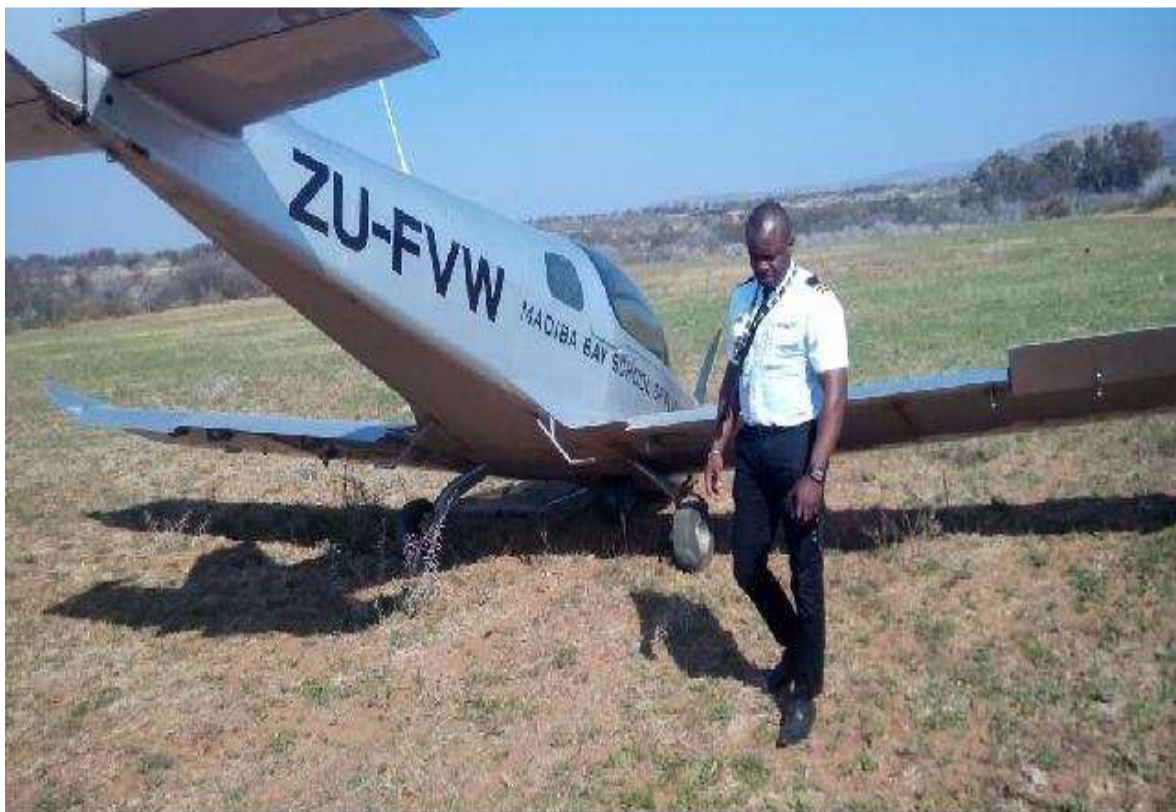
1.3.1 The landing gear, wings, propeller and the lower cowling were damaged.

**Figure 1:** The aircraft as found at the accident site

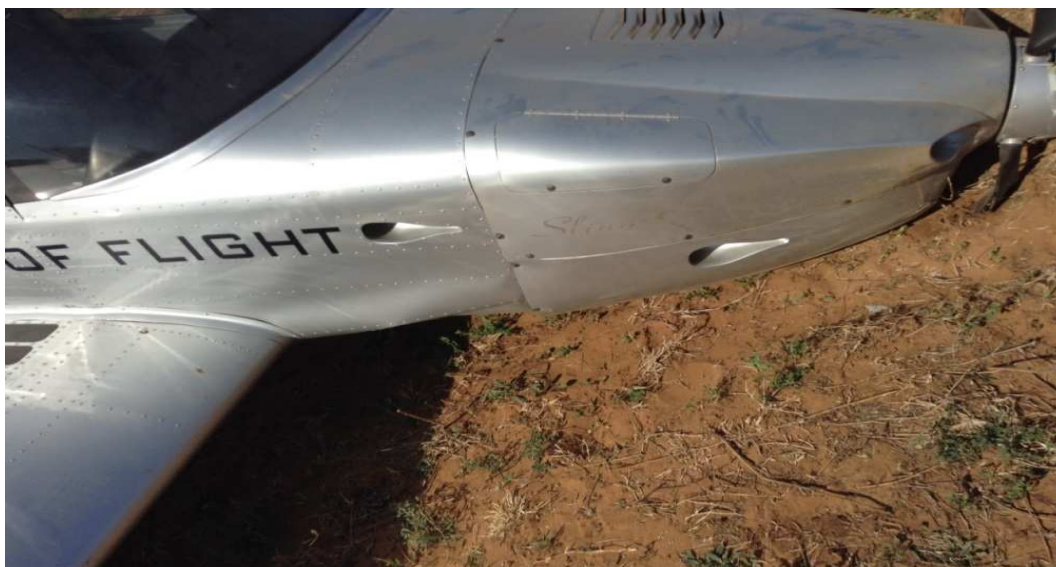
1.12.1 Following the in-flight mishap and subsequent unsuccessful forced landing on the farm, the aircraft suffered substantial damage to the wings, landing gear, and the lower cowling. The aircraft nose strut collapsed because of this and the propeller struck the ground. See figures 4, 5 and 6 below.

**Figure 4:** The aircraft in a nose low position

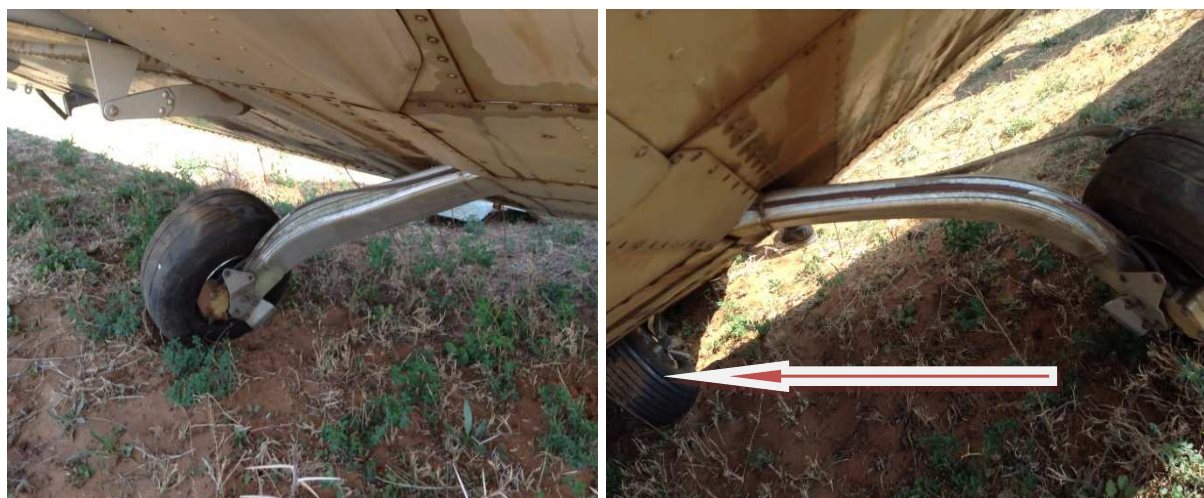
**Figure 5/6:** Damaged main landing gear with the nose wheel visible

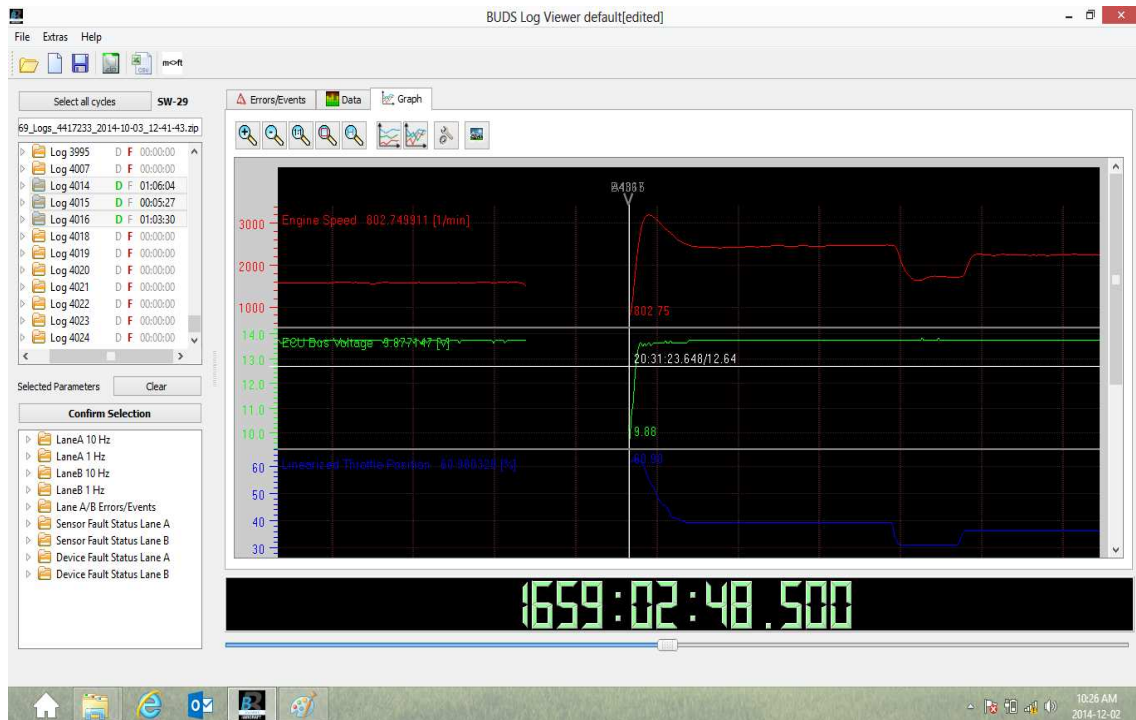
1.16.2 The investigation of the electronic engine logs saved in the engine control unit (ECU) system revealed that, immediately prior to the accident the various sensors on the engine (S/n 4417069) all failed three times to default values as a consequence of three consecutive voltage drops of the aircraft engine electrical system. Warning lamps appeared during the three engine failures occasioned by the voltage drops. The aircraft engine was restarted 3 times, shown in figure 7, where the voltage falls below 10 volts, the ECU is programmed to shut down and to re-synchronise, lanes A and B. The first engine shut down (figure 7) was at 1 659 hr 2 minutes, at which time the throttle position was at 60%. The voltage dropped below 10 volts and the engine revolutions per minutes (RPM) dropped to 802. The engine was thereupon restarted by the pilot and it continued thereafter to run until the final engine shut down.

**Figure 7:** First engine shut down

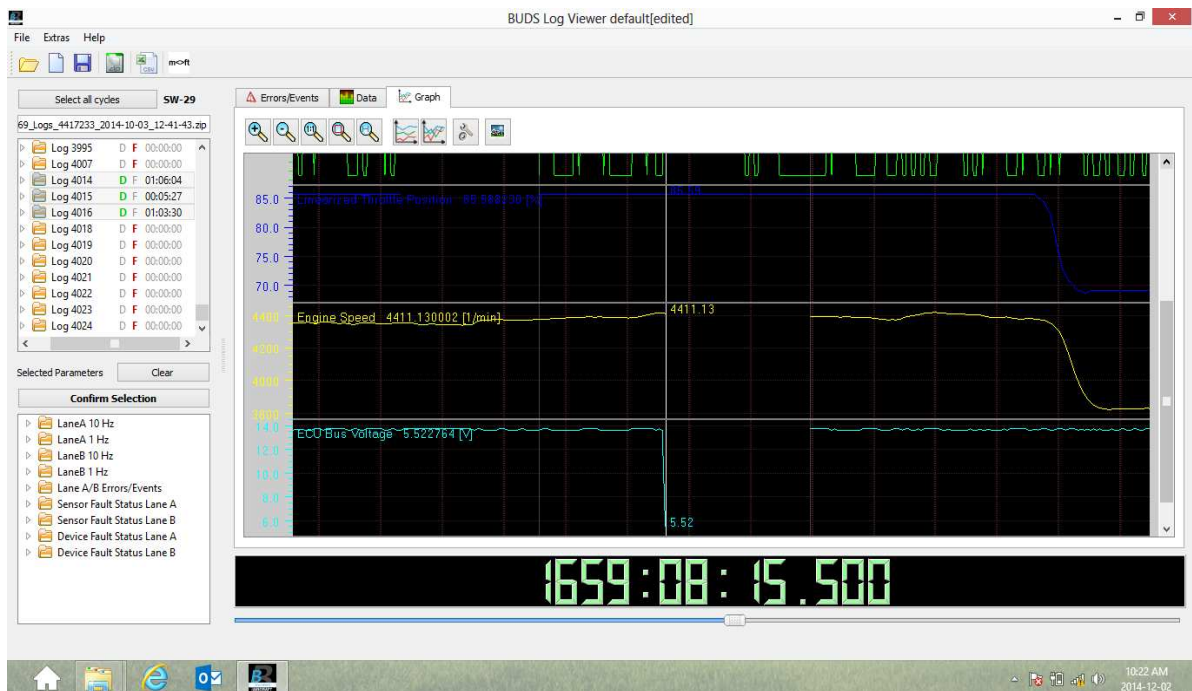
1.16.3 The second ECU voltage drop as shown in figure 8 took place at 1 659 hr 8 minutes, at which time the voltage had dropped to 5.52 volts with a throttle position of 85.59% and the engine revving at 4 411 RPM. Although the engine did not cut entirely on this occasion, the warning lights flashed.

**Figure 8:** Second voltage drop

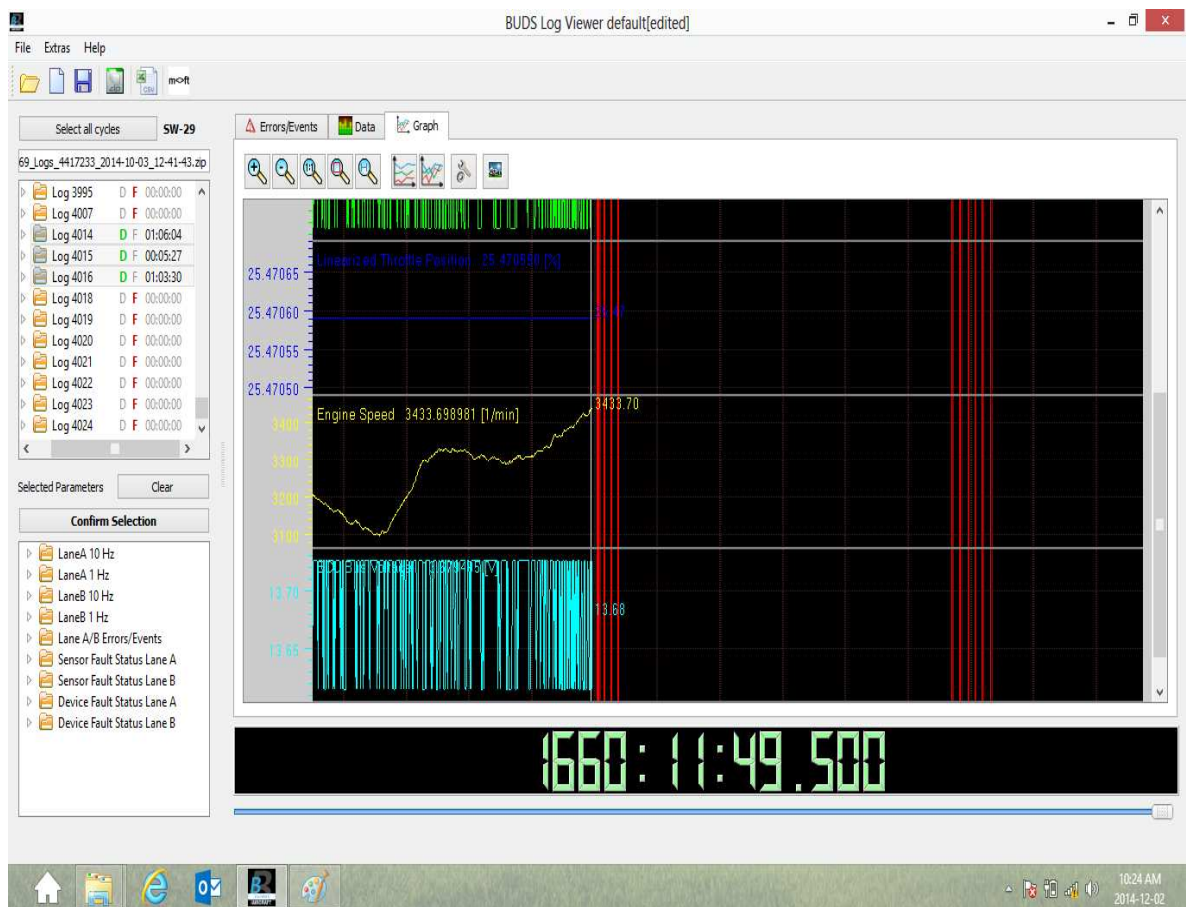
1.16.4 The third and final time was when the engine cut out and could not be restarted at 1 660 hr 11 minutes, at which time all engine sensors failed (figure 9). During this time, the engine RPM read 3 333 with a throttle position of 25.47%.

**Figure 9:** Failure of all sensors

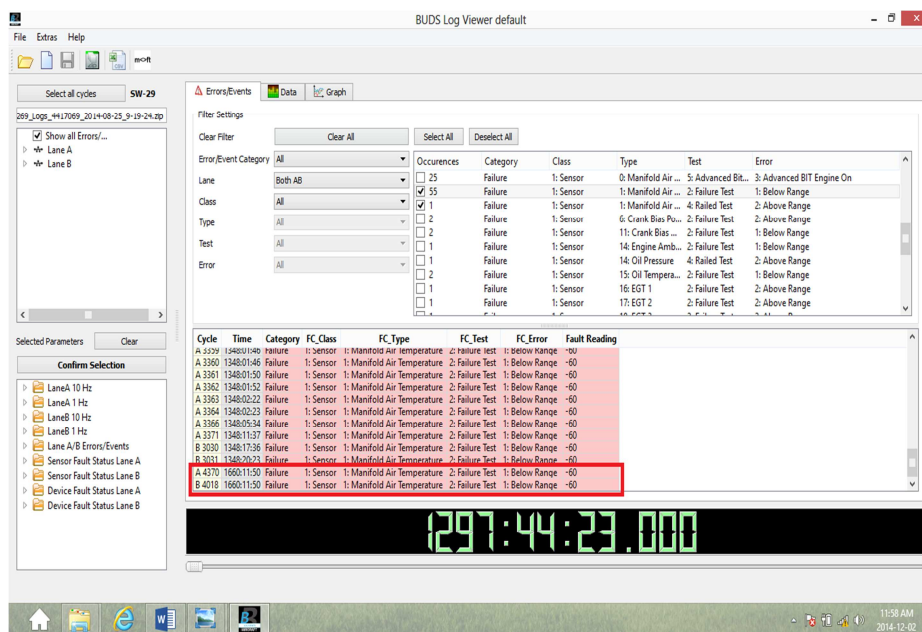
1.16.4 As illustrated in Figure 10, both manifold pressure sensors had, during this time, also ceased reading due to the low voltage. The failure of both these sensors alone led to immediate engine shutdown. Figure 11 shows in the BUDS program that all the sensors had failed to their default value.

Figure 10: Illustration of sensor failure

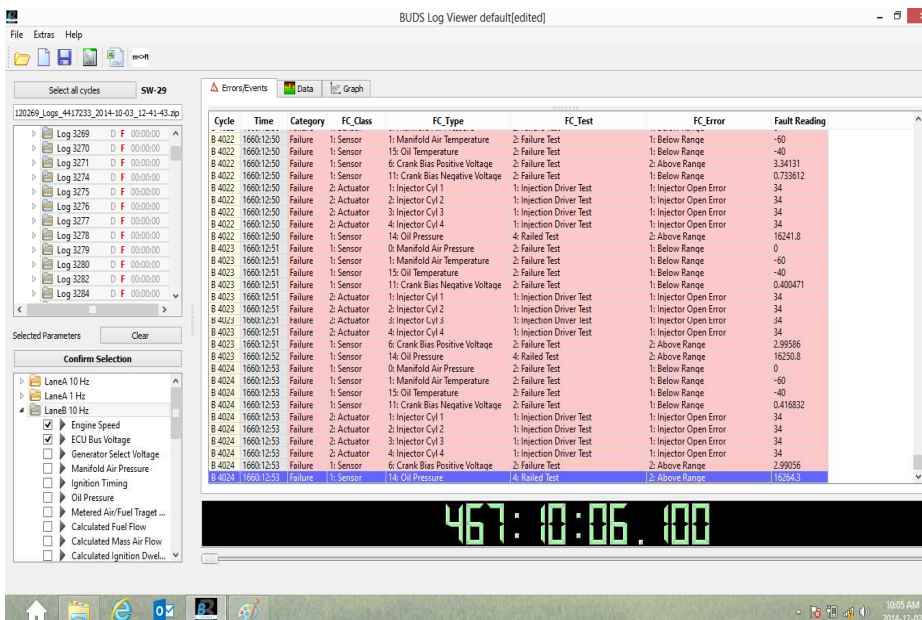
Figure 11: Sensor failure to default value.

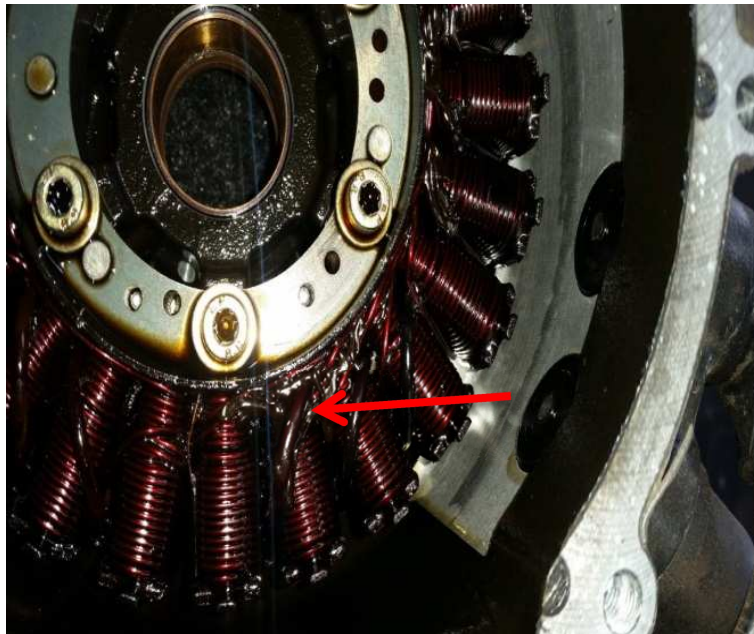
1.16.6 The cause of the engine failure in each case, however, was the loss of voltage to the ECU. The investigation of the charging system showed that regulator B on the fuse box had completely melted. This indicates an overvoltage condition, ultimately leading to total electrical failure. The engineer accordingly removed the ignition housing from the engine to inspect the stator (which is housed inside the ignition housing, submerged in oil) for signs of damage. Signs of burning on the stator were observed on the coils as shown on Figures 12 below.

**Figure 12:** Burnt stator with evidence of melting on the copper wires

1.16.7 The investigation concluded that the burning on the ignition stator coils resulted in melting of the insulation around the copper wires, leading to short circuiting and a persistent overvoltage condition. The overvoltage condition led to the failure of the regulator, causing a total electrical failure and subsequent engine stoppage. Further inspection of the stator pickups showed that they had come into contact with and rubbed against the flywheel housing. It would appear that this rubbing caused heat build-up which in turn resulted in the melting of the stator coils referred to above. Figure 14 shows signs of the stator pickups rubbing against the flywheel housing.

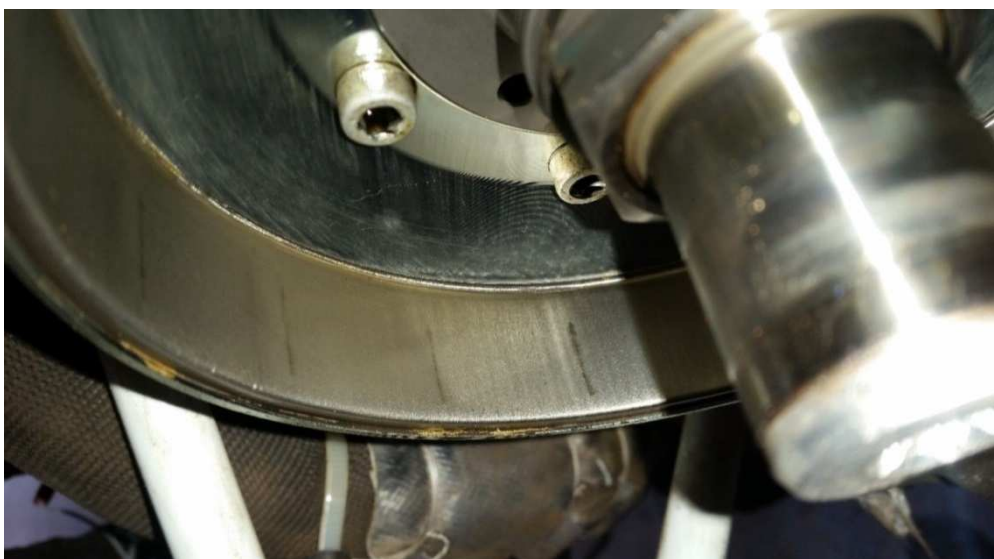
**Figure 13:** The flywheel housing
