## AIRCRAFT ACCIDENT REPORT AND EXECUTIVE SUMMARY

Reference:	CA18/2/3/9369	
<b>Aircraft Registration</b>	<b>ZS-TIC</b>	<b>Date of Accident</b>	31 July 2014		<b>Time of Accident</b>	0715Z
<b>Type of Aircraft</b>	Cessna 210N (Aeroplane)		<b>Type of Operation</b>		Private	
<b>Pilot-in-command Licence Type</b>		Commercial	<b>Age</b>	51	<b>Licence Valid</b>	Yes
<b>Pilot-in-command Flying Experience</b>		Total Flying Hours	1 248,6		Hours on Type	452,6
<b>Last point of departure</b>		Hunter's Moon airstrip, Northern Cape				
<b>Next point of intended landing</b>		Gariep Dam aerodrome, Free State				
<b>Location of the accident site with reference to easily defined geographical points (GPS readings if possible)</b>						
Hunter's Moon Safari Lodge (geographical coordinates 30°27'8" South 024°58'31" East)						
<b>Meteorological Information</b>		Wind: 315°5kt; Visibility: 10km; Temperature: 6° C; Cloud cover: Nil; Cloud base: Nil.				
<b>Number of people on board</b>	1 + 1	<b>No. of people injured</b>	0	<b>No. of people killed</b>	0

**Name of Owner** : Lima Romeo Air CC  
**Name of Operator** : Lima Romeo Air CC  
**Manufacturer** : Cessna Aircraft Company  
**Model** : 210N  
**Nationali

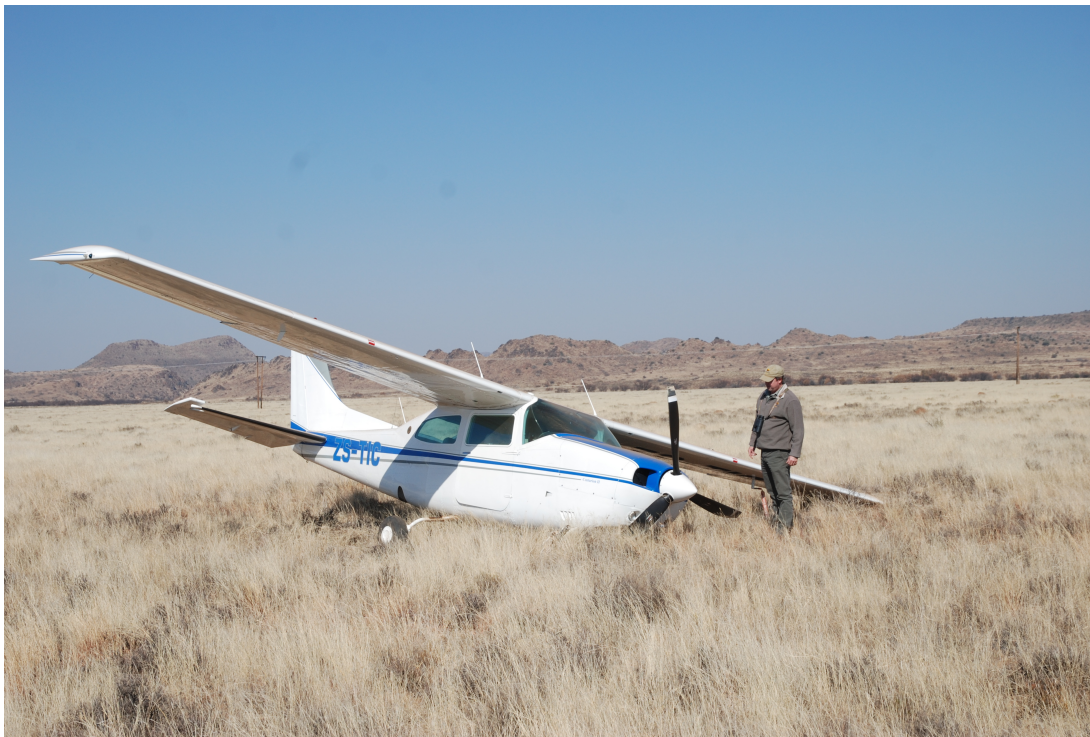
**Figure 1:** The aircraft after coming to rest.

- 1.12.1 The aircraft came to a stop with the left wing resting on the ground, as the left main landing gear had collapsed. The nose gear had also collapsed, causing the propeller to strike the ground.
- 1.12.2 The aircraft was in a level attitude and a landing configuration during the forced landing.

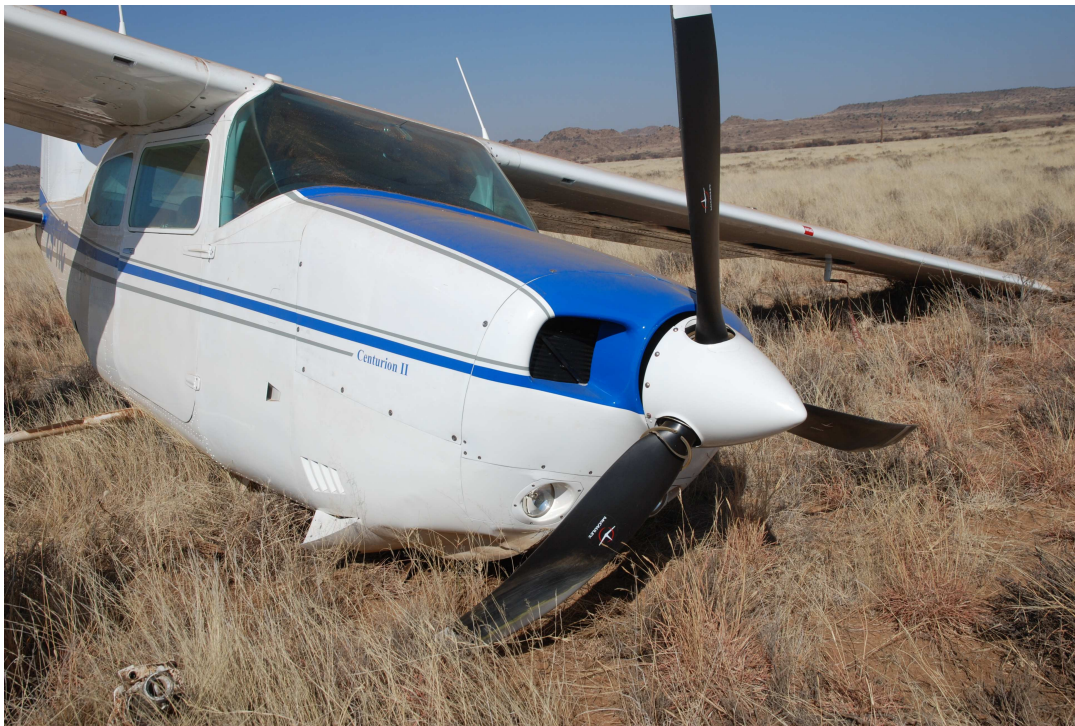
- 1.3.1 The nose gear was ripped out and was destroyed. The left main gear undercarriage collapsed backwards.
- 1.3.2 Damage to the fuel selector was as a result of the nose gear actuator that was forced through the lower firewall during the sequence of the accident.

**Figure 2:** The damage to the propeller and dents on the lower fuselage can be seen here.
