AIRCRAFT ACCIDENT REPORT AND EXECUTIVE SUMMARY

Ref No.	CA18/2/3/9388	
Aircraft Registration	OM8118	Date of Accident	16 December 2014		Time of Accident	1515Z
Type of Aircraft	Discus 2CT Glider (Sailplane)		Type of Operation		Private	
Pilot-in-command Licence Type		Gliding licence	Age	41	Licence Valid	Yes
Pilot-in-command Flying Experience		Total Flying Hours	790		Hours on Type	37
Last point of departure		Douglas private aerodrome in Kimberley: Northern Cape				
Next point of intended landing		Douglas private aerodrome in Kimberley: Northern Cape				
Location of the accident site with reference to easily defined geographical points (GPS readings if possible)						
Gravel road.						
Meteorological Information		Wind direction, easterly: Visibility, 10 km: Temperature, 20°C: Wind speed, 3 knots.				
Number of people on board		1 + 0	No. of people injured	0	No. of people killed	0
Synopsis						
<p>On the afternoon of Tuesday 16 December 2014, a certified glider pilot from the Czech Republic was conducting a cross country gliding flight from Douglas aerodrome in Kimberley when the mishap occurred. According to the pilot, the aircraft was successfully towed to the required flight level, w

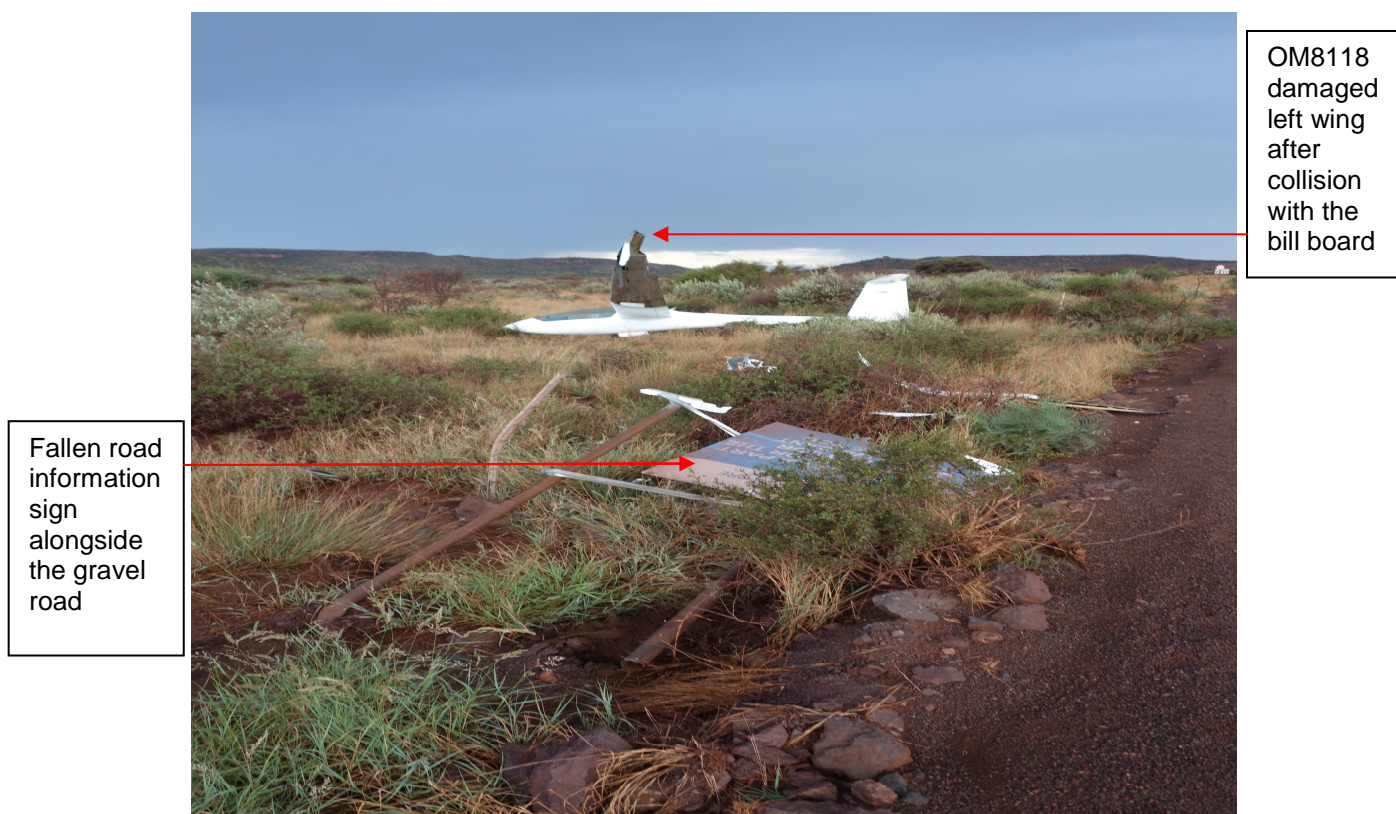
1.3.1 Damage was limited to left wing of the glider.

Figure 1: The final position of the glider after collision with the information sign

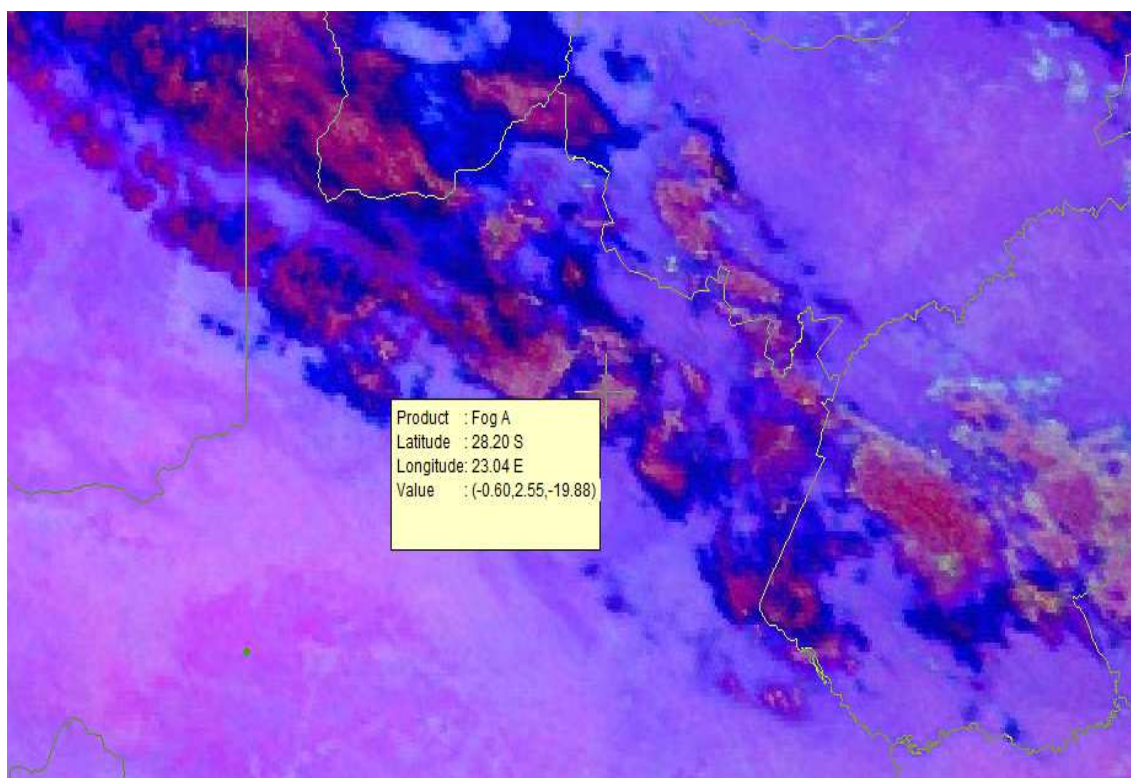
A satellite image in figure 2 below shows that Postmansburg was covered in mid-level altocumulus clouds with possible towering cumulus development occurring in the area.

Figure 2: Satallite image taken on 16 December 2014

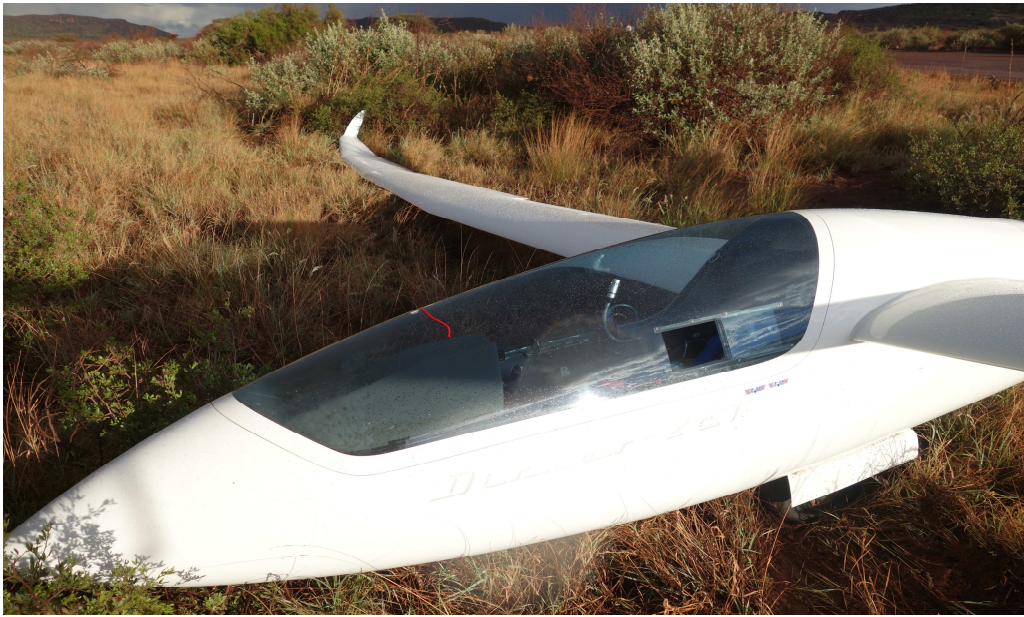
1.12.1 During the forced landing, the aircraft collided with an information bill board next to a gravel road. The amount of damage was limited to the aircraft's left hand side wing and the information sign board. Apart from that, everything else was found to

Figure 3: The aircraft as found at the accident side after the accident

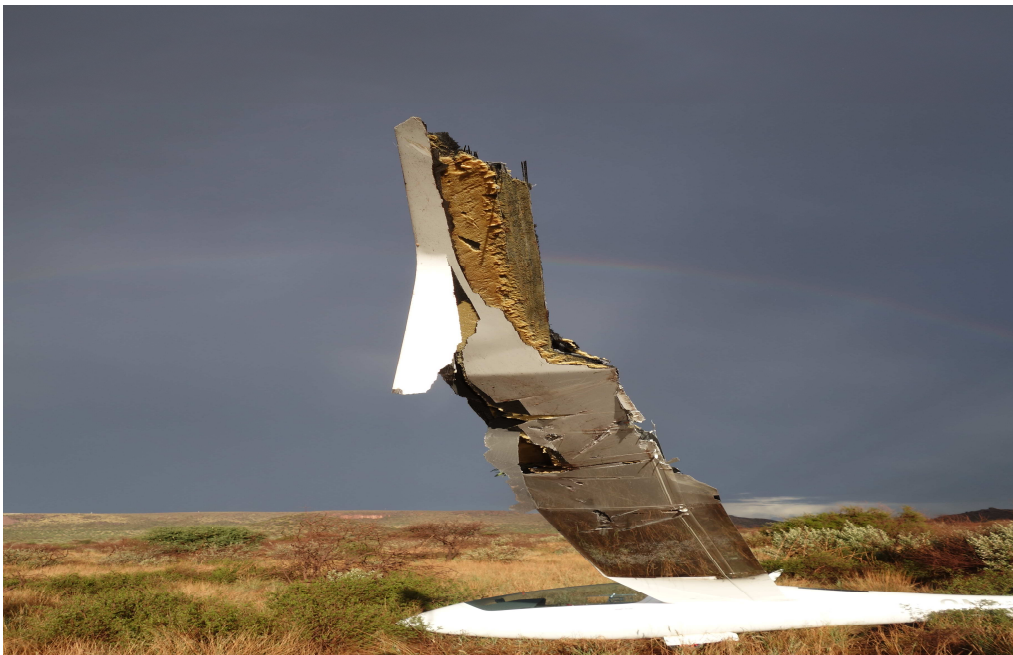
Figure 4: Damaged left hand side wing
