# AIRCRAFT ACCIDENT REPORT AND EXECUTIVE SUMMARY

| | | | | Reference: | CA18/2/3/9509 | |
| Aircraft Registration | ZS-SLS | Date of Accident | 16/12/2015 | | Time of Accident | 09:34Z |
| Type of Aircraft | Cessna 182Q | | Type of Operation | Private Flight_(Part 91) | | |

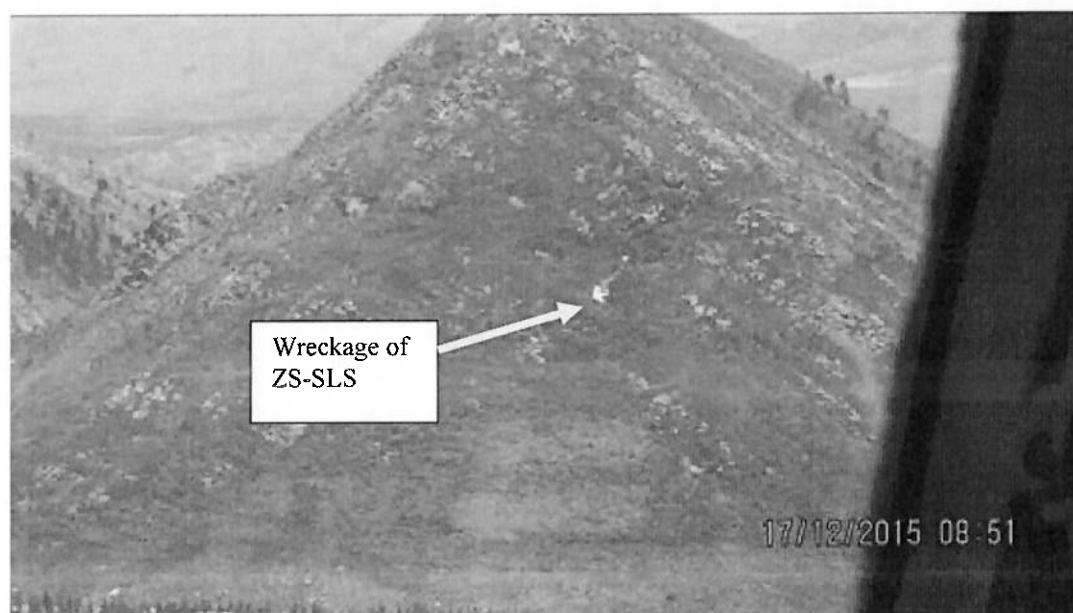
Figure 1: The aircraft is not easy to see due to white rocks on the mountain.

- 1.1.5 The aircraft had impacted the side of the mountain at an elevation of 1462 feet AMSL (GPS 34°01' 49.24" E024° 27' 48.36"S) near Humansdorp. The area was remote and inaccessible, and South African National Defence Force (SANDF) and

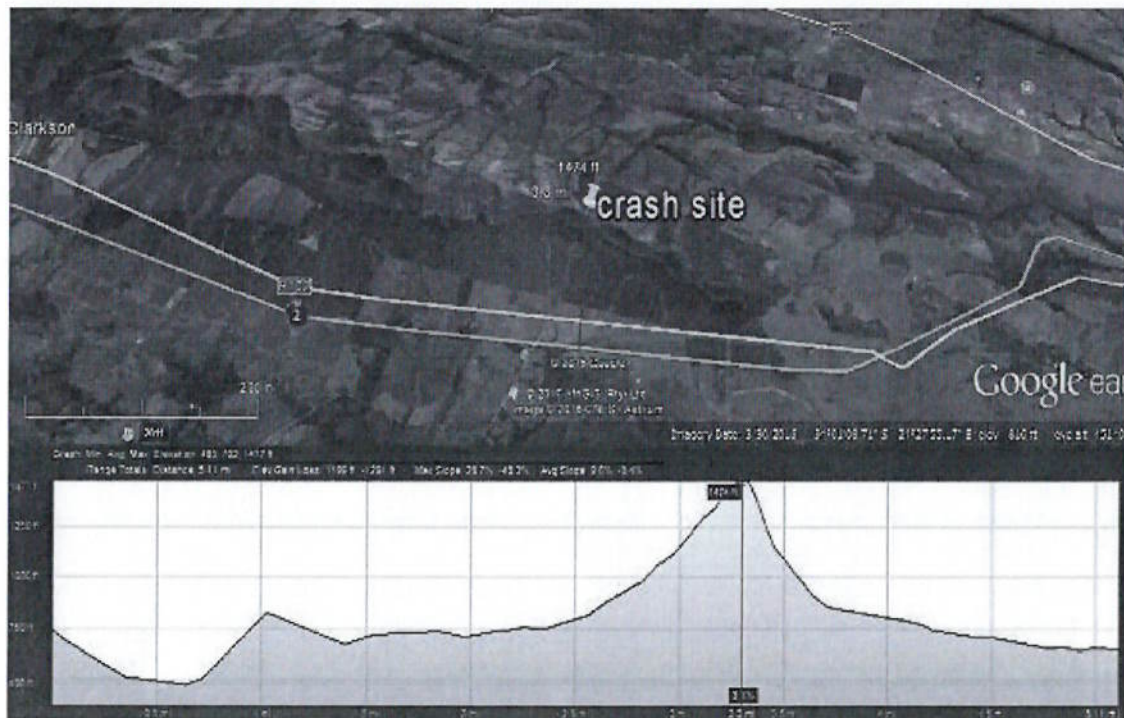
Figure 4: The area profile of the crash site

1.10.1 The accident did not happen at an aerodrome. The aircraft impacted the side of a mountain before coming to a stop.

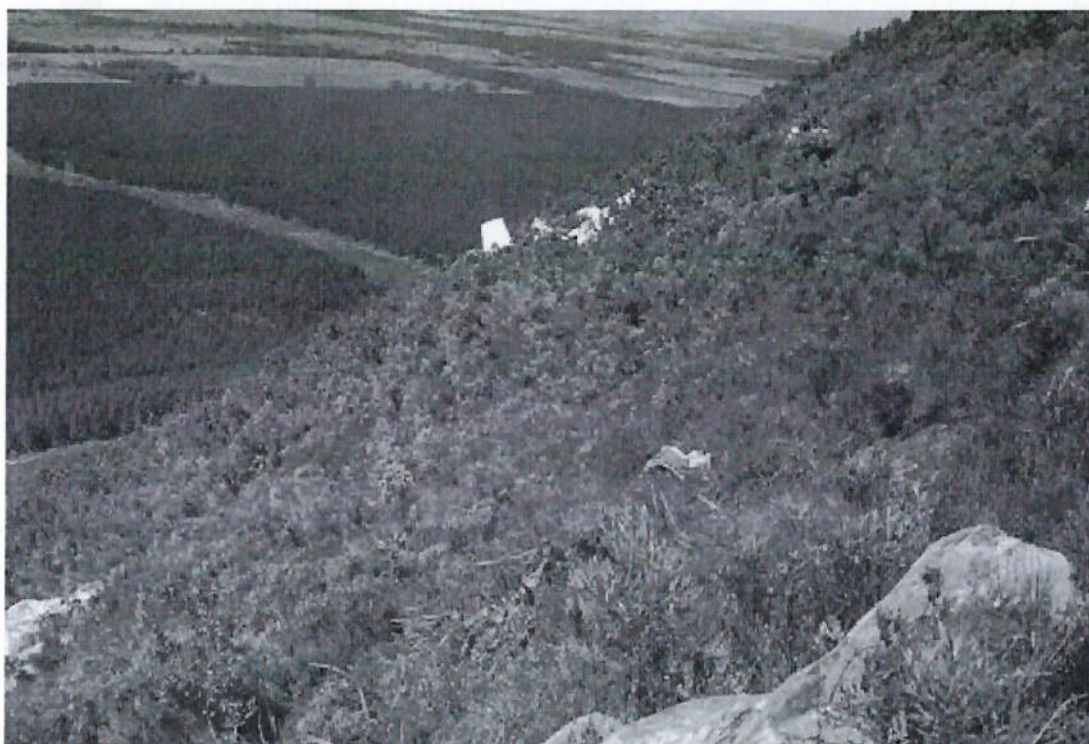
1.12.1 According to the pilot, he was maintaining 3500 feet AGL from FAGR when they encountered turbulence. The aircraft lost approximately 2000 feet in height and the pilot lost control of the aircraft before impacting the side of the mountain with the right-hand wing tip. It is not clear what was the aircraft's heading was when it impacted the mountain. After impact the aircraft continued to skid across the

mountain surface before coming to rest. The pilot had no recollection of how they impacted the mountain.

Figure 5: Aircraft wreckage on an inclined slope

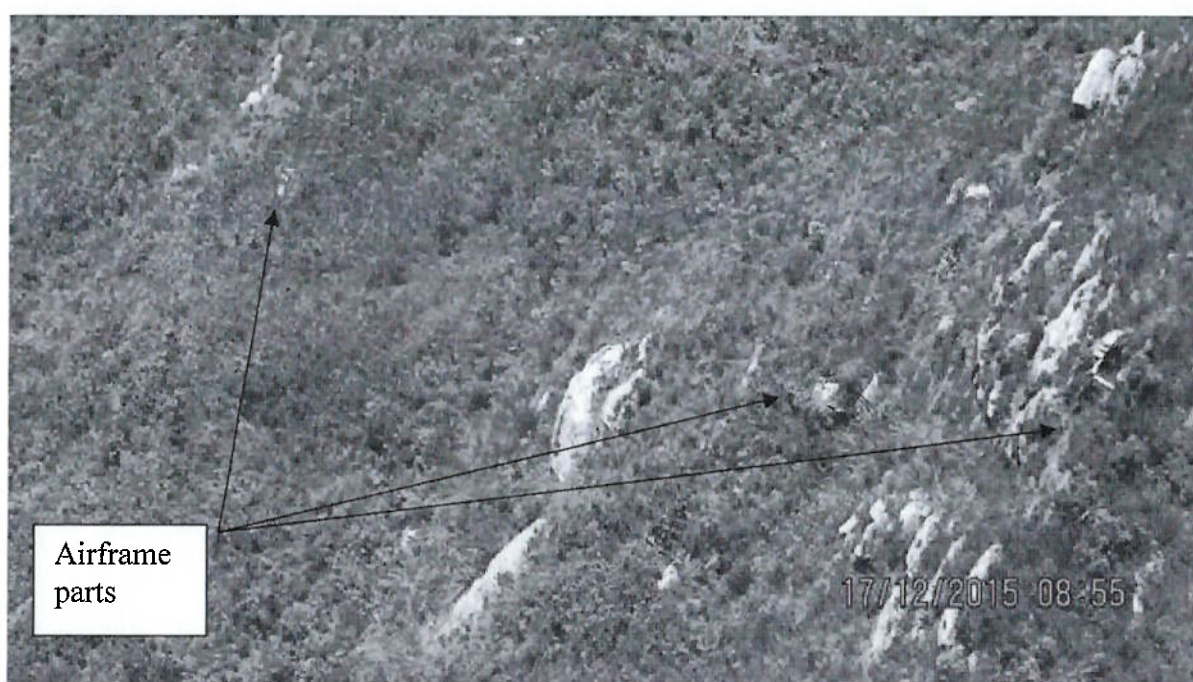
1.12.2 Aircraft debris, which included the propeller, airframe panels and one of the doors, was scattered over the area between first point of impact and the point where the aircraft came to rest. It was difficult to take measurements of all debris due to hostile terrain.

Figure 6: Aircraft parts strewn over the mountain

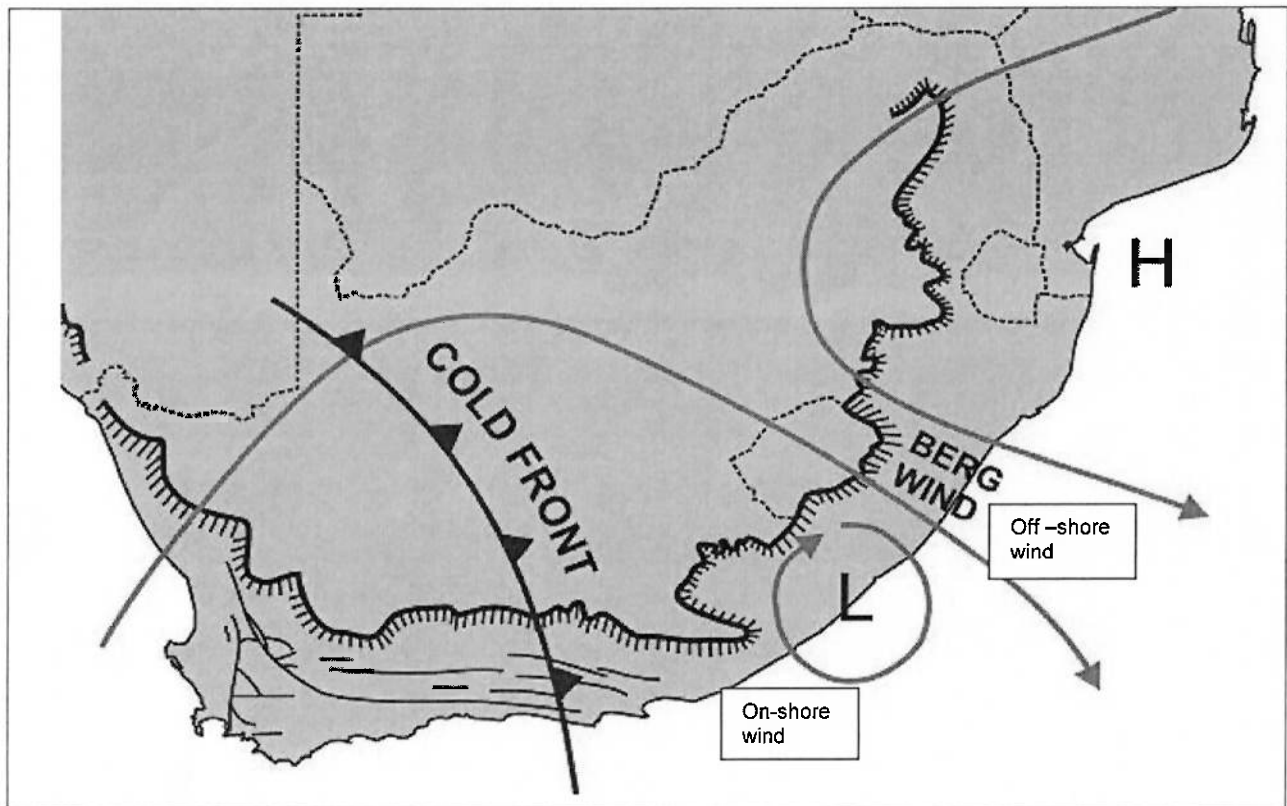
Figure 6: Typical coastal weather conditions in the area

The weather pattern commonly associated with a berg wind and accompanying coastal low along the coast of South Africa. The light blue lines indicate surface wind directions. The "H" indicates the position of a portion of the South Indian Ocean Anticyclone (high pressure system); the "L" indicates the position of the coastal low.

- 2.7 The pilot indicated that they were cruising at 3500ft AGL before losing height drastically. It is unclear whether he lost consciousness before impacting the mountain. An examination of the formation of coastal lows (see above), shows that the area they were flying in tends to form coastal lows and that when the berg winds flow from inland to the coast, they have a downward force, causing the aircraft to lose approximately 2000ft in height. It is probably at this point that the pilot was knocked unconscious and only came to after the accident.
