AIRCRAFT ACCIDENT REPORT AND EXECUTIVE SUMMARY

Reference:	CA18/2/3/9533	
Aircraft Registration	ZS-DOM	Date of Accident	26 March 2016		Time of Accident	1400Z
Type of Aircraft	Cessna T206H		Type of Operation		Private Part 91	
Pilot-in-command Licence Type	Private Pilot	Age	57	Licence Valid	Yes	
Pilot-in-command Flying Experience	Total Flying Hours	2780.9		Hours on Type	679.2	
Last point of departure	Aviators Paradise Field Airport (FAAP) Gauteng					
Next point of intended landing	Borneo Farm (Timbavati private nature reserve) Mpumalanga					
Location of the accident site with reference to easily defined geographical points (GPS readings if possible)						
On a private farm at end of the runway						
Meteorological Information	Wind direction:190°; Wind speed:5kt; Wind temperature:30°C: Visibility: Good					
Number of people on board	1+3	No. of people injured	4	No. of people killed	0	
Synopsis	<p>The pilot, accompanied by three passengers, was performing a go-around when the accident occurred. A farm worker, who resides on the farm where the accident happened, saw the aircraft on its arrival approach. He stated that he heard the aeroplane approaching and went outside as he was expect

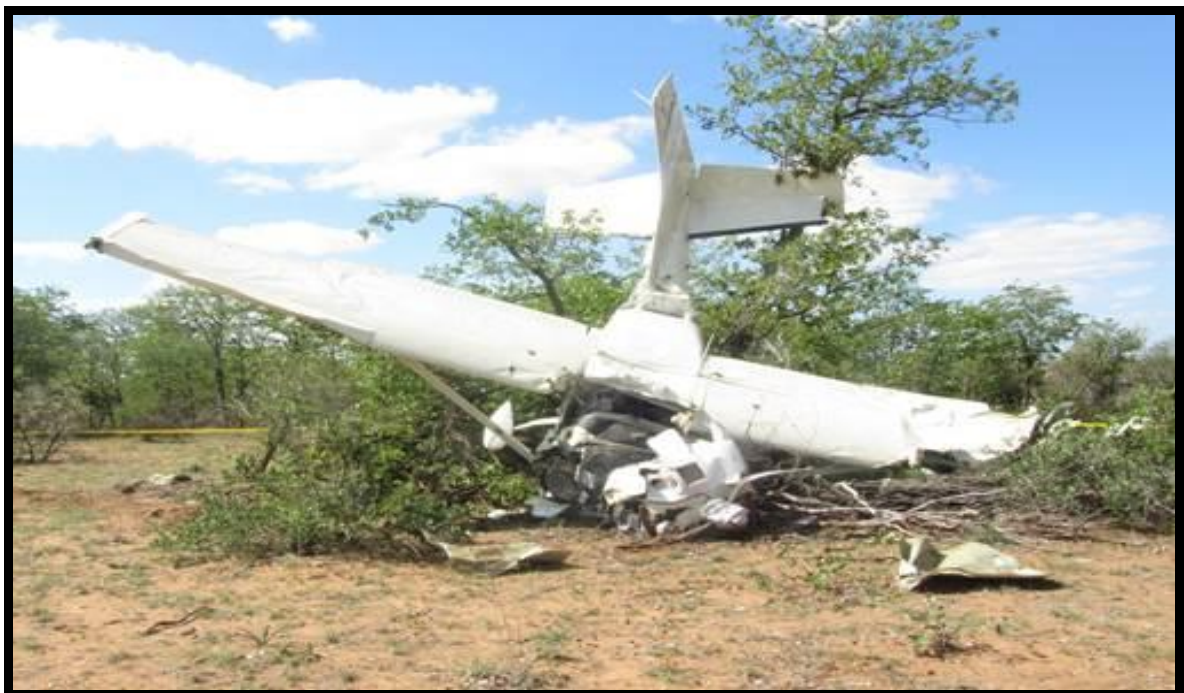
- 1.3.1 The aircraft was destroyed during the accident sequence

Figure 2: Shows the aircraft as it came to rest

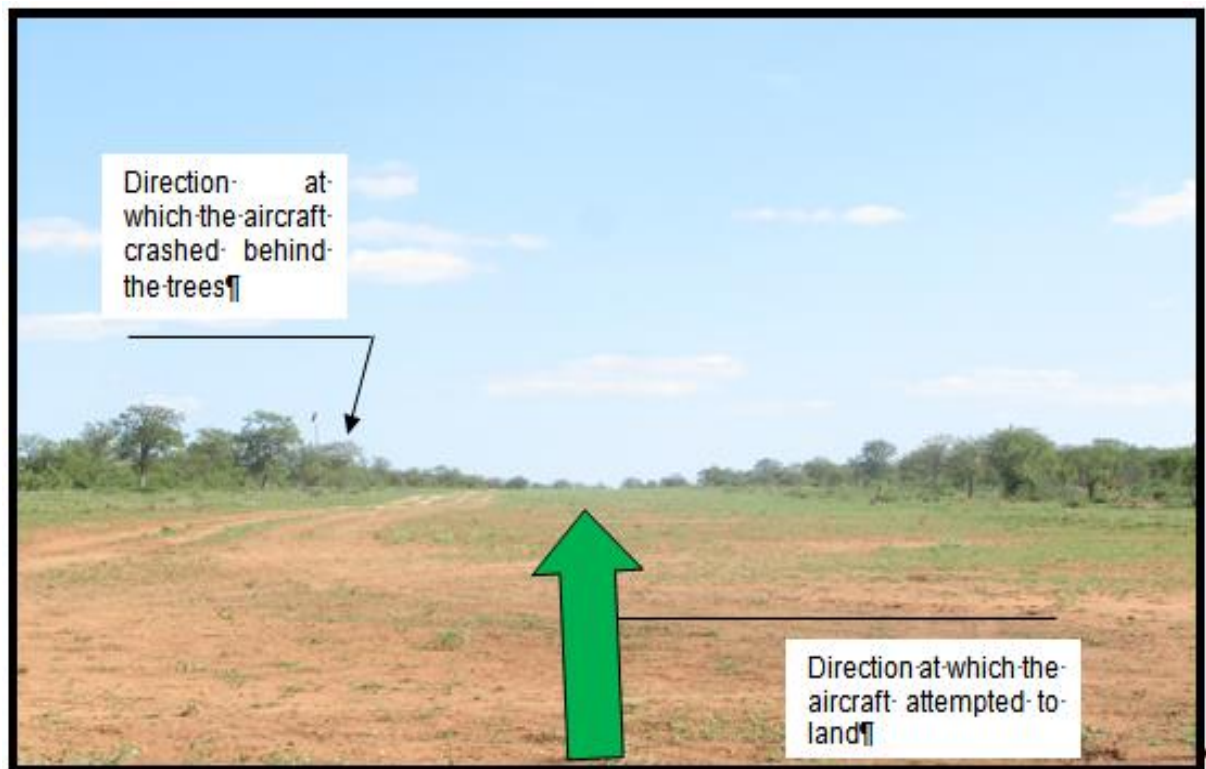
1.12.1 The aircraft crashed on the left-hand side of the runway in relation to the landing direction. The runway is surrounded by trees with most of them at a maximum height of approximately 3 meters.

Figure 3: Shows the runway on the side next to aircraft crash

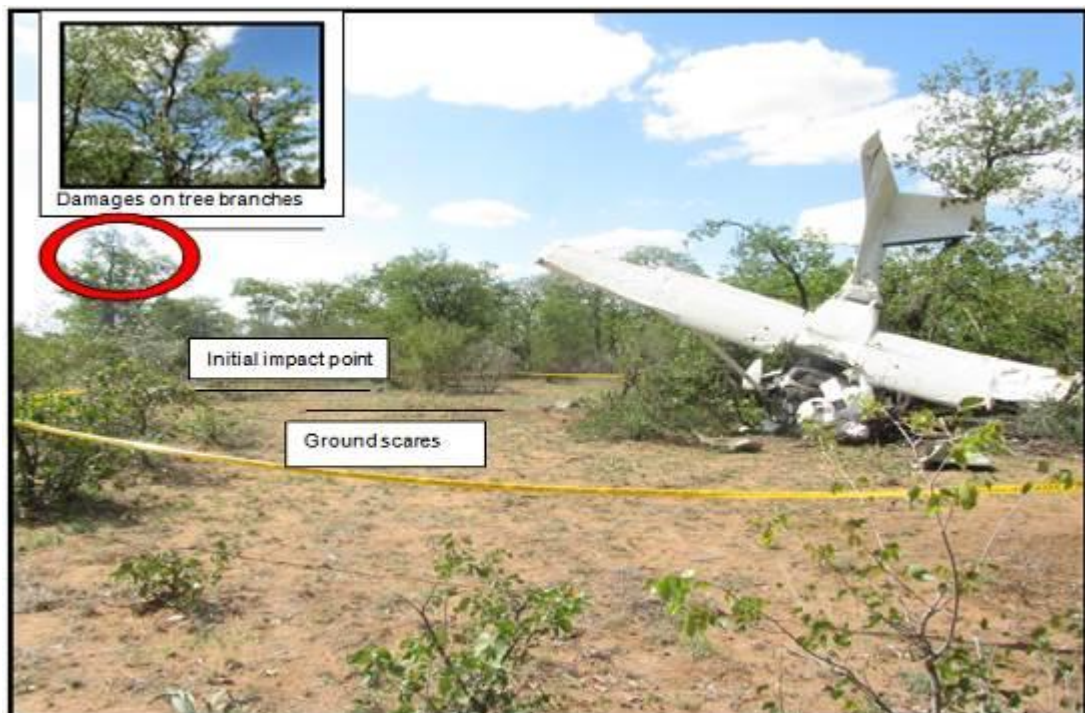
- The aircraft stalled and dropped the nose towards the left-hand side and then entered into an inverted attitude.
- According to the impact marks trail and damages, the aircraft first clipped a

tree with its left wing following a stall prior to impact with the ground.

- The initial impact with the ground was on a tree, with the left hand wing first, followed by the nose section as shown below in Figure 4.

Figure 4: Shows the tops of trees which were clipped by the aircraft

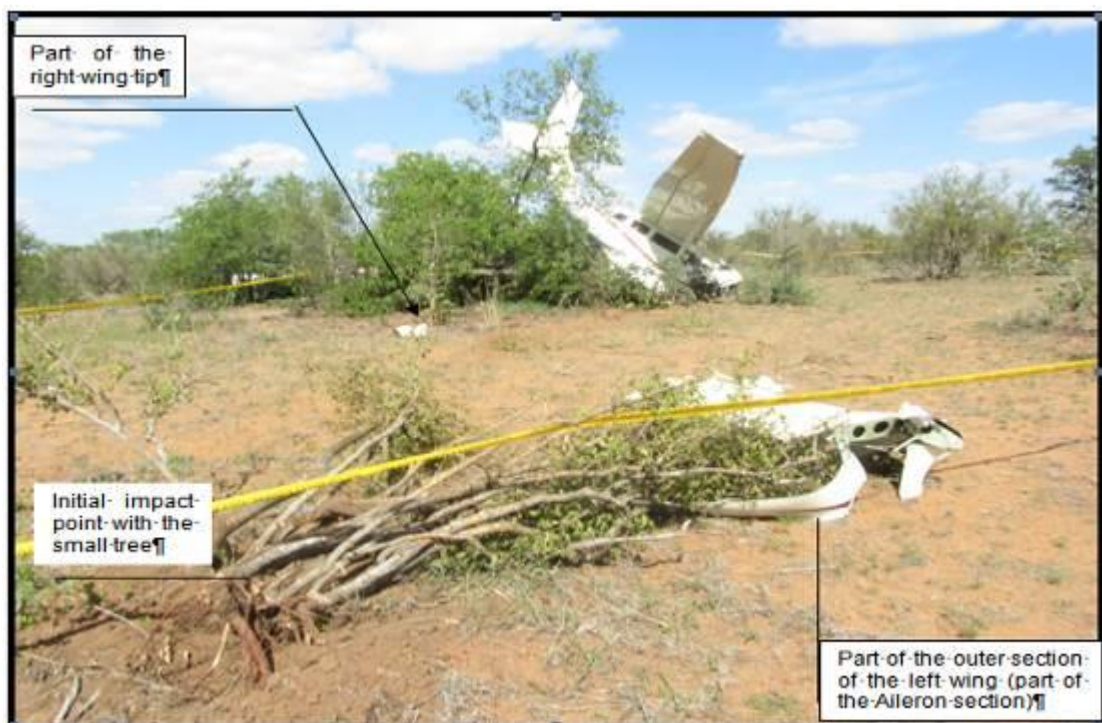
Figure 5: The aircraft impact trail

1.12.4 Following impact, the aircraft rolled to the left as the right wing contacted the ground on its tip, becoming a pivot point allowing the aircraft to rotate further. It came to rest against the big tree as shown in Figure 5 above. The aircraft remained resting against the tree with the nose in a facing down attitude.

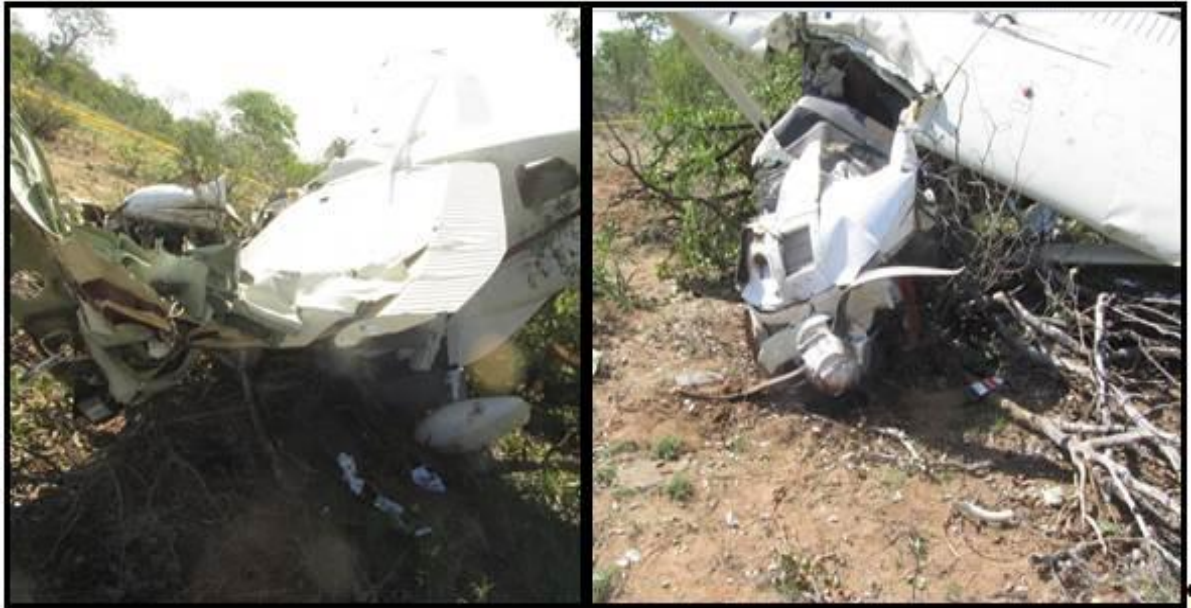
Figure 6: Shows damages on the left wing

Figure 7: Shows damages on the nose section

1.12.5 More damage was observed on the left wing and the nose section. The damage to the propeller blades is consistent with damage resulting on impact when the engine is running with high power. The aircraft empennage was damaged. Most of the wreckage was intact and localised within a radius of approximately 15 meters at the impact contact points.
