AIRCRAFT ACCIDENT REPORT AND EXECUTIVE SUMMARY

Reference:	CA18/2/3/9585	
Aircraft Registration	ZU-JVR	Date of Accident	7 December 2016		Time of Accident	0900Z
Type of Aircraft	Van's RV 10		Type of Operation		Private (Part 91)	
Pilot-in-command Licence Type		Private Pilot License	Age	48	Licence Valid	Yes
Pilot-in-command Flying Experience		Total Flying Hours	1690.3		Hours on Type	Unknown
Last point of departure		Zebula Lodge Airstrip, Limpopo Province				
Next point of intended landing		Vaalwater private airstrip, Limpopo Province				
Location of the accident site with reference to easily defined geographical points (GPS readings if possible)						
Limpopo Province on the mountainous terrain 6nm north east of Zebula airfield on a place with GPS: S 24°38'36.25", E 027°58'54.47" and a field elevation of 4583ft.						
Meteorological Information		Wind direction: 220; wind speed: 04kt; Air temperature: 32; Visibility: CAVOK				
Number of people on board	1+0	No. of people injured	1	No. of people killed	1

AIRCRAFT ACCIDENT REPORT

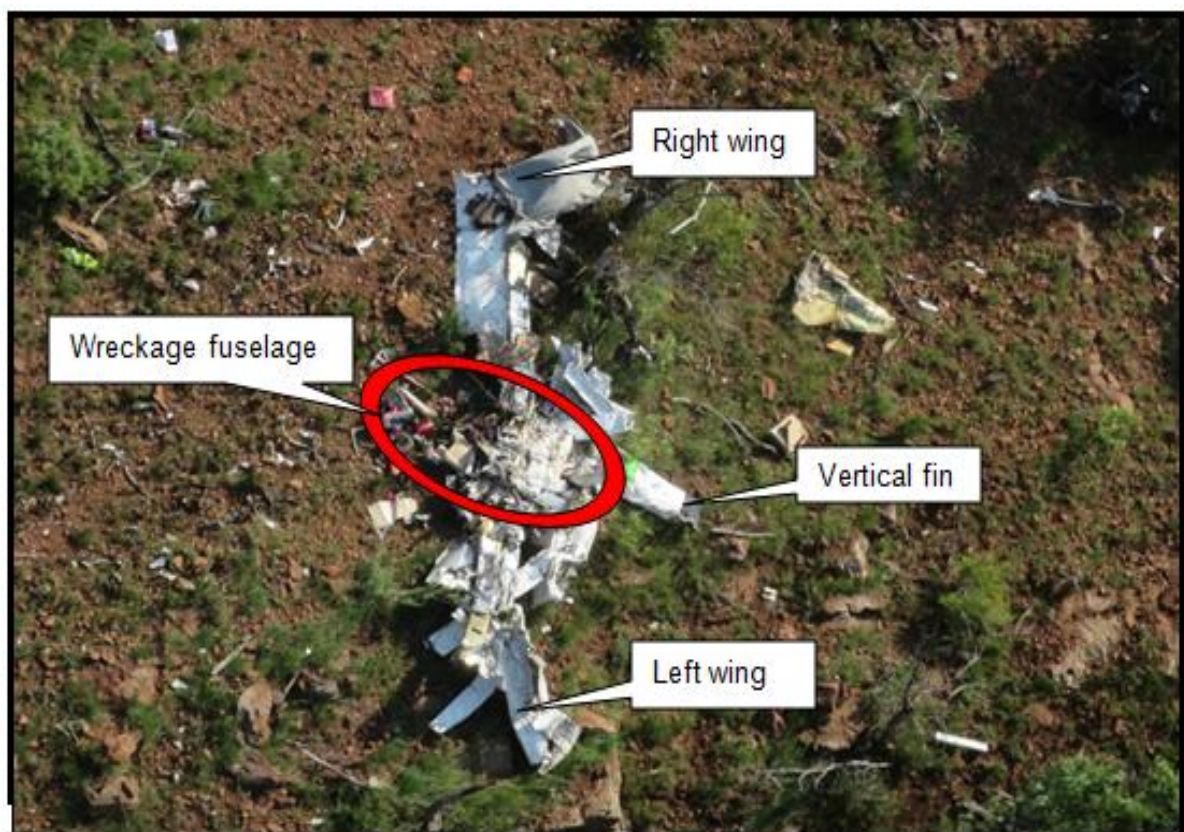
1.3.1 The aircraft was destroyed during the accident sequence

Figure 2: Shows the aircraft remaining wreckage

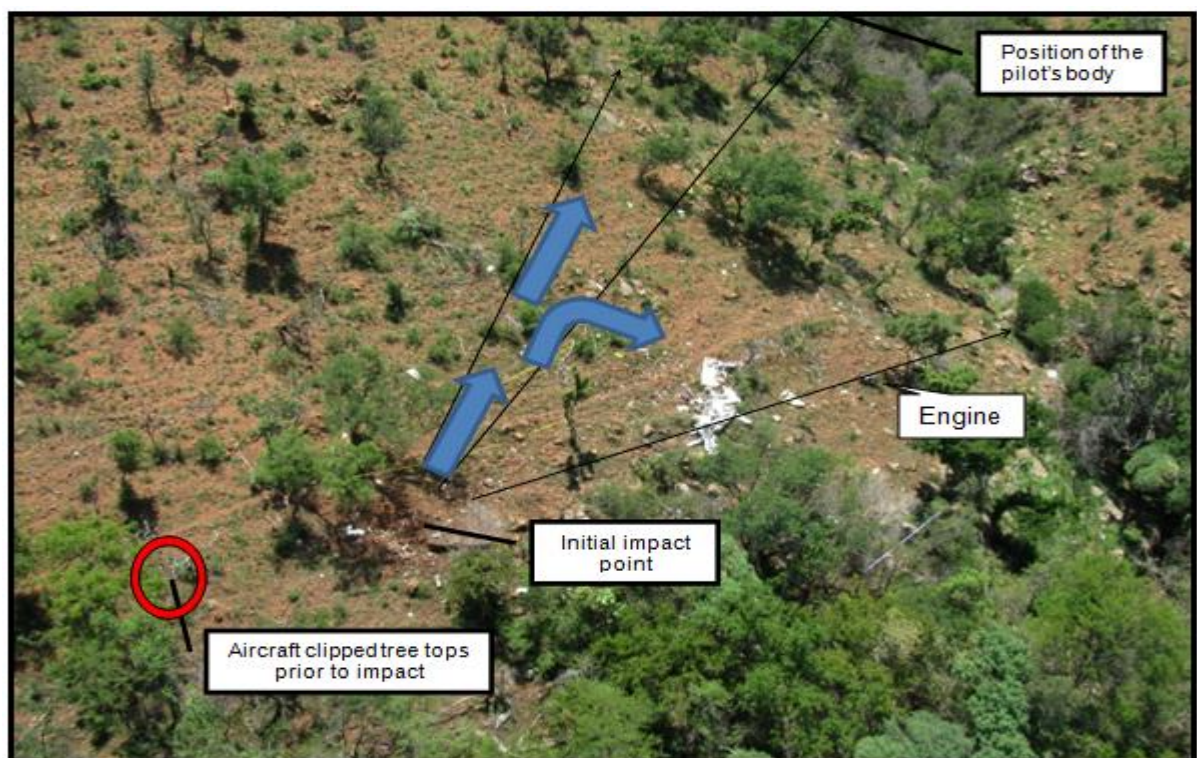
Figure 4: Shows the accident site

1.12.1 The aircraft was found on the mountainous terrain destroyed 6nm north east of Zebula airfield at a place with GPS S 24°38'36.25", E 027°58'54.47" and a field elevation of 4583ft AMSL. Zebula airfield is situated at an elevation of approximately 4194ft AMSL. The highest point of the mountain peak is approximately 5400ft AMSL. The aircraft's initial impact point was with the nose first

on a rocky surface and was followed by the left wing outer leading edge with the tree. A wreckage trail (blue arrows) shown by the on-site ground marks observation is indicative with the aircraft that continued moving uphill following the impact however lost momentum and settle on some trees few metres down the slope. The wreckage pattern is indicative of the aircraft that impacted at a high speed and high angle of impact. This was also indicated by one of trees next to the initial impact point which was clipped on top.

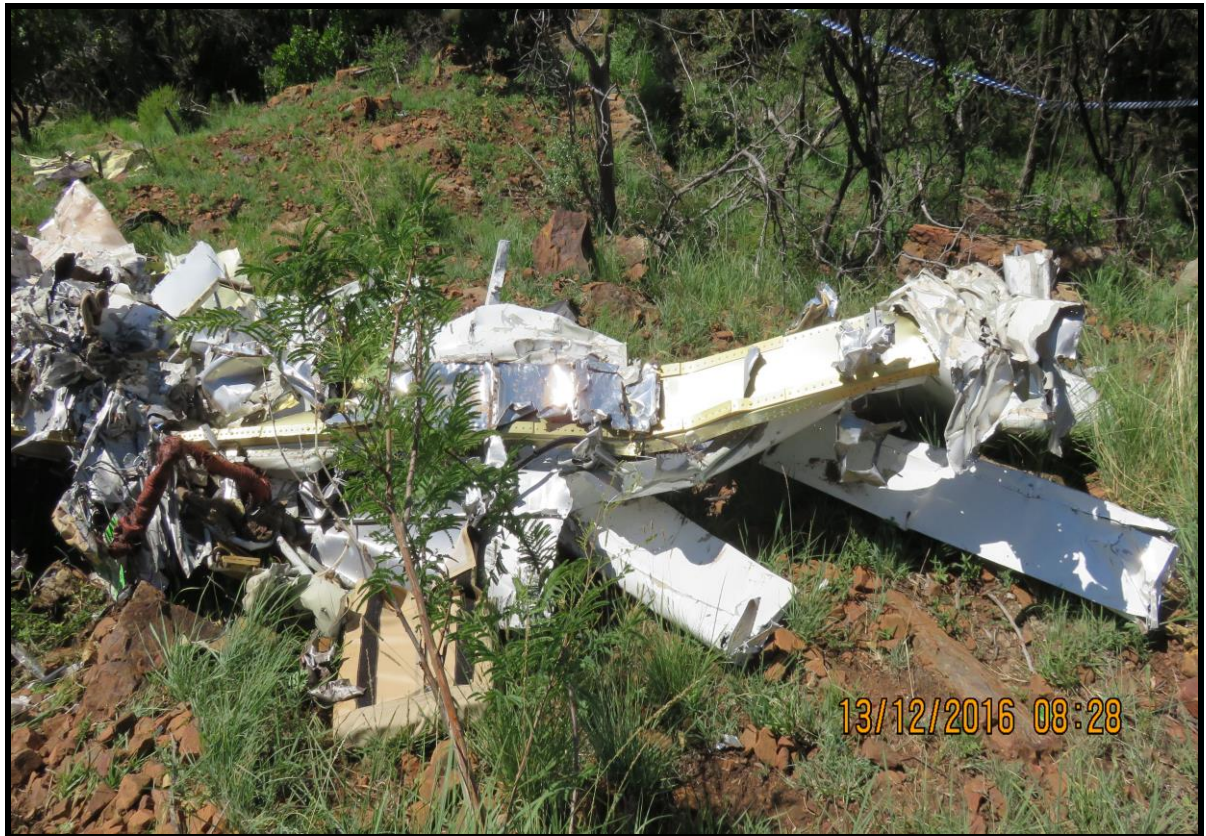
Figure 5: Shows the remains of the wreckage

1.12.2 Both propeller blades were discovered damaged at the accident site within five meters from the initial impact point. One blade was located in the bushes towards bottom of the mountain on the right hand side of the initial impact point in relation with the aircraft initial direction whereas the other one was at close proximity to the initial impact point and was destroyed. The damages are indicative of an object that got damaged while it was driven at high engine power. The engine was found at a distance of approximately 20m from the initial impact point leaning against the tree. The aircraft cockpit top was found 80 metres next to the pilot remaining body. The main wreckage was destroyed and was folded together.

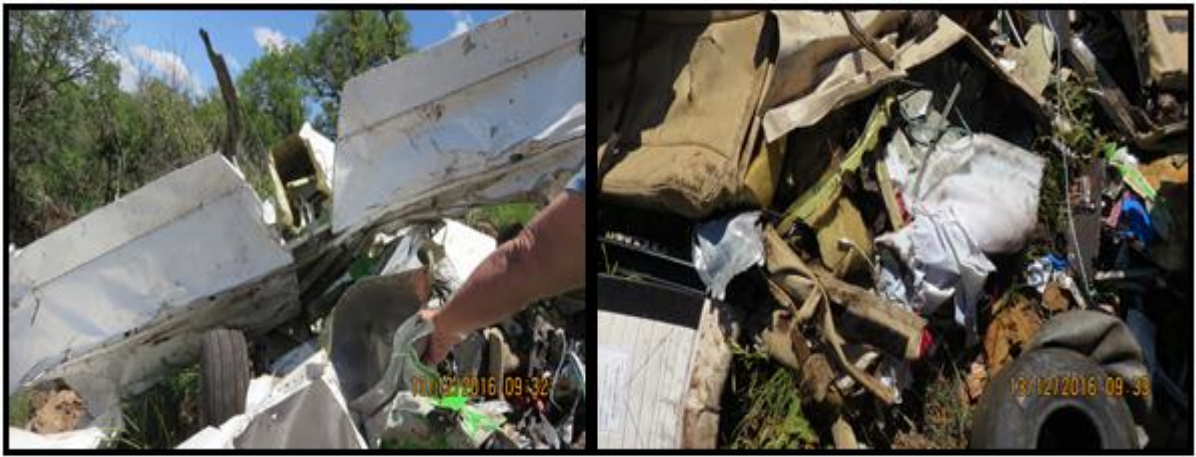
Figure 6: Shows the wreckage damages

- The wreckage inspection indicated that the aircraft was configured correctly for the flight. This was also indicated by elevator trim tab wheel which was in a correct position.
- The propeller hub damages were indicative with direct impact with a rocky surface at a high angle of impact.
- All landing gear separated from the main wreckage.
- According to the position of the tree and the point at which the aircraft clipped the branch in reference to the impact point, the induced angle of impact was determine to be at approximately 40°.
- The damages of the propeller hub are indicative with the aircraft that impacted first with the nose.

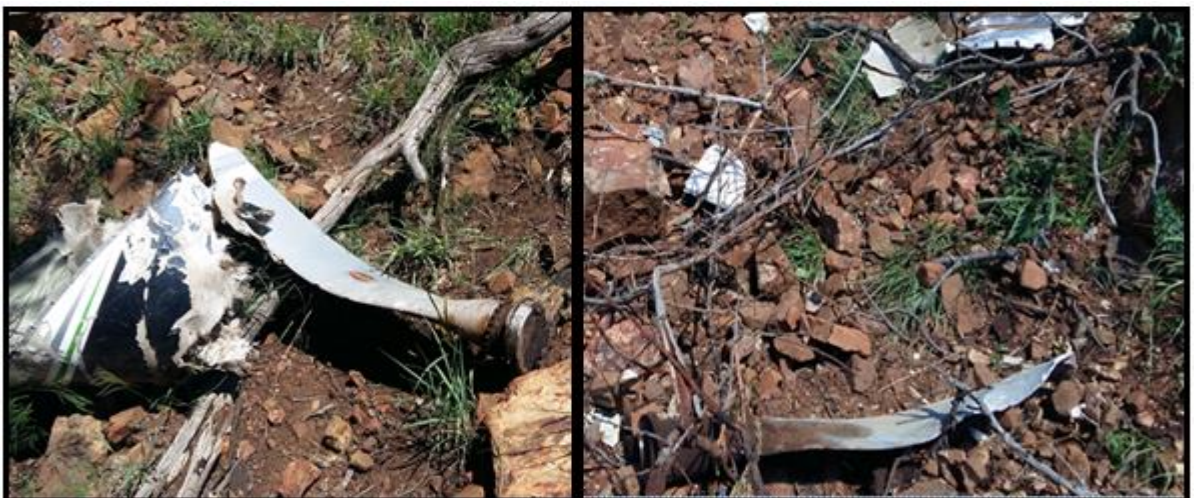
Figure 7: Shows damages on both propeller blades
