AIRCRAFT ACCIDENT REPORT AND EXECUTIVE SUMMARY

Reference:	SP 0088	
Aircraft Registration	N/A	Date of Accident	18 October 2009		Time of Accident	1400Z
Type of Aircraft	Paraglider		Type of Operation		Private	
Pilot-in-command Licence Type		Paraglider	Age	37	Licence Valid	Yes
Pilot-in-command Flying Experience		Total Flying Hours	31,7		Hours on Type	Unknown
Last point of departure		Dunnottar Airfield (Gauteng)				
Next point of intended landing		Delmas Airfield (Gauteng)				
Location of the accident site with reference to easily defined geographical points (GPS readings if possible)						
At GPS co-ordinates S26°19.864 E028°32.460 near Springs.						
Meteorological Information		Surface wind: 240°/10 kt; Temperature: 25°C; Visibility: Good.				
Number of people on board	1 + 0	No. of people injured	0	No. of people killed	1	
Synopsis						
<p>The pilot planned to fly the paraglider from Dunnottar Airfield to Delmas Airfield, and was winched into flight at approximately 1230Z. The aircraft was reported missing by a member of the South African Hang Glider and Paragliding Association (SAHPA) at 1700Z. A search-and-rescue operation was initiated by South African Search and Rescue (SASAR).</

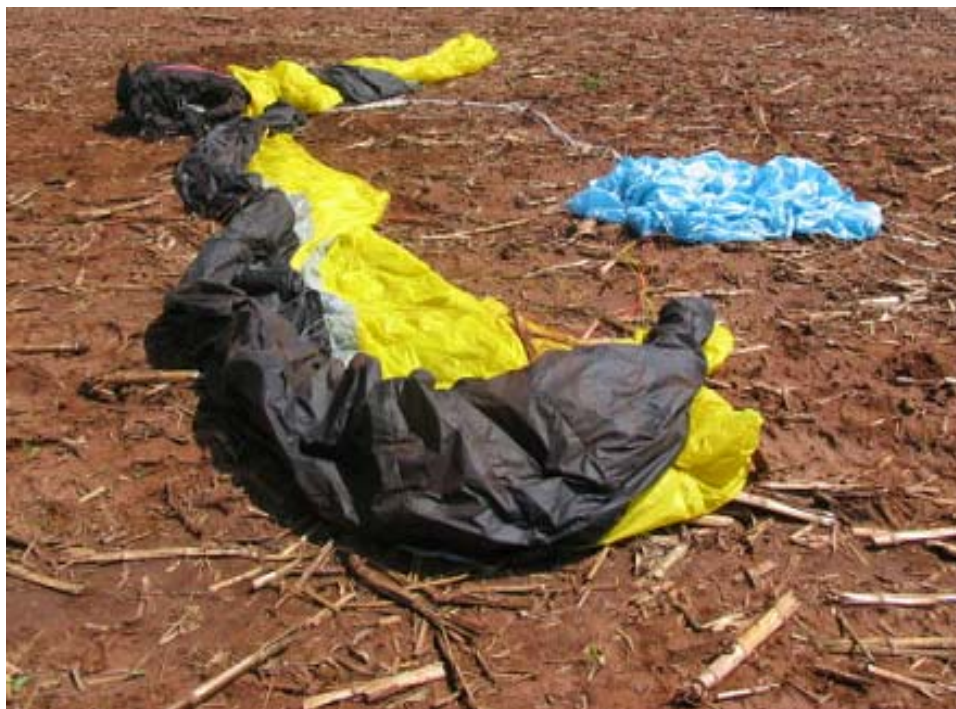
1.3.1 The paraglider sustained substantial damage.

Figure 1. The wreck of the paraglider.

1.12.2 The paraglider was inspected and no problem was identified with any of the cells, cross ports or V-ribs. All stitching seemed to be in order and there was no damage caused to the leading edge or other parts of the glider.

1.12.3 The lines were checked and only a minimal amount of damage was observed to the sheathing of two of the lines.

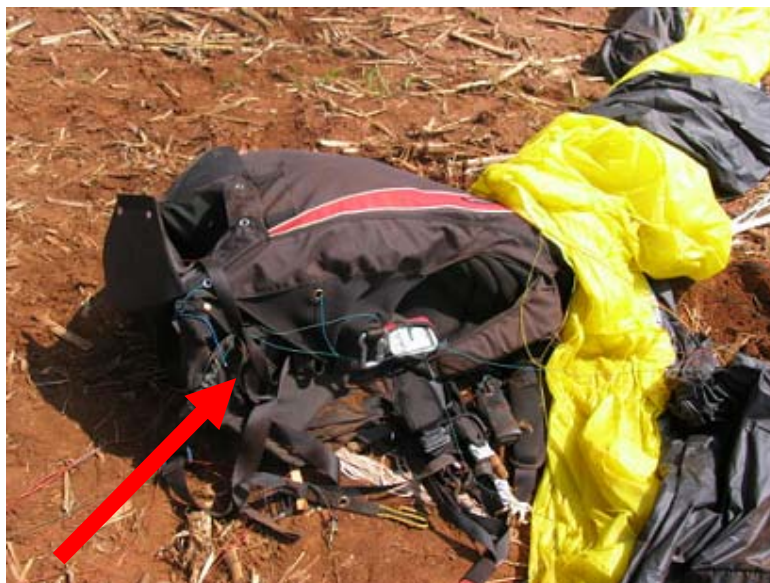
Figure 2. The harness.

1.12.5 The paraglider harness ended up on its left side after striking the ground. The side protection on the right side was damaged, whereas that on the other side was undamaged. The rest of the harness was still intact, and all webbing and material were in a good condition.

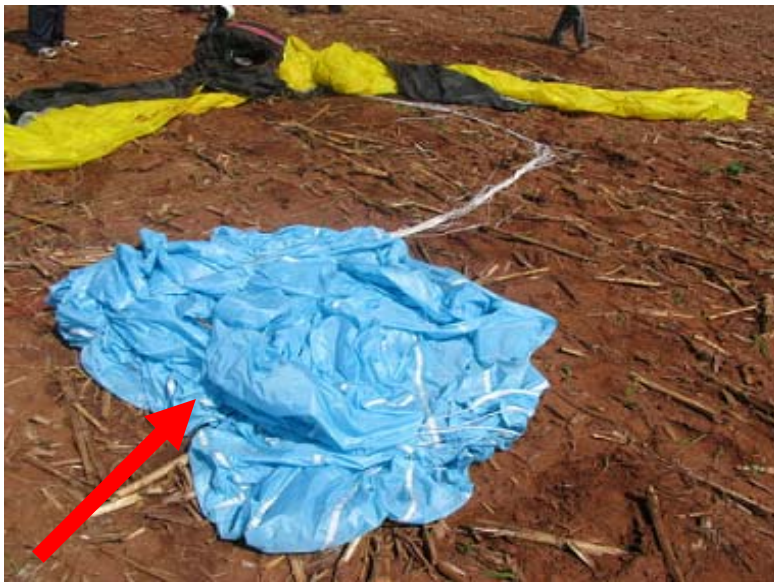
Figure 3. The reserve parachute.

1.6.1 There was no documentary evidence indicating when the reserve parachute had last been packed or inspected. During the onsite investigation it was found that the reserve parachute was not contained, from which it would appear that the pilot had attempted to deploy the parachute.

1.12.6 The reserve parachute was not damaged, but was not contained as expected. All elastic material of the reserve parachute was in a good condition.

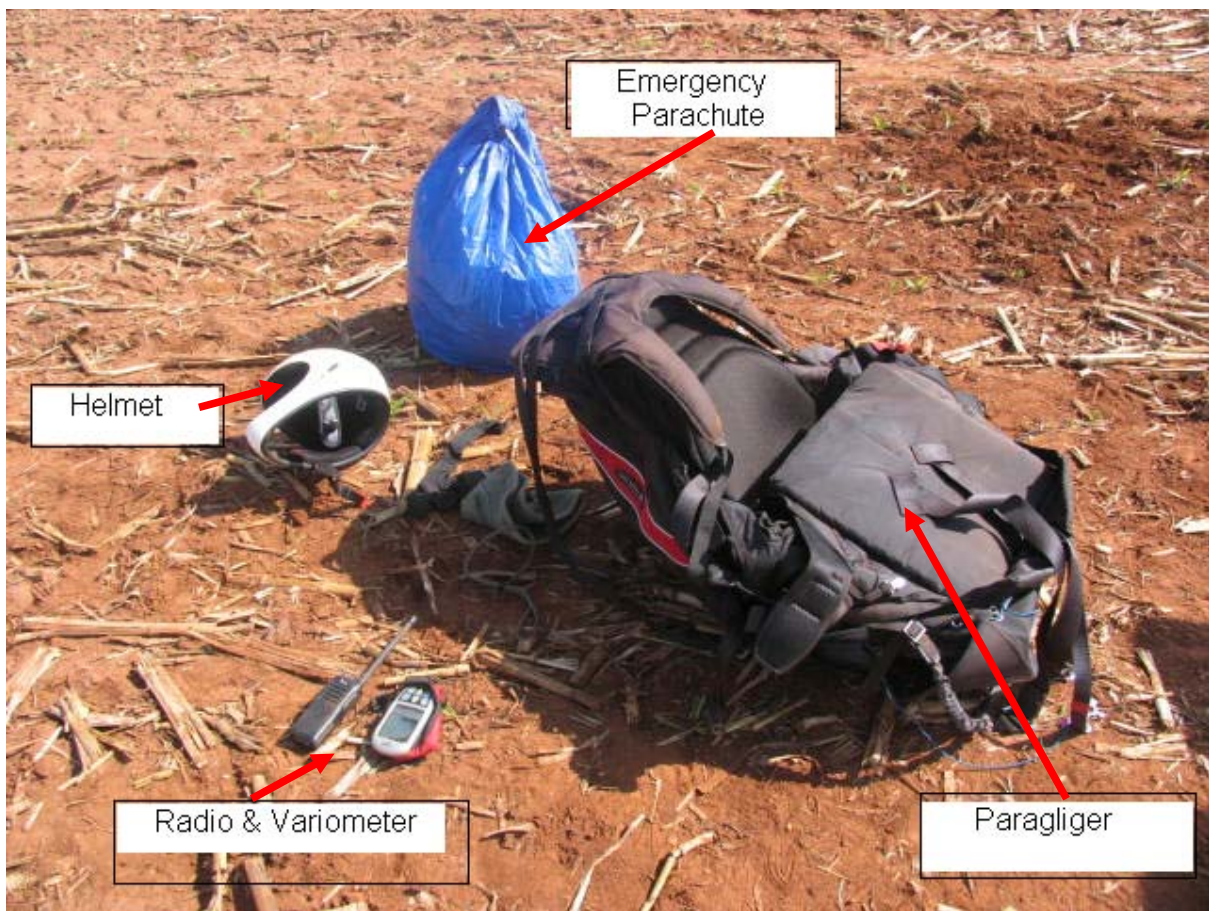
- (i) The descent rate of the paraglider was approximately 12,6 m/s (45 km/h).
- (ii) High-speed impact impression marks were found on the ground.
- (iii) There was a line-over on the right of the glider.
- (iv) There was entanglement of the left side of glider.
- (v) The right riser had detached from the caribiner.
- (vi) The pilot had deployed the reserve parachute.
- (vii) The reserve nappy was found 99 m from the impact area.

Figure 4. Paraglider equipment removed from the accident site.
