**AIRCRAFT ACCIDENT REPORT**

**REPORT ON THE ACCIDENT TO A EUROCOPTER AS 350 B3  
REGISTRATION ZS-HDI WHICH OCCURRED AT FRANCISTOWN AIRPORT  
ON 31<sup>ST</sup> OCTOBER 2012**

**REF: MTC AIG 06/12**

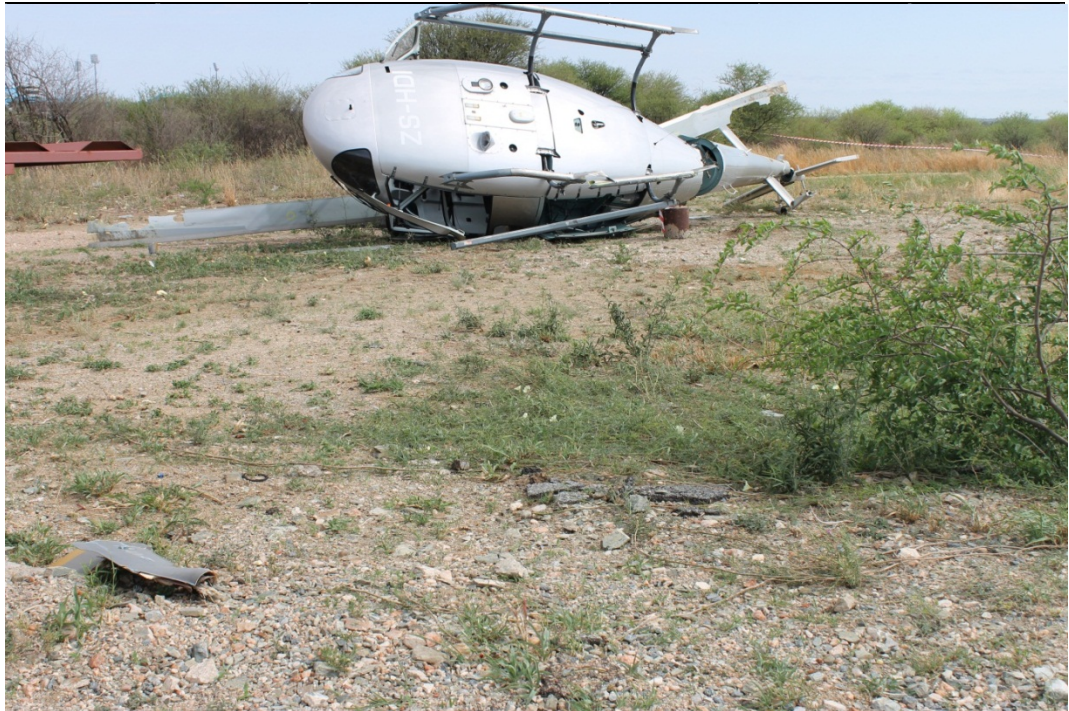
- 1.12.2 The starboard skid broke in the middle, possibly being the first contact point on ground impact.

The helicopter rolled on its side

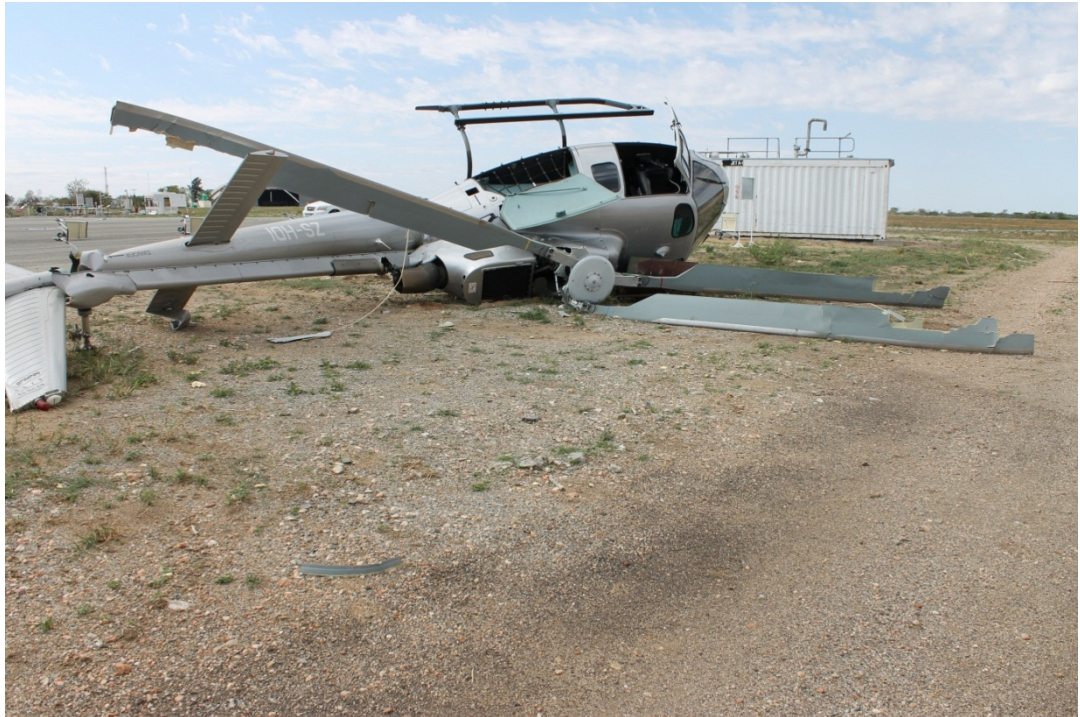
- 1.12.3 The tail rotor blades detached from the helicopter, the first being deposited next to the step ladder and the other approximately 15 metres from the main wreckage. The main rotors struck the ground and were damaged consistent with aircraft under little or no power (See fig below).

The damage to the main rotors suggests low rpm impact

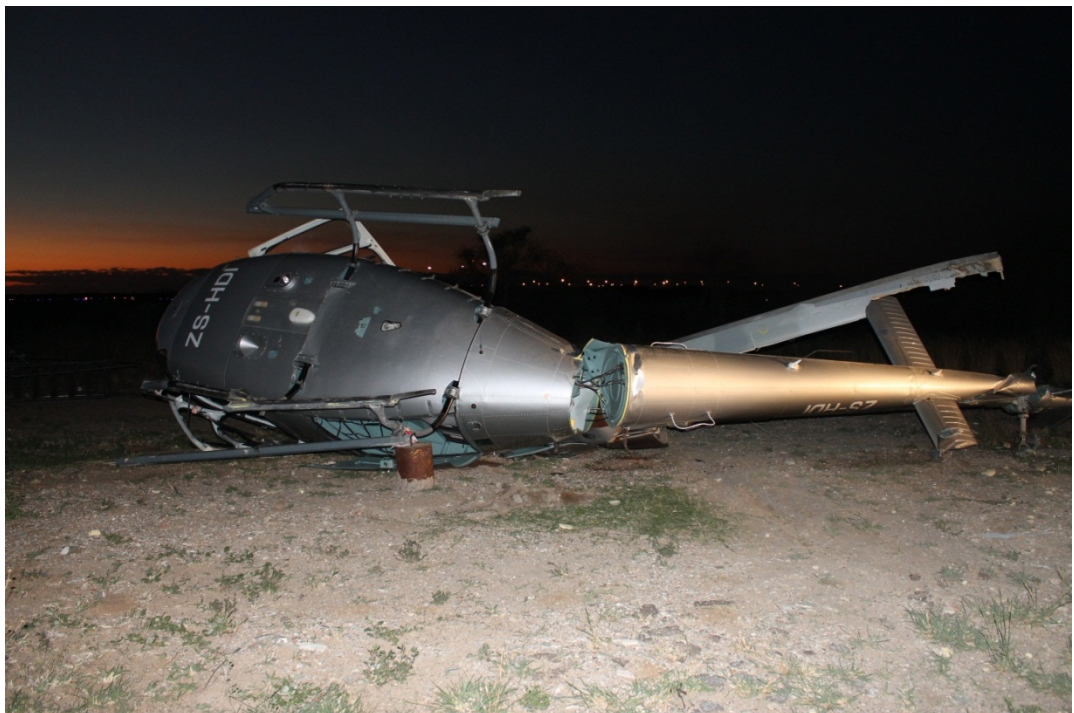
- 1.12.4 The tail boom detached from the main fuselage at the bulkhead but remained with the main wreckage being held by cables.

The cabin area was not extensively damaged by impact forces

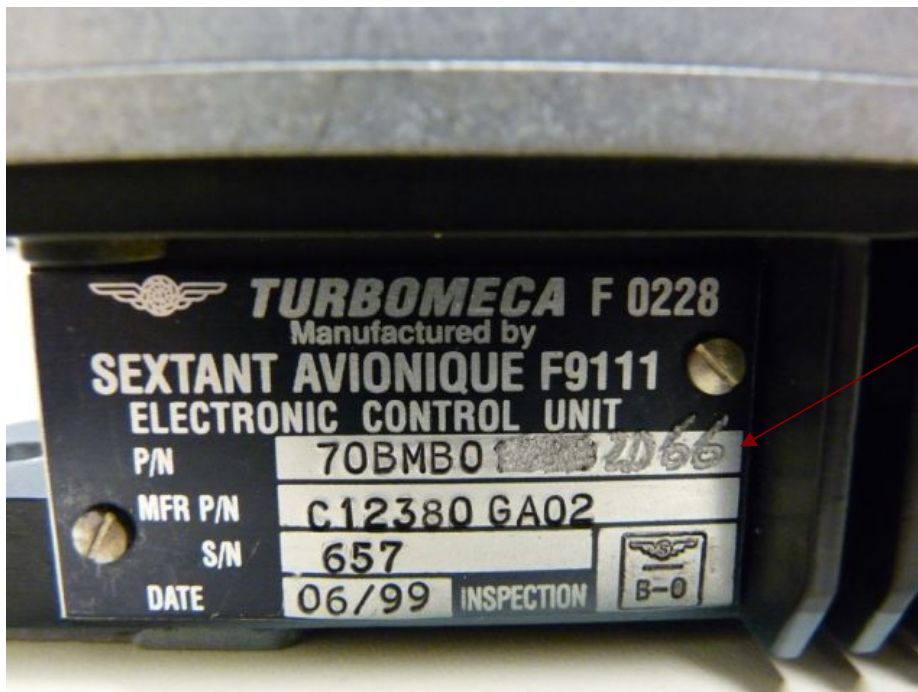
The DECU had no log card. Its P/N 70BMB02066 does not exist; "2066" was manually engraved (probably during the embodiment of SB 292732066).  
Thales P/N is C12380GA02 associated with the date 06/99.

P/N manually engraved

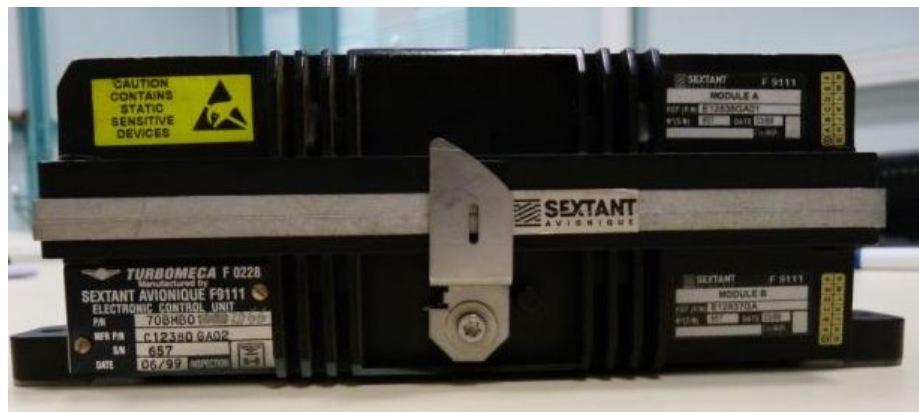
External condition: good

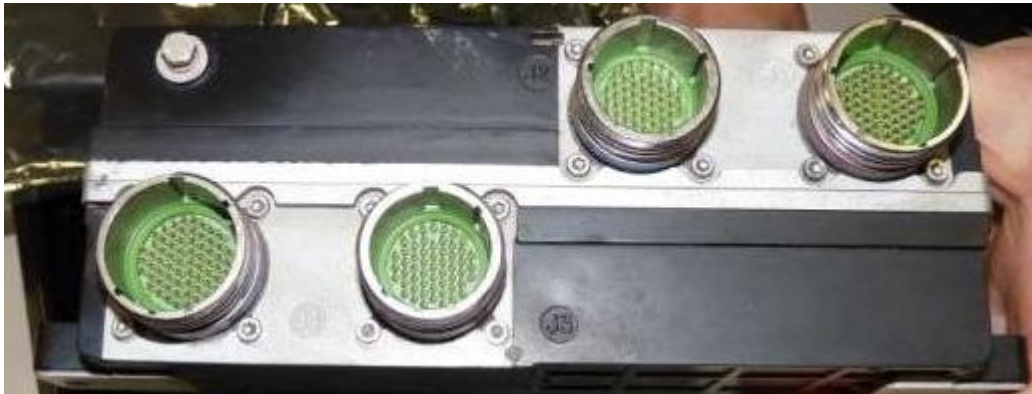
The electrical connectors were in good condition

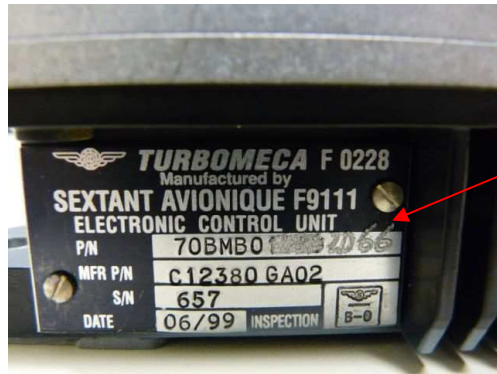
External and internal visual inspections were performed at BEA. The computer was in good condition. Turbomeca P/N 70BMB02066 does not correspond to any standard DECU reference. "2066" was manually engraved (probably during the embodiment of the SB 0292732066). The purpose of this SB is to increase tolerance to pitch loss during strong accelerations.

P/N manually engraved

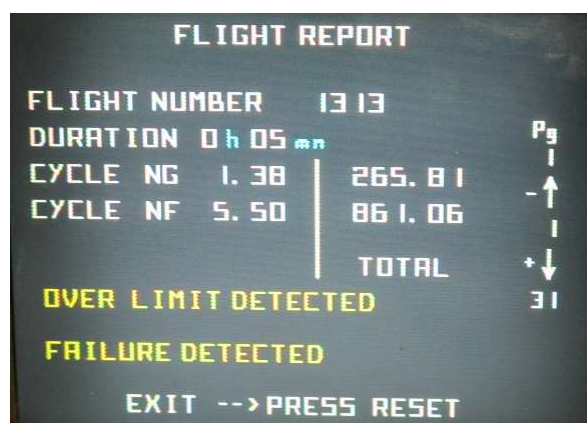
This page indicates that the accident flight was the flight number 1313.  
The cycle counting is not normal (NG=1.38 and NF=5.50). The value is too high for a standard flight, but could be explained due to the NF over limit recorded.  
This counting is made during the VEMD flight closure process.  
“Over limit” and “Failure” are detected during this flight.

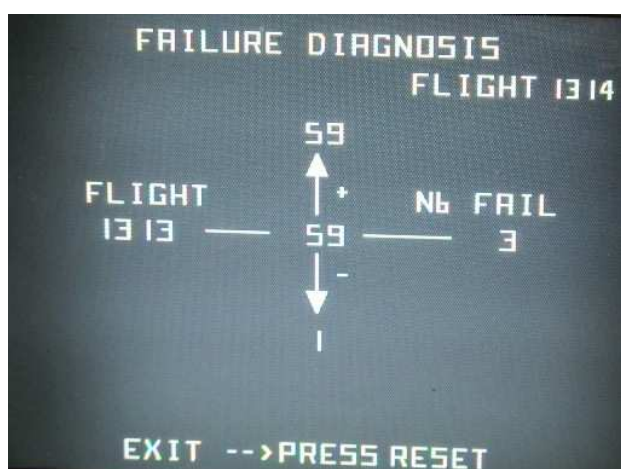
During the flight number 1313 (flight of the event), 3 failures were recorded. The “Enter” button was pressed in order to obtain the details of these failures.

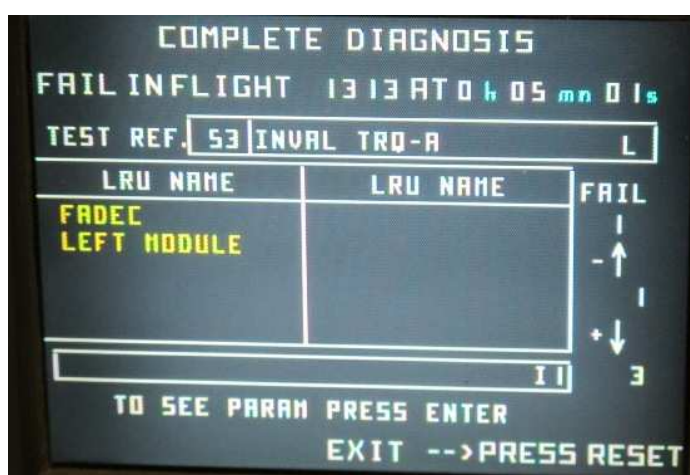
Failure code 53: In this case, excessive value of torque (104.4%) at 05'01"  
This failure occurs consistently at the time of impact of the helicopter.  
Associated parameters are the following ones:

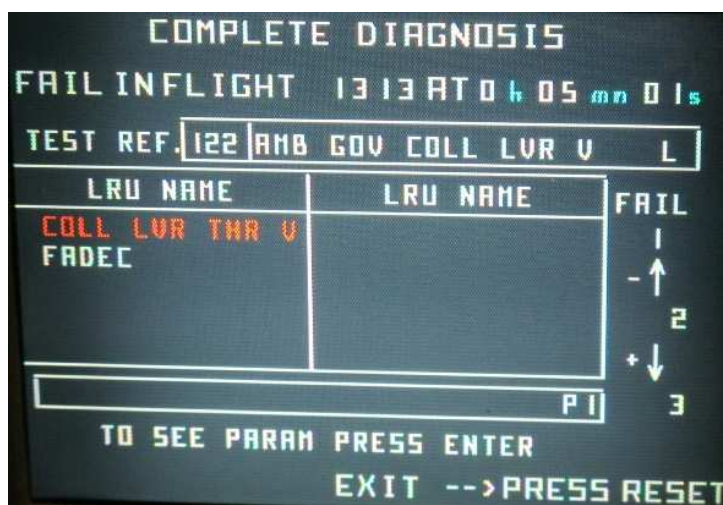
Failure code 122: Failure of collective pitch anticipator potentiometer (XPC) at 05'01"

This failure occurs consistently at the time of impact of the helicopter.

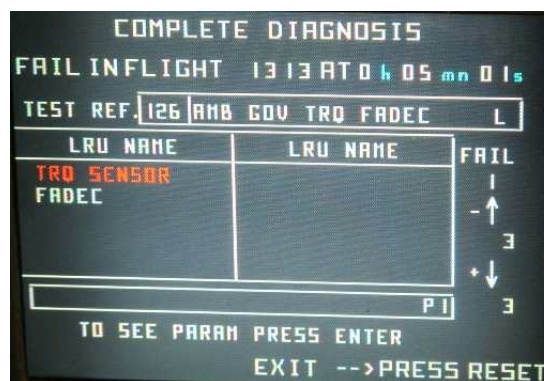
Failure code126: In this case, the torque decrease strongly (44,2%) at the same second (05'01").

The system estimates that it's not possible in normal operation to have this kind of variation without a failure of the torque sensor (See Label 350 – Fail 1 hereunder).

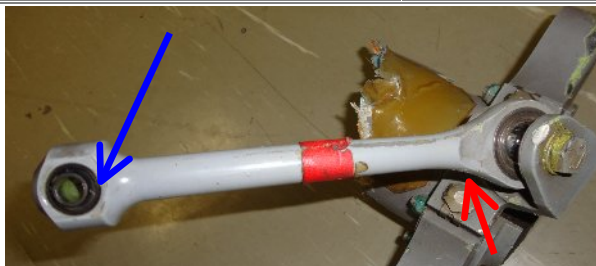
Photo 5: Impact marks, red pitch control rod (digital)

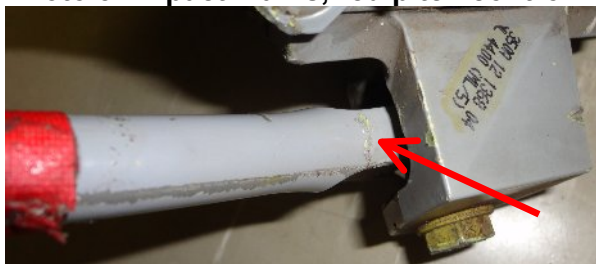
Photo 6: Impact marks, red pitch control rod (digital)

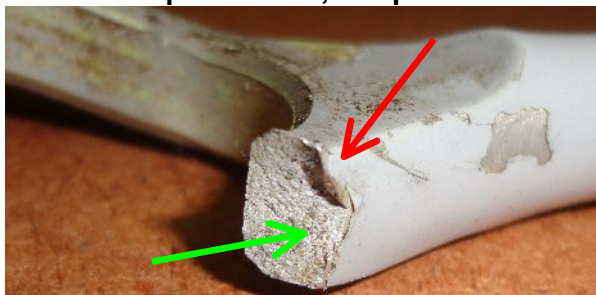
Photo 7: Fracture surface, yellow pitch control rod (digital)

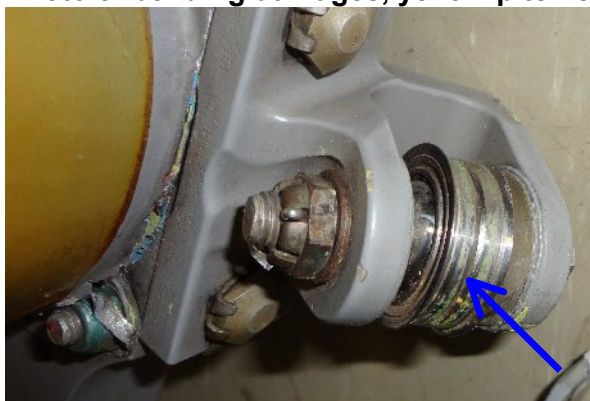
Photo 9: Big-end bearing at blade connector, yellow pitch control rod (digital)

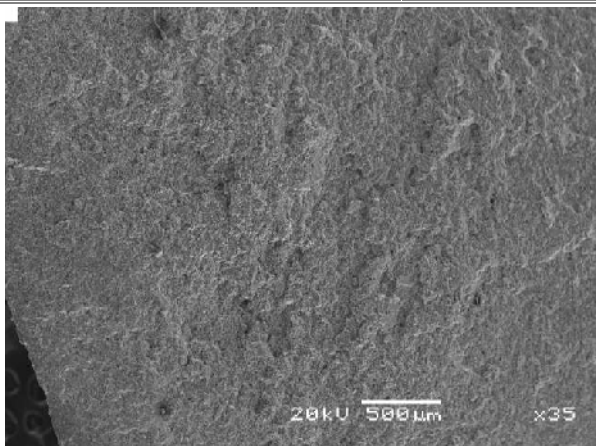
Photo 10: Fracture surface, yellow pitch control rod (x35, SEM)

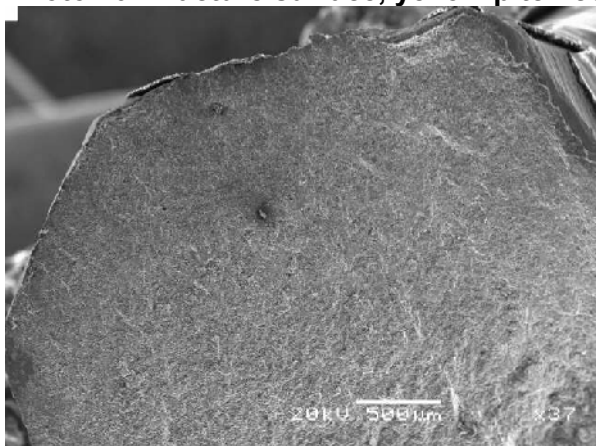
Photo 11: Fracture surface, yellow pitch control rod (x37, SEM)

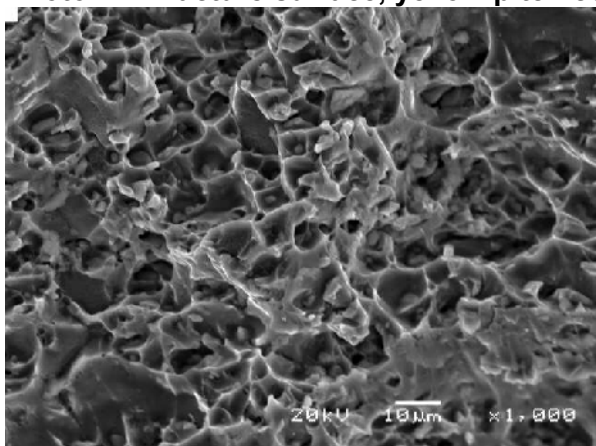
Photo 12: Fracture surface, yellow pitch control rod (x1000, SEM)

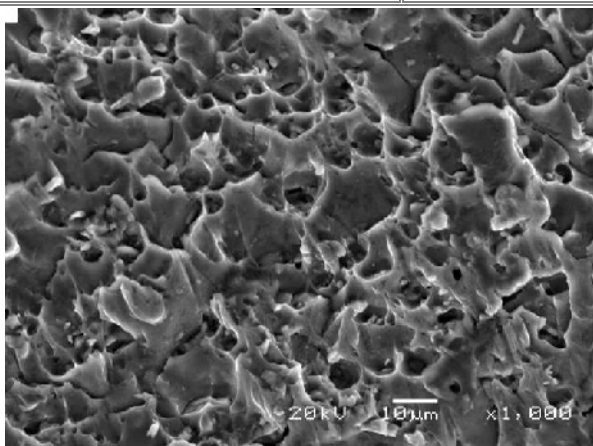
**Photo 13: Fracture surface, yellow pitch control rod (x1000, SEM)**

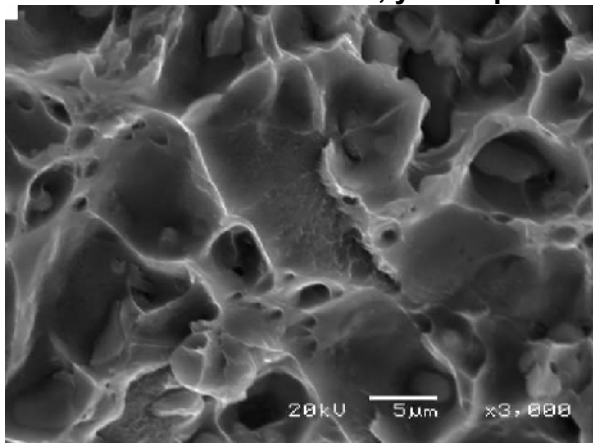
**Photo 14: Fracture surface, yellow pitch control rod (x3000, SEM)**
