AIRCRAFT ACCIDENT REPORT AND EXECUTIVE SUMMARY

Reference:		CA18/2/3/10033	
Aircraft Registration	ZS-KFG	Date of Accident	26 August 2021		Time of Accident	0900Z	
Type of Aircraft	Piper Seneca II (PA-34-200T)		Type of Operation		Training (Part 141)		
Pilot-in-command Licence Type	Commercial Pilot Licence (CPL)		Age	26	Licence Valid	Yes	
Pilot-in-command Flying Experience	Total Flying Hours		1 255.4		Hours on Type	78.8	
Last Point of Departure	Springs Aerodrome (FASI), Gauteng Province						
Next Point of Intended Landing	Springs Aerodrome (FASI), Gauteng Province						
Damage to Aircraft	Substantial						
Location of the accident site with reference to easily defined geographical points (GPS readings if possible)							
Runway (RWY) 21 at FASI at Global Position System (GPS) co-ordinates determined to be 26°14'51.86" South 028°23'51.57" East, at elevation 5 340 feet (ft)							
Meteorological Information	Wind 320° at 11kt, Temperature 19°C, Dew point 06°, Visibility 9999m

Probable Cause							
The aircraft landed whilst the main landing gears were not in the down and locked position, which resulted in the failure of the nose gear down lock link assembly. This led to the nose gear c

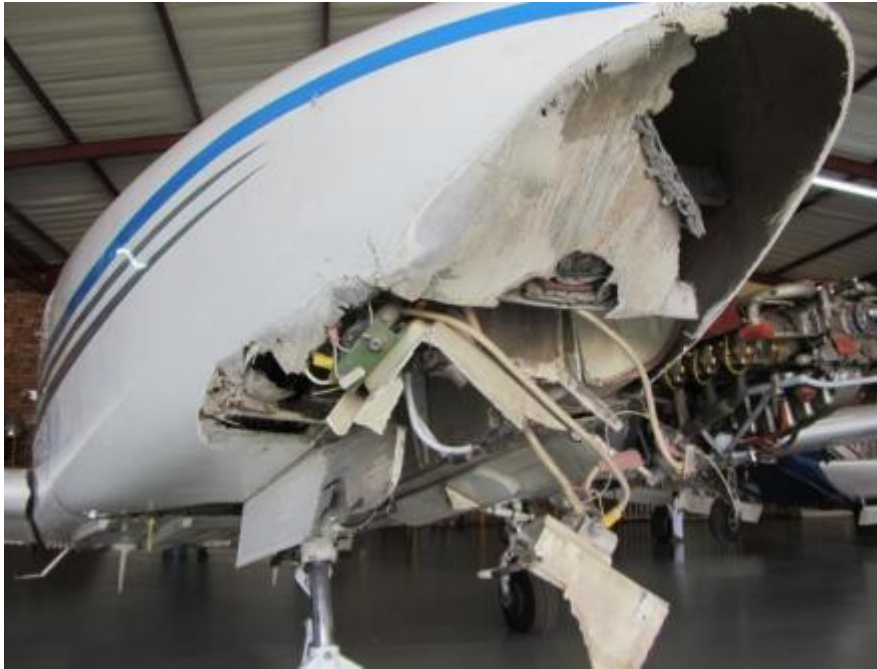
1.3.1. The aircraft was substantially damaged.

Figure 2: The damaged nose section.

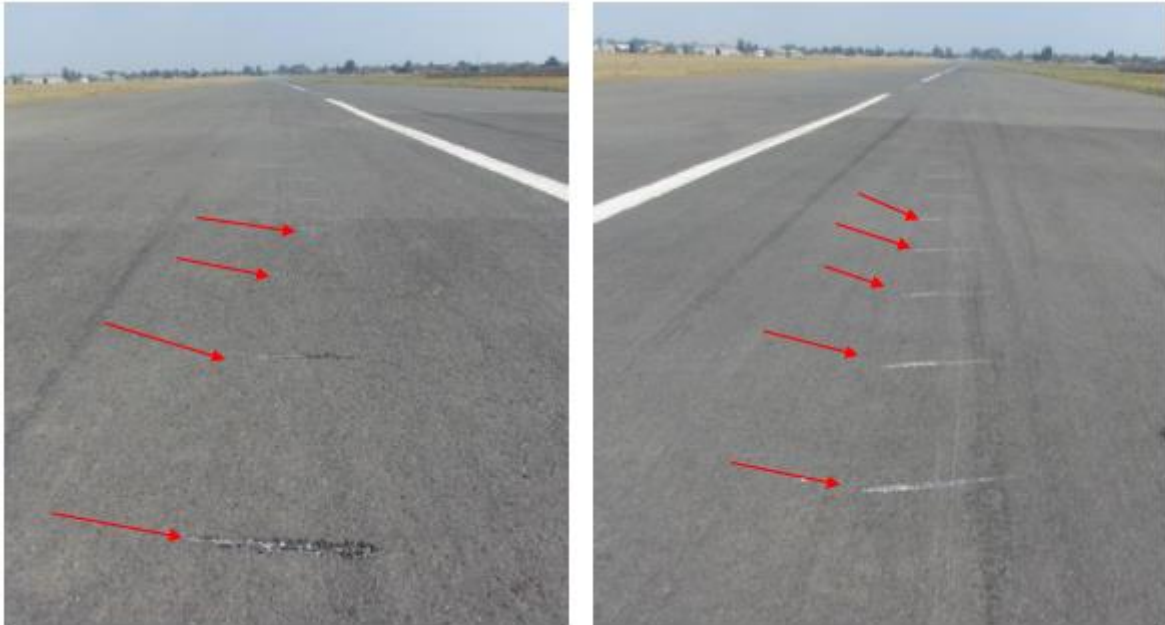
1.12.2. As evidenced by the propeller marks on the asphalt runway surface, the first impact marks of both propeller tips were approximately 255m from the runway threshold. Both propeller tip marks continued for approximately 20m. Towards the end of the propeller tip marks on the runway, the nose cone contacted the runway surface and the aircraft skidded on its nose cone and propeller tips for a further 282m before it came to a halt just after the second taxiway intersection. The distance from the threshold to the end of the nose cone scraping marks was 557m.

Figures 3 and 4: Arrows showing the left- and right-side propeller tip marks on the asphalt runway.

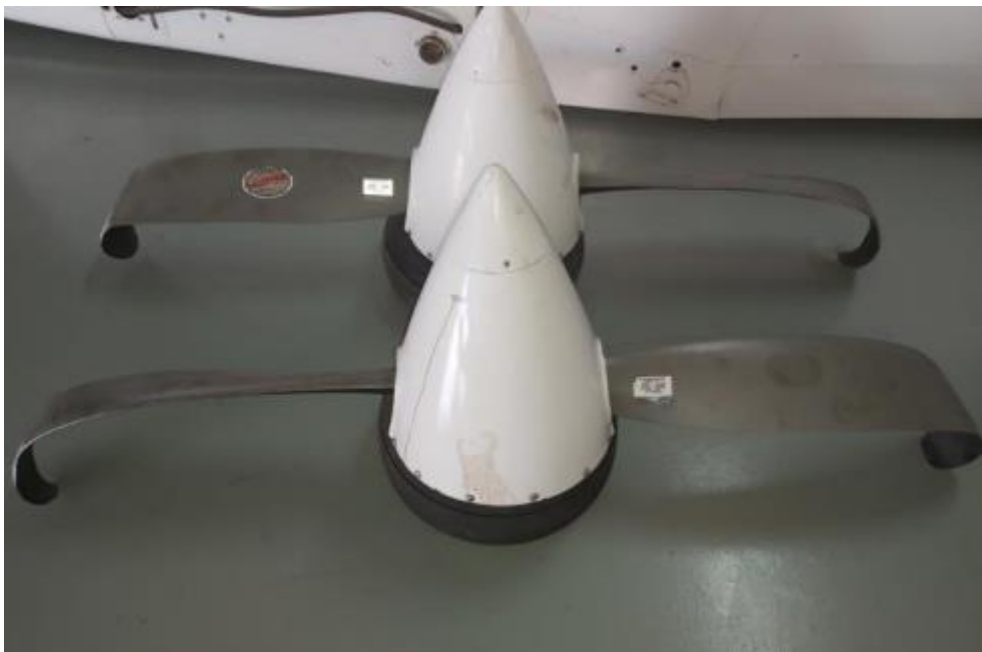
1.12.1. The aircraft touched down just after the threshold of Runway 21 at FASI. During the landing roll, the nose wheel collapsed which caused all four blades of the propellers to contact the ground and, as a result, curled (folded) inward.

Figure 5: Left- and right-side propeller assemblies.

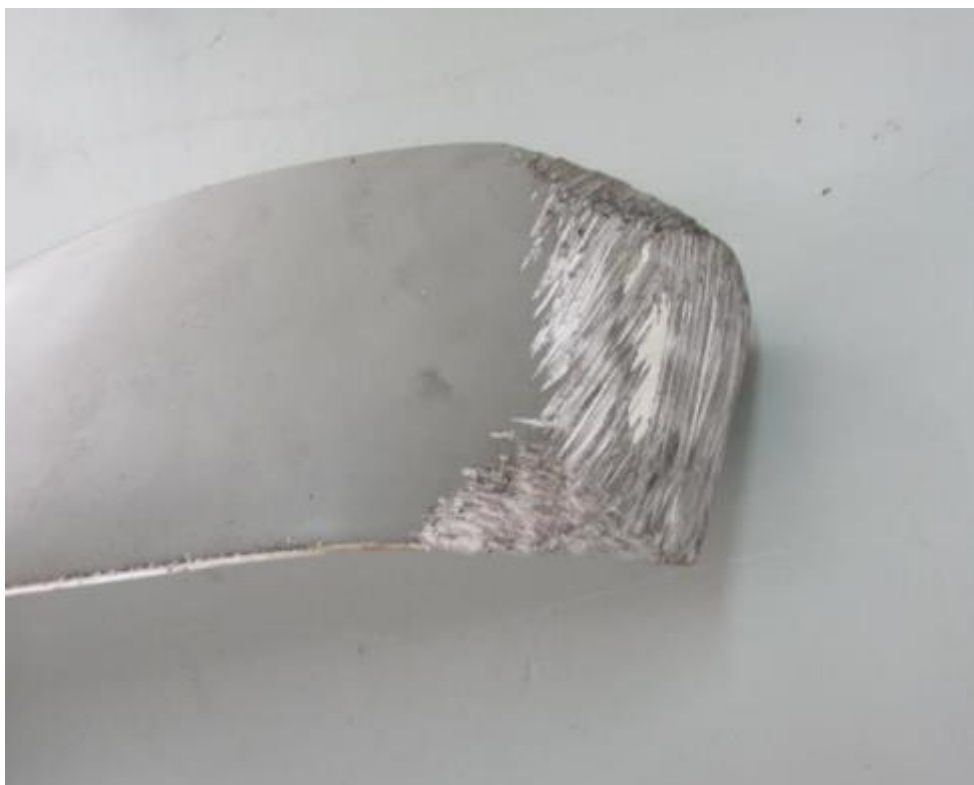
Figure 6: The propeller tip with scrape marks.

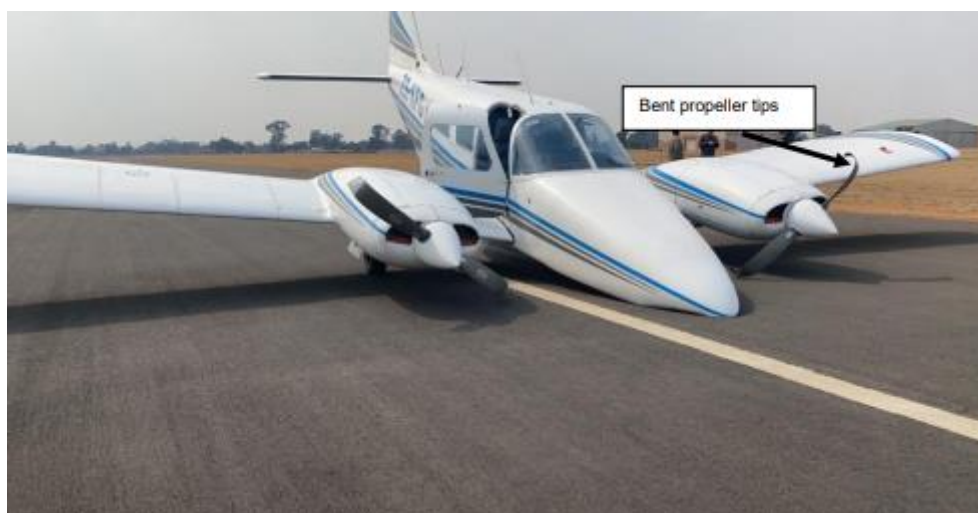
Figure 7: Final resting position of the aircraft. (Source: ATO)

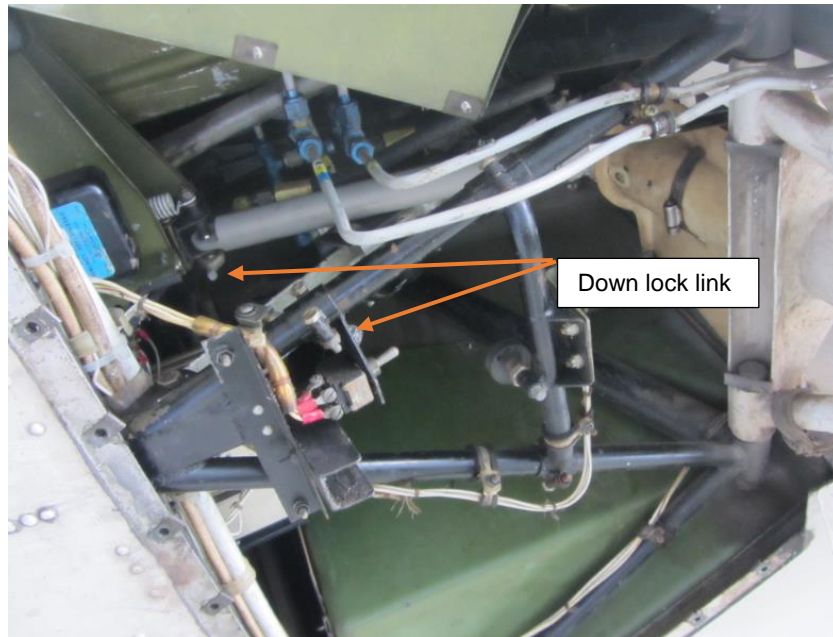
Figure 8: Location of the down lock link.

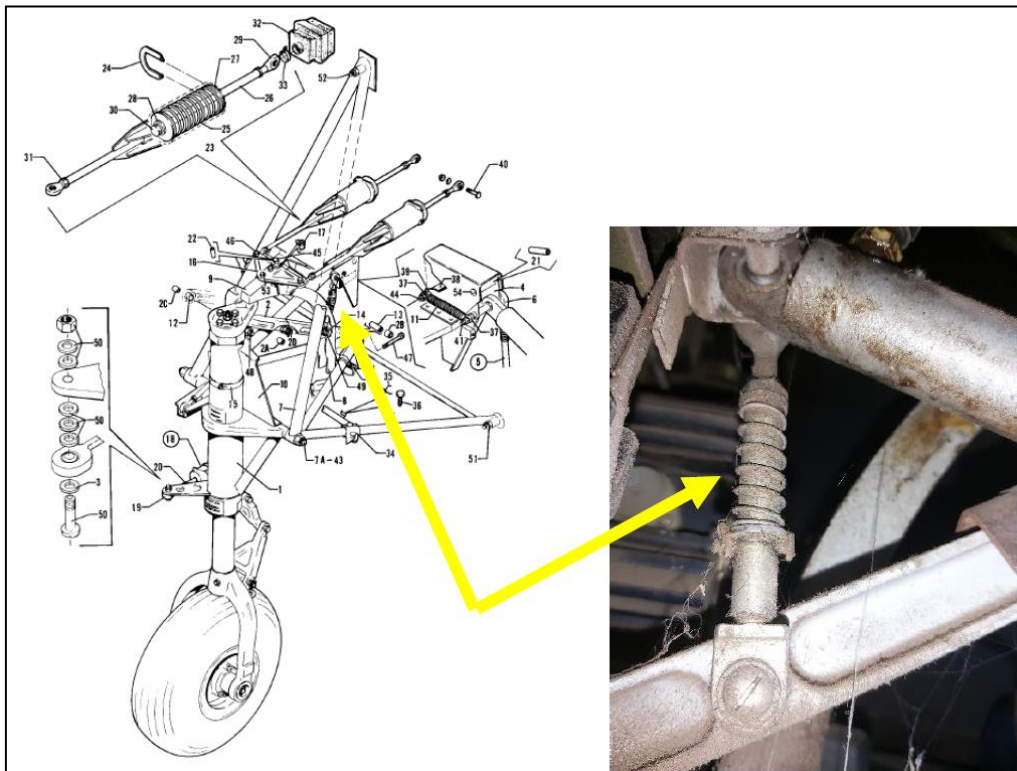
The visual inspection revealed a fracture within the threaded section of the down lock link rod end shown by the yellow arrows in Figure 9 (Schematic left and Image right). The location of the fracture is shown by the blue arrow in Figure 10.

Figure 9: Nose Gear assembly, fitment of Down Lock Link ASSY showed.
(Picture taken from a serviceable aircraft)

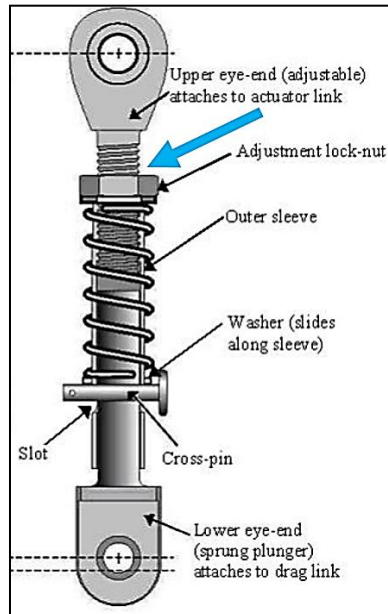
Figure 10: Schematic of a Down Lock Link assembly (blue arrow indicating location of failure at the threaded area). (Source: Metallurgy report)

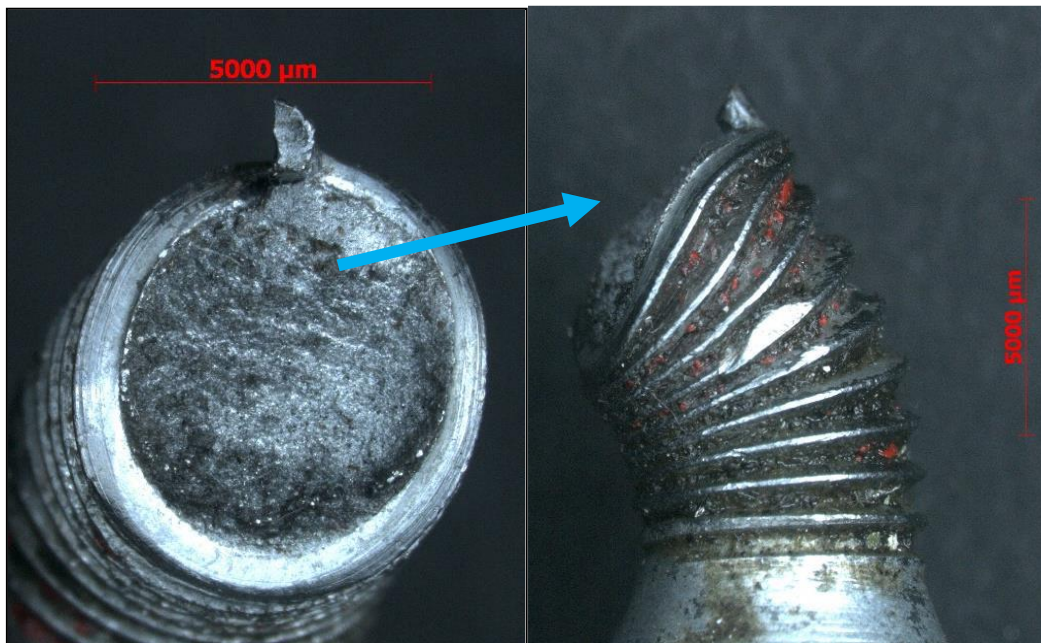
1.16.2.2 *At lower magnifications using the Stereomicroscope, the corresponding fracture surface morphologies revealed no clear indications of pre-existing corrosion-, fatigue- or metal inclusion induced fracture initiation/s (Figure 11).*

Figure 11: Fracture surface morphology and side view of the threaded section of the failed upper-eye rod end observed under the Stereomicroscope. (Source: University of Pretoria Failure Analysis Report)

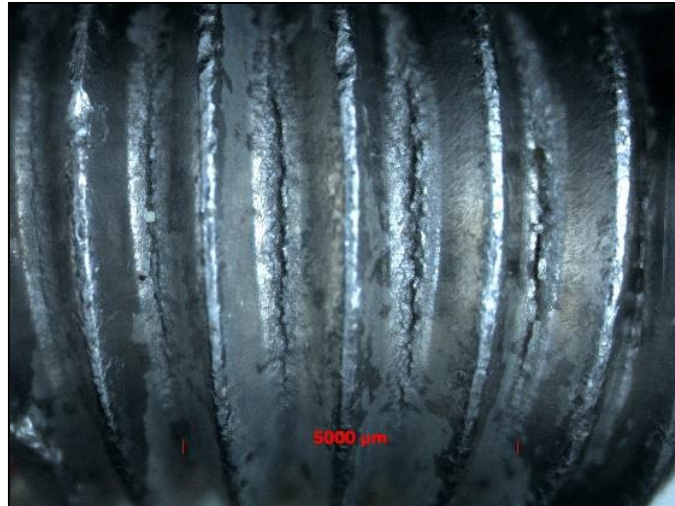
1.16.2.3 *The threaded section just adjacent to the locknut revealed extensive bending damages which resulted in secondary fracture formation within the thread root areas (Figure 12). This is indicative of a single overload (compression) bending event caused by the unlocking of the upper draglink during operation allowing for the noted compression load applied to the Down Lock Link ASSY.*

Figure 12: Bending damages on the threaded section, secondary fracture initiations of the failed upper-eye rod end observed under the Stereomicroscope. (Source: University of Pretoria Failure Analysis Report)

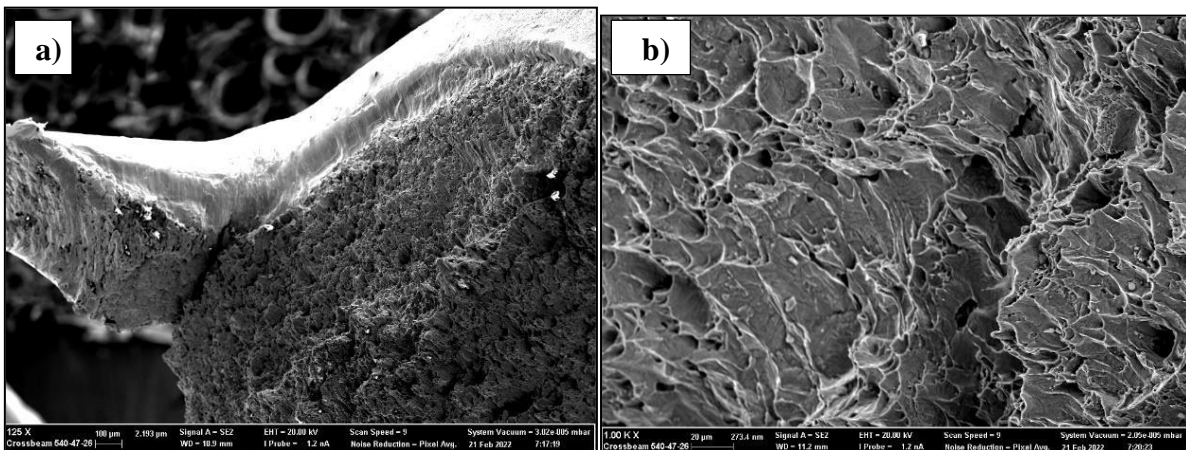
1.16.2.4 *At higher magnifications, the corresponding fracture surfaces revealed no indication/s of pre-existing fracture initiation/s (Figure 13 (a and b)) while the surfaces correspond with a typical micro-void coalescence morphology with indications of ductile shear.*

Figure 13: **a)** Fracture surface morphology (85-125X, 20kV, SE, FEGSEM). **b)** Fracture surface morphology (1000-1500X, 20kV, SE, FEGSEM) (Source: UP Microscopy Laboratory)

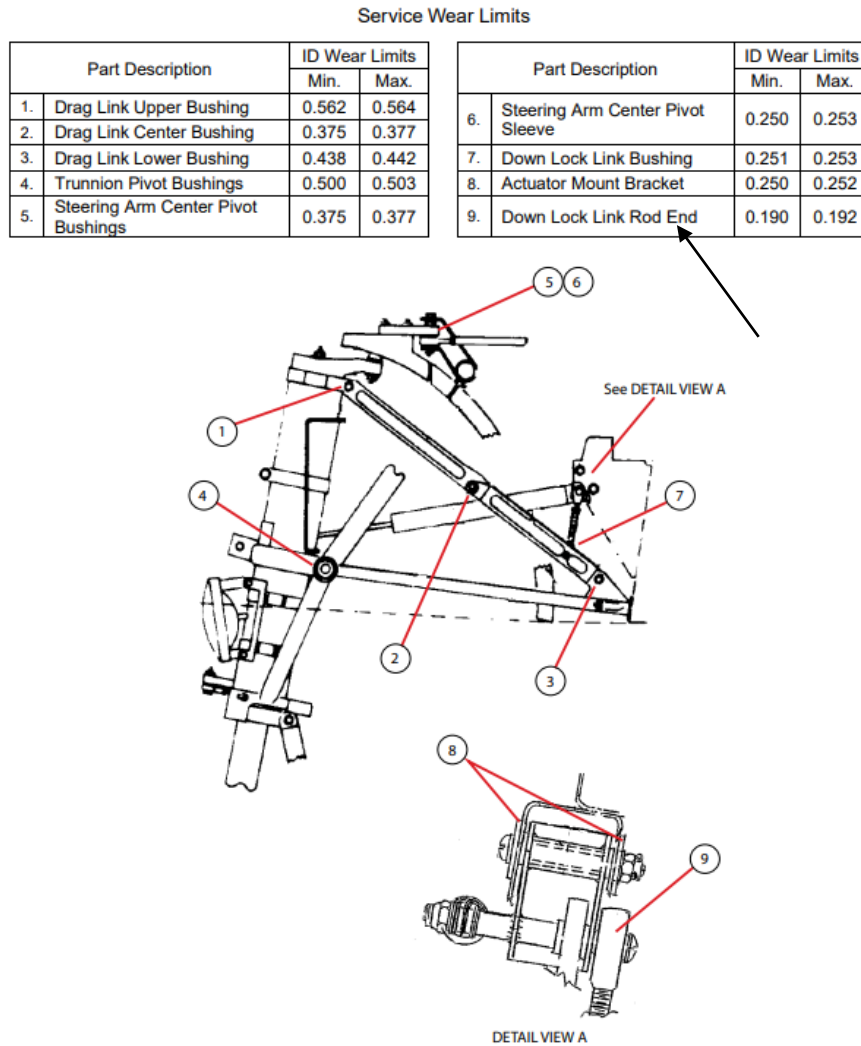
Illustration 2: Nose gear schematics (Source: SB 1123C)

- Upper rod end was measured to be 0.189 inches.
- Pin slot was measured to be 0.191 inches.
- Lower eye end was measured to be 0.190 inches.

1.16.4 According to the service bulletin (SB), the measurement limits are as follows.

The AMO did not comply with the requirements of the SB 1123C and this was found to be unsatisfactory. The values for the rigging of the nose gear as required by inspection instruction number G39 were not found. It is not known if at the time of the MPI the nose gear rigging was within limits. Damage sustained by the nose gear after the nose landing gear collapse made it difficult for the investigator to verify the rigging. The inspection instruction also called for lubrication of the nose gear hardware. The nose gear hardware was lubricated

4.2.1. It is recommended that the AMO follow the service manual instructions as laid out by the manufacturer during inspections to ensure that maintenance of aircraft are done safely and efficiently.
