AIRCRAFT ACCIDENT REPORT AND EXECUTIVE SUMMARY

Reference:		CA18/2/3/10041	
Aircraft Registration	ZS-SFV	Date of Accident	20 September 2021		Time of Accident	1840Z	
Type of Aircraft	Learjet 35		Type of Operation	Private (Part 91)			
Pilot-in-command Licence Type	Airline Transport Pilot Licence (ATPL)		Age	47	Licence Valid	Yes	
Pilot-in-command Flying Experience	Total Flying Hours		4736.6		Hours on Type	382.9	
First Officer Licence Type	Airline Transport Pilot Licence (ATPL)		Age	40	Licence Valid	Yes	
First Officer Flying Experience	Total Flying Hours		3459.7		Hours on Type	705.7	
Last Point of Departure	Cape Town International Airport (FACT), Western Cape Province						
Next Point of Intended Landing	Lanseria International Airport (FALA), Gauteng Province						
Damage to Aircraft	Substantial						
Location of the accident site with reference to easily defined geographical points (GPS readings if possible)							
Runway 25 at FALA at Global Positioning System (GPS) co-ordinates determined to be 25°56'30.83" South 027°55'23.44 East, at an elevation of 4 420 feet (ft)

Occurrence Details

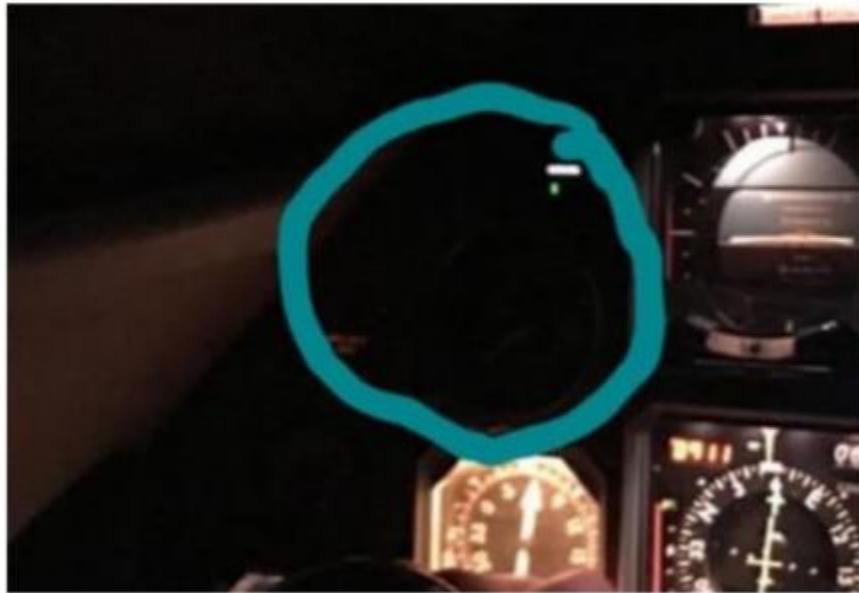
- The left generator failed.
- The primary altimeter back light was unserviceable.
- The primary airspeed indicator back light was unserviceable.
- The emergency air indicator light was unserviceable.
- The hydraulic pressure indicator light was unserviceable.
- The left-side amp meter back light was unserviceable.

Figure 1: The air speed indicator backlight that was unserviceable.

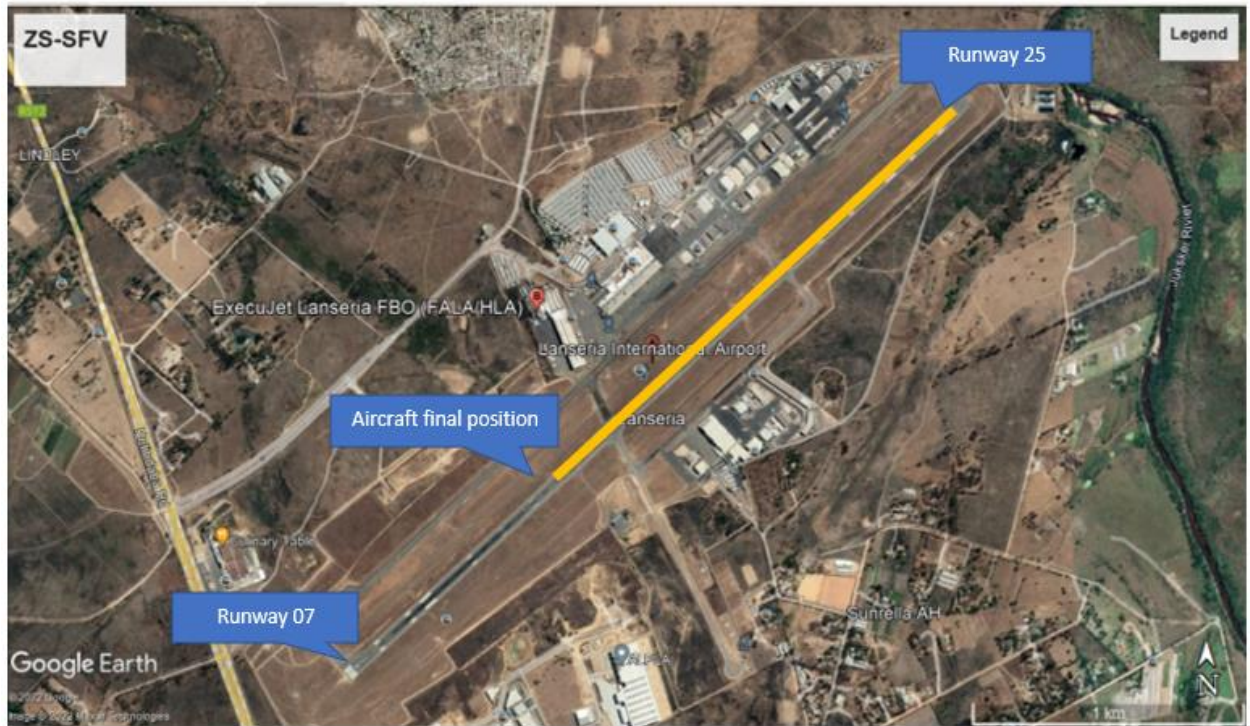
Figure 2: The approximate skidding distance of the aircraft during the accident.
(Source: Google Earth)

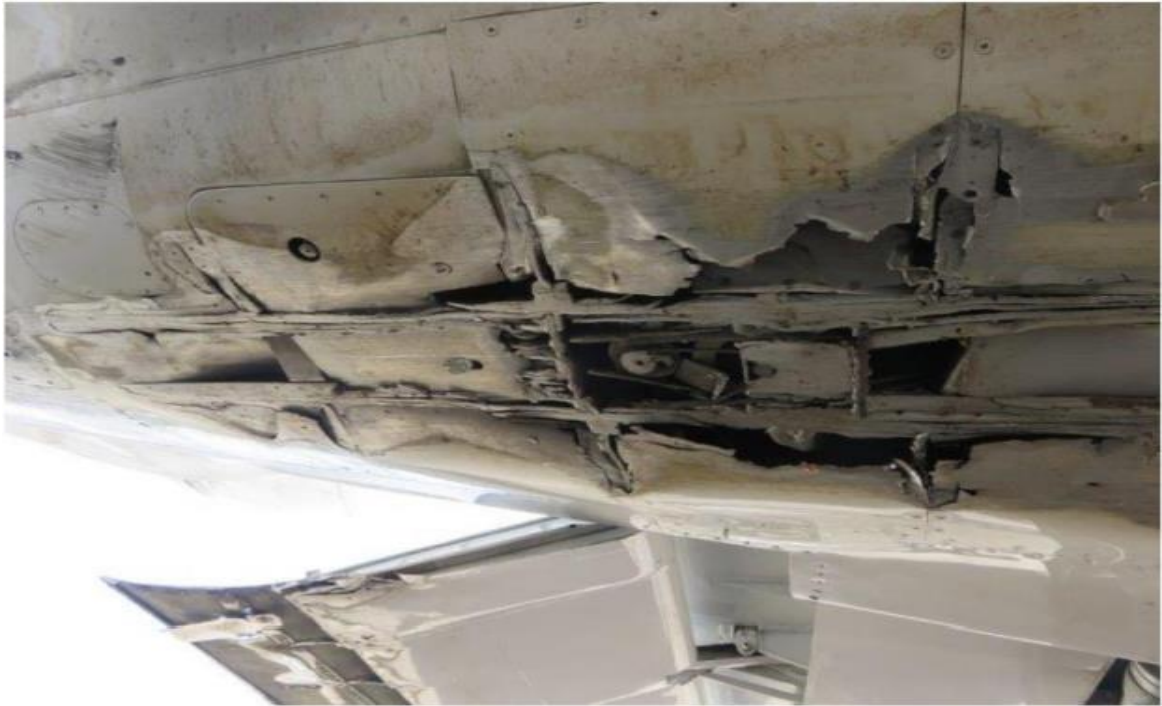
1.3.1 The aircraft was substantially damaged during the accident sequence.

Figure 3: Damage to the underbelly and flaps.

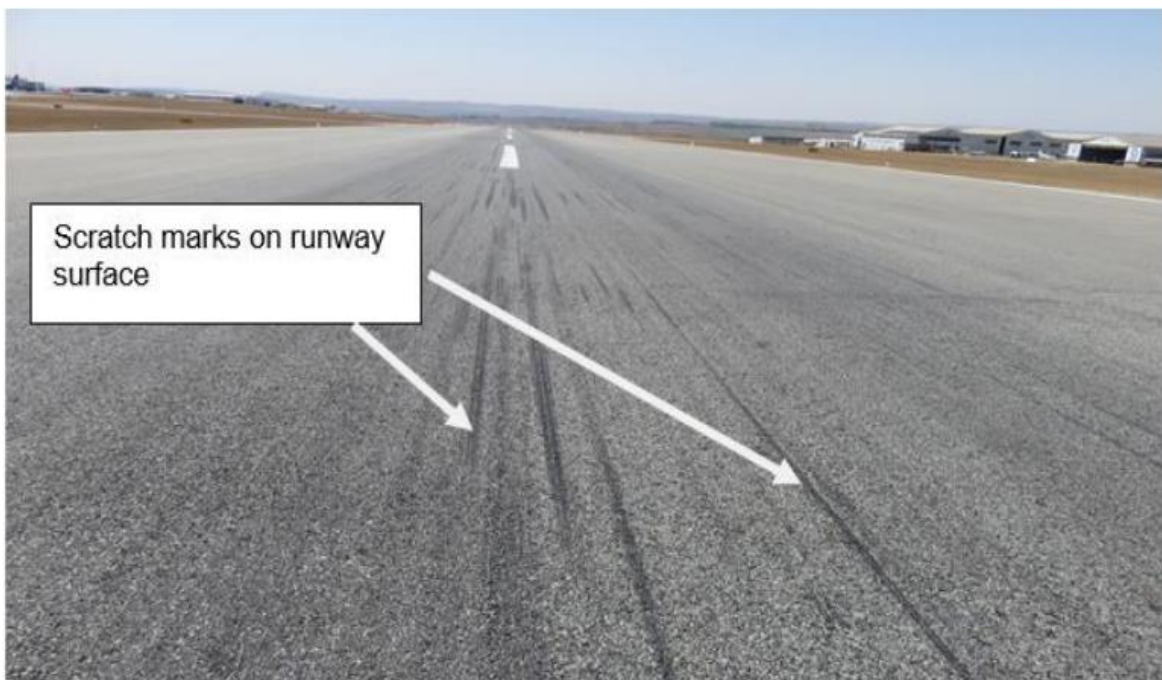
1.4.1 The runway surface was slightly damaged.

Figure 4: Scratch marks on the runway surface at FALA.

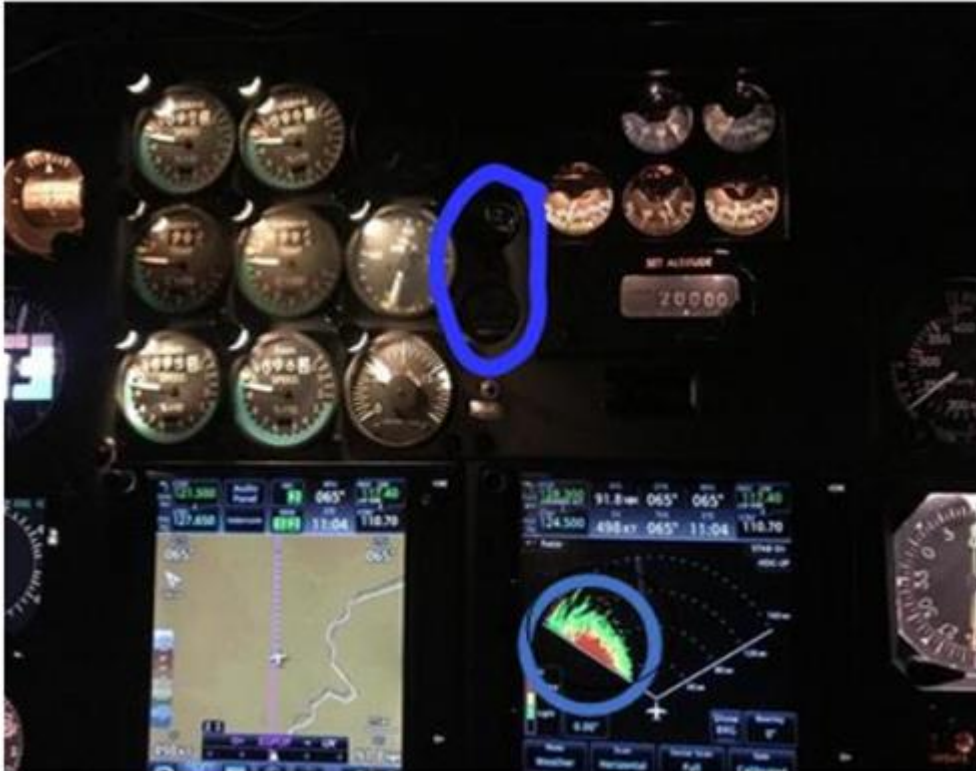
- On 20 September 2021 during the accident flight from FACT to FALA, the following major defects were recorded:
 - a) Augmentation aileron failed when the flaps were set at 45°
 - b) Autopilot did not track Navigation
 - c) Left-side stall master warning activated
 - d) Left-side generator failed, amber caution illuminated
 - e) Emergency air indicator light unserviceable (see Figure 5)
 - f) Radar paints left low (see Figure 5)
 - g) Master landing gear warning unserviceable

Figure 5: Emergency air unserviceable and radar paints left.

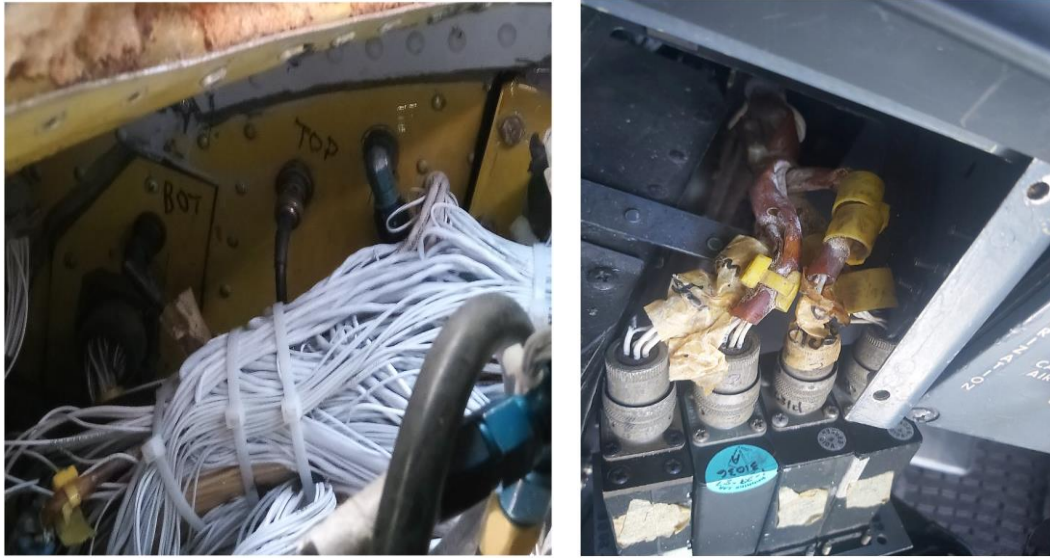
1.6.7 According to available information, the owner had several meetings with the AMO to address the recurring defects and had asked the AMO to replace the entire looms of the aircraft. The investigation team found that the looms were not replaced in their entirety but only parts that related to the defects were replaced (see Annexure D CRMA).

Figures 6 & 7: New wires on the left, and old corroded wires on the right post-accident.

- 3.2.11 The owner had several meetings with the AMO addressing the recurring defects and had requested that the entire loom be replaced. However, only parts of the looms were replaced.

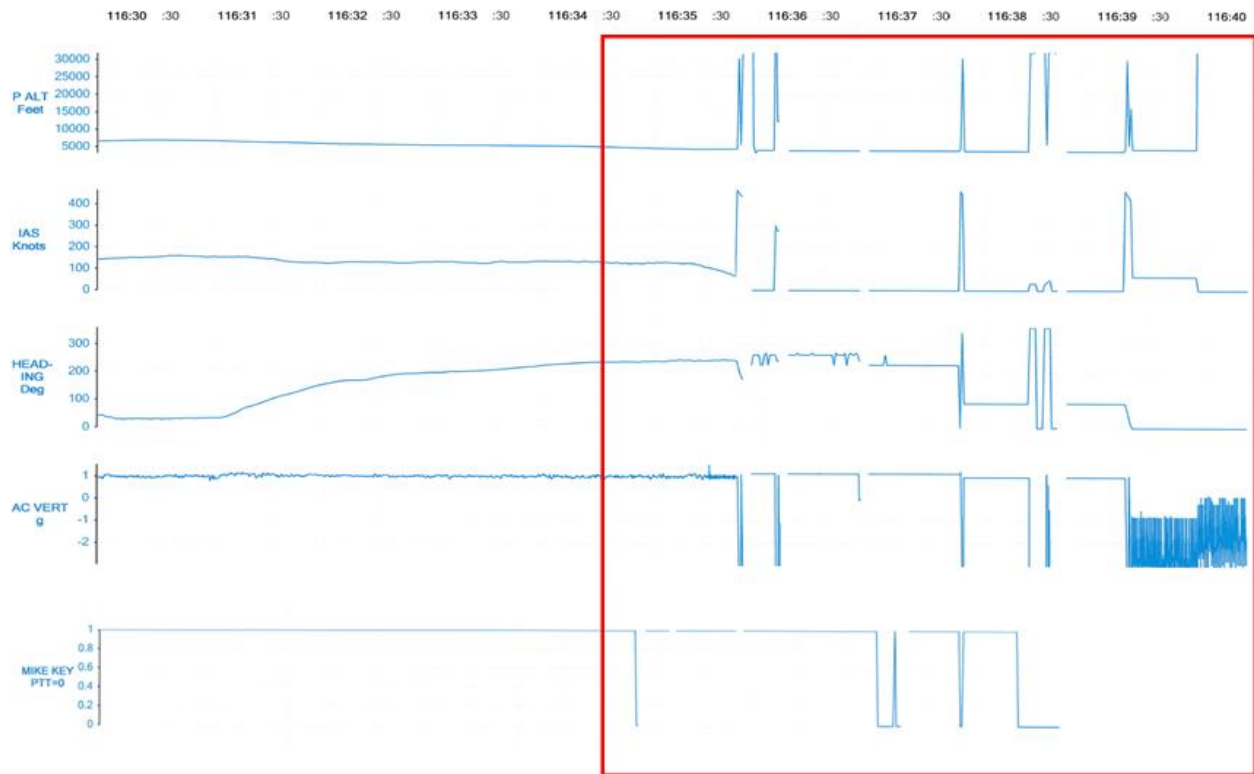
Graph 1: The red block shows the fluctuation of the instruments which occurred during the belly landing due to vibration as the aircraft scraped the runway.

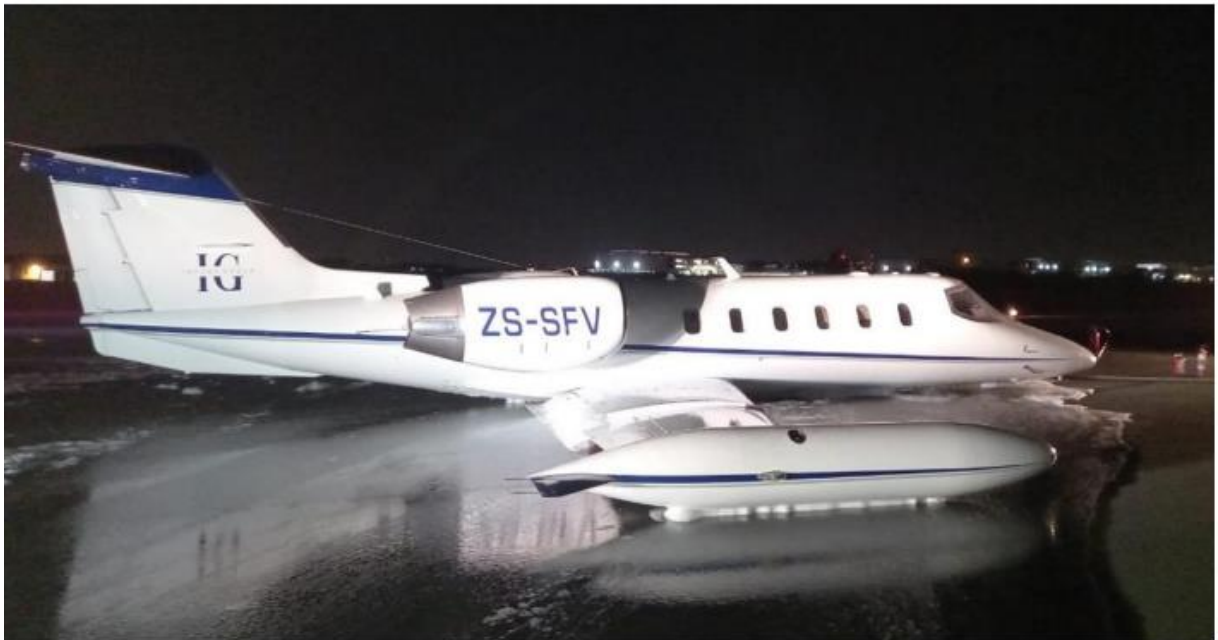
1.12.1 The aircraft touched down on the threshold of Runway 25 with the landing gears retracted; it skidded on its belly for approximately 2km in a nose-up attitude. There was no damage to the nose section. The accident occurred on a heading of approximately 240 degrees (°) magnetic (MAG).

Figure 8: The ZS-SFV aircraft as it came to rest on its belly on the runway. (Source: AMO)

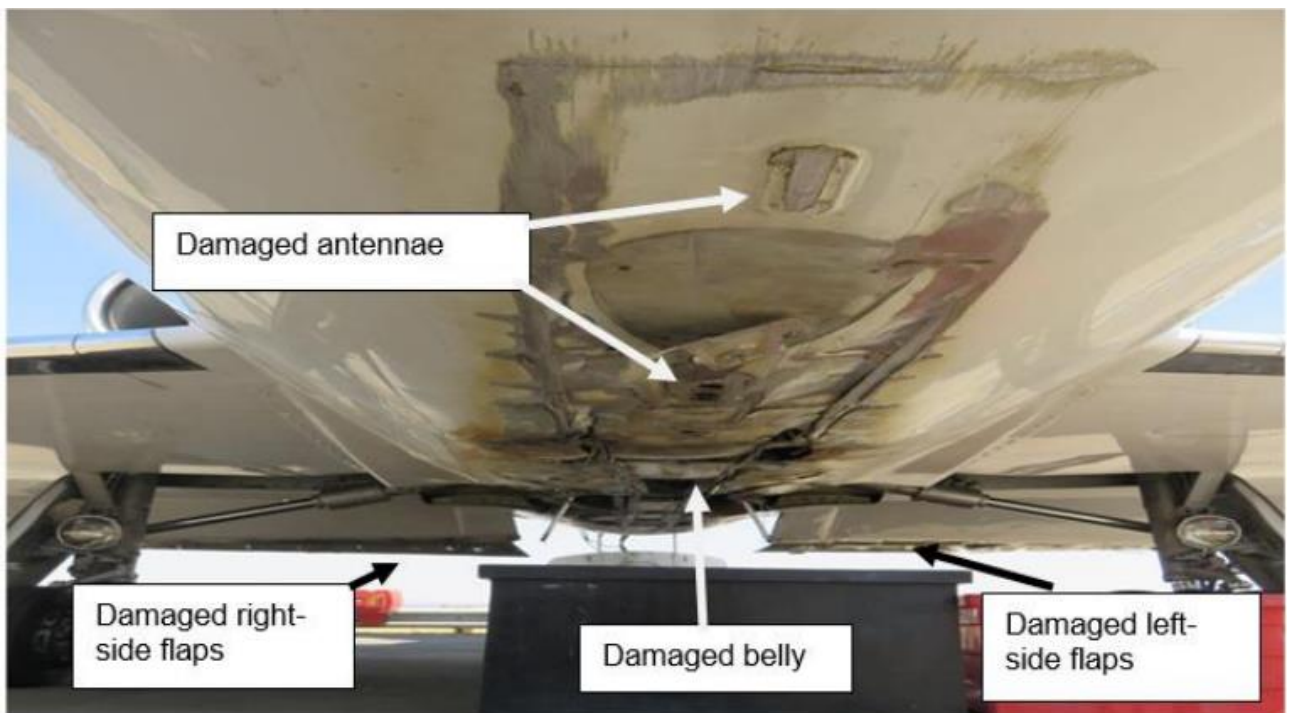
1.12.2 On-site investigation found that the aircraft sustained damage to the flaps, antennae and underbelly.

Figure 9: Aircraft damage post-accident.

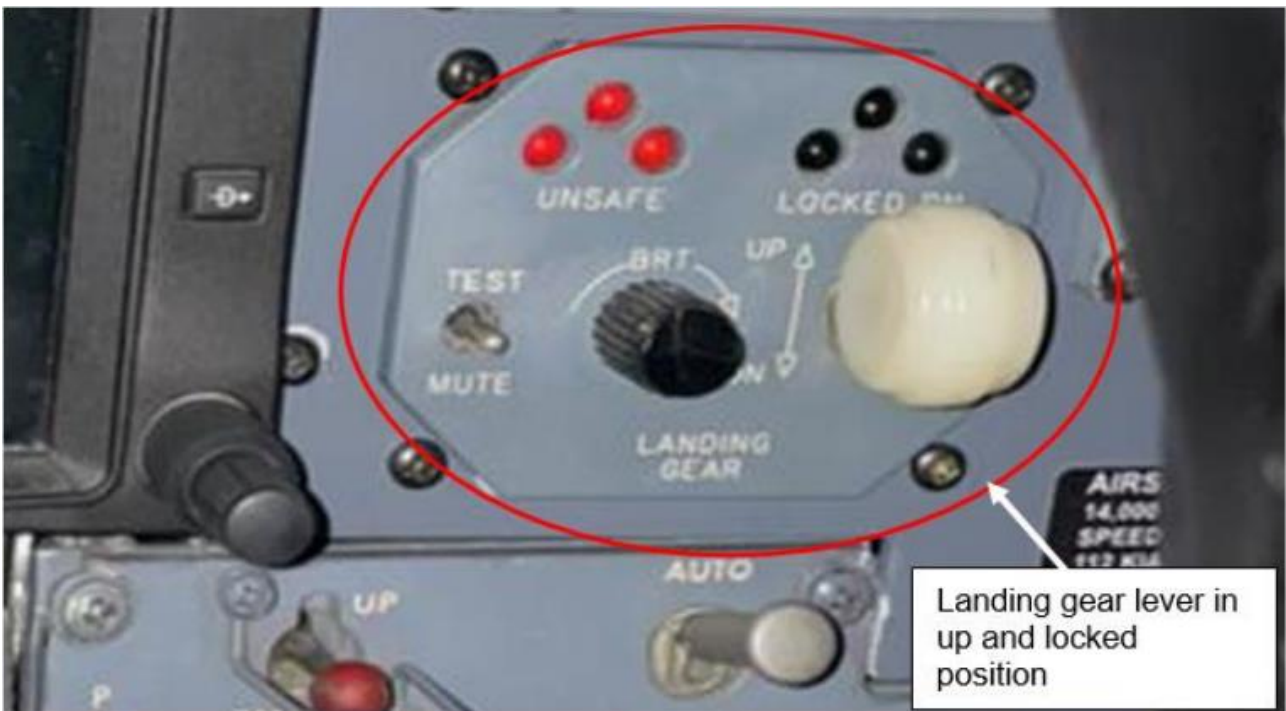
1.12.3 According to the AMO, the landing gear lever was found in an up and locked position.

Figure 10: Landing gear lever in up and locked position. (Source: AMO)

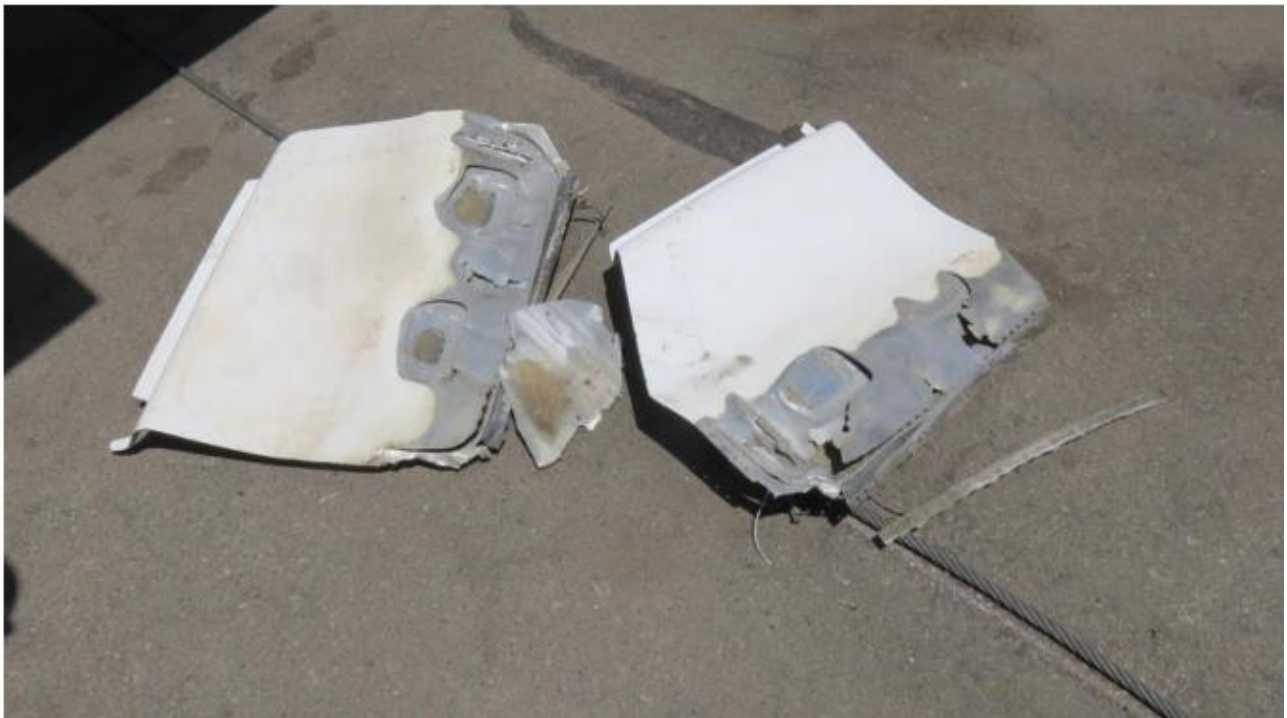
1.12.4 The left- and right-side main landing gear doors were damaged during the accident sequence.

Figure 11: Damaged main landing gear doors.

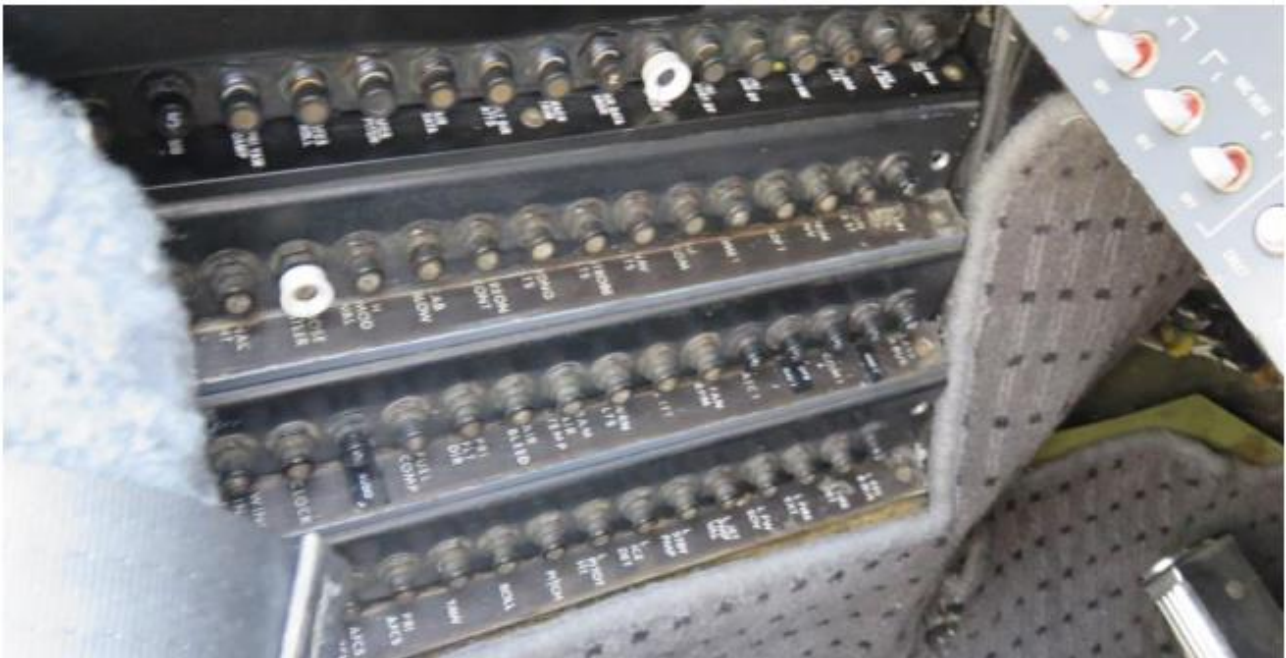
1.12.5 All circuit breakers (CBs) were found in closed position.

Figure 12: All circuit breakers were in closed position after the accident.

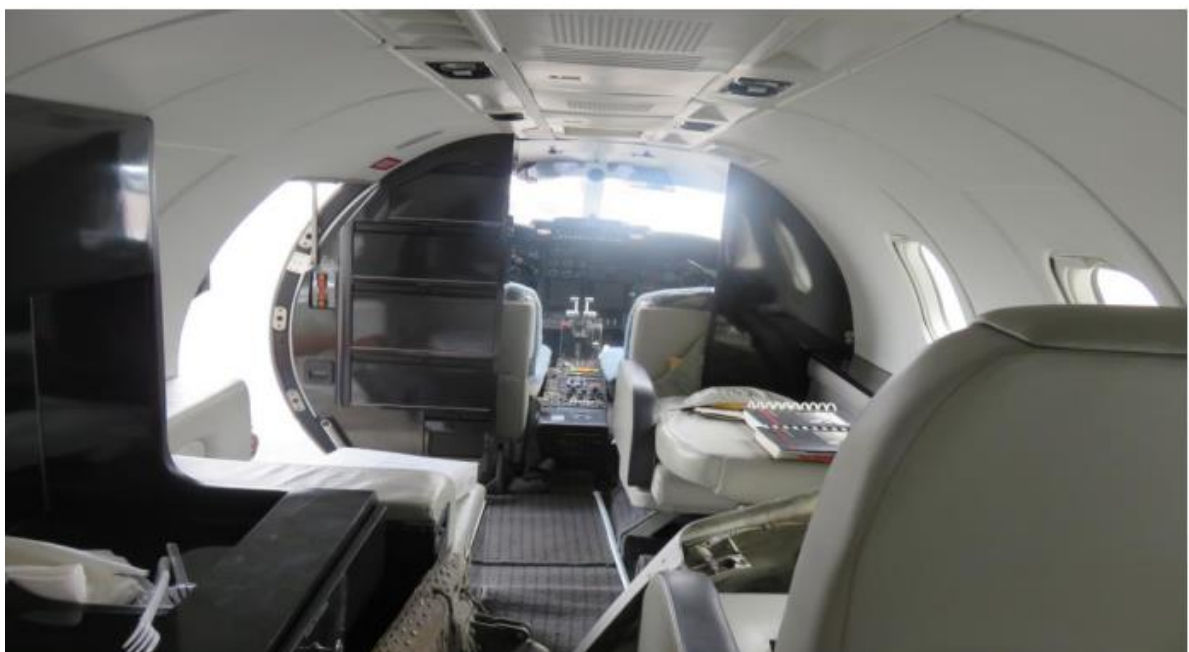
1.15.1 The accident was considered survivable as no damage was caused to the cockpit and cabin structure of the aircraft.

Figure 13: Cockpit and cabin structure still intact.
