LIMITED ACCIDENT INVESTIGATION REPORT
--

Reference Number		CA18/2/3/10042					
Classification	Accident	Date	18 September 2021	Time	1430Z		
Type of Operation	Private (Part 91)						
Location							
Place of Departure		Vereeniging Aerodrome (FAVV)	Place of Intended Landing		Vereeniging Aerodrome (FAVV)		
Place of Accident		Runway 03 FAVV, Gauteng Province					
GPS Co-ordinates	Latitude	26°34'15.42" S	Longitude	027°57'36.41" E	Elevation	4862ft	
Aircraft Information							
Registration		ZS-LLS					
Model/Make		Cessna C 177 RG					
Damage to Aircraft		Substantial	Total Aircraft Hours		6768.33		
Pilot-in-command							
Licence Valid		Yes	Gender	Male	Age	38	
Licence Type		Private Pilot Licence (PPL) Aeroplane					
Total Hours on Type		±170	Total Flying Hours		239		
People On-board	1+0	Injuries	0	Fatalities	0	Other (on ground)	0
What Happened							
<p>On Saturday afternoon, 18 September 2021 at approximately 1430Z, the pilot on-board a Cessna 177 RG aircraft with registration ZS-LLS took off on a local flight from Vereeniging Aerodrome (FAVV) in Gauteng province with the intention to fly to Heidelberg very high frequency (VHF) omni range (HGV) and return to FAVV. After initiating the tak

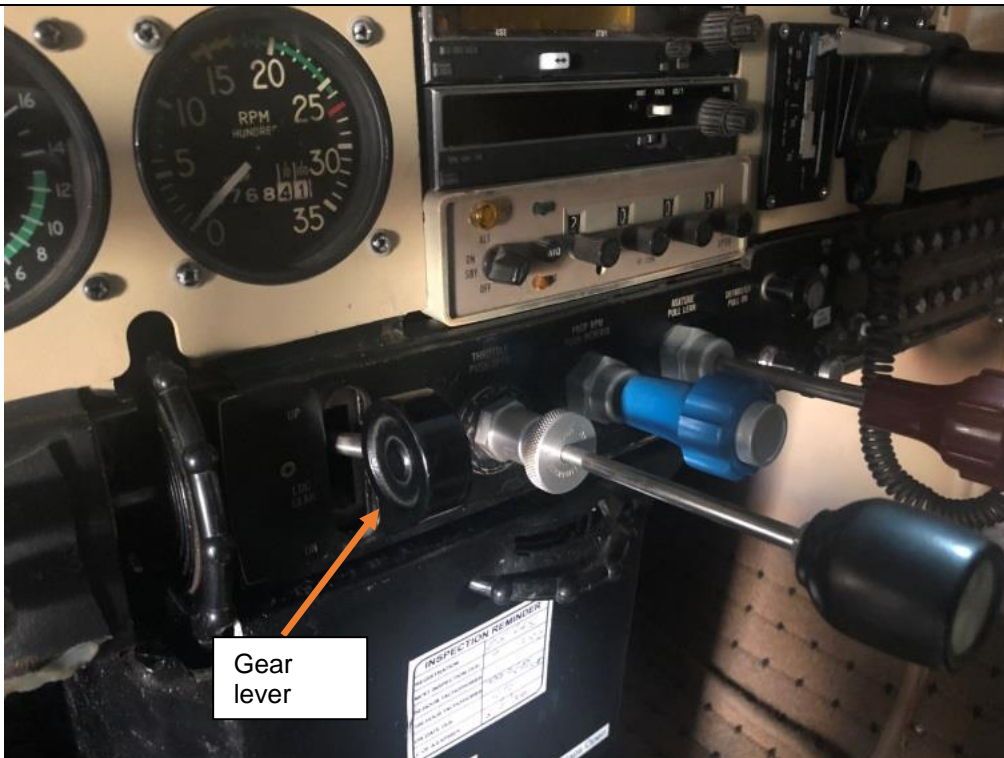
Figure 1: An approximate position of the gear lever during the accident. (Source: Pilot)

The undercarriage collapsed because the pilot accidentally moved the gear lever to the retracted position during the take-off roll.

Safety Message	
Pilots need to be careful when conducting pre-take-off checks to prevent accidents such as retracting/moving the landing gear lever while conducting other pre-take-off checks.	
Purpose of the Investigation	
<i>In terms of Regulation 12.03.1 of the Civil Aviation Regulations (CAR) 2011, this report was compiled in the interest of the promotion of aviation safety and the reduction of the risk of aviation accidents or incidents and not to apportion blame or liability.</i>	
About this Report	
<i>Decisions regarding whether to investigate, and the scope of an investigation are based on many factors, including the level of safety benefit likely to be obtained from an investigation. For this occurrence, no investigation has been conducted, and the Accident and Incident Investigations Division (AIID) has relied on the information submitted by the affected person/s and organisation/s to compile this brief report. The report has been compiled using information supplied in the initial notification, as well as follow-up information to bring awareness of potential safety issues to the industry in respect of this occurrence, as well as possible safety action/s that the industry might want to consider in preventing a recurrence of a similar accident.</i>

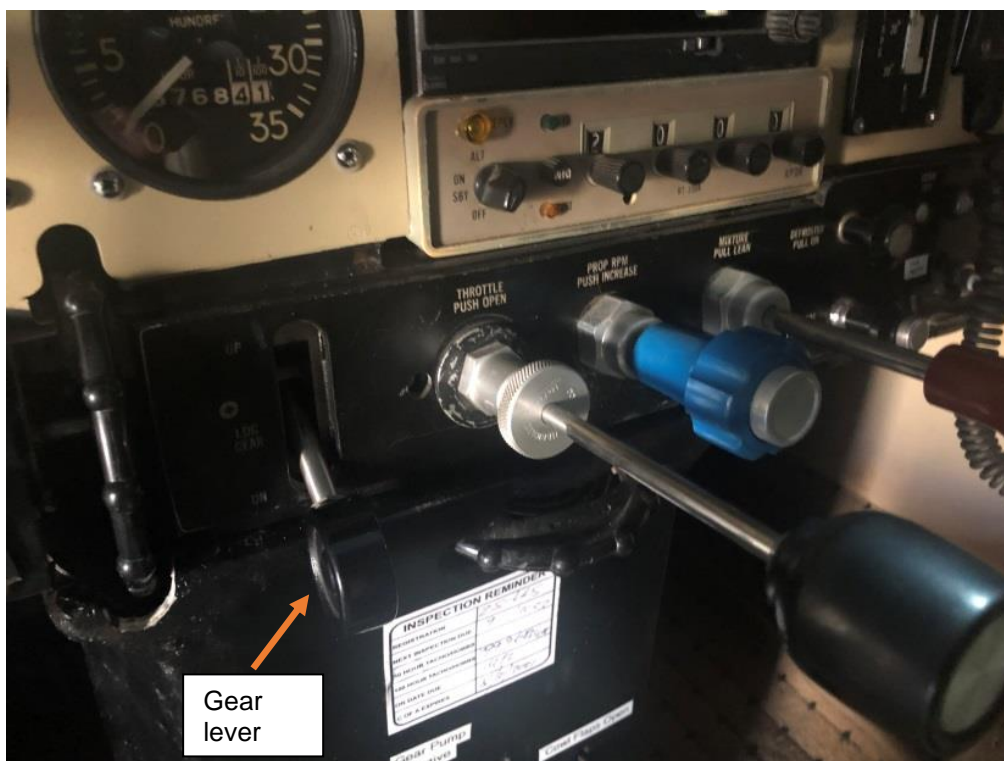
Figure 2: The gear lever when it is in the down and locked position. (Source: Pilot)

- According to the Pilot’s Operating Handbook (POH), the gear lever needs to be pulled out slightly to clear a detent before it can be repositioned. The pilot retracted the nose gear half-way and only realised his mistake when the aircraft had gathered speed during the take-off run.

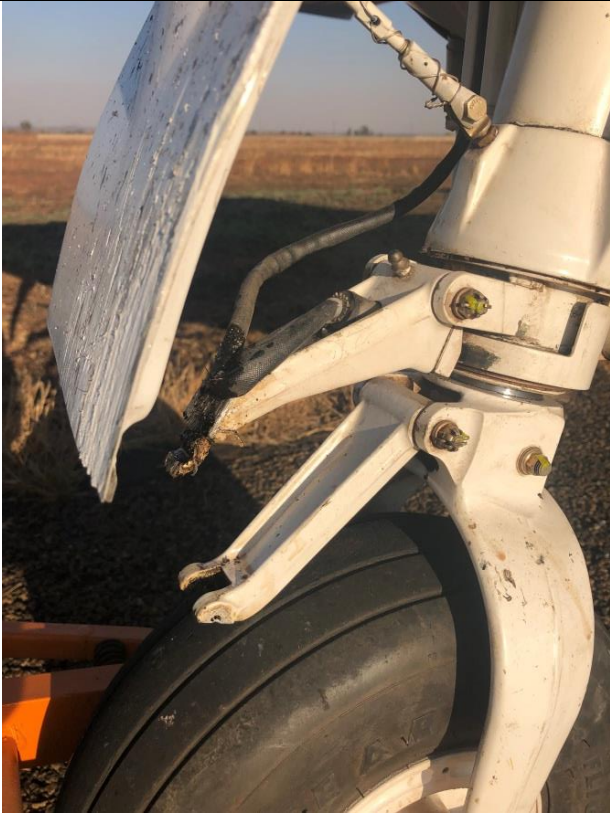
The aircraft sustained damages to the propeller, nose gear and exhaust (see Figures 3 to 6). No injuries were reported during the accident.

Figures 3 and 4: Damage to the nose gear (left) and skid marks on the runway surface (right).

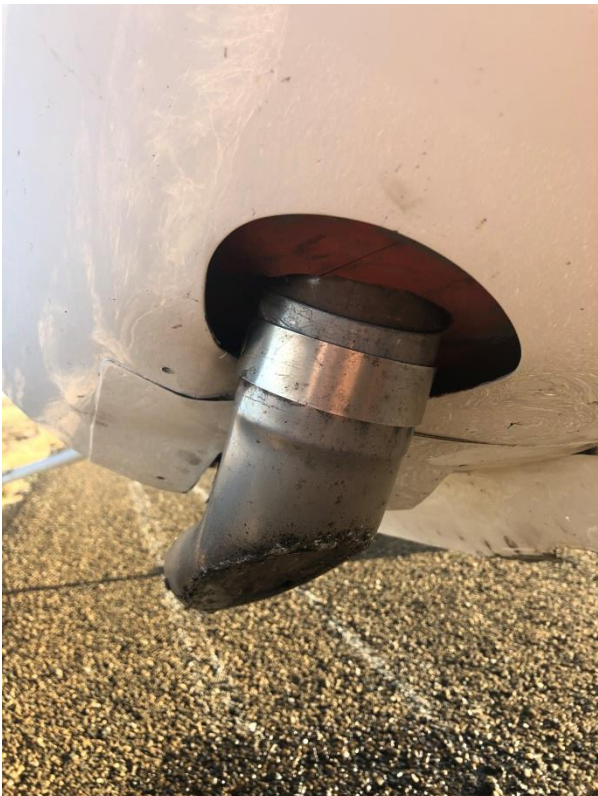
Figures 5 and 6: Damage on the exhaust (left) and propeller blade tips (right).
